SOUTHWESTERN MONUMENTS
SPECIAL REPORT

NO. 10

REPAIR AND RESTORATION
OF TUMACACORI-1921

FRANK PINKLEY

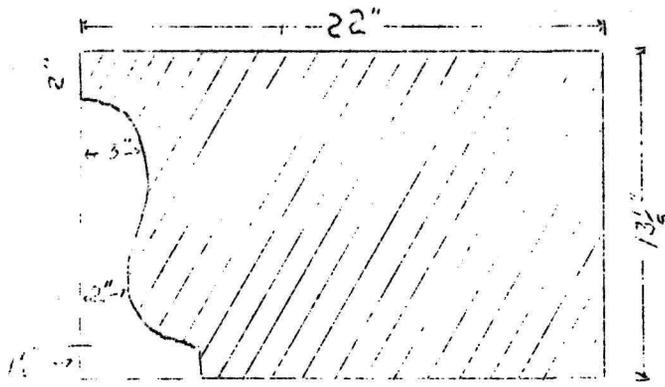
FIG. 1 - Cornice Brick
3" Thick

These cornice bricks, you will remember, were about 13 x 22 inches in size. We found that the simple method of laying the brick flat, covering it with mortar and then turning it up into place, would not work at all. The common run of mortar was too stiff to work down between the bricks if we stood them in position and then tried to fill the cracks. We next mixed the mortar to the consistency of a thin slop and tried pouring it between the bricks after they were set in position. Being so thin, the mortar promptly ran out of the crack at both ends of

the brick. We finally found that two men could work best on this job. The mason would set up the fresh brick at the proper distance. The helper then held a board over the crack at the back end and a special mould cut to fit the front curve, over the front end of the crack, while the mason upset half a bucket of mortar into the crack. In less than half a minute the mortar was set enough to allow the boards to be removed and the process could be repeated on the next brick. Since each of the bricks had to be lifted, carried, set and lined up, separately, it will be readily understood that a good bit of time was consumed in laying these cornices.

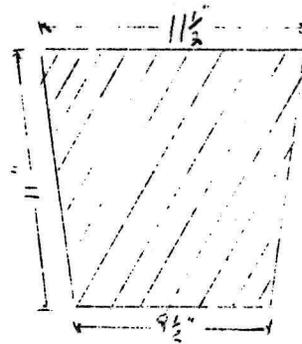
FIG. 2 - Wedge Shape
Scant 3" Thick

The wedge shape brick shown at Figure 2, Plate I, gave us considerable cause for study and it was the better part of two months before we finally decided upon the reason for its shape. Architects, engineers, and contractors, all declared it was built for an arch brick, but all the arches in Tumacacori are built of the plain mission adobes. The wedge shape brick was found too in places where its shape could not be accounted for. It was used on the shoulder or offset of the outside walls, in the pediment on top of the front wall, and one or two other places where the 8 by 16 brick would have given more satisfaction.

The explanation finally arrived at was that it was a dome brick put to a secondary use in all the places we had been finding it. Upon this theory we experimented and found that the bricks laid flat, side by side, with the small end of the wedge pointing inward, formed a circle about seven feet in diameter. Smaller or larger circles could be made by making the cracks between the bricks wedge shaped, at the outer side for smaller circles and at the inner side for larger circles, so that a dome of any size could be started and gradually drawn in at the top without using false work underneath to support it during construction.

We arrived at this solution of the problem of the wedge shaped brack too late to keep us from burning a supply of them, so while it was not really necessary, we restored the wedge shaped brick where we found it had been used with the exception of the pediment at the top of the front wall where we considered the 8 by 16 size stronger for the purpose.

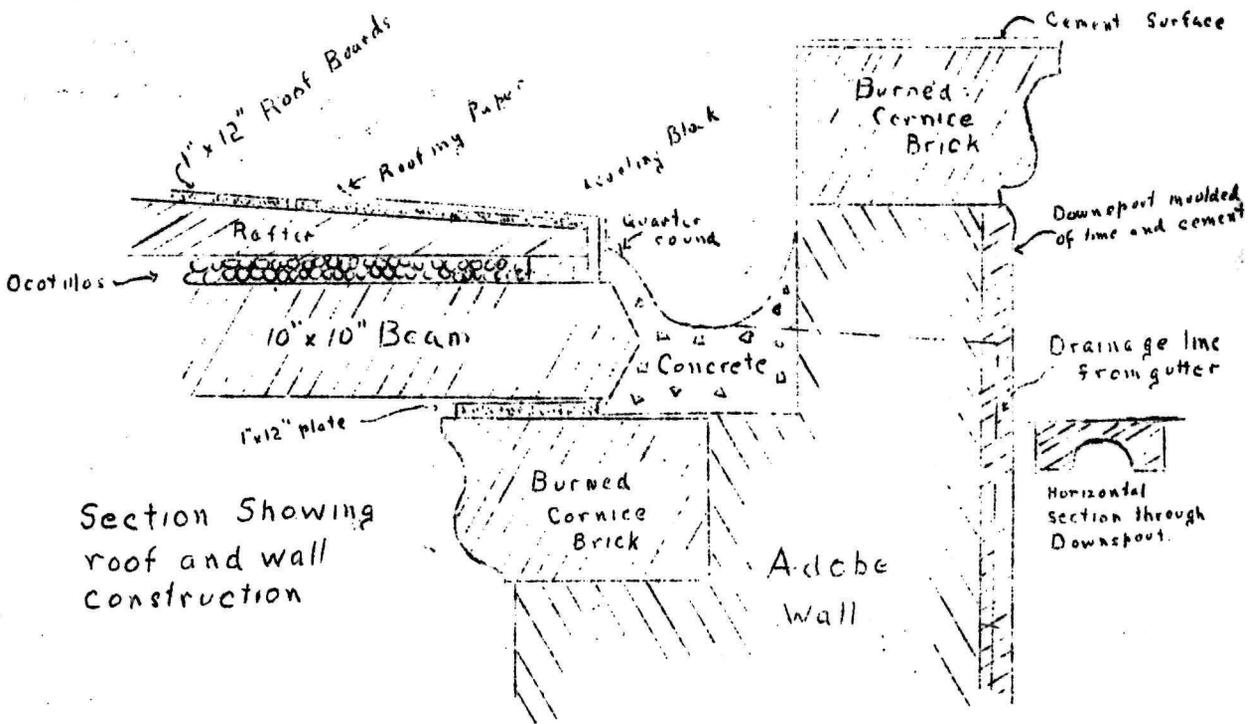
Section Showing
roof and wall
construction

As is stated on page 10 the roof drainage was handled by means of 18 downspouts. Nine of these took care of the water from the roof of the nave, five on the west side and four on the east side. These drains were all in bad condition and we had to repair what was left of them as well as extend them up over the new wall which we had built. They were originally made of lime but we used cement for restoring them. The water comes into these drains from the bottom of the gutter by means of openings just under the cornice of the parapet as is shown in the detailed drawing of the roof and parapet construction in Plate II.
