MISSION

SAN JOSE DE TUMACACORI
CHOIR LOFT PROBLEM

THE TUMACACORI CHOIR LOFT PROBLEM

By Frank Pinkley and J. H. Tovrea

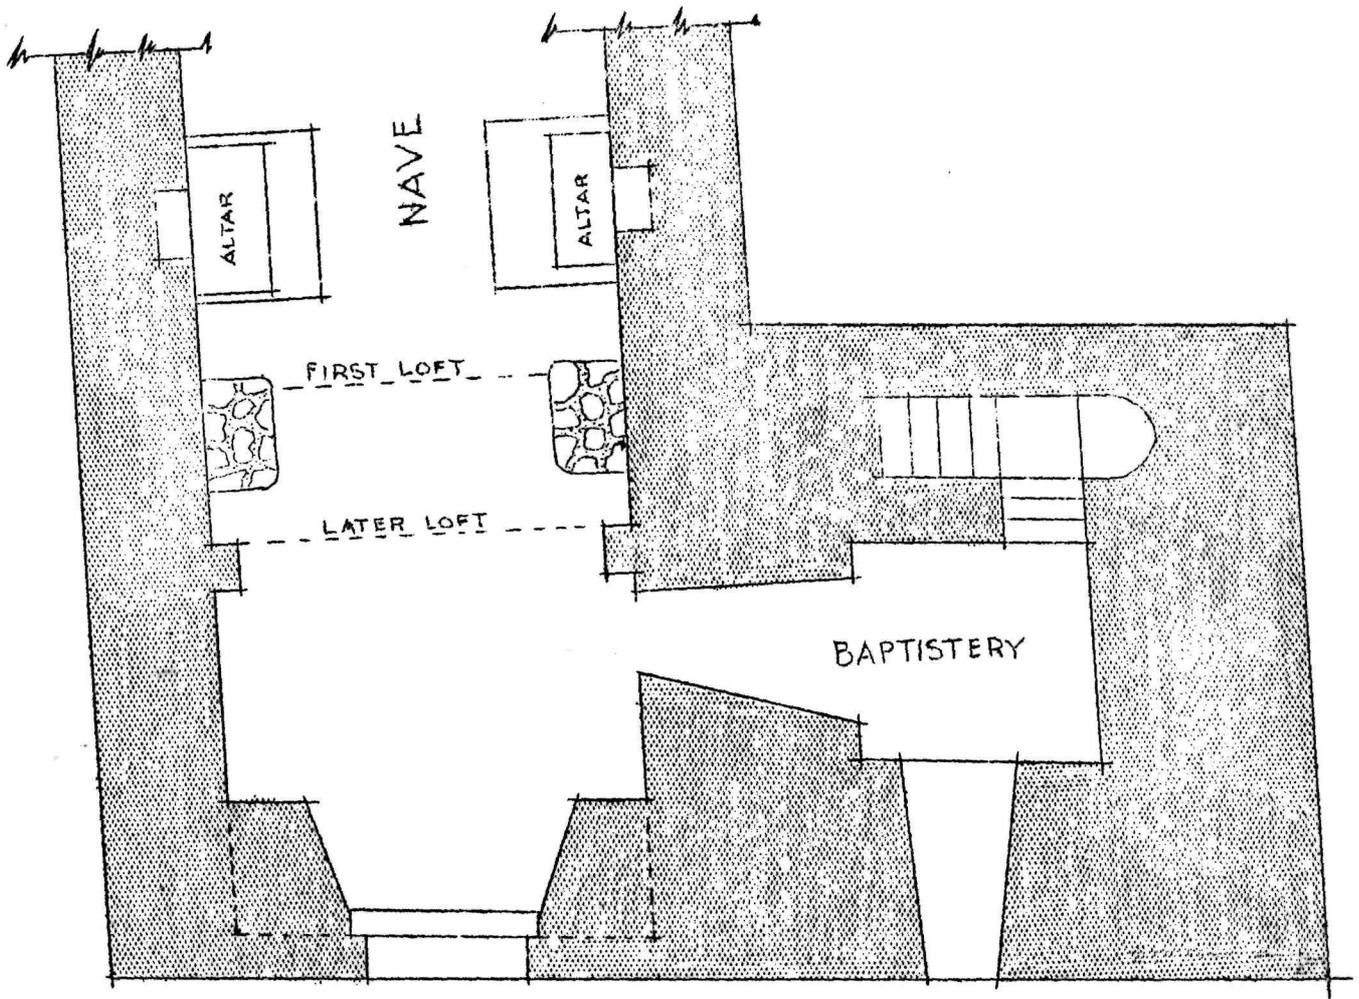
PLATE 1-PLAN.

Mr. Beaubien's report on his excavations of 1935 will disclose the plan of foundations which he discovered under the present floor of the church. (See Plate 1.) One of these foundations occurs on each side of the room directly under each of these triangles.

It will be noted on the plan shown in Plate 1 that the axis of the passage into the Baptistry is not centered on the Baptistry. The inside end of the passage is centered on the axis of the Baptistry but the outside end is not centered between the present pilaster and the corner of the church, but is centered between the supposed older choir loft pilaster and the corner of the church as is shown in Plate 3. This, to us, is strong evidence for an older choir loft. It would be hard, with the labor then at hand, to build an arched passageway, keyed with adobe bricks, having a large arch at one end and diminishing to a small arch at the other. It would have been considerably harder to move the outer end of the passage a foot or more to the left and then bring the arched ceiling through, diminishing from a large end to a small end on that warped line. Yet they went to this extra amount of trouble and care. We think the desire to center the outer end of the passage on the center of the transverse vault of the choir loft while leaving the inside end centered on the axis of the Baptistry, is the only possible cause for this peculiarly shaped passageway.

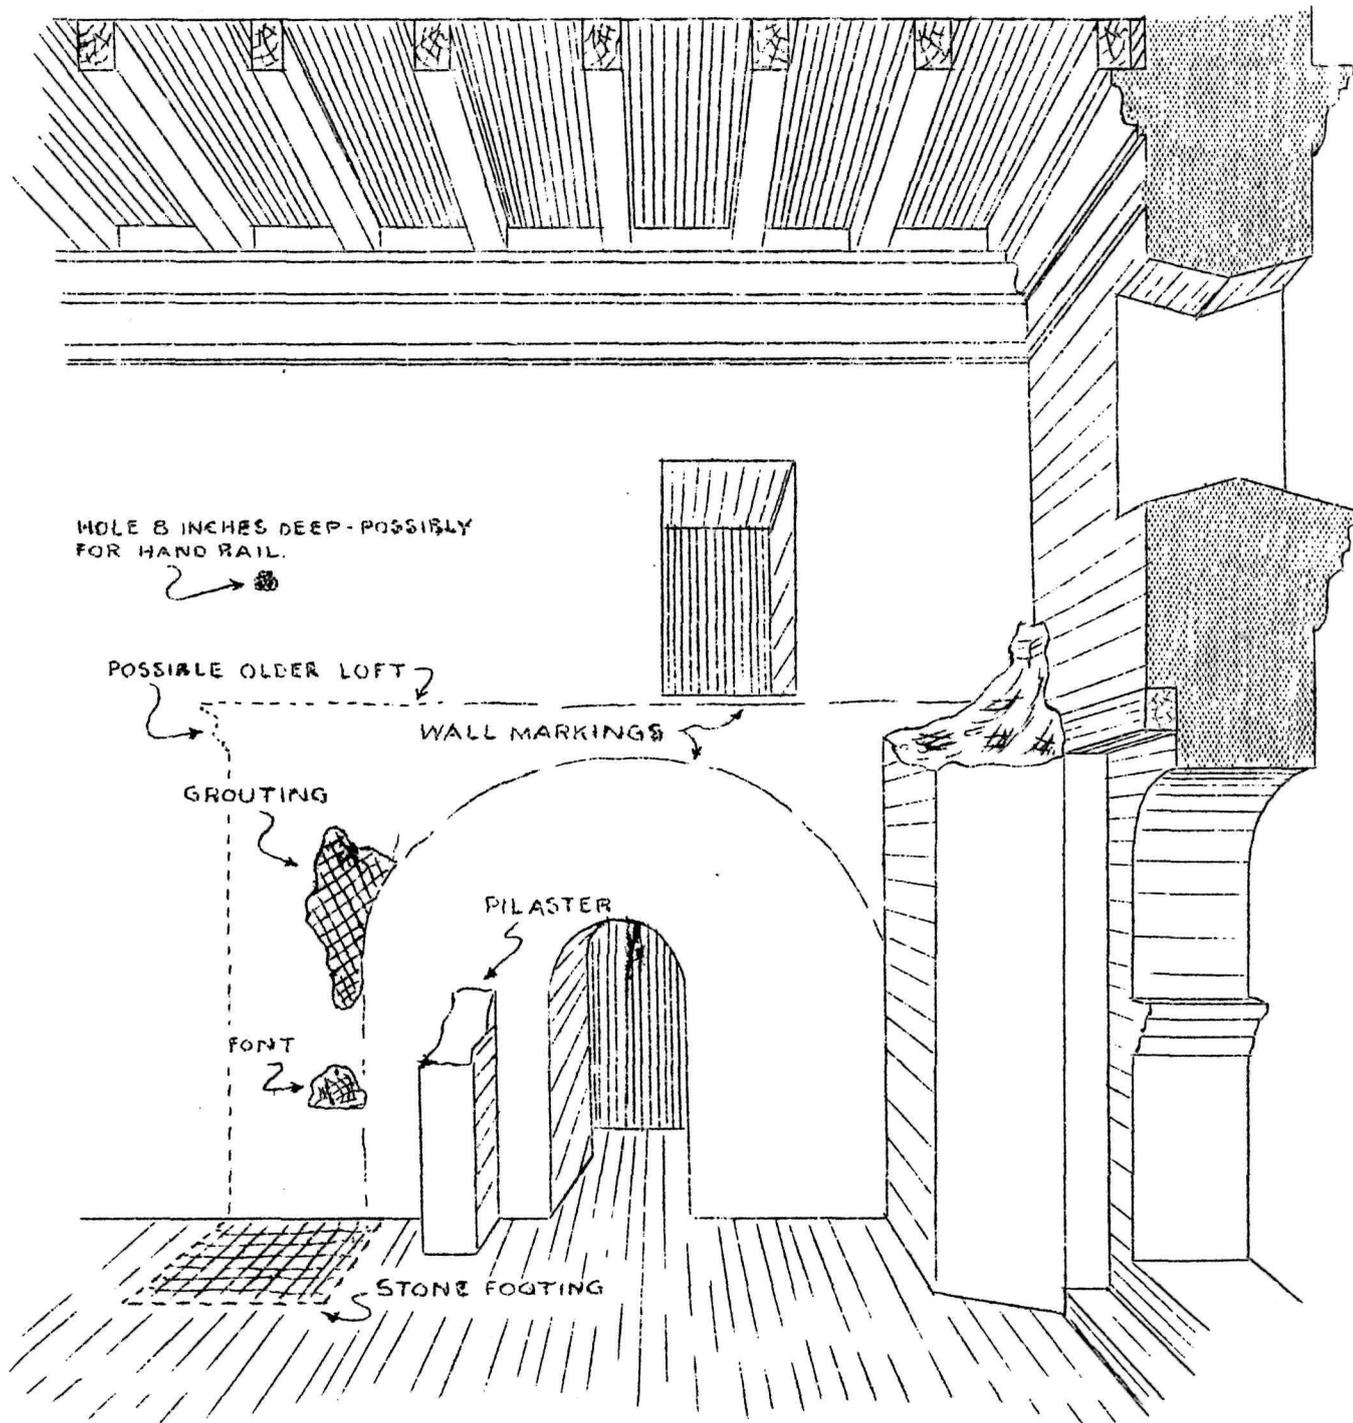
PLATE 2.
 EAST WALL.

front wall some twenty-five feet to the north, and from the floor to the roof. The present condition of this wall is shown in Plate 2. The view is from the west side of the room looking east and shows the large buttress to the east of the entrance doorway at the right side of the picture. To the left of this buttress can be seen the entrance archway to the Baptistery and further to the left is the pilaster which once carried a choir loft arch. Above the archway to the Baptistery is a doorway opening from a second story passage in the tower on what was once the choir loft floor.

The choir loft arch was standing as late as 1889 and we have a picture of it taken that year from a point about under the triumphal arch at the front of the nave. Above and a little to the left of this pilaster will be seen a peculiar curved effect in the wall construction where the plaster has broken away enough to expose it. Closer inspection will show that this curve is roughly centered on the curve of the Baptistery archway. From the high point of this curve, a little below the choir loft doorway, a horizontal line can be seen running to the left and meeting a vertical line which falls vertically parallel to a tangent to the left end of the curve. This triangle, if you will pardon the slightly inaccurate expression, has been the source of hours of study, worry and conjecture on our part. It was originally filled with a grouting of lime mortar, stones and an occasional brick bat. About half of this filling has long ago broken away and disappeared, the remainder is still embedded in the wall. It is totally different from any of the wall construction near it and lies in what appears to have been a plain piece of wall. An examination of the opposite wall of the church discloses the same condition on that side although the plaster, being in a much better condition, covers most of the triangle.

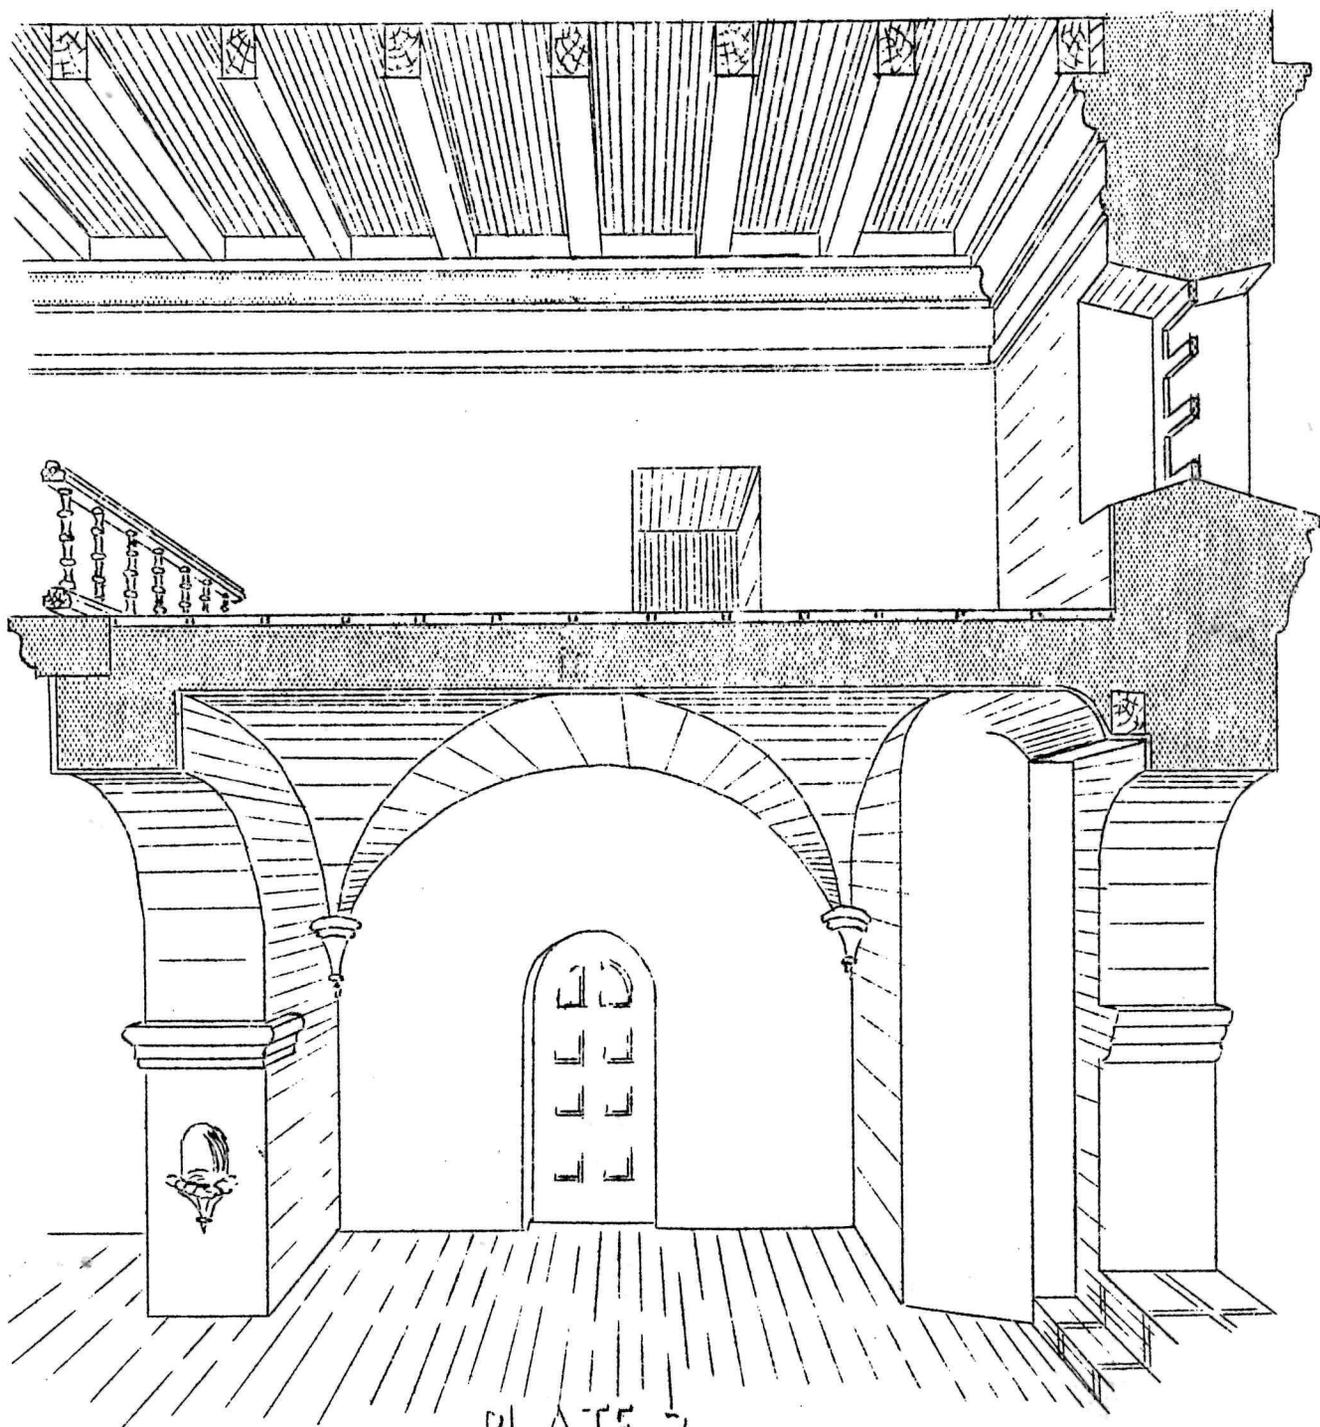
PLATE 3.
THEORETICAL GROIN VAULTED
CHOIR LOFT.

think it indicates the line of vaulting of a groin vaulted choir loft. Groin vaulting would account for the extra thickness of the choir loft arch, because there would be a thrust against it and its thickness would help to keep it from overturning. This would also account for the two large buttresses in the south corners of the nave, for they would help to carry the thrust of the vaulting against the front wall of the church. Groin vaulting would likewise account for the grouting of lime mortar and stones remaining in the triangles in the walls of the church, for the vaults might have been formed of lumber and filled with the grouting, not unlike we would handle the job with concrete today, in which case the builders might have dug back into the church wall in order to give this grouting a chance to key into the wall, thus getting a better hold against the corner thrust. They might at the same time have keyed the grouting into the choir loft arch itself and when that arch was destroyed or taken down a section of this grouting fell out, accounting for the missing piece which is now gone from the church at the front of the loft.
