UNITED STATES DEPARTMENT OF THE INTERIOR

NATIONAL PARK SERVICE

August 4, 1969

Subject: Report on "The Blue Duck," Acadia NP

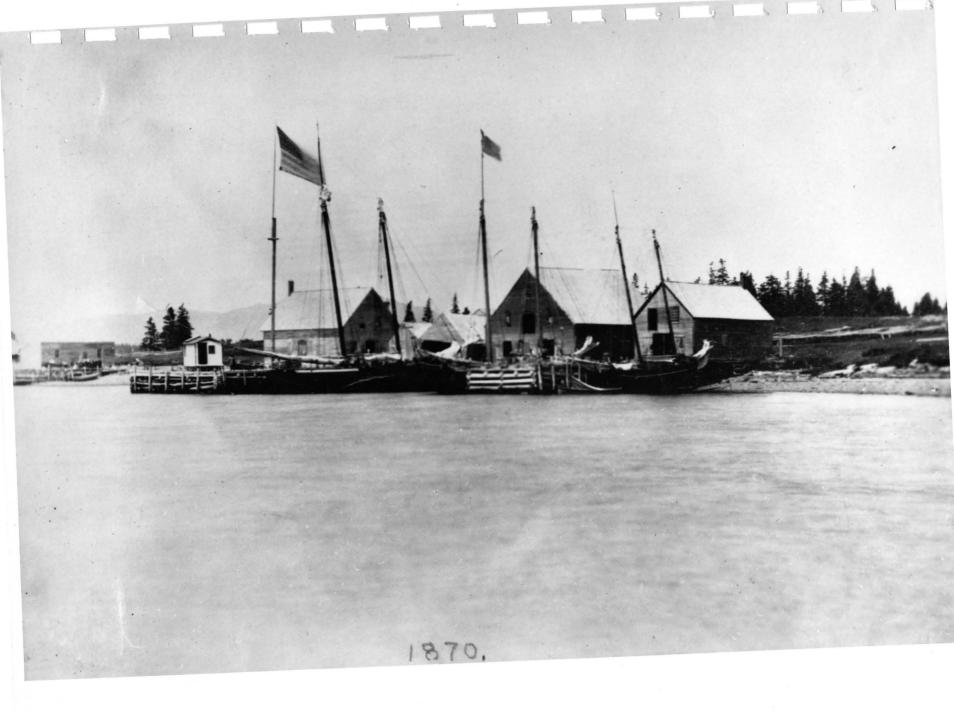
Oldest known photograph taken of "The Blue Duck" which is the building to the left having the single end chimney. Notice seemingly lack of windows along the south or waterfront side of the structure. Building in center (gable facing water) was buildt in 1808, and was the first Samuel Hadlock store.

Photograph by: Mr. Bragg (Tintype) July 4, 1870 Copy negative in Acadia NP

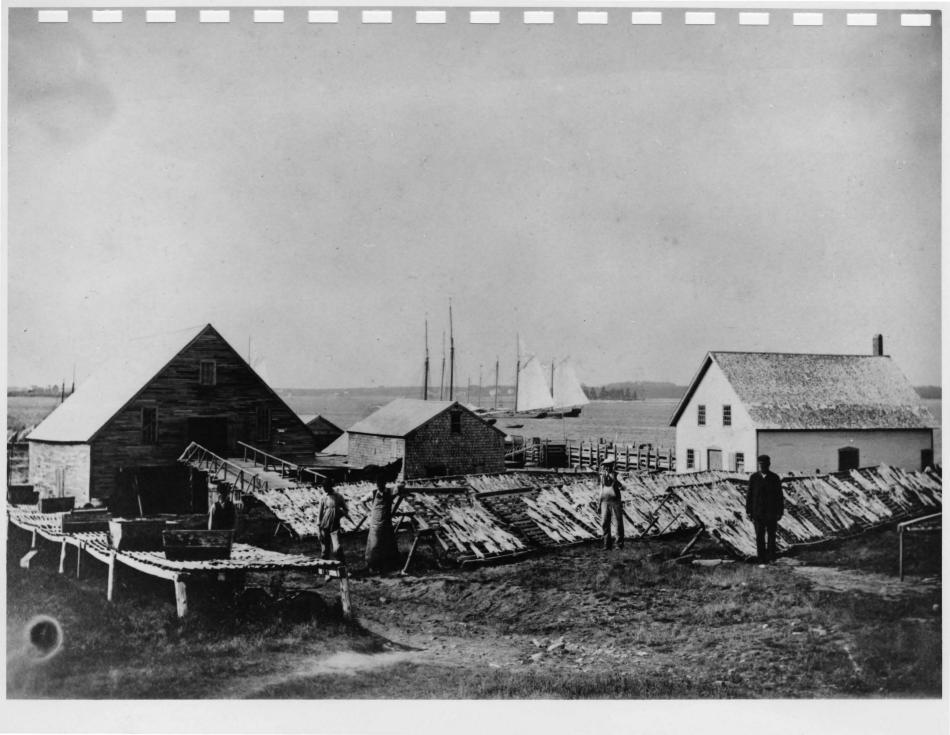
View from the northwest. Location of window and door openings on west gable end remain unchanged. Center double doors, north wall, remain unchanged but single doorway near east end has been removed. Pamphlet dated 1916 was found under short floor boards on 2nd floor indicating the original stairway could have been removed at this time. Dark color of double doors suggest no glass in doors but there is a possibility that removable blinds could have been used to cover glass for protection. Notice 6 over 6 light window sash, wooden shingle roof with comb boards.

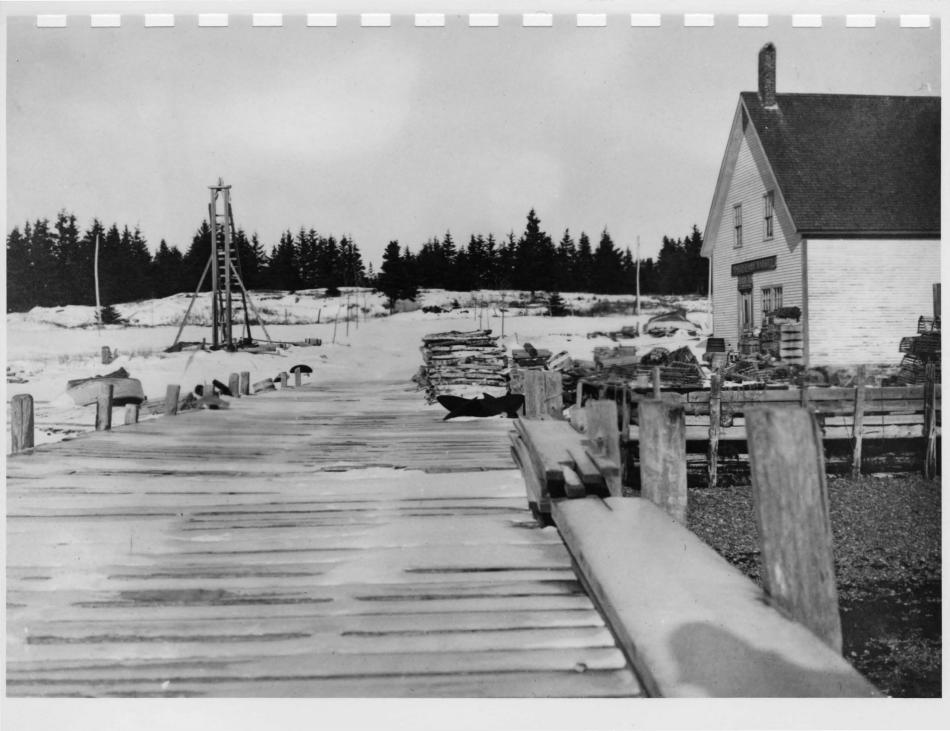
View of southwest end of building. Notice sign over door "Islesford Market." Window sæsh are still 6 over 6 lights. It appears some changes have been made to 1st floor door and window openings in the west end; more architectural study needs to be done to determine the original conditions. The window opening and blind on the south wall may be a later addition when compared to the windowless wall in Illustration No. 1. The brick museum built in 1927 centers in line with the wharf of this view.

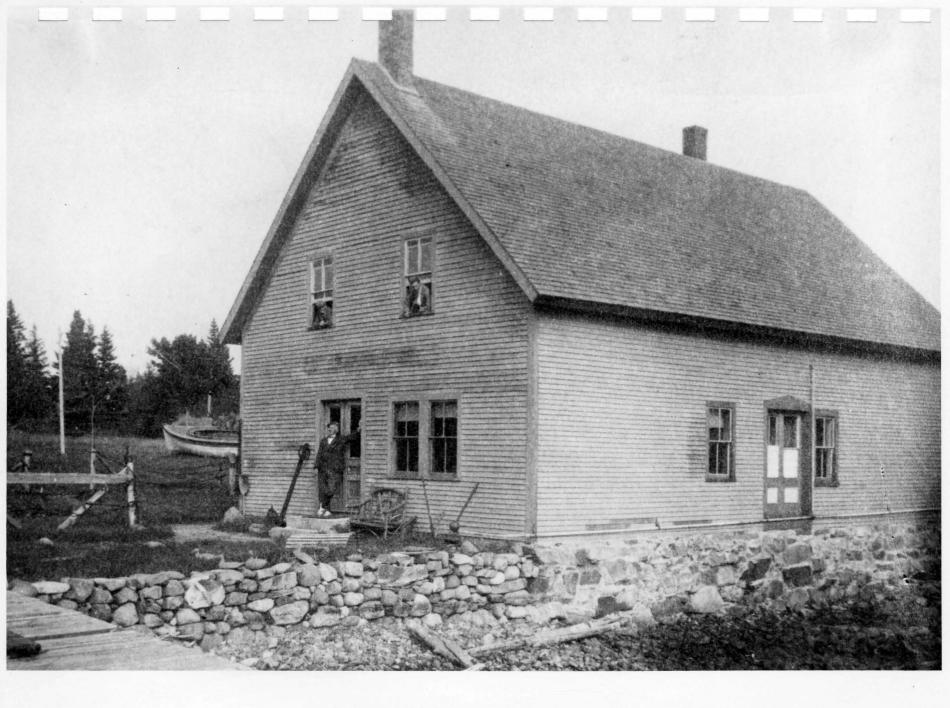
William Sawtelle standing in west doorway of "The Blue Duck." The far chimney was added between 1900 - 1908. The old 6 over 6 light, double hung sash have been removed and replaced with 2 over 2 light sash. In the south wall, an additional window opening was added right of the doorway and the double doors altered. The blind has been removed from the left window (south wall). Notice the pointed trim board above the door which is not part of the narrower double door in the west end. The level of the rocky beach along the foundation wall appears to be about four feet below the foundation sill. Today this depth has been reduced to about thirty inches or $2\frac{1}{2}$ feet.

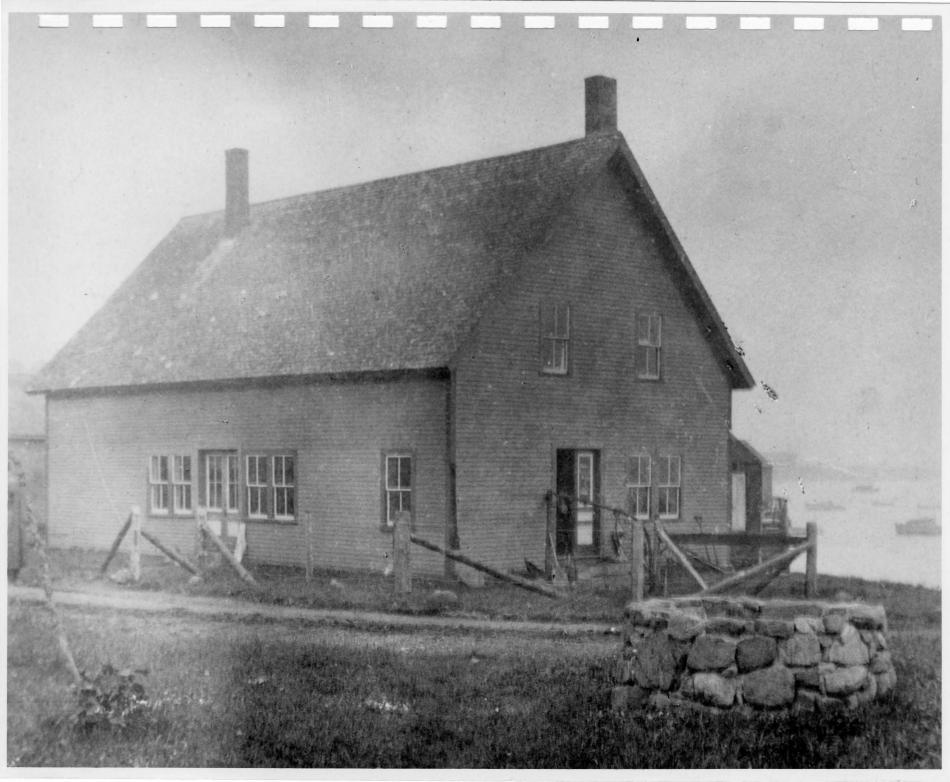
View from northwest showing additions and changes to the window and door fenestration. The original single door leading to the narrow stairway in the northwest corner has been removed and a single window cut into the wall immediately to the left. Two window openings have been cut on each side of the north double doors and paint applied to the sash and doors. The arched chimney cap has been removed. The old road leading to the wharf can been seen in the foreground. Recently dug well shows in lower right. Sign on glass door reads, Islesford Historical Society.

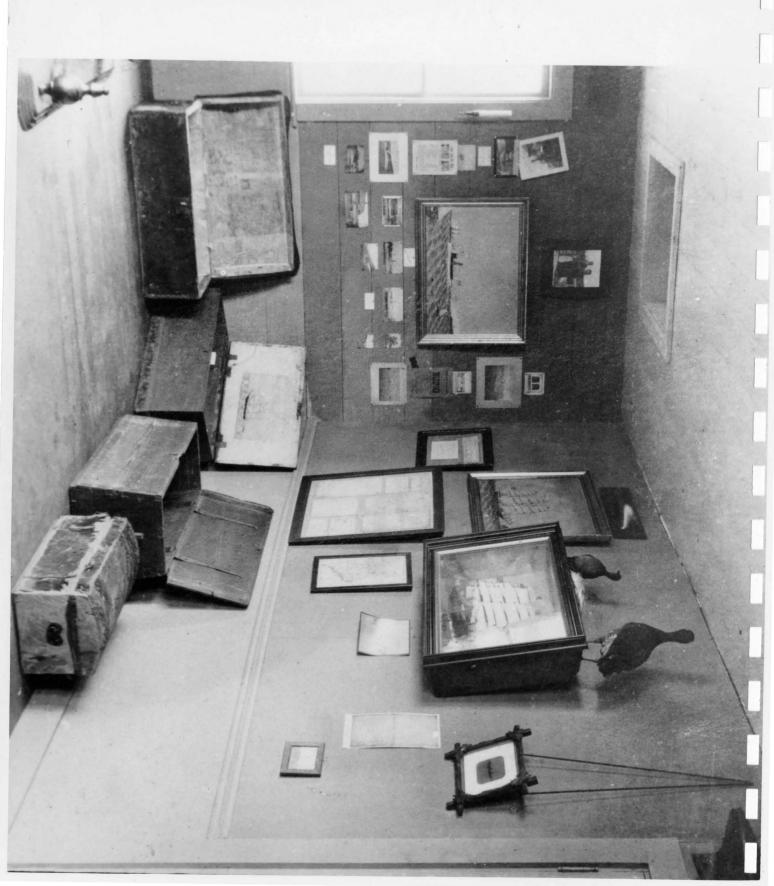
Interior view of west room, 1st floor, looking northeast, two weeks after exhibits of local island history had been arranged. The wooden wall and ceiling boards (excluding the new partition and wainscot) are probably the original room finish. Ceiling scuttle may be original. Window opening dates to about 1916. The partition probably dates shortly before photo was taken in 1919. A small stove appears in the left foreground.

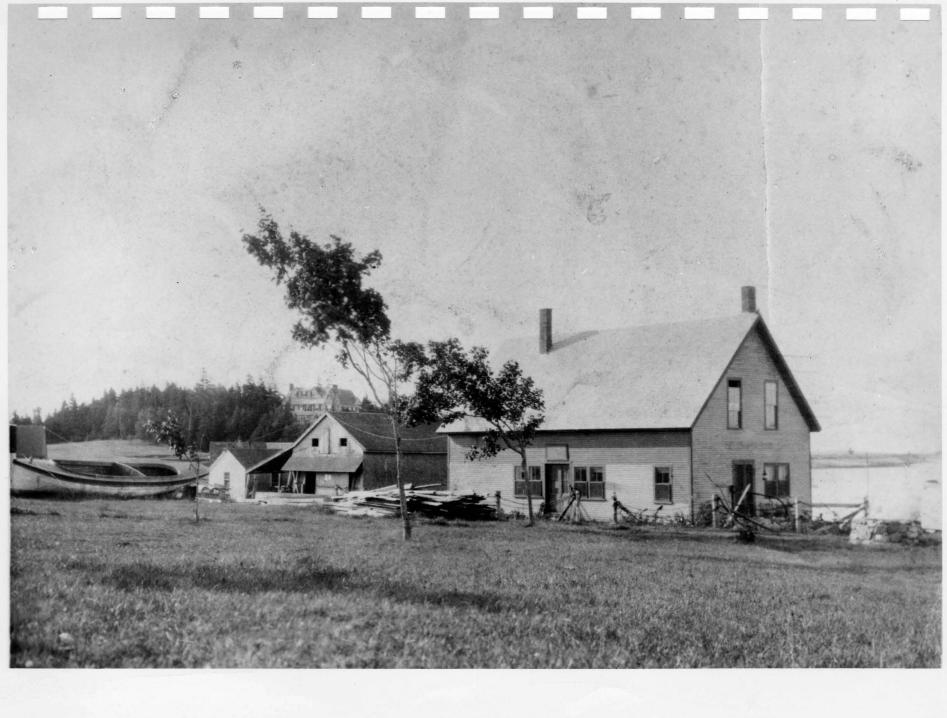
View from the southwest approximately where the 1927 museum stands. The old store of 1808 was removed sometime after 1900. To the east of "The Blue Duck" is the old coal wharf, still standing. Notice that there are larger 2 over 2 light sash in the west gable end, 2nd floor. Why longer sash were needed is not known.

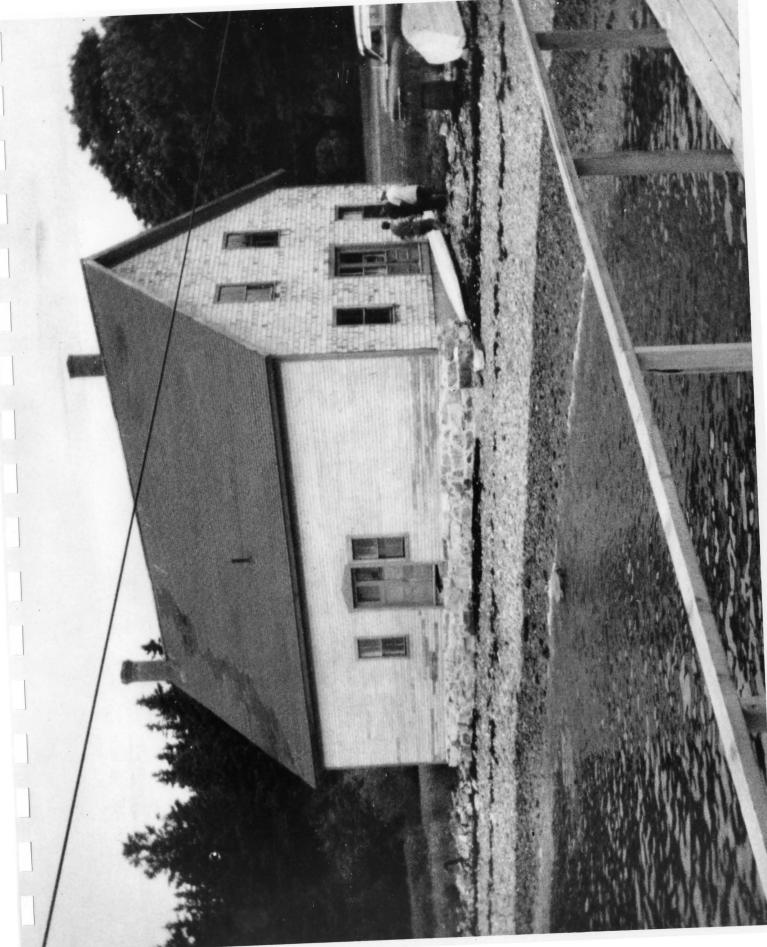
are supported at third points by 12" unpeeled hemlock logs surfaced on the top and bottom sides. These joists, stringers, and floor boards are in very good condition but are kept kamp along the south wall by sea water seeping through holes in the foundation wall. This condition should be corrected. The ground surface of the crawl space consists of smooth stones & gravel in clean condition. The south foundation sill under the south doorway has rotted away (perhaps more). This should have immediate attention as well as the south door sill; both pieces should be duplicated in size & shape when replaced.

where leaking occurs in the asphalt shingles.

Present day view of "The Blue Duck" as seen from the old coal wharf, looking northwest. The east gable end is now shingles over clapboards. The present roof is asphalt shingles, very deteriorated near the west end. Notice the rotted foundation sill under the south door. The structure is much like it was left in ca. 1920. The west wharf is gone as well as the short dock opposite the south double doors. The short beach between the coal wharf and "The Blue Duck" is the Town Landing, a public right of way. Vent stack in roof is for modern plumbing.

- 1. Repoint south stone foundation wall w/matching mortar.
- 2. Replace rotted foundation sill, south wall.
 - Replace rotted door sill, south doorway. Match original sill.
- 4. Paint clapboards white (white lead & oil, two coats).
- 5. Paint trim, doors & window sash, historic color (white lead & oil w/tinting colors, two coats).
- 6. Remove asphalt roof & replace with white cedar shingles (extra grade) having comb boards to match old photographs.
- 7. Protect 1st floor joists & foundation sill from moisture.
- 8. Replace poor clapboards where necessary & renail w/cut nails.

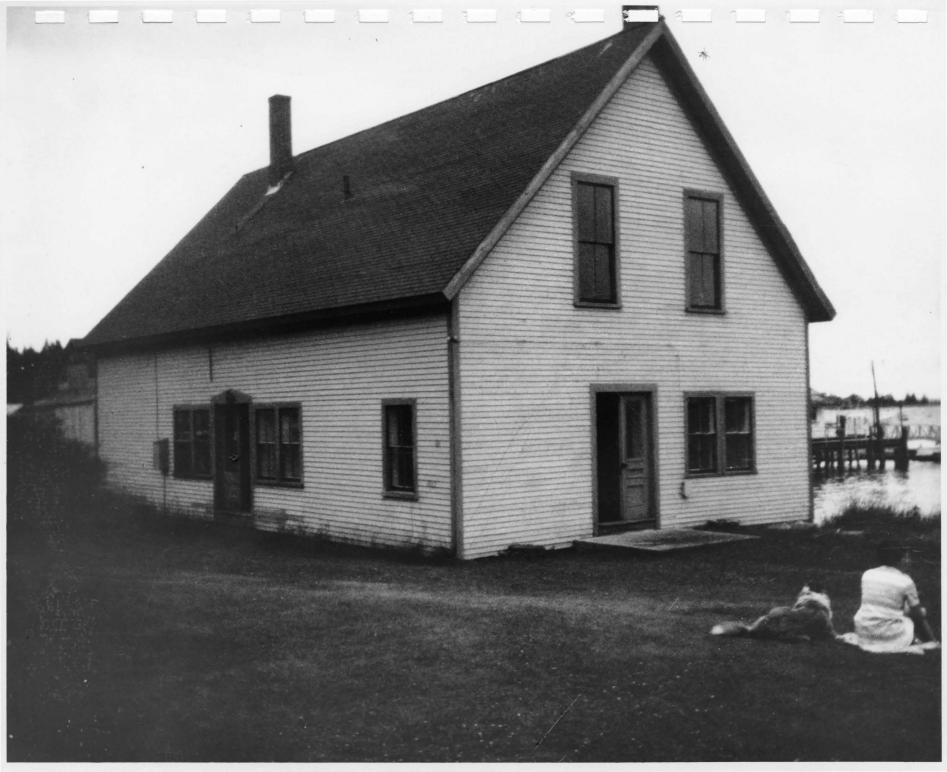
Present day view looking southeast. The ground elevation is approximately eight inches higher than 1915. The old road to the wharf has been obliterated. The west room, lst floor, is currently used as an access to rest rooms on the interior. Some exhibits are on display.

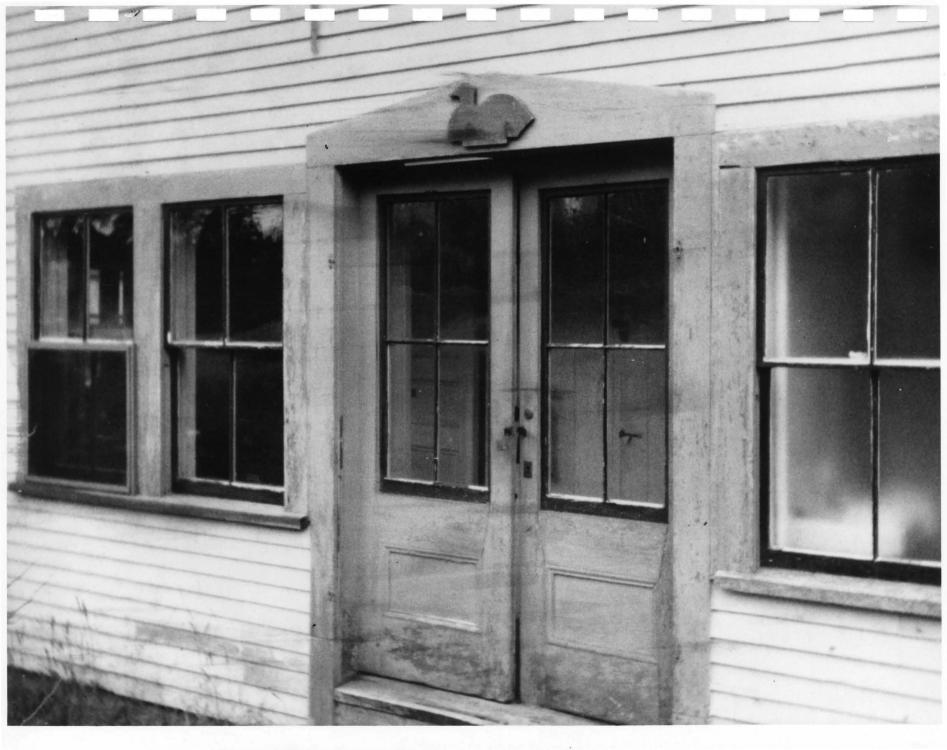
Symbol of "The Blue Duck" as seen over the north doorway. Notice unusual construction of lock rail in door. The glass in the doors seem to match the ca. 1915 window sash but the doors still have cast iron split leaf hinges and cast iron thumb latches that could date back to 1850. A wooden blind in the attic appears to be the size of the present door glass.
