Historic Structure Report

Baker Island Light Station

Acadia National Park, Maine

2013

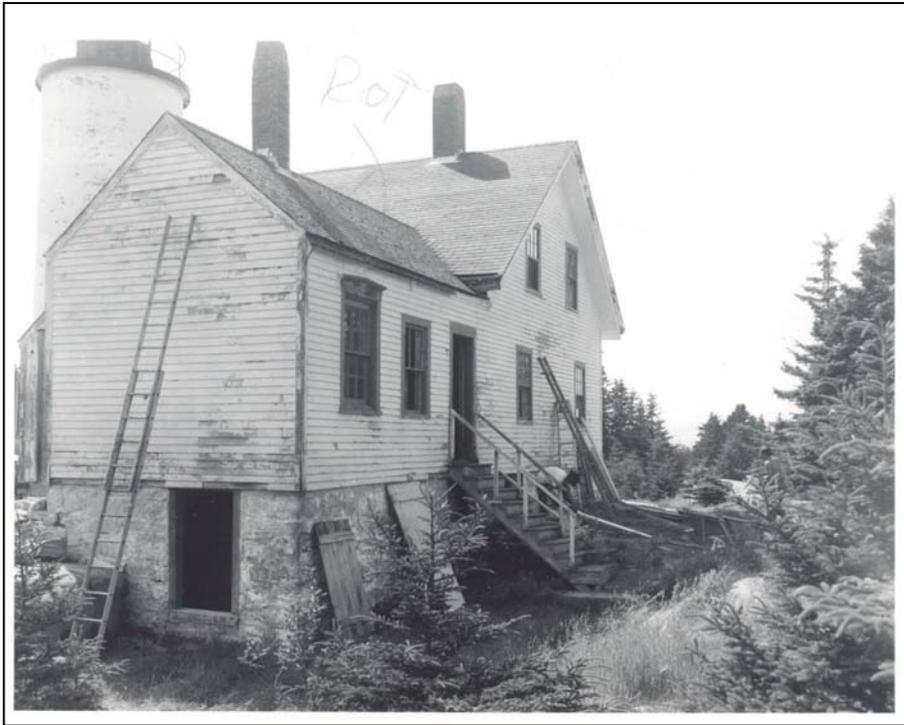
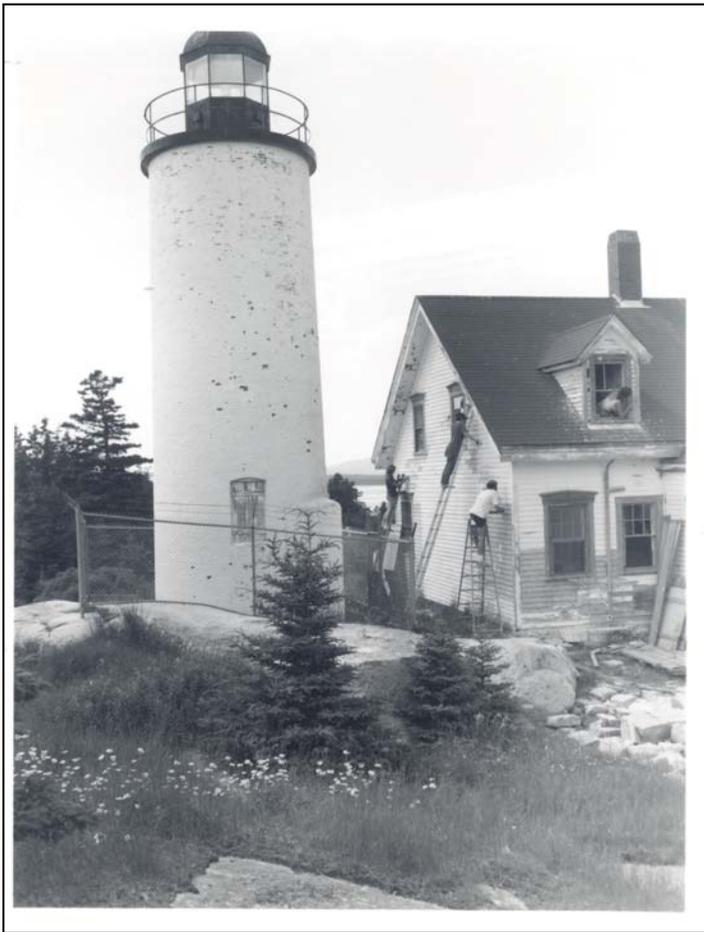
Figure 26. Exterior repair of the keeper's dwelling, by the National Park Service, 1974.

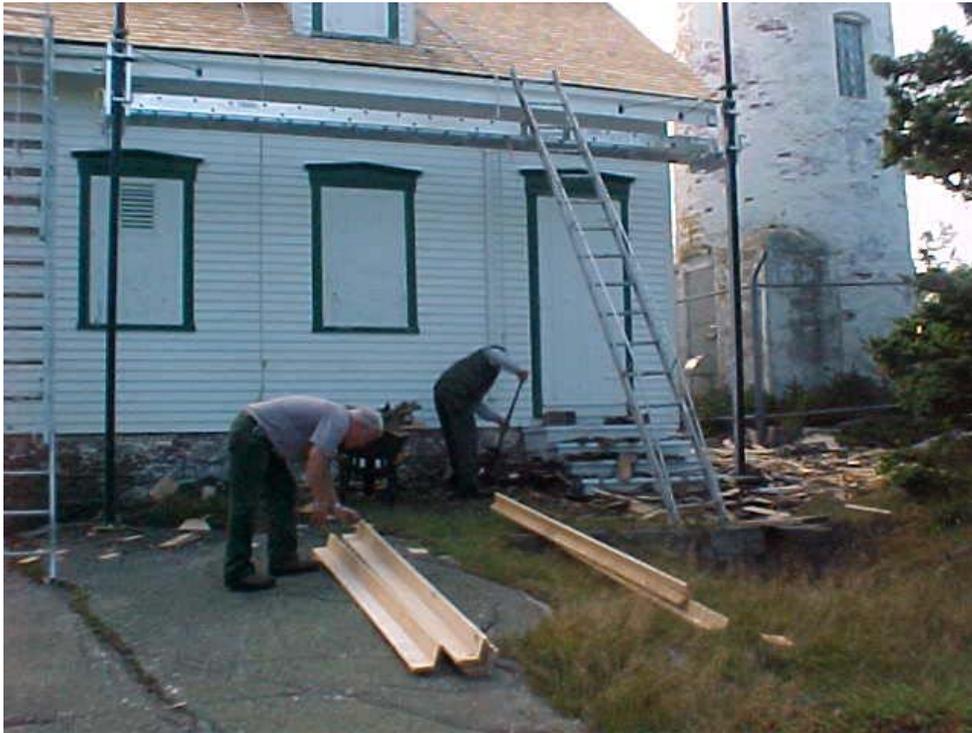
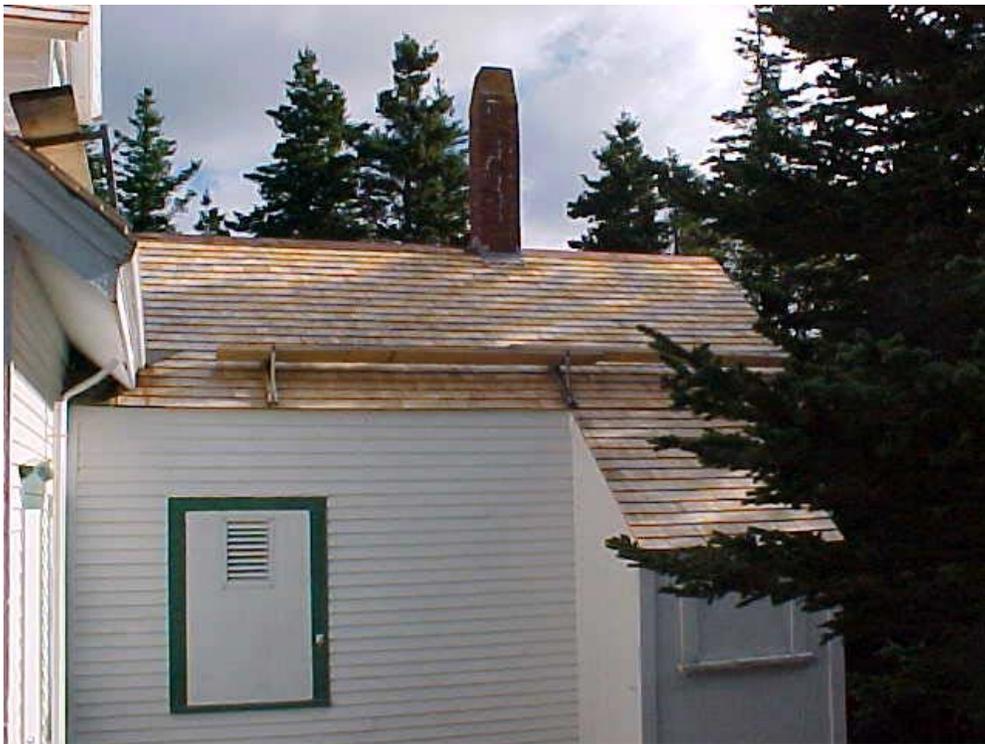
Figure 37. New wood shingle roofing for the keeper's house, 2002.

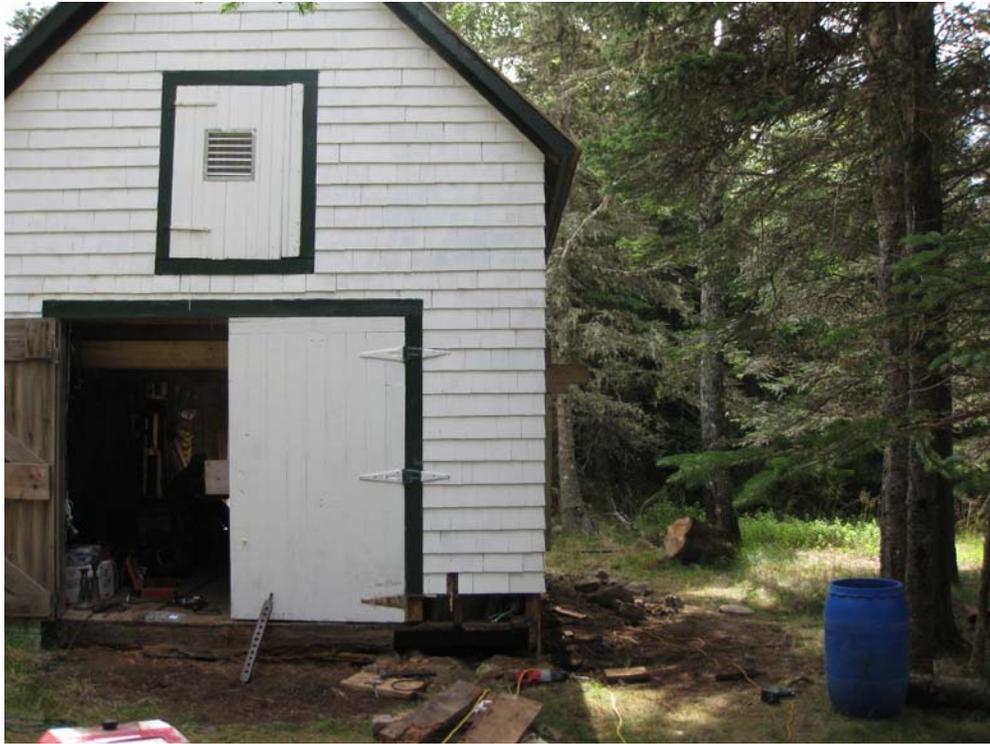
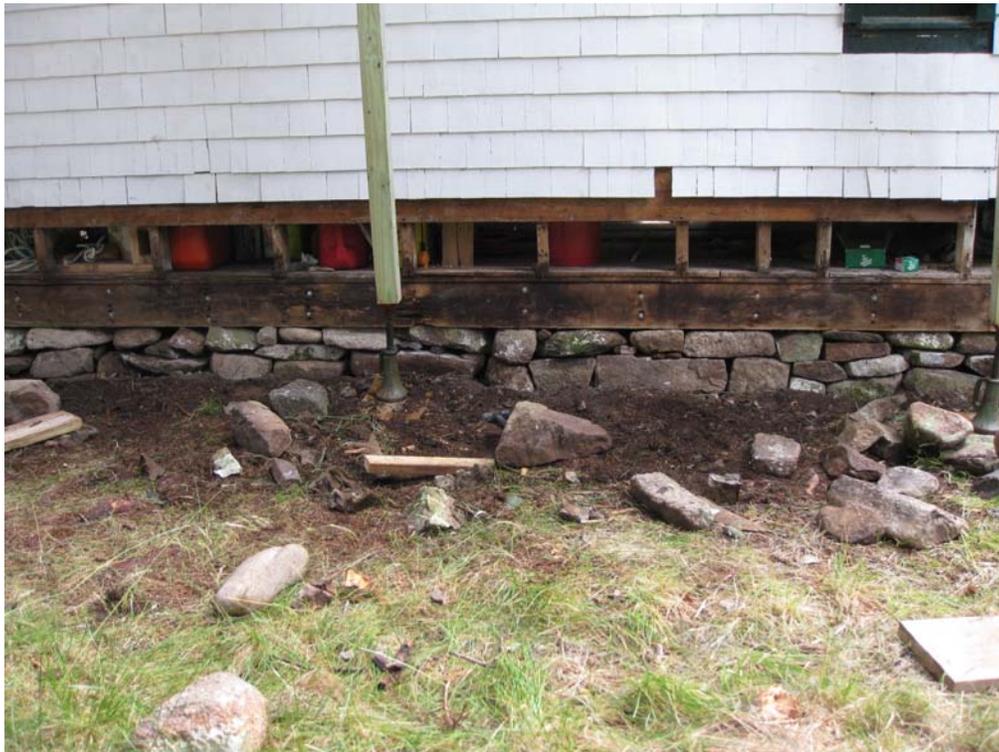
Figure 38. Repairs to the east and west sills of the garage, 2011.

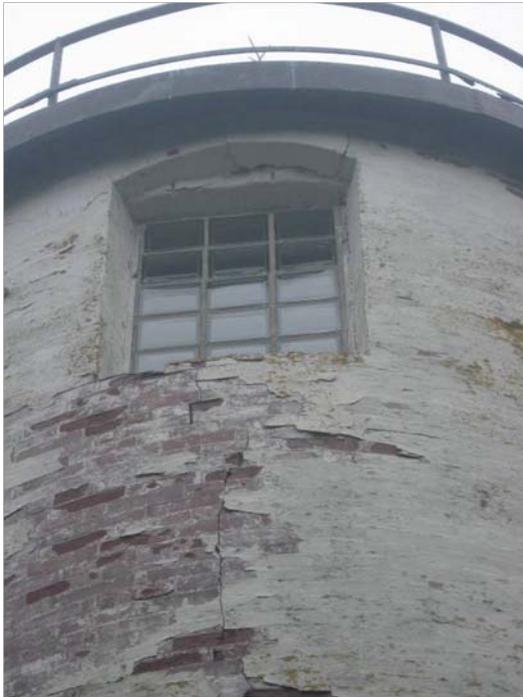
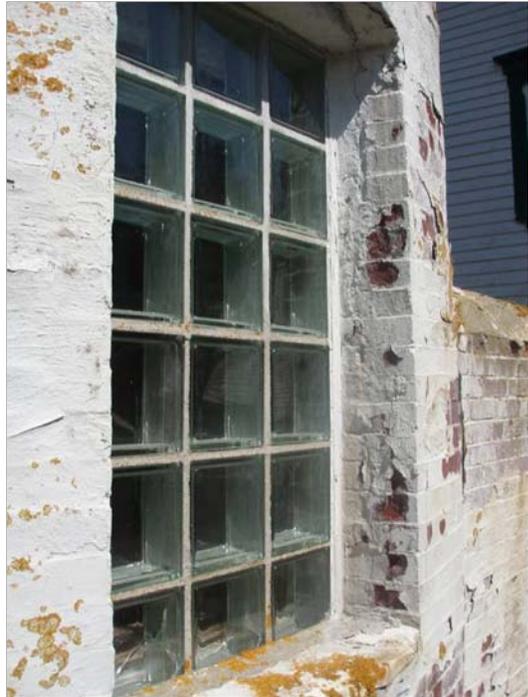
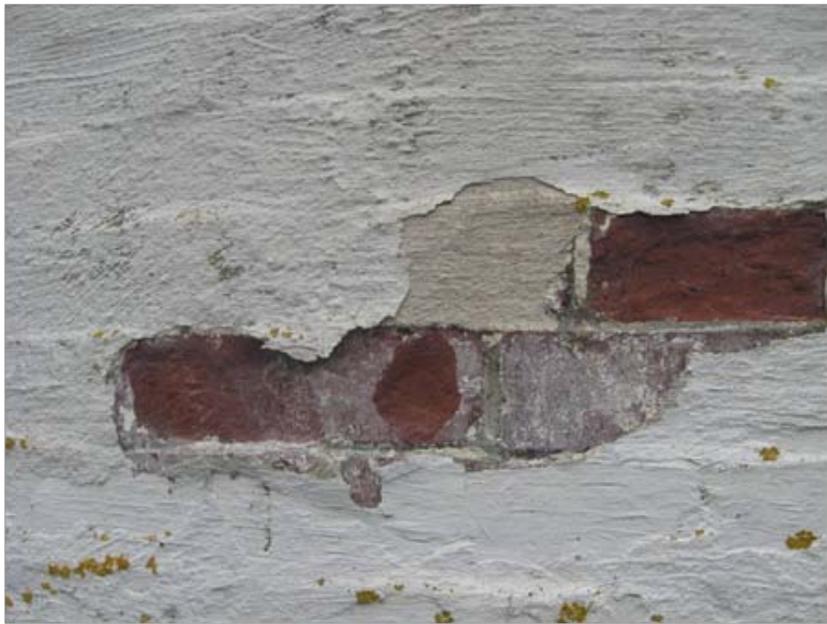
Figure 39. Deteriorating brick conditions recorded by an assessment of the lighthouse in 2008.
