**HISTORIC STRUCTURES REPORT**

**PART I**

**THE GREENHOUSE**

**Adams National Historic Site**

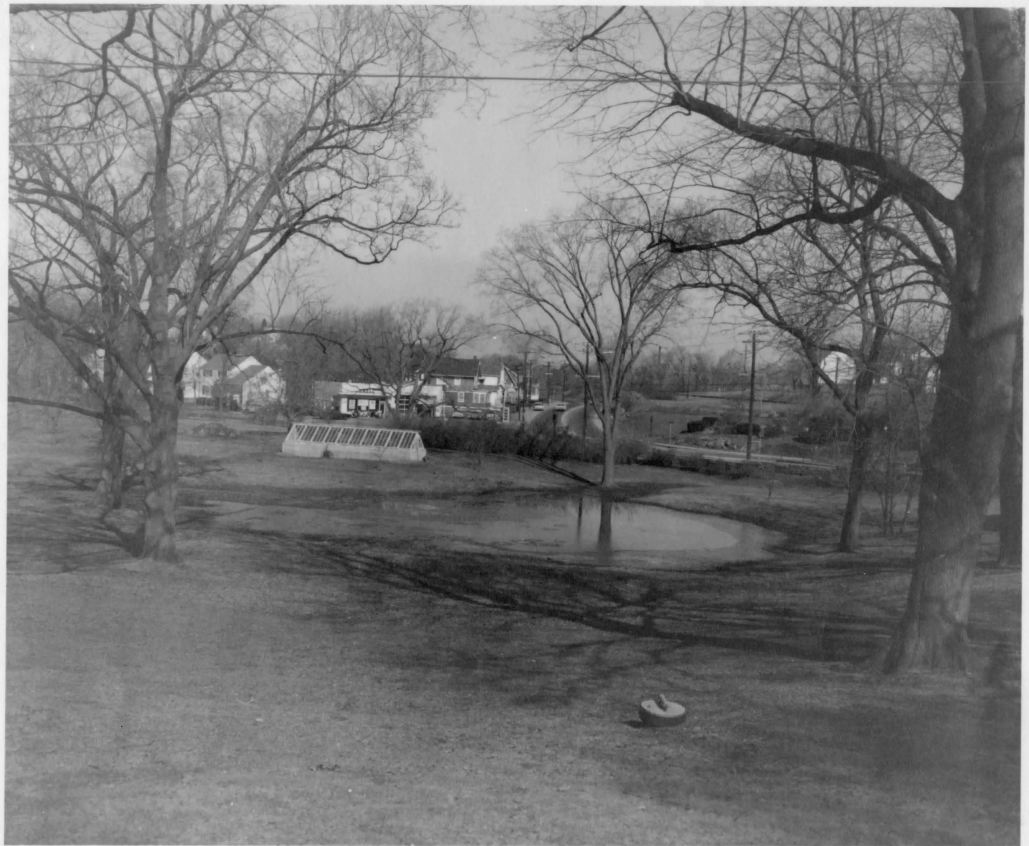
Illustration No. 1

- e. Concrete foundations and wood frame are in reasonably good condition. Some of the shelving and the posts supporting it are in poor condition with rot at the base of the posts. The floor boarding is in poor condition. The wood frame is in need of paint. The stove is broken.

View of Greenhouse from south.

- f. No additional work is required to complete architectural research and investigation. In the course of rehabilitation work it is proposed to patch the concrete foundations, reconstruct sections of the interior shelving and shelf supports, relay the floor, acquire and install a new stove, replace the sash with panes of the correct size for the historic period and paint the wood frame and sash.
