ALCATRAZ POST EXCHANGE

ABBREVIATED HISTORIC STRUCTURE REPORT
ALCATRAZ POST EXCHANGE BUILDING

ALCATRAZ ISLAND
SAN FRANCISCO, CALIFORNIA

October 31, 2001

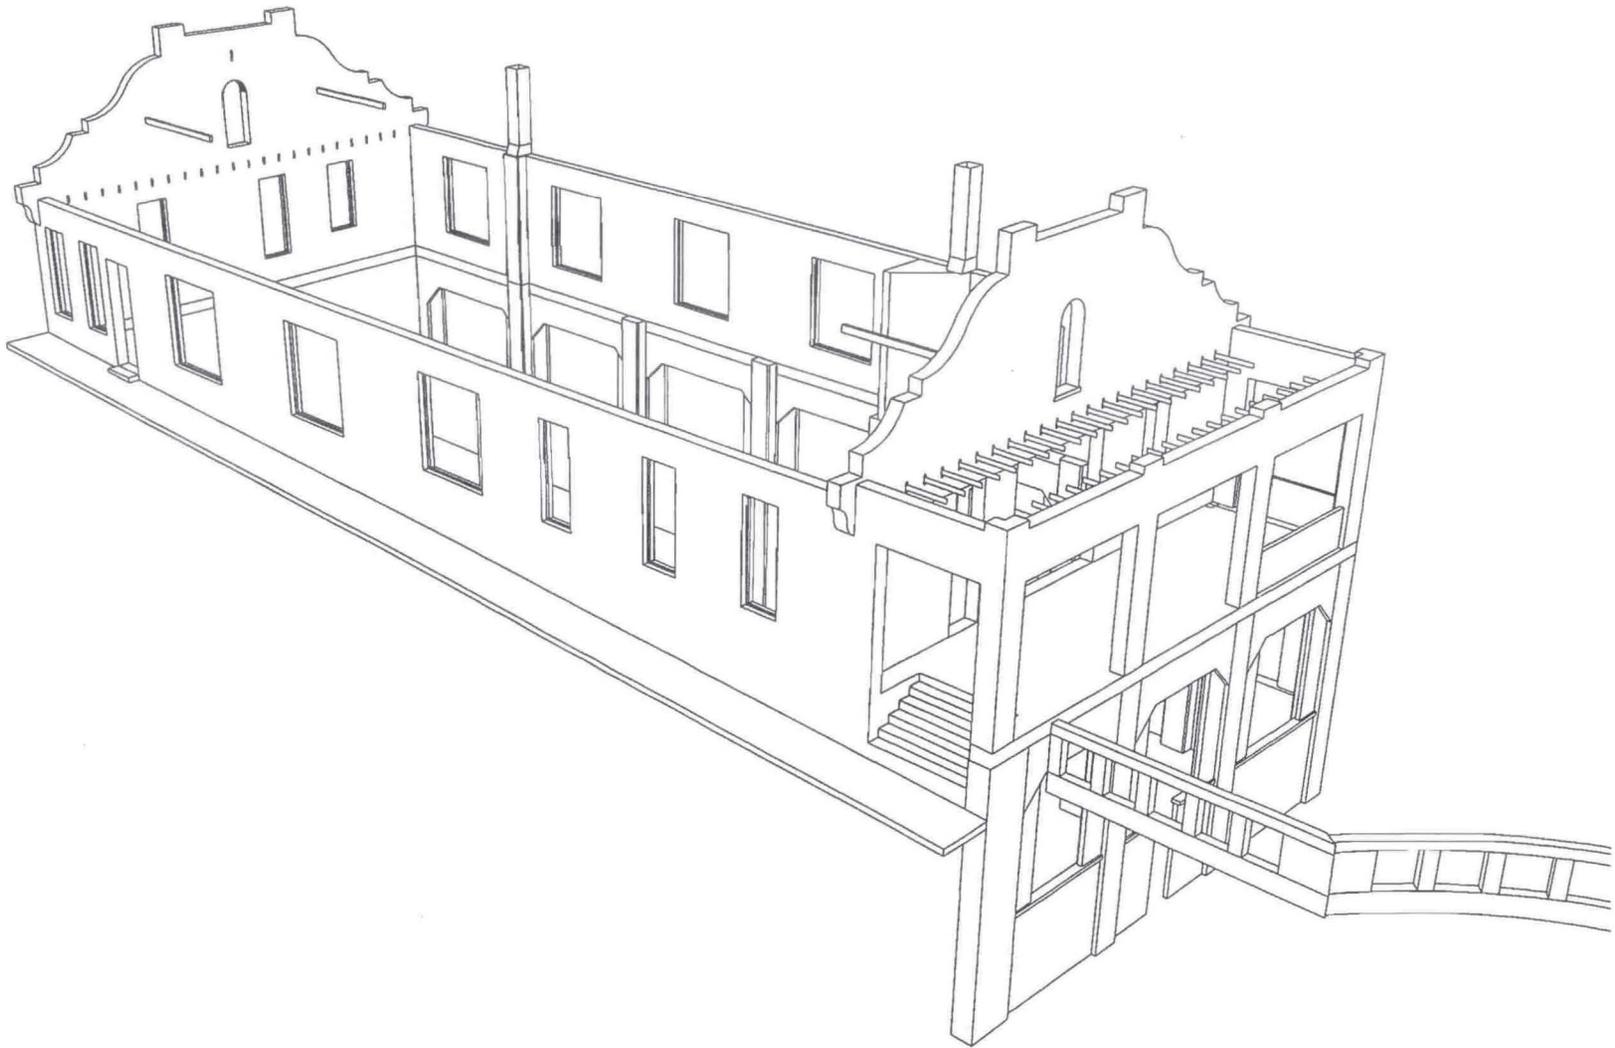
ALCATRAZ OFFICER'S CLUB BUILDING - PERSPECTIVE VIEW
EXISTING CONDITIONS

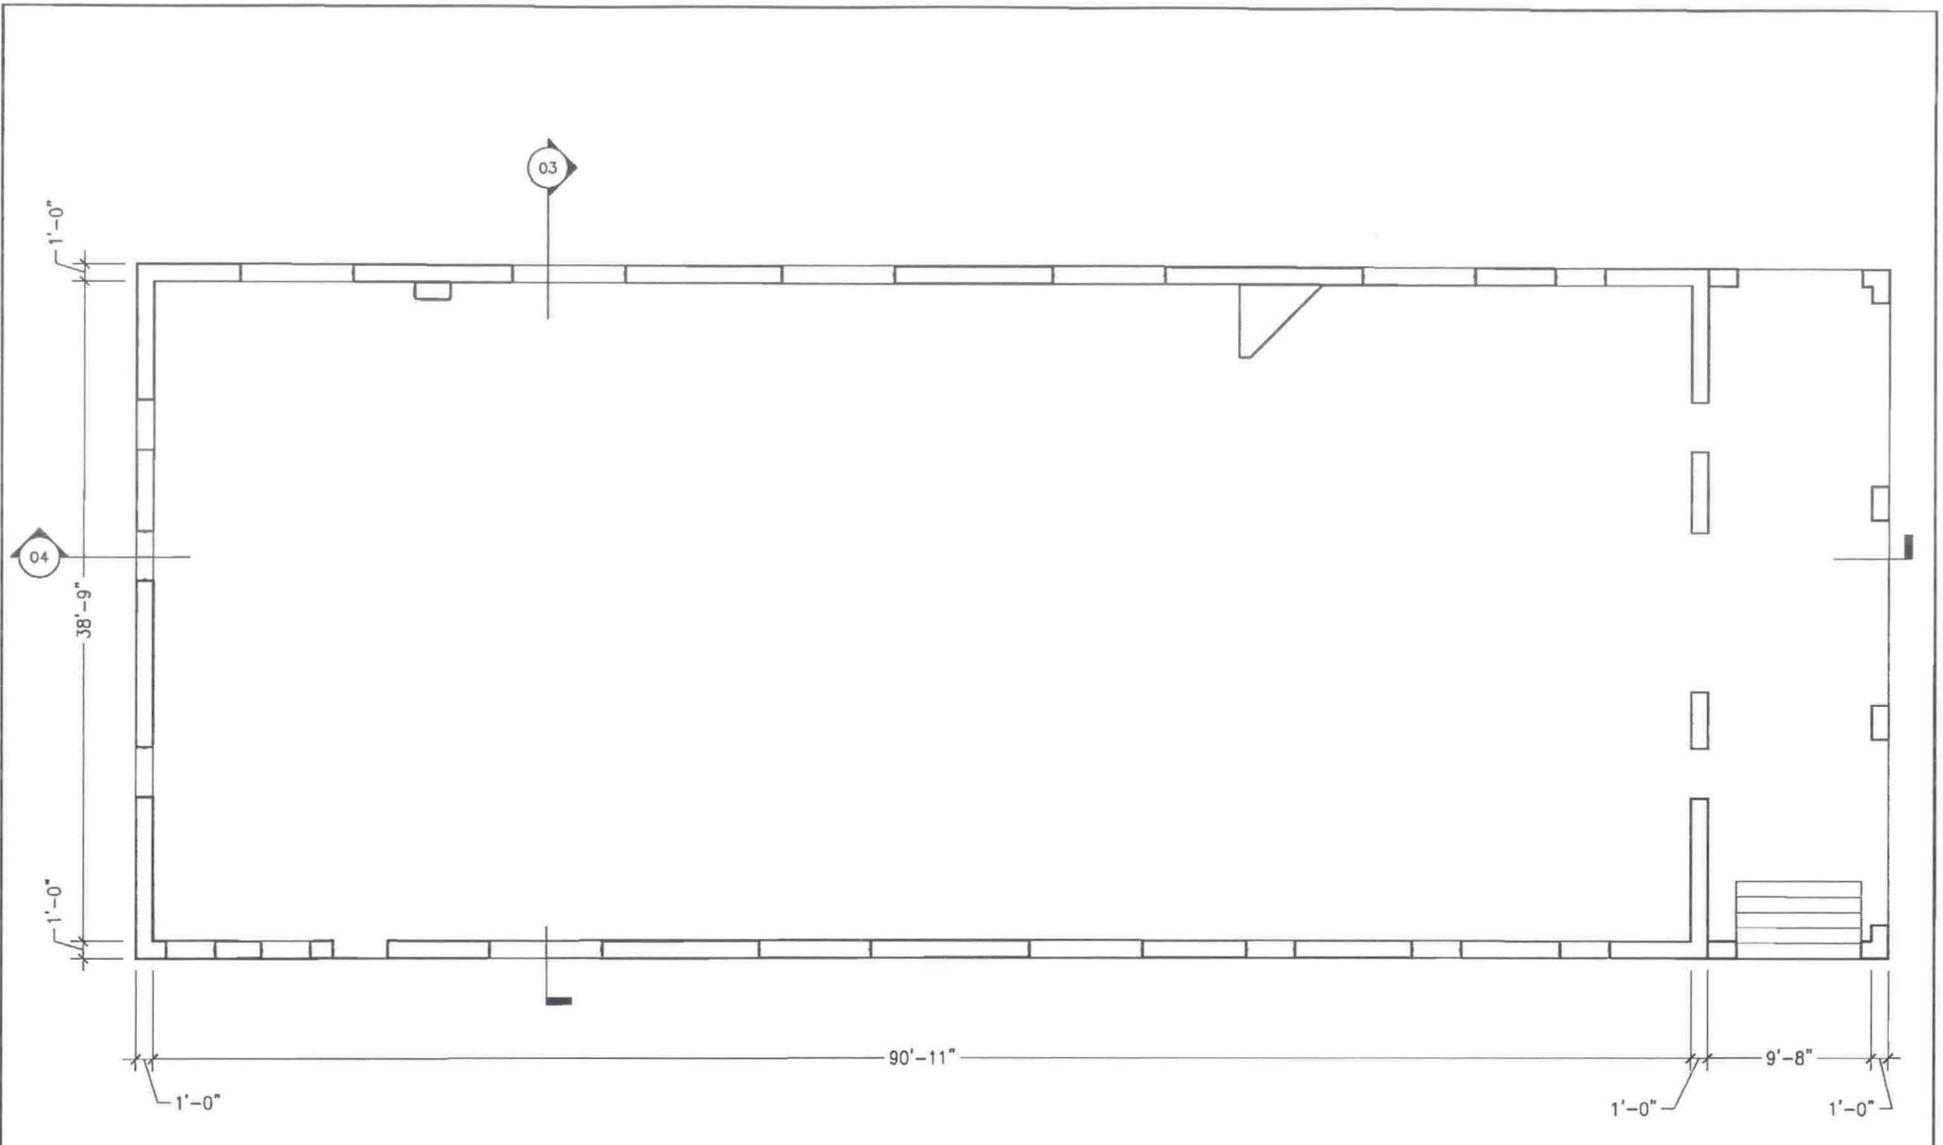
FIRST FLOOR PLAN - EXISTING CONDITIONS

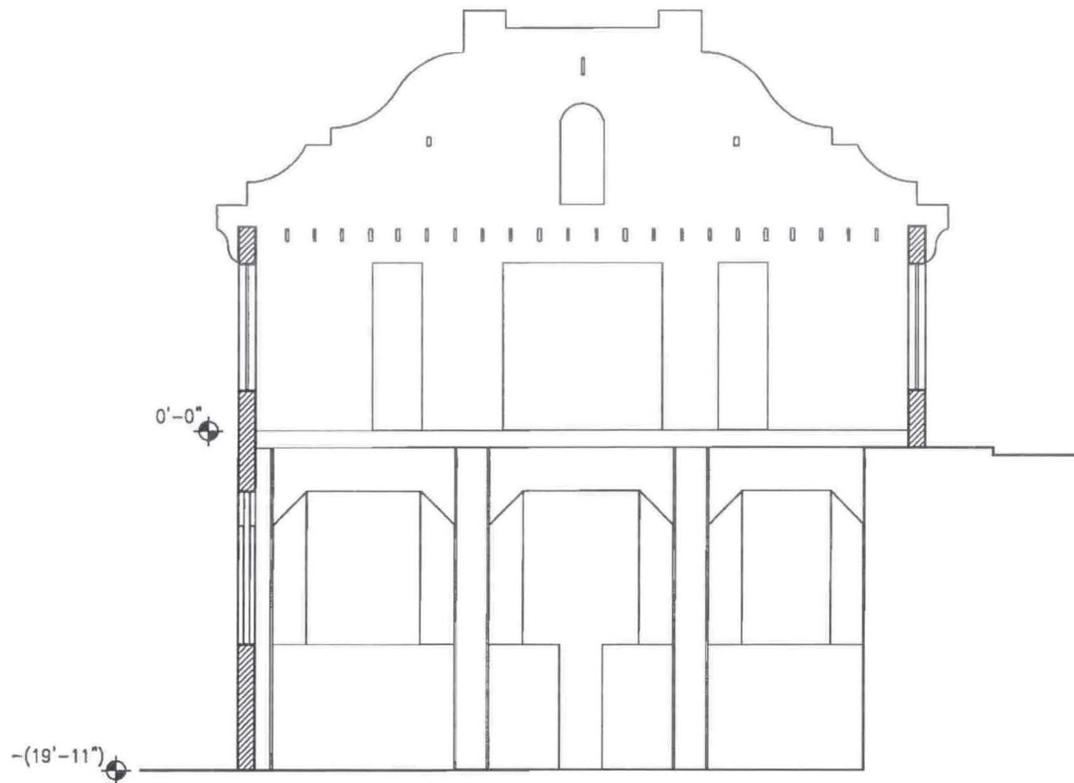
BUILDING SECTION LOOKING NORTH - EXISTING CONDITIONS

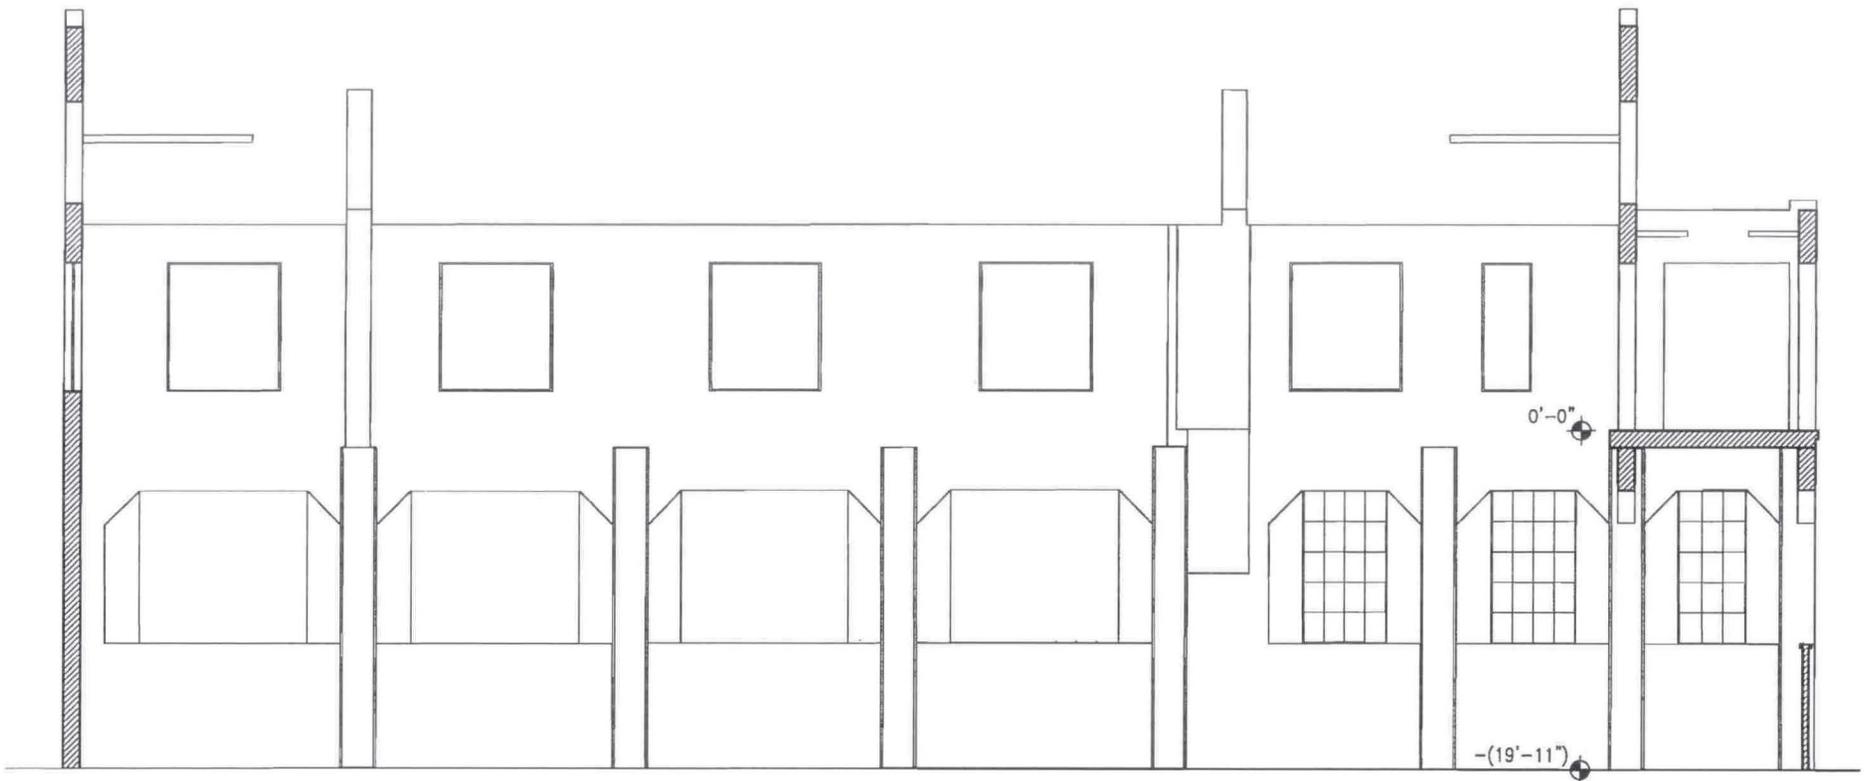
BUILDING SECTION LOOKING EAST - EXISTING CONDITIONS
