ALCATRAZ QUARTERMASTER WAREHOUSE BUILDING

ABBREVIATED HISTORIC STRUCTURE REPORT

October 31, 2001

Prepared by:
Lerner + Associates Architects
John A. Martini, Historian

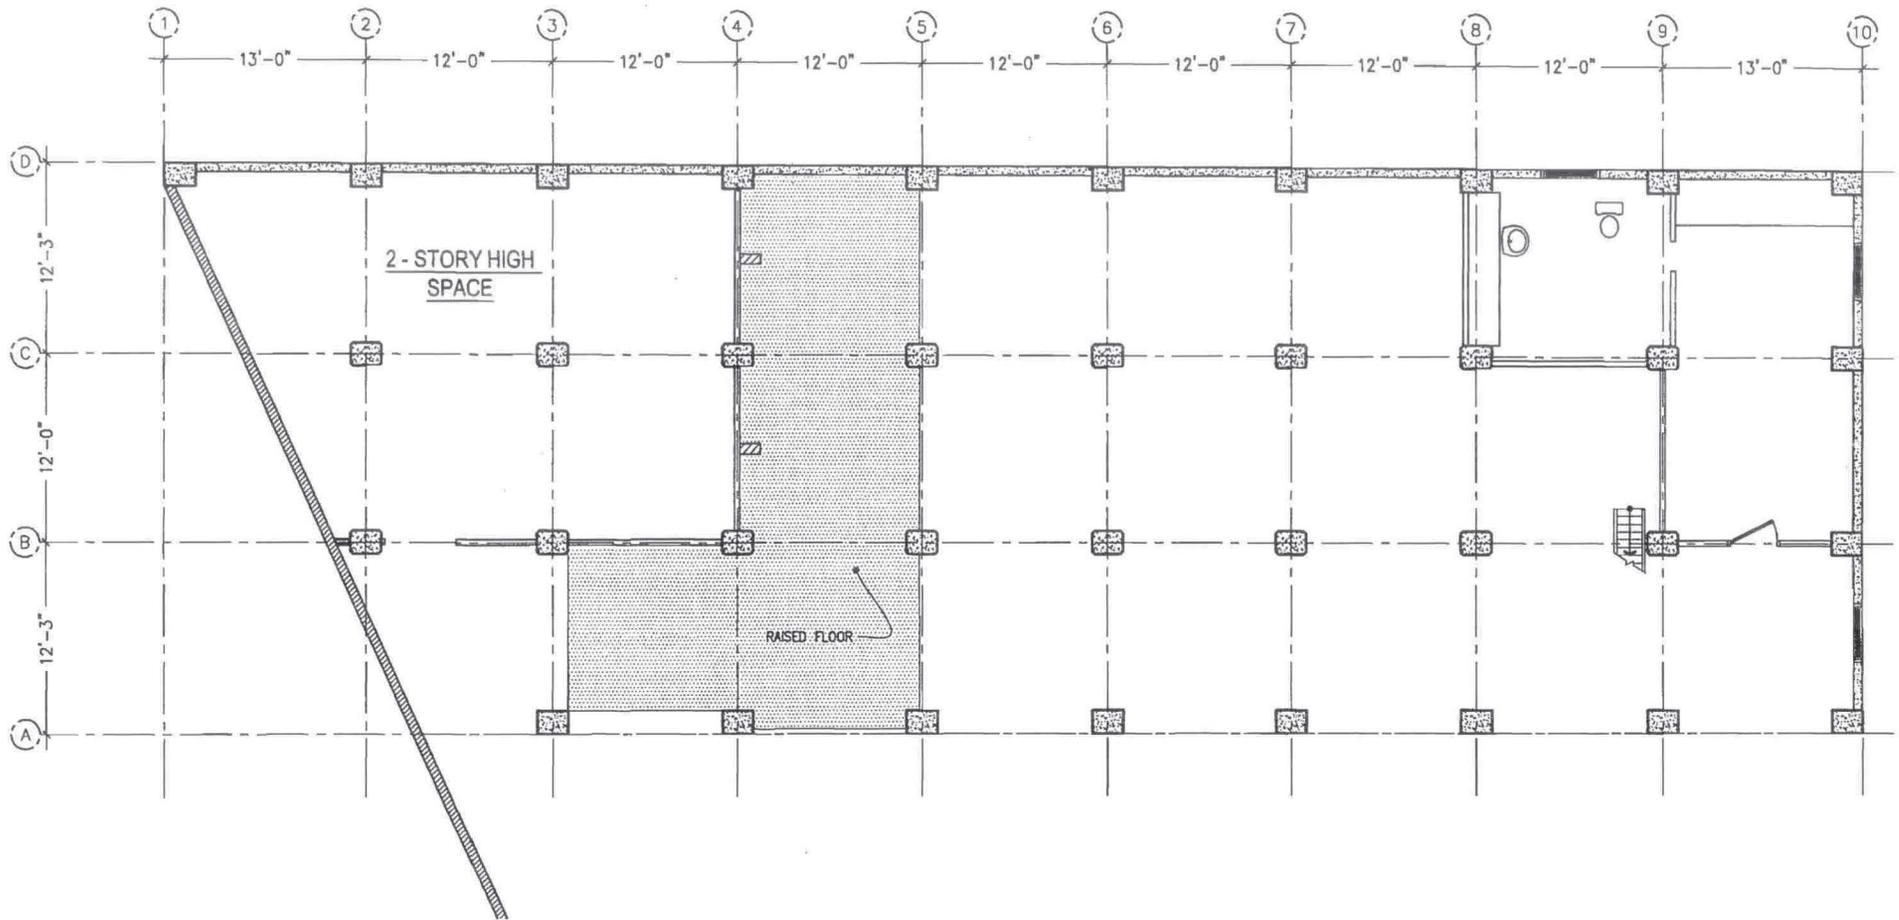
QUARTER MASTER BUILDING - BASEMENT FLOOR
EXISTING CONDITIONS

At the 8'-4" high Basement level, the cubic bays are created by 24"x18" concrete columns. At the northeast corner of the Basement level, the Mezzanine floor has been removed to create a space with a 16'-8" height. At the Mezzanine level of the north wall in the double high space, a sliding door to the former Supply Room is visible more than eight feet above the floor level. At the Mezzanine Level on the east wall of the double high space a blocked up window 3'-5" wide by 5'-6" high is visible. The double height space is separated from the rest of the open Basement by single wythe concrete block partition walls laid up in a hasty fashion. These concrete block infill walls appear to be unreinforced, show few cracks and are in good condition. The Basement floor slab in the single story space between Column Lines 3 and 5 has been raised from 2 - 5 inches above the rest of the floor slab. The reinforced concrete east wall of the building at Basement Level has a 3'-5" wide by 5'-6" high window centered in the infill wall between Column Lines 8 and 9. The south wall has two 3'-5" wide by 5'-6" high windows centered in the infill

walls between Column Lines A and B, and C and D. The west wall at the Basement Level is open.

At the far south of the Basement level are two rooms with wood frame and drywall partition walls. One is a toilet room with fixtures and plumbing in poor condition. The partition walls are in fair condition. The toilet room in this location does not appear on the 1933 Quartermaster plans. The floor framing for the Mezzanine level is visible at the ceiling of the Basement and is composed of two 4x12 joists attached to each side of the columns running in the transverse direction (from east to west), with 6x6 beams at 24 inch centers running longitudinally (north to south) supporting a finish floor on the Mezzanine Level of tongue and groove wood planking of differing widths. At the south end of the Basement level, the Mezzanine Floor structure is protected with sheet metal nailed to the framing that is badly rusted and in poor condition. There is a wood ladder stair to the Mezzanine level in this area that has no handrails and open risers that poses a hazard for users.

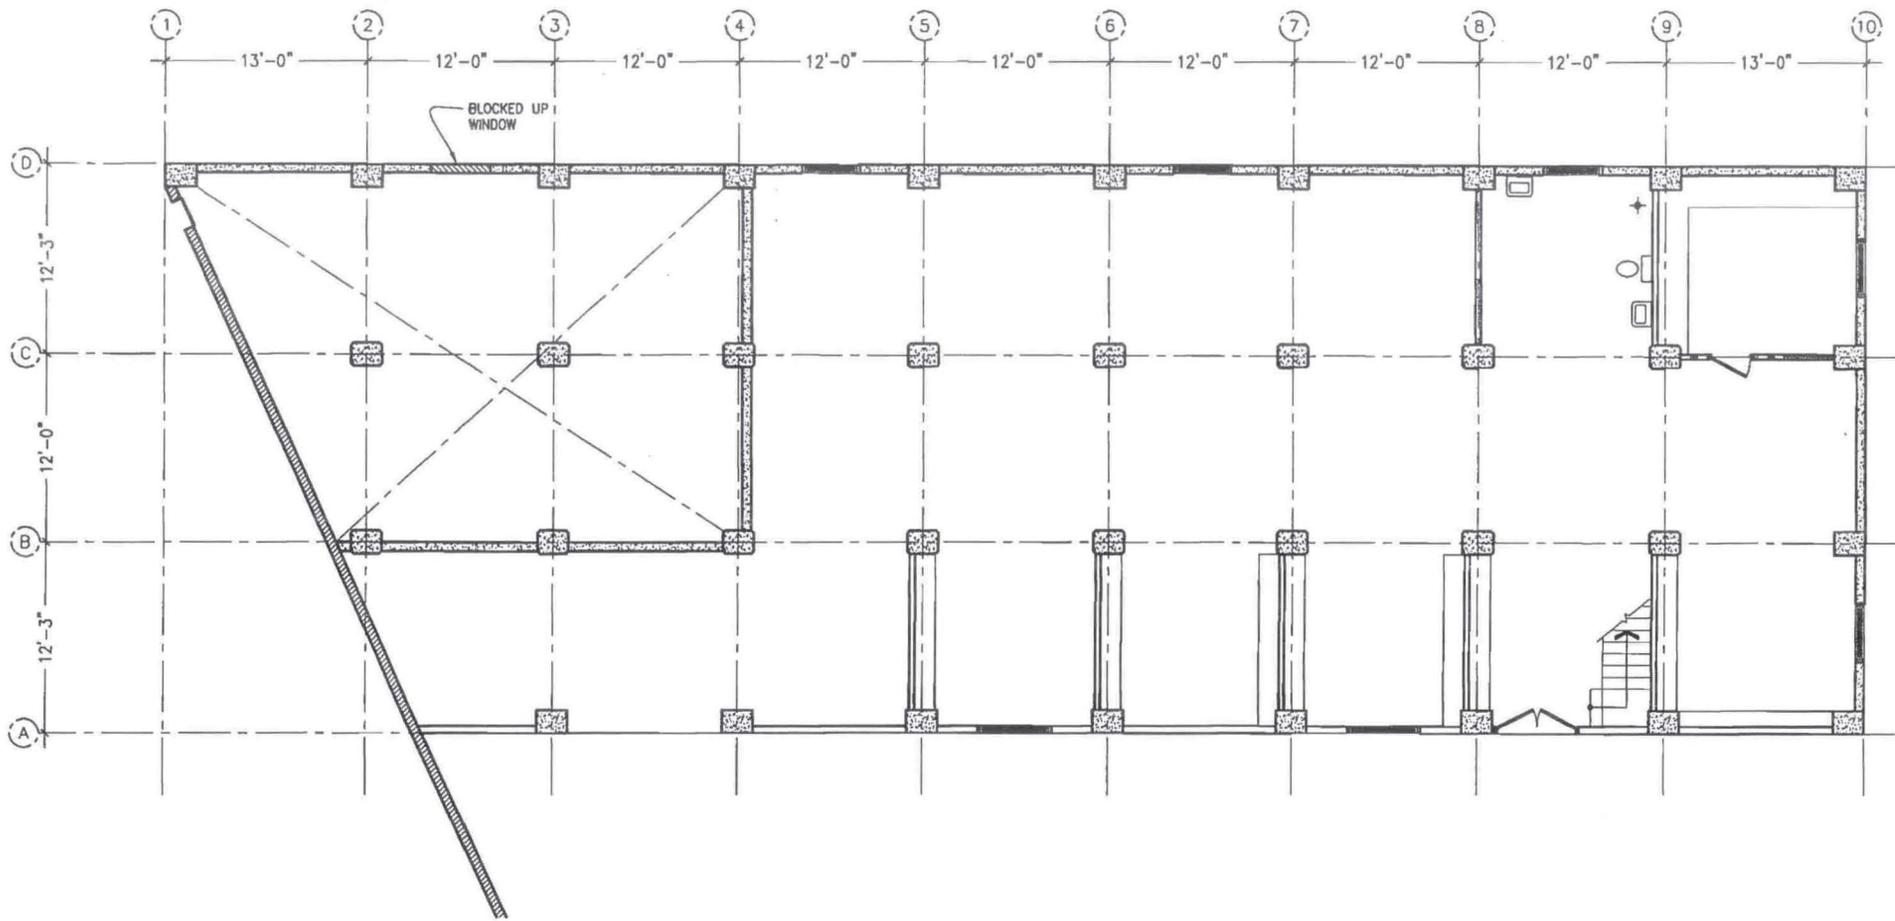
QUARTER MASTER BUILDING - MEZZANINE FLOOR
EXISTING CONDITIONS

The 8'-3" high Mezzanine level is divided into bays by 18"x18" steel reinforced concrete columns in good condition. The west wall of the Mezzanine level was constructed of wood frame infill walls with a cementitious stucco exterior finish in the bays between columns.

These infill walls are in fair to poor condition with portions of the exterior finish missing and cracked, showing the wood substructure which is showing signs of dry rot. The exterior concrete finish of columns on Lines 3, 4, 5, 8 and 9 of the west wall have spalls exposing steel reinforcement. The northeast corner of the Mezzanine Floor is blocked off by concrete block partition walls laid up in a shoddy fashion. The west wall has three window openings centered in the wood infill walls between Column Lines 3 and 4, 5 and 6 and 7 and 8. The opening in the wood infill wall between Column Lines 8 and 9 is off center and would have been a four foot wide door under the bridge. Adjacent to this opening inside is a stairway to the First Floor Level that poses a hazard to users as it has no handrails and has risers of differing heights. The majority of the Mezzanine Level interior is filled with wooden shelving that appears to be racks for piping or lumber. In the southern six bays of the Mezzanine, wood frame partition walls separate a Toilet Room and a Store Room. The window in the Toilet Room is missing, fixtures in the Toilet Room are missing and the plumbing is in poor condition. The Store Room ceiling is in poor condition and a window is missing in the opening on the South wall.

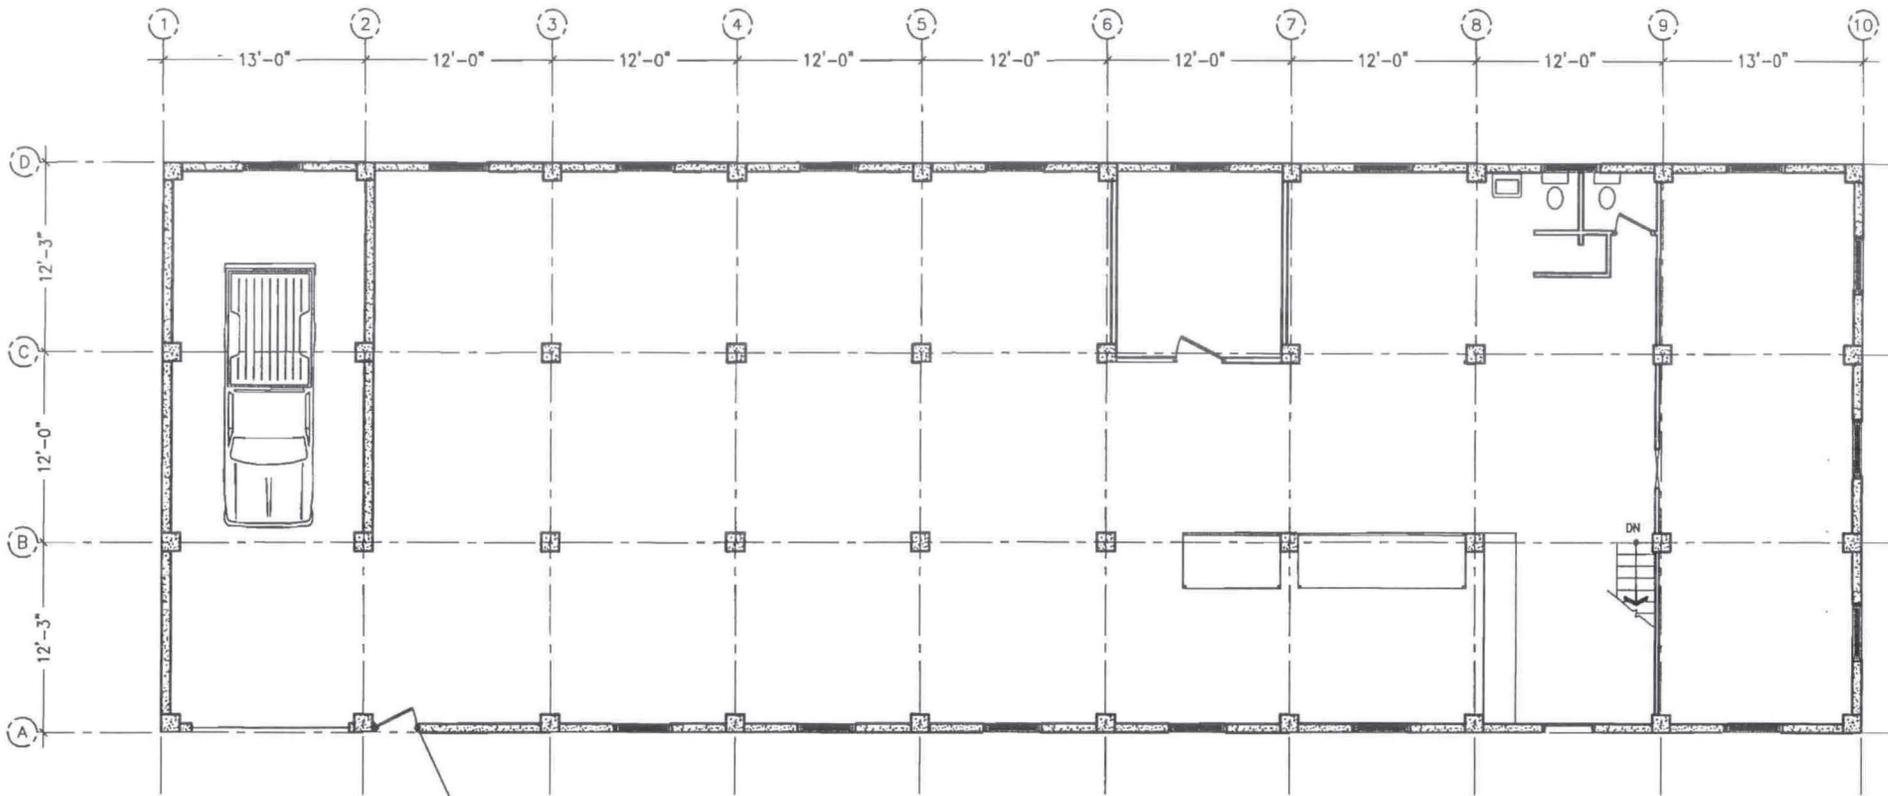
QUARTER MASTER BUILDING - FIRST FLOOR
EXISTING CONDITIONS

The 11'-4" high First Floor Level is divided into twenty-seven equal bays by 14"x14" steel reinforced concrete columns in good condition. The main entry to this floor is at the northwest corner of the building through a roll-up garage door and a new wood entry door in the west wall.

The west wall has six windows that measure 3'-5" wide by 5'-6" high centered between the columns in the infill walls, 3'-4" above the finish floor. The window sashes are in fair condition and have been fitted with Plexiglas to form a minimal weather barrier. In the bay between columns 8 and 9 along Column Line A, a doorway 3'-0" wide and 7'-0" high used to be the entry door from the bridge.

Two of the three north bays of the First Floor are separated from the rest of the space by concrete block partition walls laid up in shoddy fashion to form a "garage" space for the Island Fire Truck. There is a wall mounted radiator on the partition wall in fair condition. The interior finish of the north wall is smooth in the wall between columns on Lines A and B, form board patterns are visible in the center bay infill wall, and the finish is smooth in the easternmost bay infill wall to a vertical line behind the column on Line C, which would indicate that a partition wall was erected along Column Line

The east wall has nine windows 3'-5" wide by 5'-6" high centered between the columns in the infill walls, 3'-4" above the finish floor. The window sashes are in poor condition and have been fitted with Plexiglas to form a minimal weather barrier.

by full height wood frame partition walls, constructed of 2x4s and drywall on Column Lines 9 and 10. The partition walls are in fair condition. The painted finish in the space is delaminating. The tongue and groove wood floor covered in linoleum in this area is raised off the concrete floor of the outer space approximately 3½". The Floor is in good condition and the linoleum is in poor condition. On the south wall, there are three windows that measure 3'-5" wide by 5'-6" high centered between the columns in the infill walls, 3'-4" above the finish floor. The window sashes are in poor condition and have been fitted with Plexiglas to form a minimal weather barrier. The window trim on two of the windows shows a pointed "gable" motif that is unique to this space. There is a floor mounted radiator in poor condition.

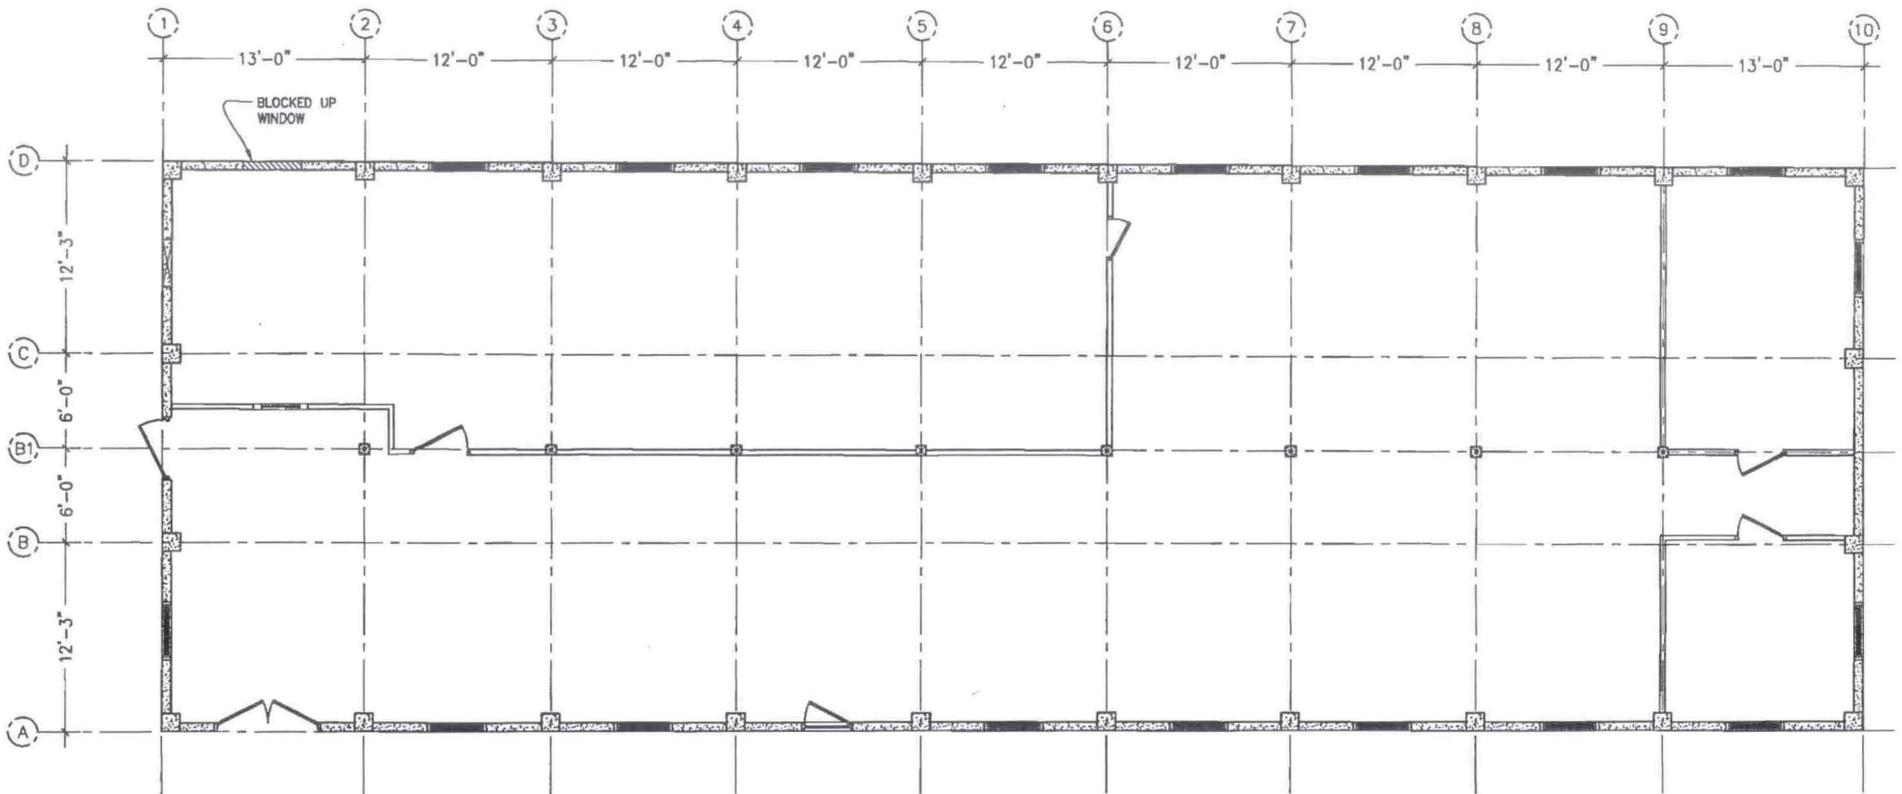
QUARTER MASTER BUILDING - SECOND FLOOR
EXISTING CONDITIONS

The 11'-0" high Second Floor Level has wood columns that run the full length of the space down the center (along Column Line B.1), that essentially divide the space in half along its centerline. The Second Floor space is accessed via a stair that runs along the west façade of the building between the Warehouse and the Powerhouse. The stair allows access to the roof of the Salt Store Room where an entry door in the north wall of the warehouse allows access to the Second Floor of the Warehouse building. The stair is in poor

condition and is not useable. This stair is not located on the 1933 Quartermaster Plans and a ca. 1934 photo shows a stair in a slightly different location. There also is empirical evidence of a stair that connected the First and Second Floor levels on the west façade of the Warehouse, by way of a doorway in the bay between Columns 4 and 5 along Column Line A.

In the northeast portion of the space is an area separated from the rest of the space by wood frame and wire mesh screening partition walls in poor condition. This area used to house the Clothing Store Room. The portion of wall between Column Lines 1 and 2 has an arched counter window with shutter door and in fair to poor condition. The counters that were related to the use of the window have been lost, and the partition wall is in fair condition.

The ceiling is ¼" gypsum board nailed to the truss roof structure and secured with narrow battens. The gypsum board ceiling is in poor condition. The gabled attic space formed by the roof trusses is accessed by way of a ladder mounted to the board and batten partition wall at the south end of the space. The roof trusses appear

to be in good condition. The roof trusses are made out of wood 4x6s and the Transite roof panels are supported by 3x6 purlins spaced 2'-0" to centerline. Daylight is visible around the entire perimeter of the Attic space at the eaves. Two shallow arched louvered openings are centered in the north and south walls. The louvers are in poor condition. The Transite roof panels appear to be in fair to poor condition, and could present an environmental hazard due to their asbestos content.
