Antietam National Cemetery Lodge

Physical History and Condition Assessment

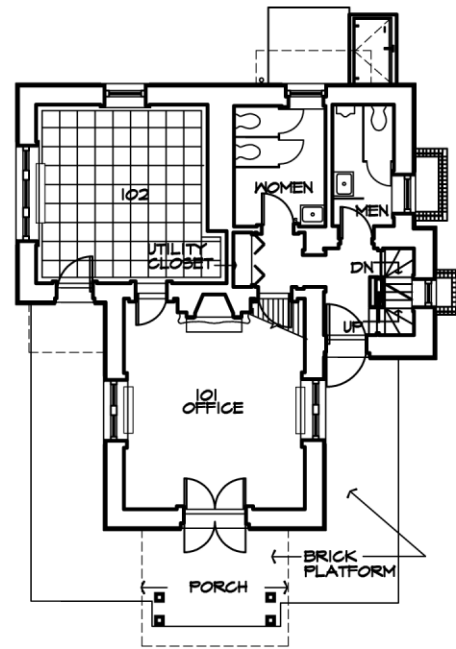
EXISTING CONDITIONS
 1999

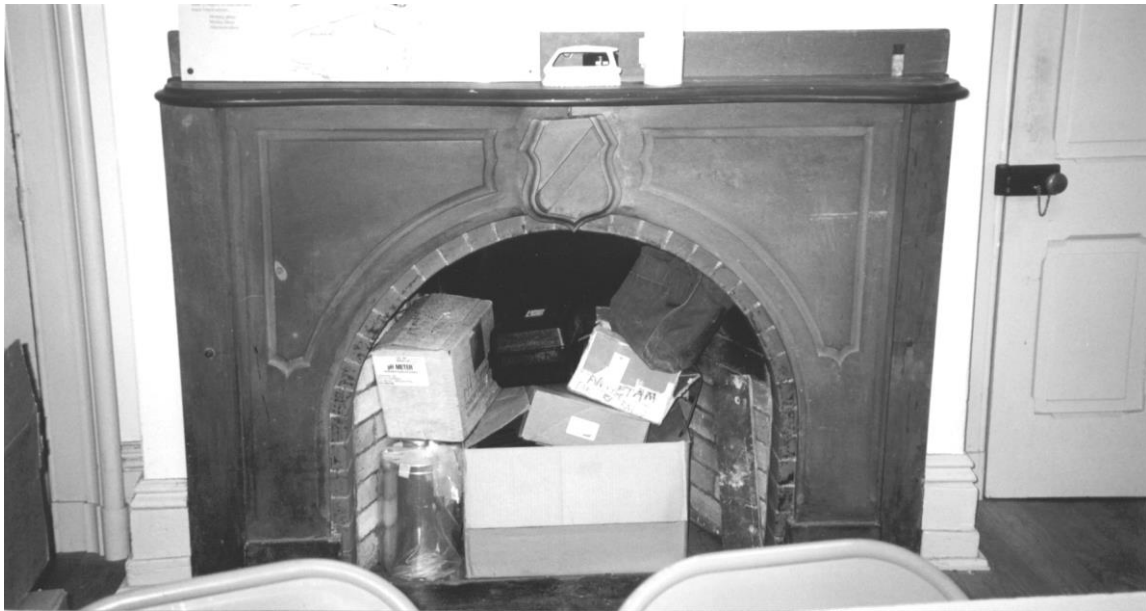
The fireplace in the original reception room is one of the most elaborate interior features in the Superintendent's Lodge. Photograph, 1999, Robinson & Associates, Inc.

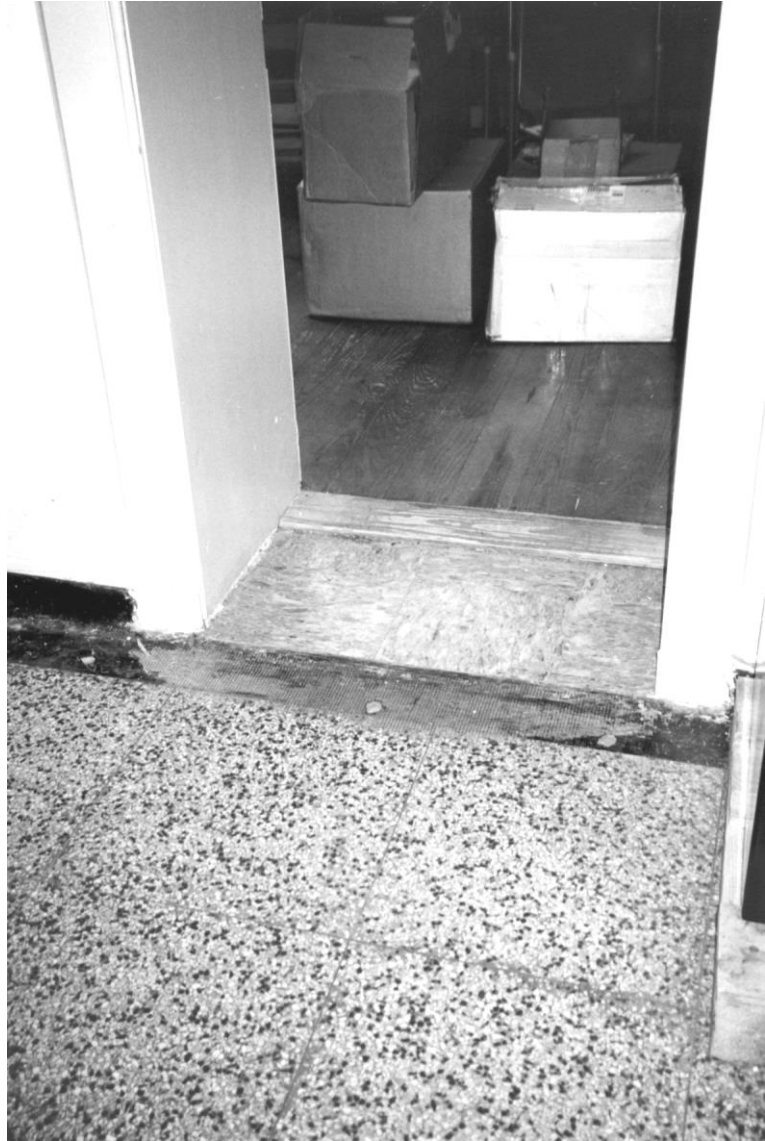
Terrazzo flooring remains in the south room, converted into a women's restroom in 1935 and to office space later. This view shows the transition from the south room to the east (reception) room. This opening was apparently cut after the 1935 installation of the women's restroom, possibly when the space was converted to an office, explaining the existence of terrazzo abutting vinyl tile, next to a wood threshold before the wood floor of the reception room.. Photograph, 1999, Robinson & Associates, Inc.

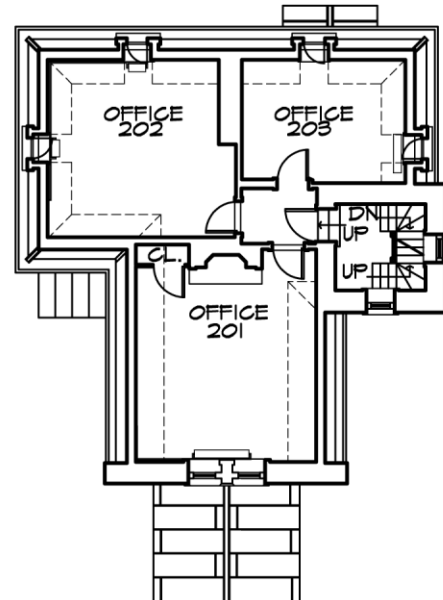
EXISTING CONDITIONS
1999

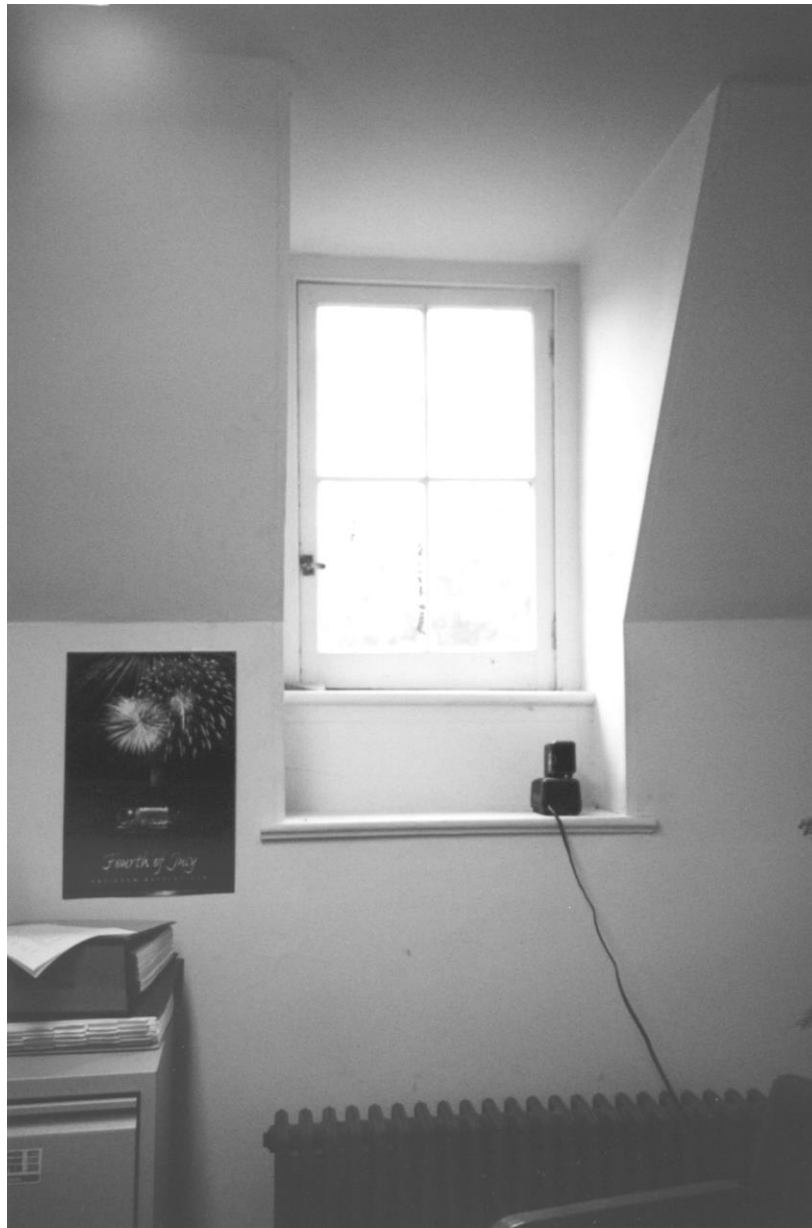
Typical windows on the second floor are in-swinging casements set into dormers. Note the canted walls that accommodate the hipped roof. Photograph 1999, Robinson & Associates, Inc.

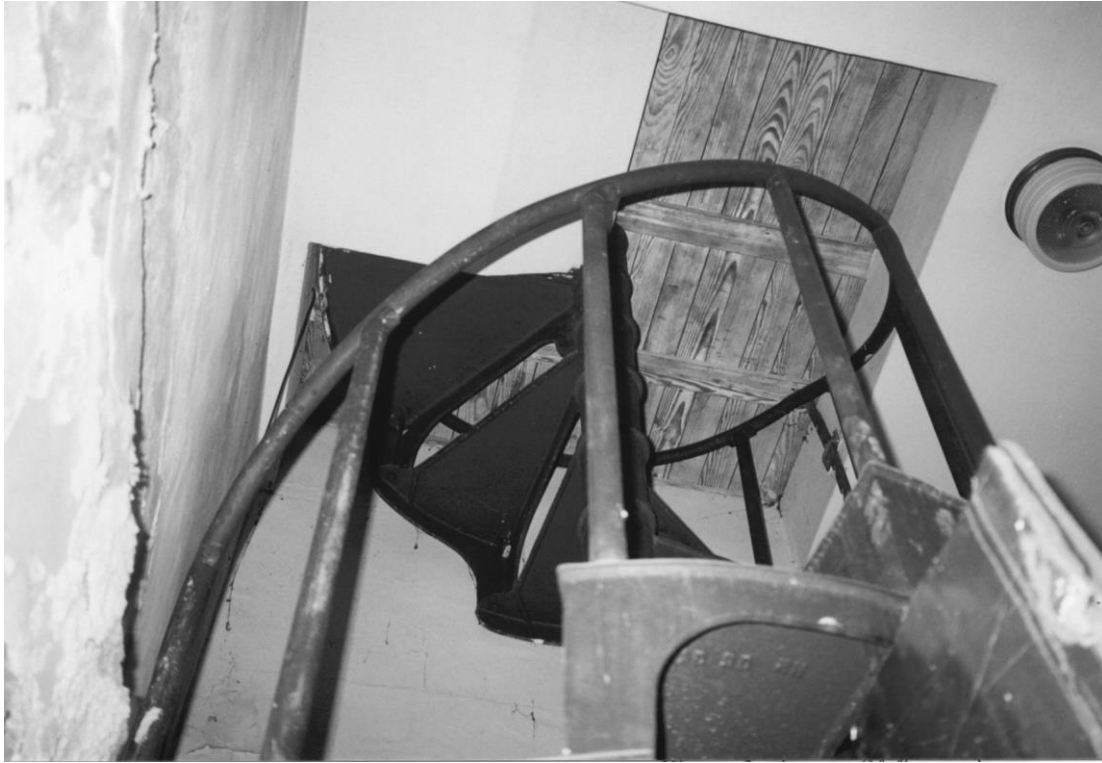
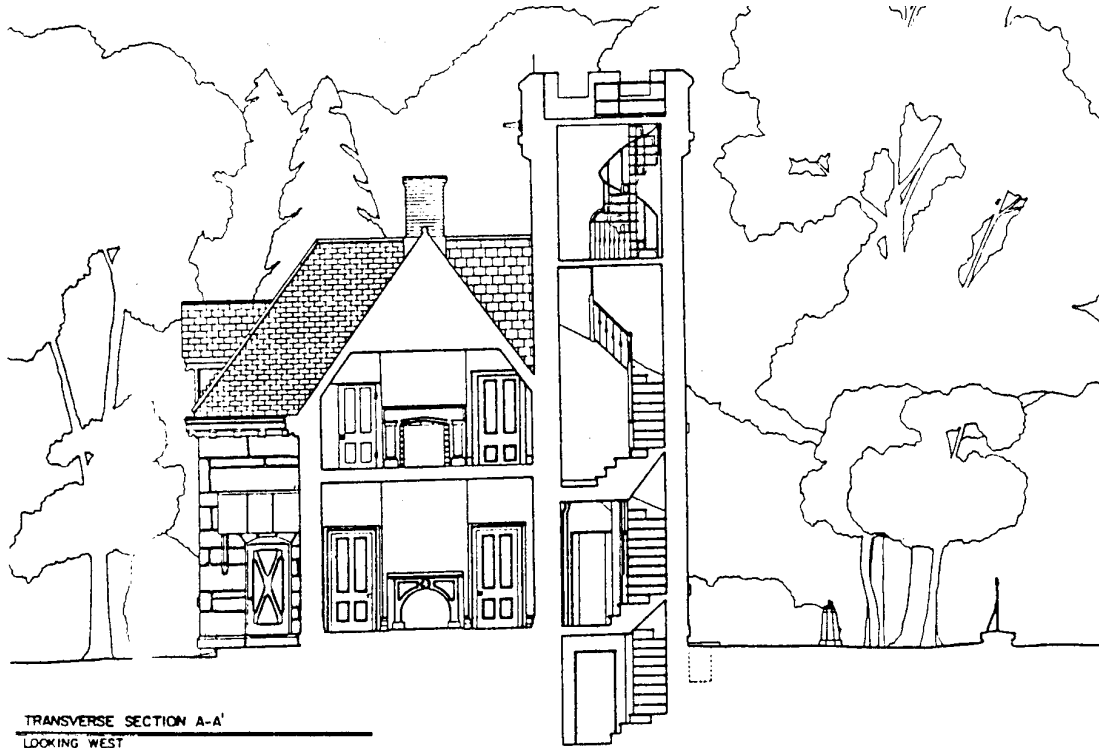
*top. The spiral staircase from the third story level of the tower to the rooftop observation area. Note water damaged plaster to left in photo and hatch to observation deck. Photograph 1999, Robinson & Associates, Inc.
bottom. This HABS section drawing (1986) shows the easternmost rooms on the first and second floor and the tower staircase. HABS Collection, Prints and Photographs Division, Library of Congress, HABS No. MD-936-A.*

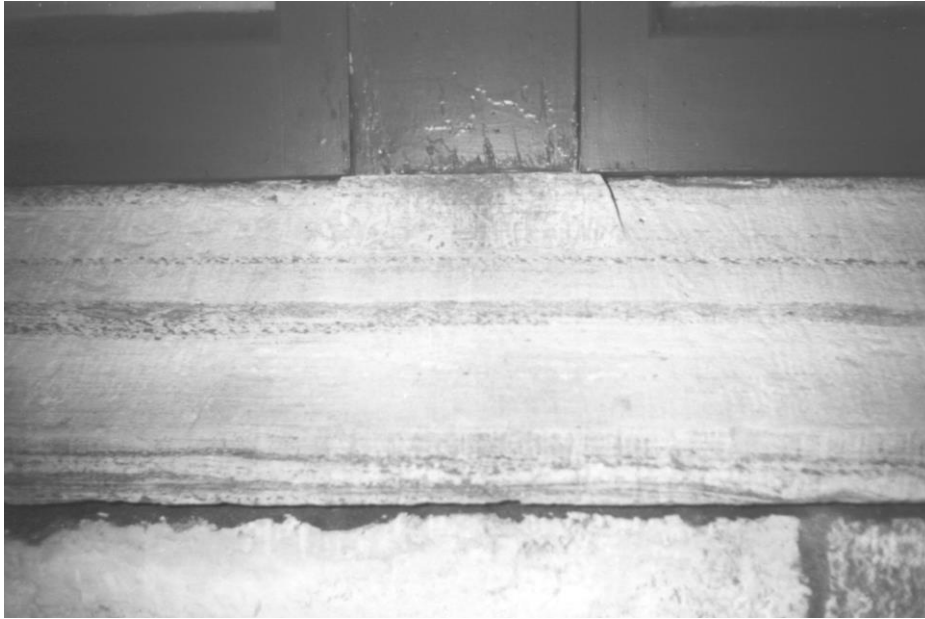
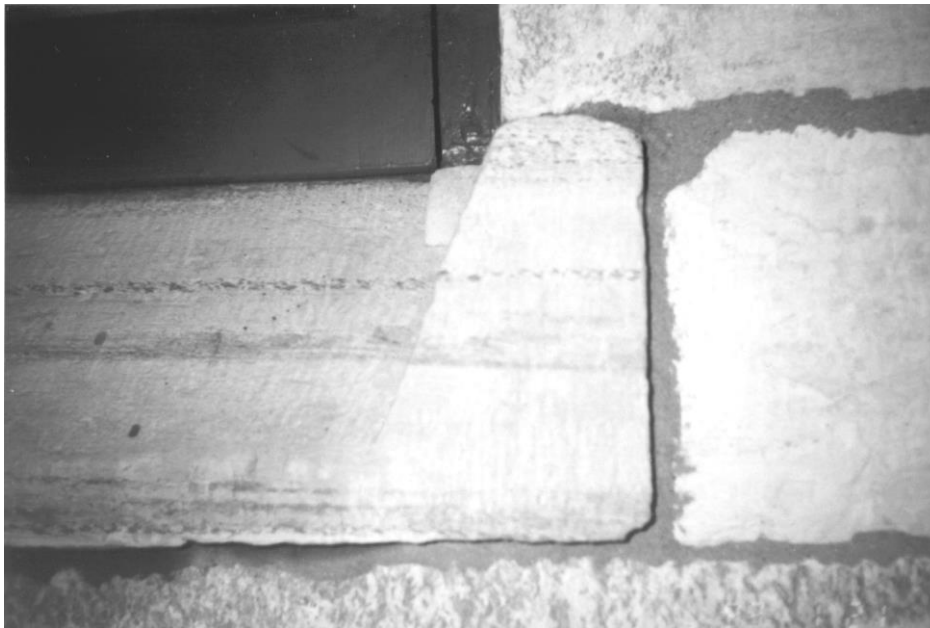
*left. Dressed stone sills
at windows.*

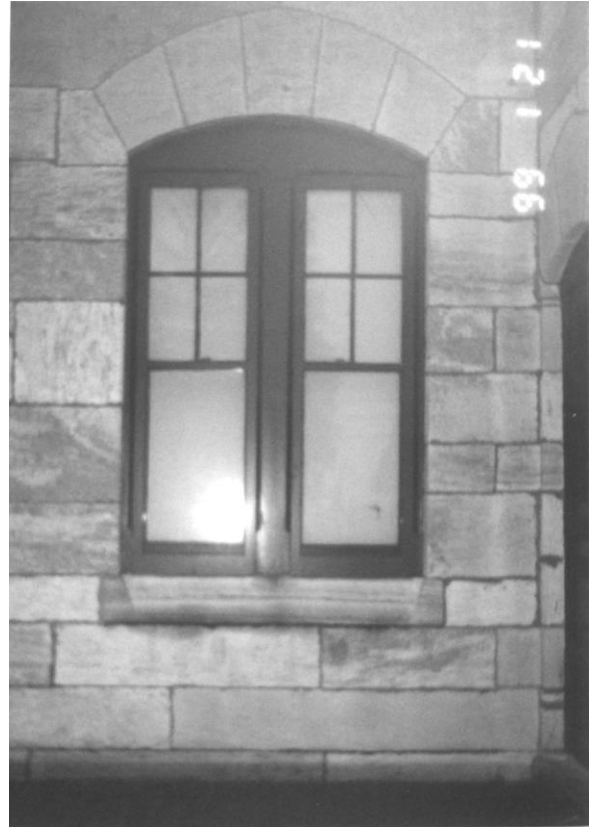
Four-over one windows on north elevation into front reception room.

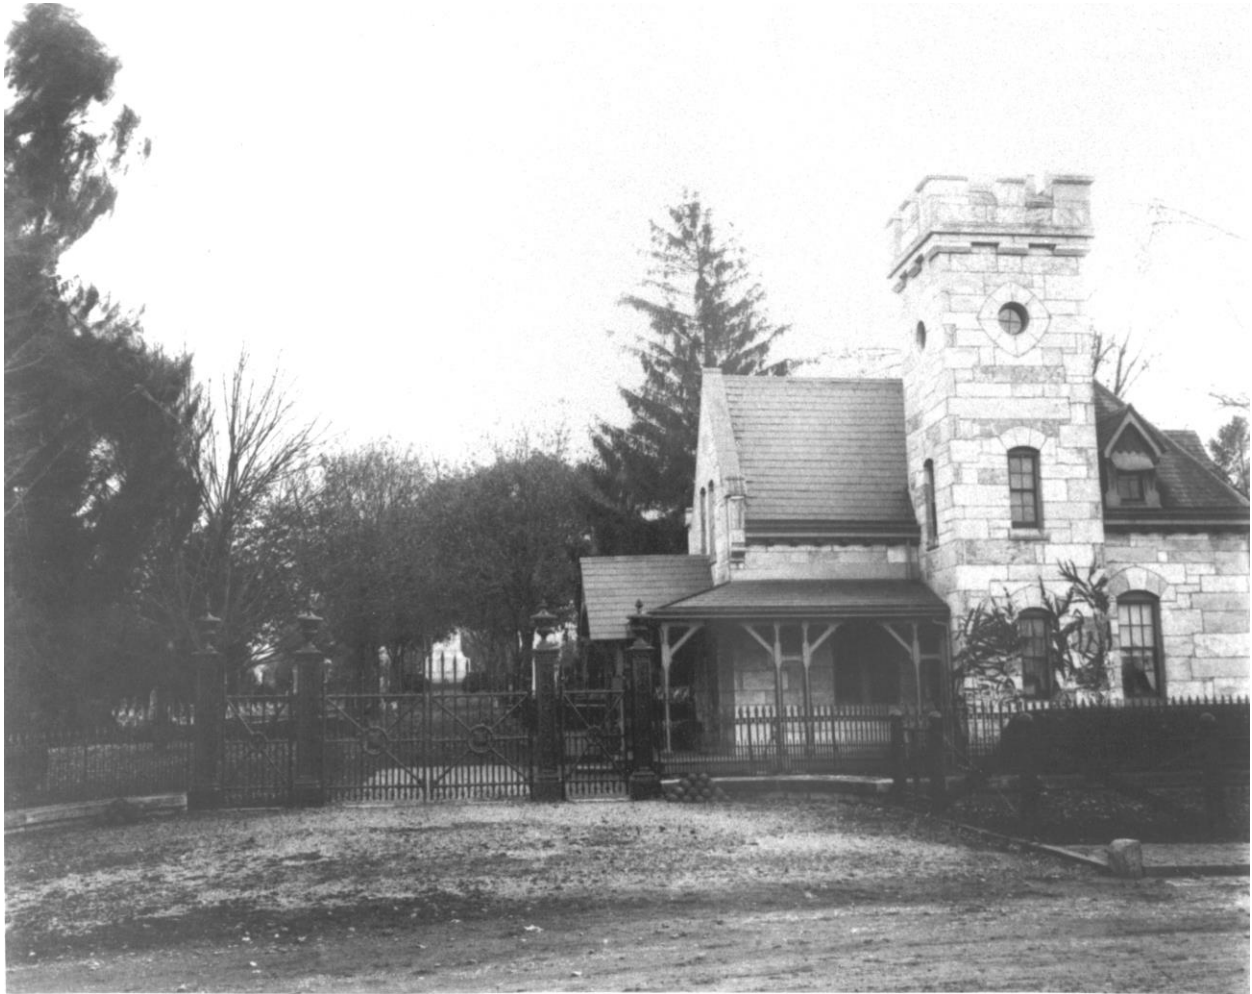
A view of the entrance to the cemetery in 1904 shows the original wrap-around porch. It also shows the roofs of the gabled and hipped sections and porches clad in slate shingles, and that the dormers once had small awnings. Most of the character-defining features appear today as they did at the time of this photograph. Note the piles of cannonballs along the fence to either side of the main entrance. National Archives, RG 92, Prints and Photographs Division, Photographs of Military Cemeteries, 1875-1912.

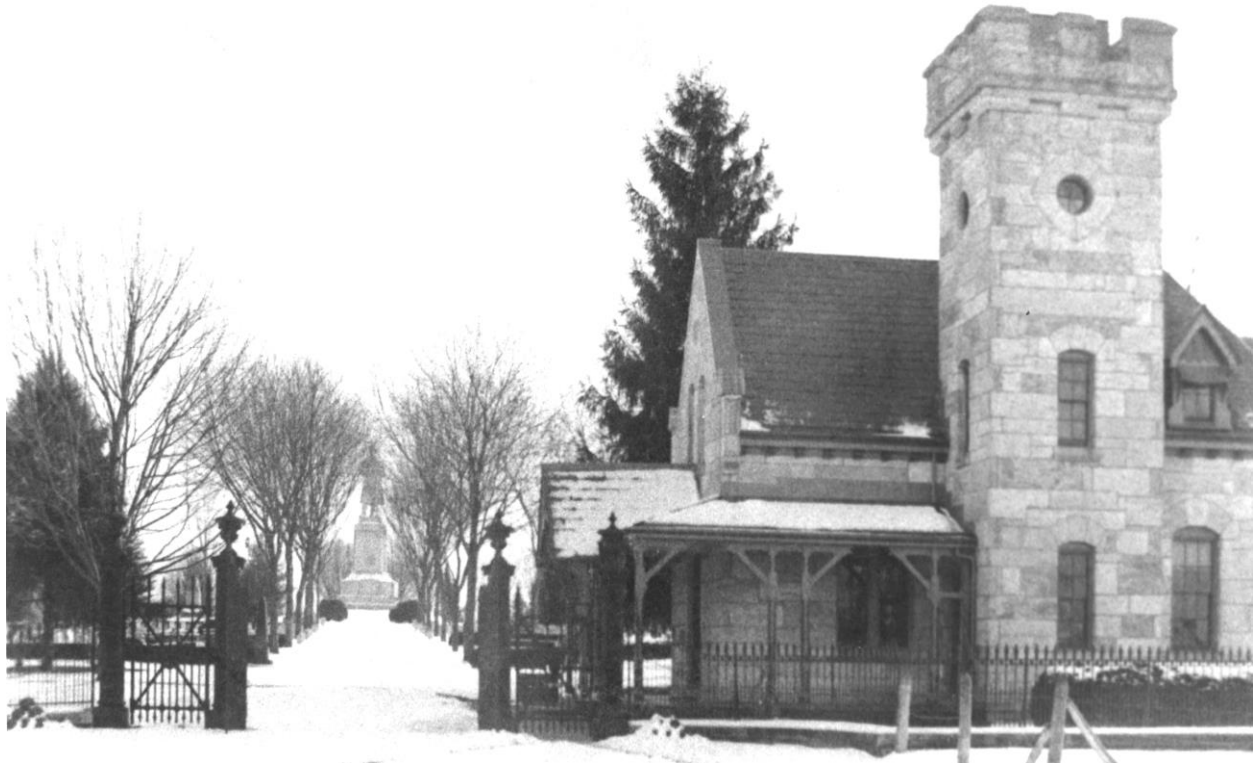
A view of the entrance to the cemetery in winter, probably taken shortly before the 1904 photograph (based on the absence of ivy on the tower in this view), shows many of the same features visible in the 1904 image. The winter foliage and snow make it easier to see the landscaping of the center of the site, a tree-lined allee leading to the central statue prominent.

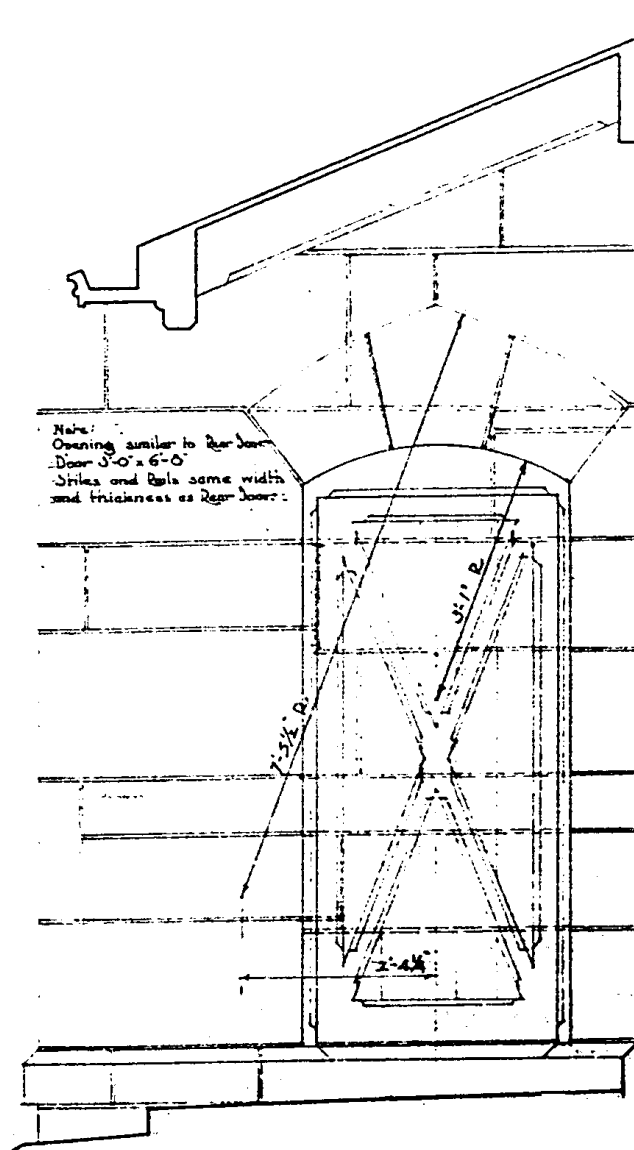
Heating, Ventilating, and Air Conditioning Systems (HVAC); Electrical and Plumbing

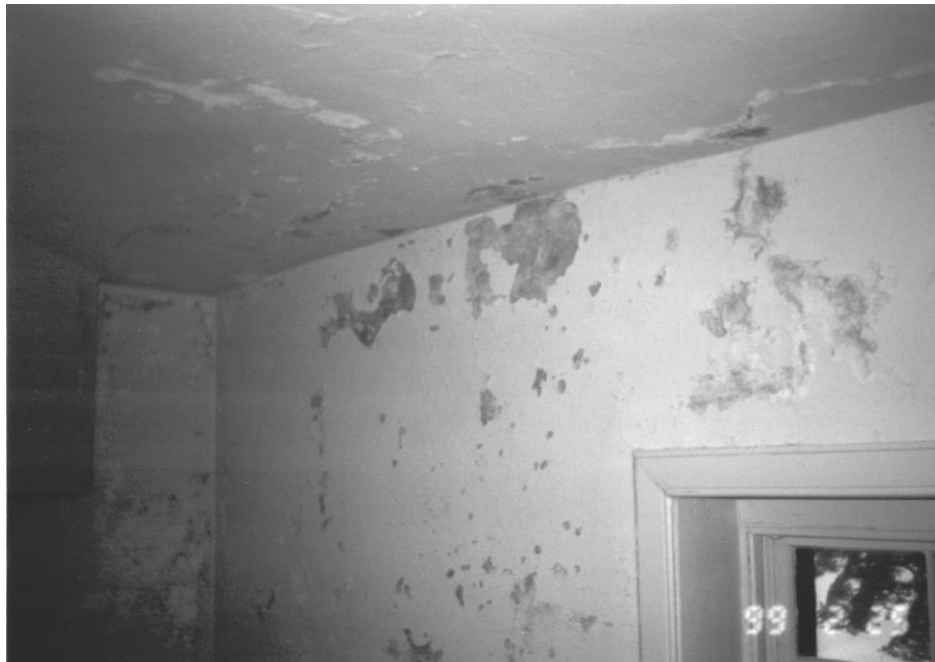
*View of damaged plaster in tower, typical of damaged plaster throughout the building.
Photograph 1999, architrave p.c., architects.*

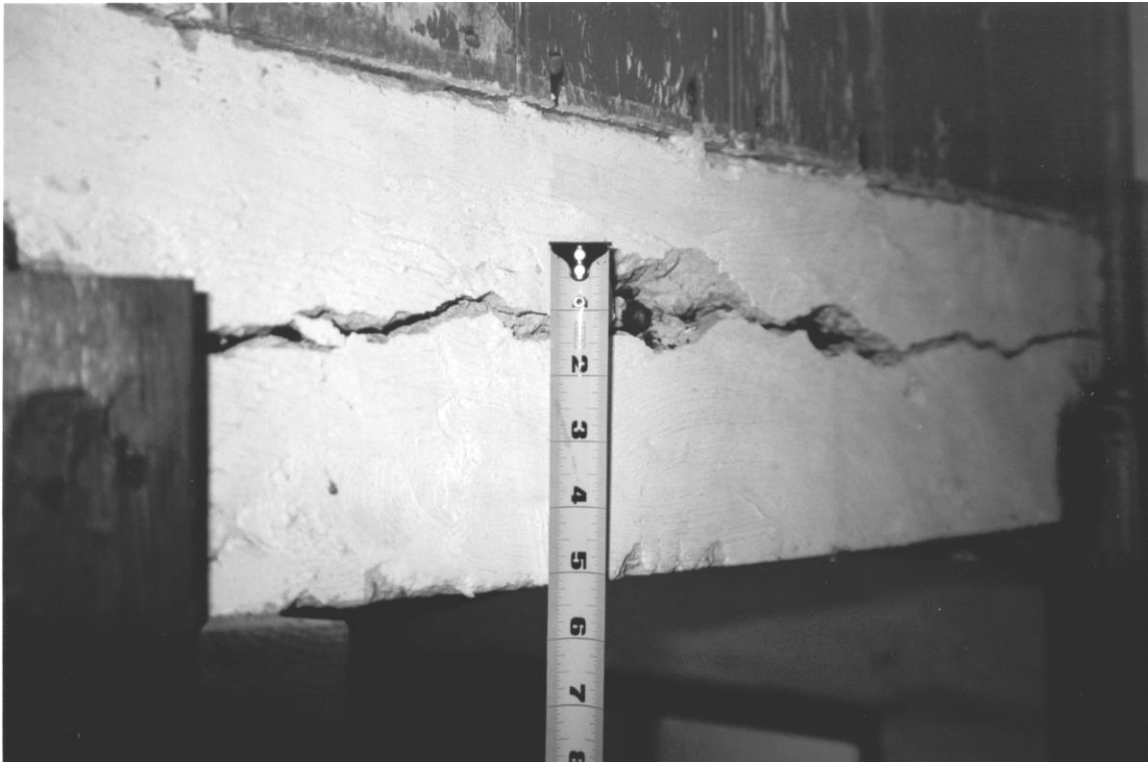
The crack at the first floor slab edge of the tower stair needs to be repaired or the slab edge must be supported by other means. Photograph 1999, McMullan & Associates

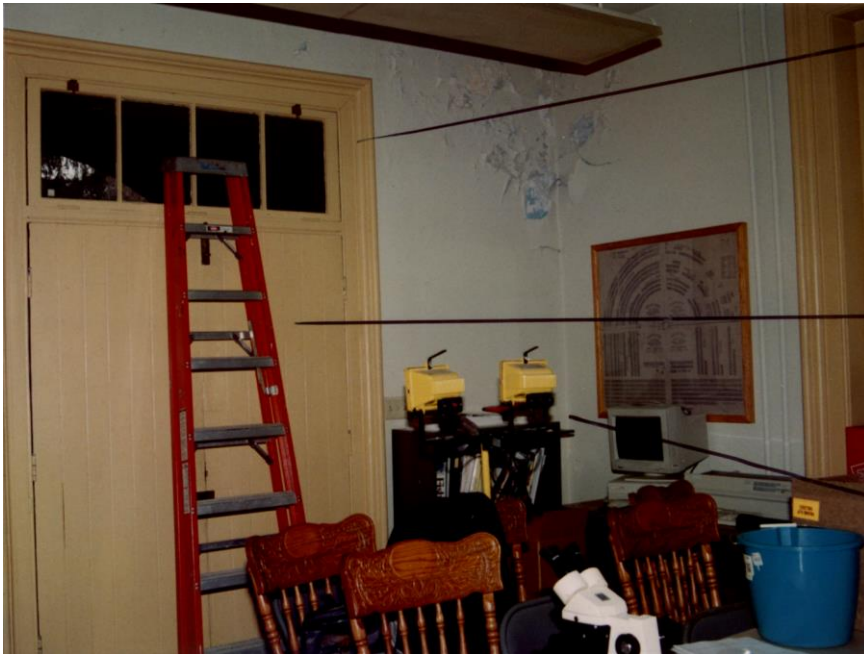
Photo 5. Office, Room 101. East wall.

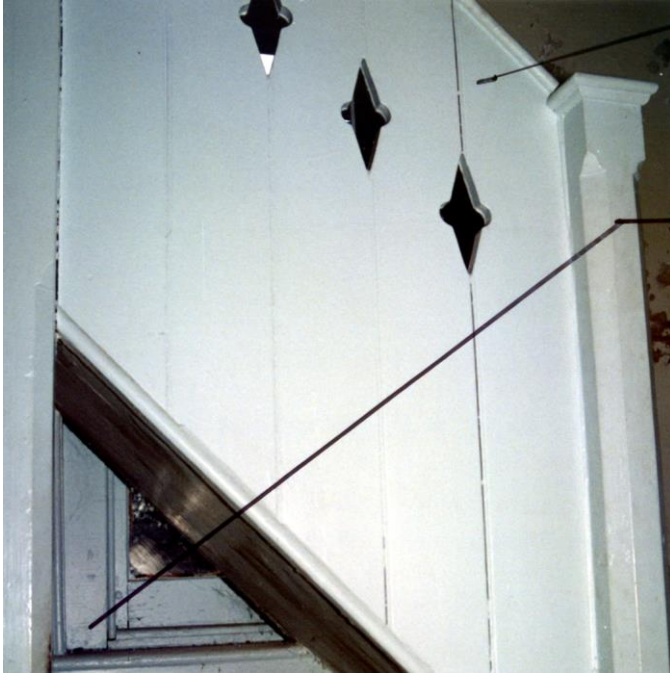
**Rail and apron: Light tan**

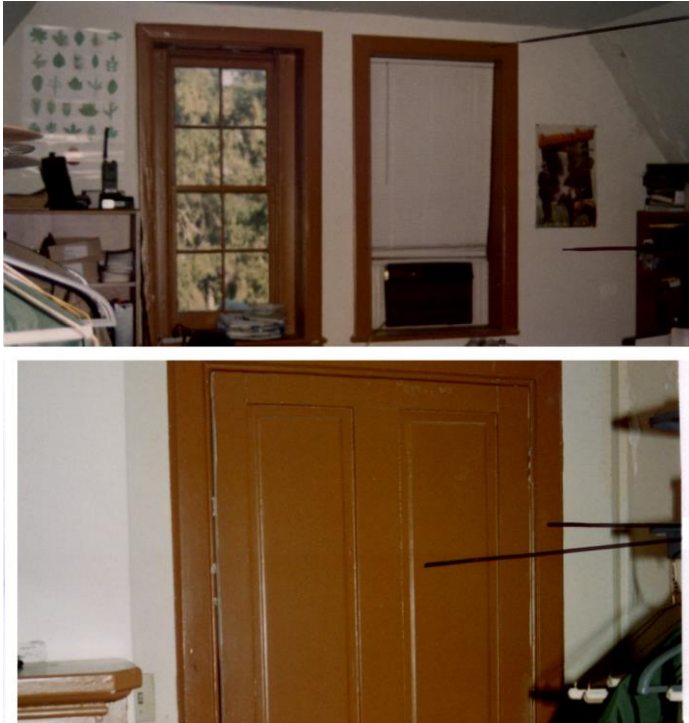
Window trim: Graining

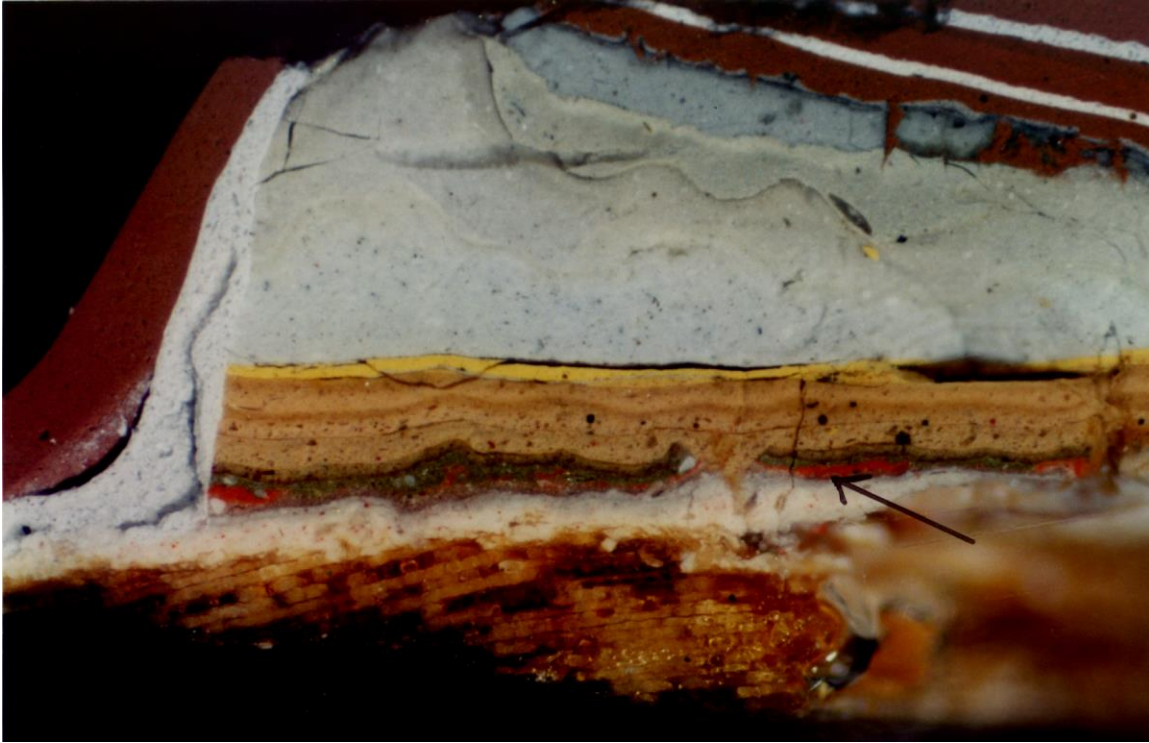
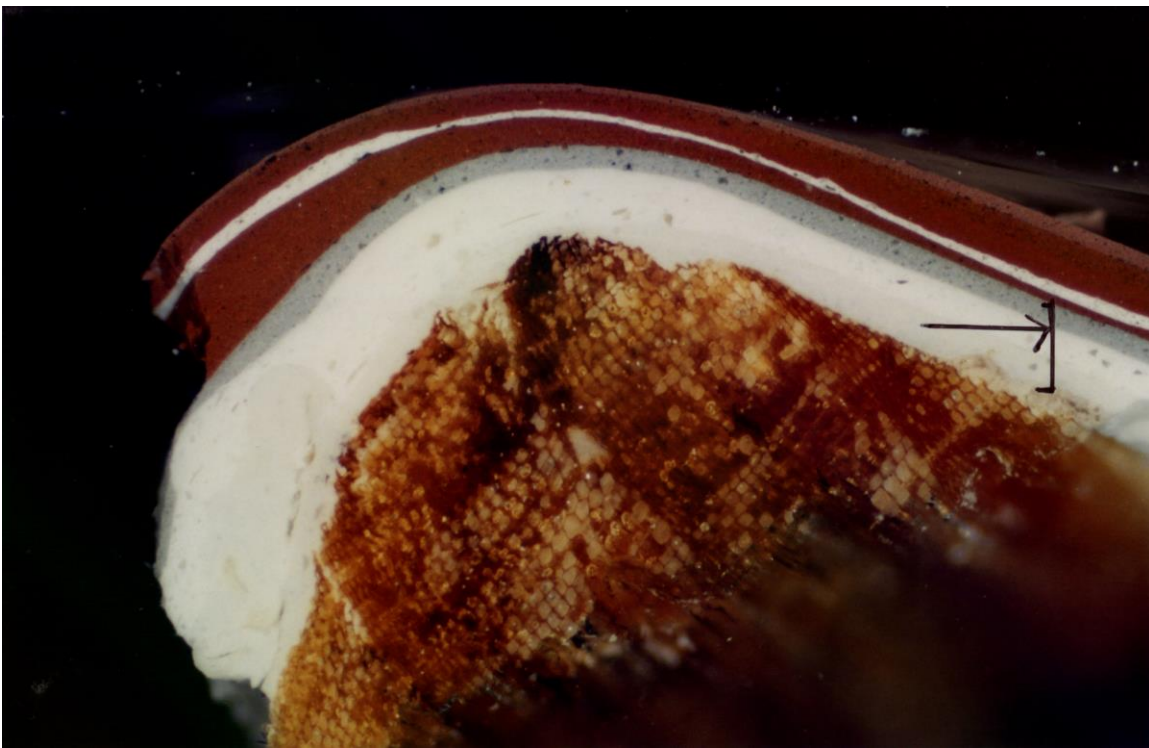
2. (above) Photomicrograph. Exterior. East porch horizontals. The paint stratigraphy illustrates that found on many of the exterior surfaces: white prime and gray.

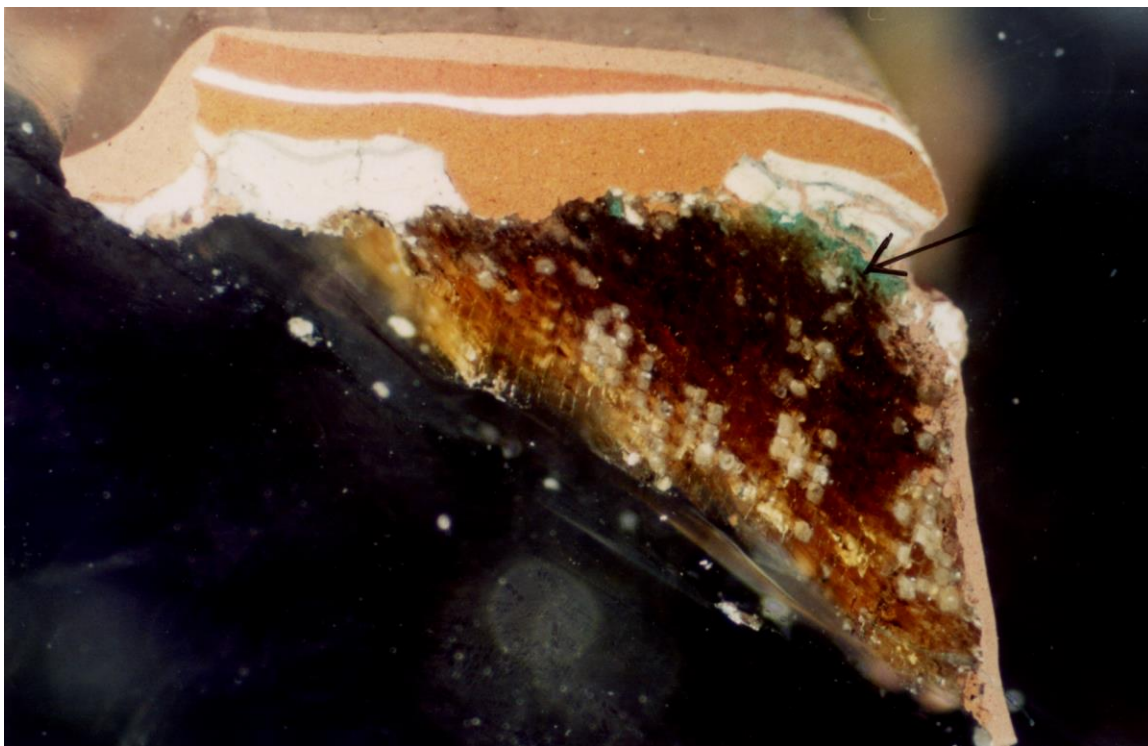
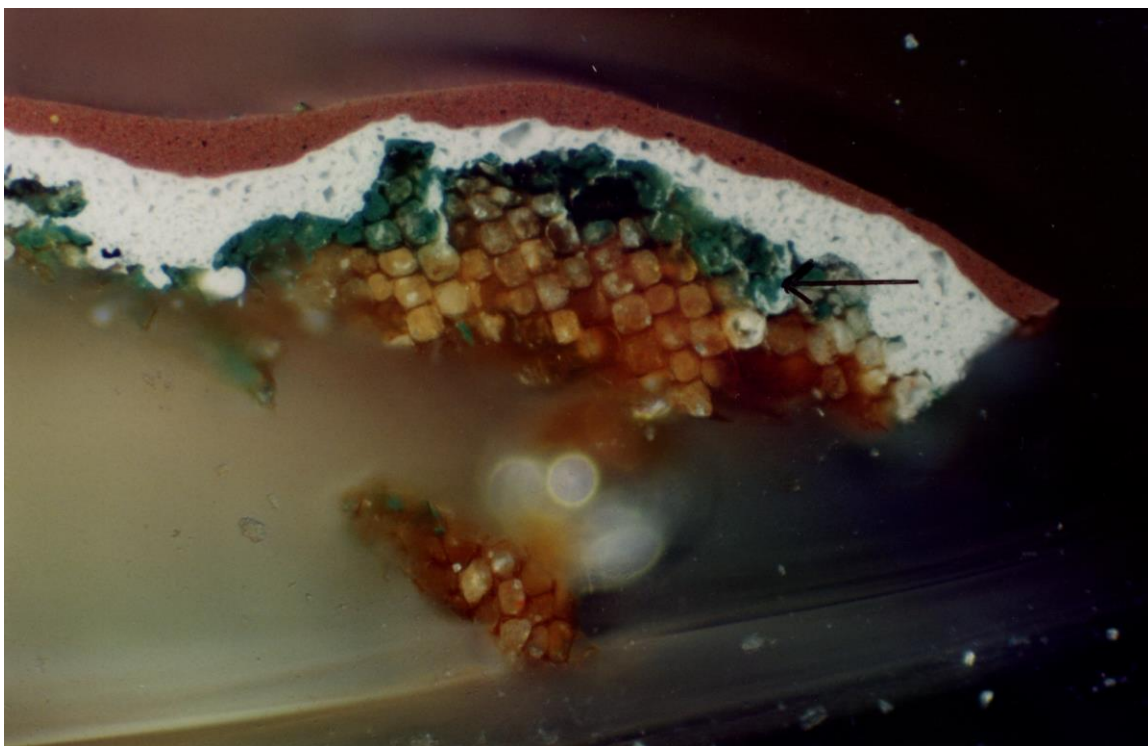
4. (above) Photomicrograph. Exterior. In other cases, the presence of a later paint suggests that the substrate was replaced, as here in a sample taken from the molding at the juncture of the roof.

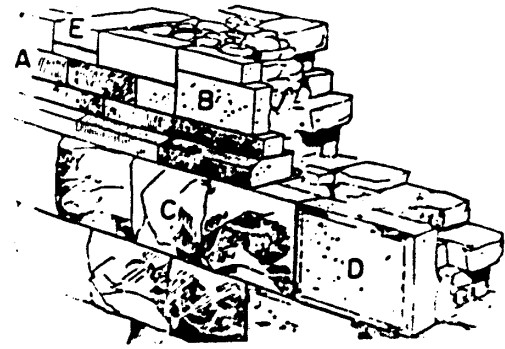
ashlar masonry Masonry composed of rectangular units of burnt clay or shale, or stone, generally larger in size than brick and properly bonded, having sawn, dressed, or squared beds and joints laid in mortar. (Harris, Cyril M. ed. *Dictionary of Architecture and Construction*. New York: McGraw-Hill Book Company. 1975.)
