National Park Service
U.S. Department of the Interior

Of Adobe, Lime, and Cement: The Preservation History of the San José de Tumacácori Mission Church (Part II - Structures)

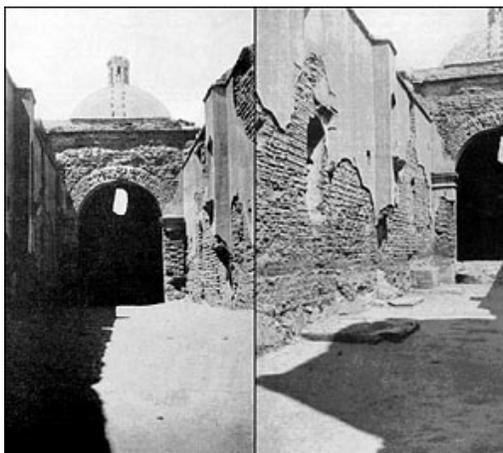
Nave floor before and after excavation by Noon in 1919. Four vertical feet of debris covered the floor.

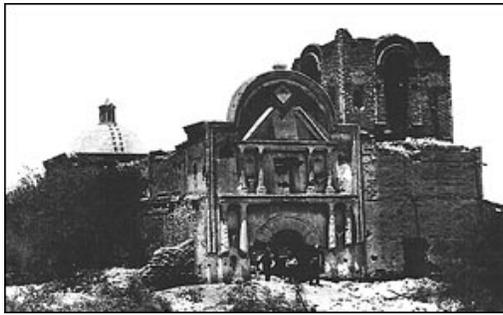
Mission church in 1889. This photo was used by Pinkley (1921) as a reference for the reconstruction of the façade pediment. Photo taken by George Roskrug.

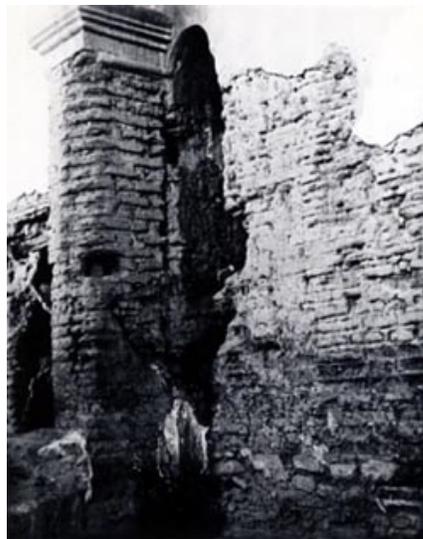
The pulpit before restoration in 1922-1923. The photo shows the wall markings from the original pulpit floor. Pinkley used the marks to build an accurate pulpit floor.

Noon uncovered remnants of the wooden frame of the pulpit when he excavated the church floor in 1919.¹¹ Pinkley partially restored the pulpit between 1923 and 1924, based on the existing architectural evidence and on pulpits of churches in Sonora. All that was left of the pulpit at the time of restoration was a few marks in the wall plaster. The pulpit is only partially restored. In 1978, a plugged doorway was found during the removal of cement on the eastern wall. Chambers suggests that this doorway may have been the pulpit doorway before the church was modified from its original cruciform design.¹²

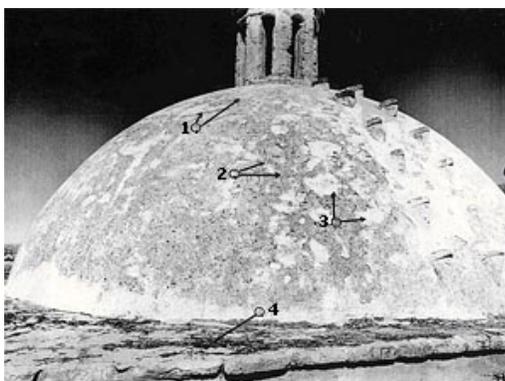
Sanctuary Dome in 1961, before stabilization by Richert (RSU). Problems included: 1) Cracked patches of modern cement, 2) small furrows and cracks in original lime mortar, 3) white patches of modern lime-cement plaster (Pinkley 1921) and 4) eroded tar roofing.

After Pinkley's work in 1921, only minor repairs were made to the dome and lantern. In 1961, Roland Richert of the Ruins Stabilization Unit began work on the eroded dome exterior. The dome had several different types of eroded plasters and the lantern was crumbling. Richert scraped all loose plaster off and removed the modern cement patches to reveal the underlying lime mortar base.²⁰ The dome was then painted with a mixture of Daraweld and water and deeper holes filled with bonding cement.

Daraweld is an acrylic polymer bonding agent still in use at other parks. The bonding cement was a mixture of Trinity white water-proof cement, sand, Daraweld (acrylic-polymer bonding agent), and water. The entire dome and apron was covered with an eighth-inch coating of bonding cement. After 1961, numerous coats of cement bonding paints and latex paints were used to seal hairline cracks in the dome exterior plaster. These coats added weight to the dome and trapped moisture, increasing the erosion of interior plasters.

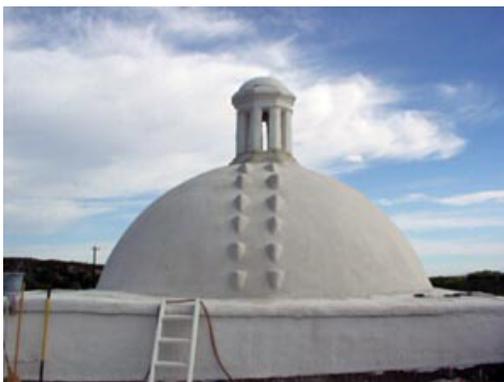
Work on the dome exterior was sporadic until 2004, when David Yubeta completed the most recent major repairs. Cracks had formed in the exterior plaster, and the bright white color of the dome was historically inaccurate. The first step was to remove the thick layer of paint and old plaster down to the brick substrate. Historic hand and toe-holds were discovered after the removal of over 2.6 tons of latex paint and eroded plaster. The hand and toe-holds begin at the base of the dome and continue to the top. They were built into the design for easier access to the top of the dome during construction and plastering of the exterior. Removal of old plaster also revealed that trapezoid-shaped bricks were laid flat in a circular manner to form the dome shape. The steps to the lantern are made from diamond-shaped bricks, some of which were replaced by Pinkley.²⁵

Sanctuary Dome after plaster replacement in 2004.

Once the old stabilization plasters/paints were removed, the dome was sprayed with lime water, which made the dome better able to accept lime plaster. Next, St. Astiers Natural Hydraulic Lime (NHL 5), imported from France, was applied. Hydraulic lime sets in water, but it also sets by absorbing CO₂ from the air, therefore, it hardens or sets twice. Three plaster layers were applied over the fired adobe brick substrate. The final product is a more subdued grayish-white dome that is historically accurate and consists of natural materials. The dome exterior is on a 3-5 year maintenance cycle.

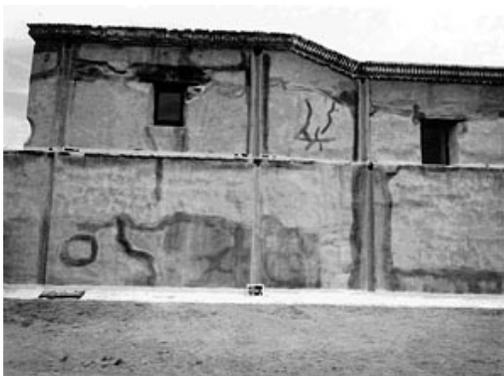
The exterior plaster of the west wall eroded at a quicker rate than other exterior walls and no original plaster exists on the west wall exterior. The biggest problem effecting plaster on the east wall exterior has been moisture entering through cracks and erosion at the base of the wall.

West wall of nave/sanctuary exterior in 1972. Note the jigsaw like appearance.
