A PRELIMINARY REPORT:
CHRIST CHURCH BELL TOWER

BY: CHARLOTTE WORSHAM

Old North
Box

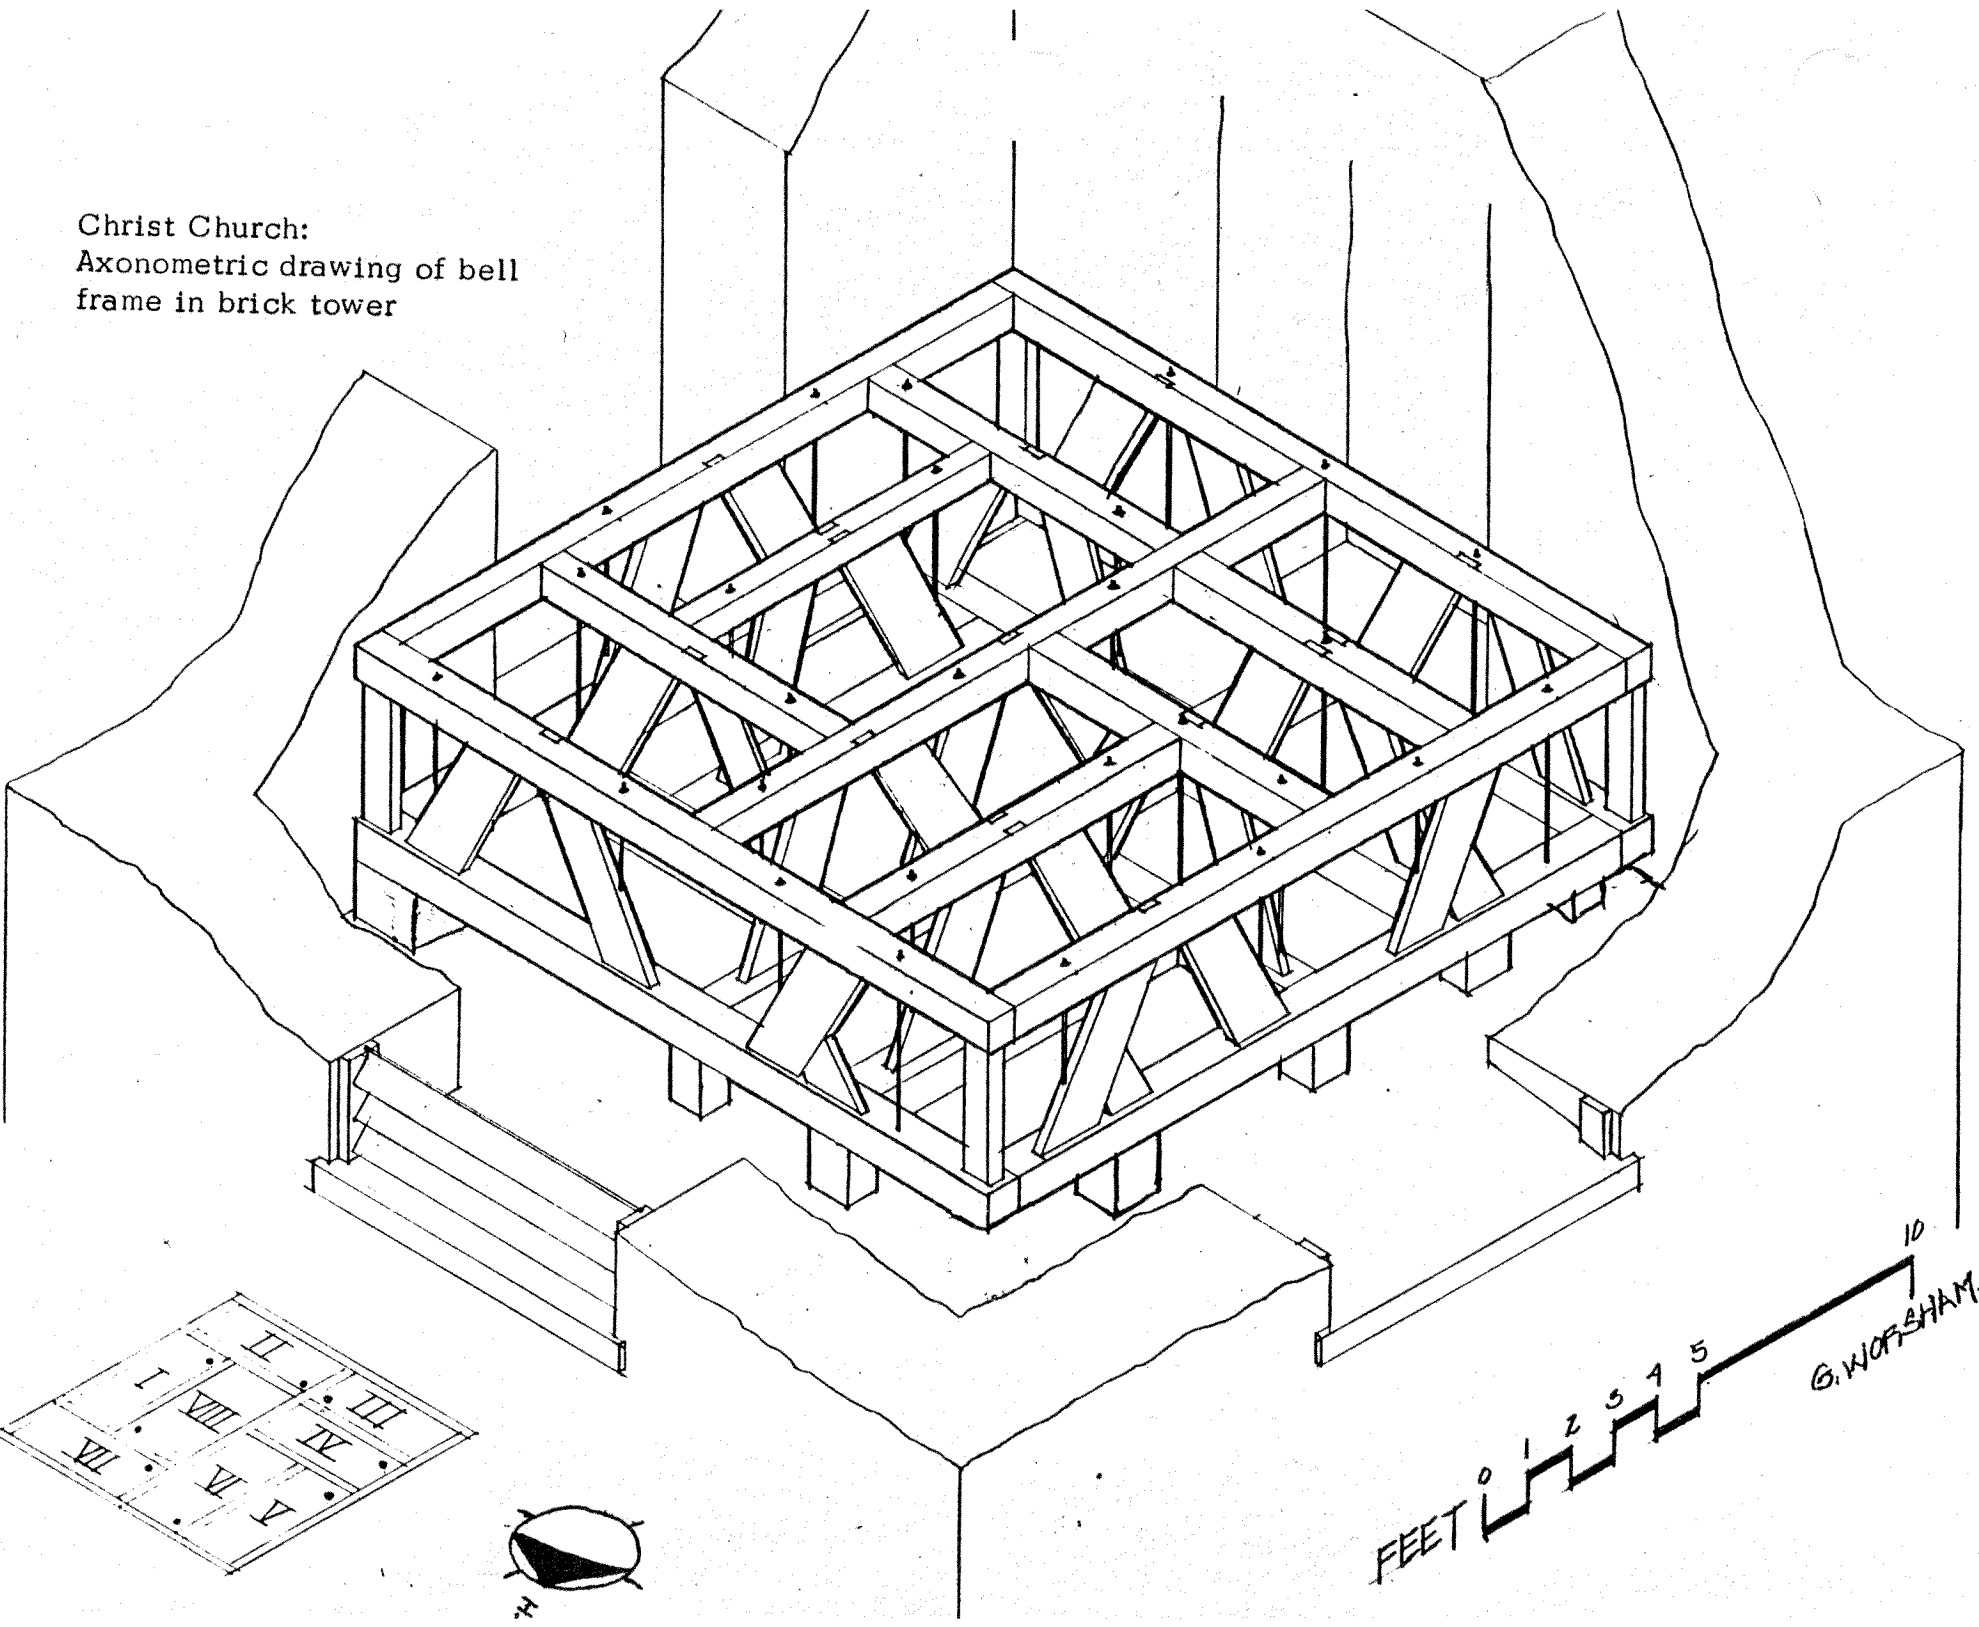
Christ Church:
Axonometric drawing of bell
frame in brick tower

The form of the present frame is similar to type V in Figure E, page 34 ¹³ of The Towers and Bells Handbook. The positions of the bells are shown in the axonometric drawing (see attachment). The 1847 "asphaltum" deck beneath the frame slopes down approximately eleven inches in fifteen feet from south to north. The frame is supported by blocks of graduated heights. The two-inch random width splined decking is supported on joists mounted at graduated heights above a "grillage" of two sets of four foundation timbers set perpendicularly to each other. These transmit the forces generated by ringing to the tower walls along both horizontal axes. Tie-bolts extend from the frame heads to the sills; an additional seven modern tie-bolts attach the top of the sill to the foundation timbers. Three early tie-bolts

now extend past the frame and through the decking only. The distance from the bottom of the sills to the top of the foundation timbers is approximately two feet. It would seem likely that the original frame sat on a level deck applied directly to the foundation timbers and was unprotected from the moisture penetration which eventually caused the failure of the steeple itself. The form of the original foundation timbers is uncertain. The brickwork in the pockets holding the timbers is chipped and disturbed, indicating that the timbers were not planned for in the tower's construction.
