HISTORIC STRUCTURE REPORT  
ARCHITECTURAL DATA SECTION  
(VOLUME II - SYSTEMS ANALYSIS)

June 1988

OLD STATE HOUSE  
BOSTON NATIONAL HISTORICAL PARK

John B. Marsh  
and  
Morgan Phillips

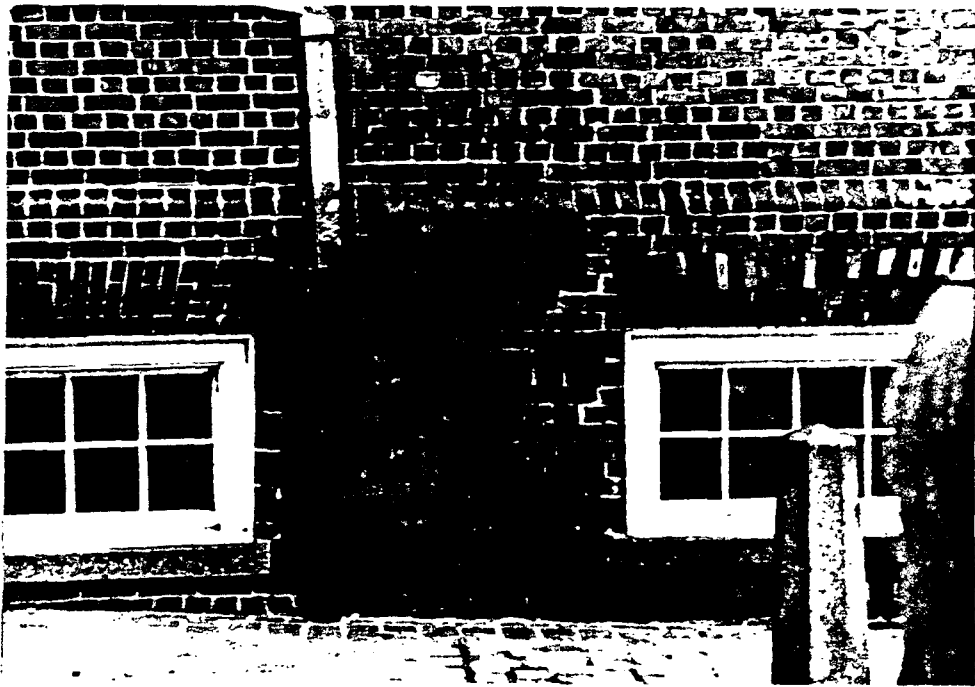
ILLUSTRATION 7. OLD STATE HOUSE: SOUTH WALL, WEST END, BRICKWORK NEEDING REPOINTING, 1987.

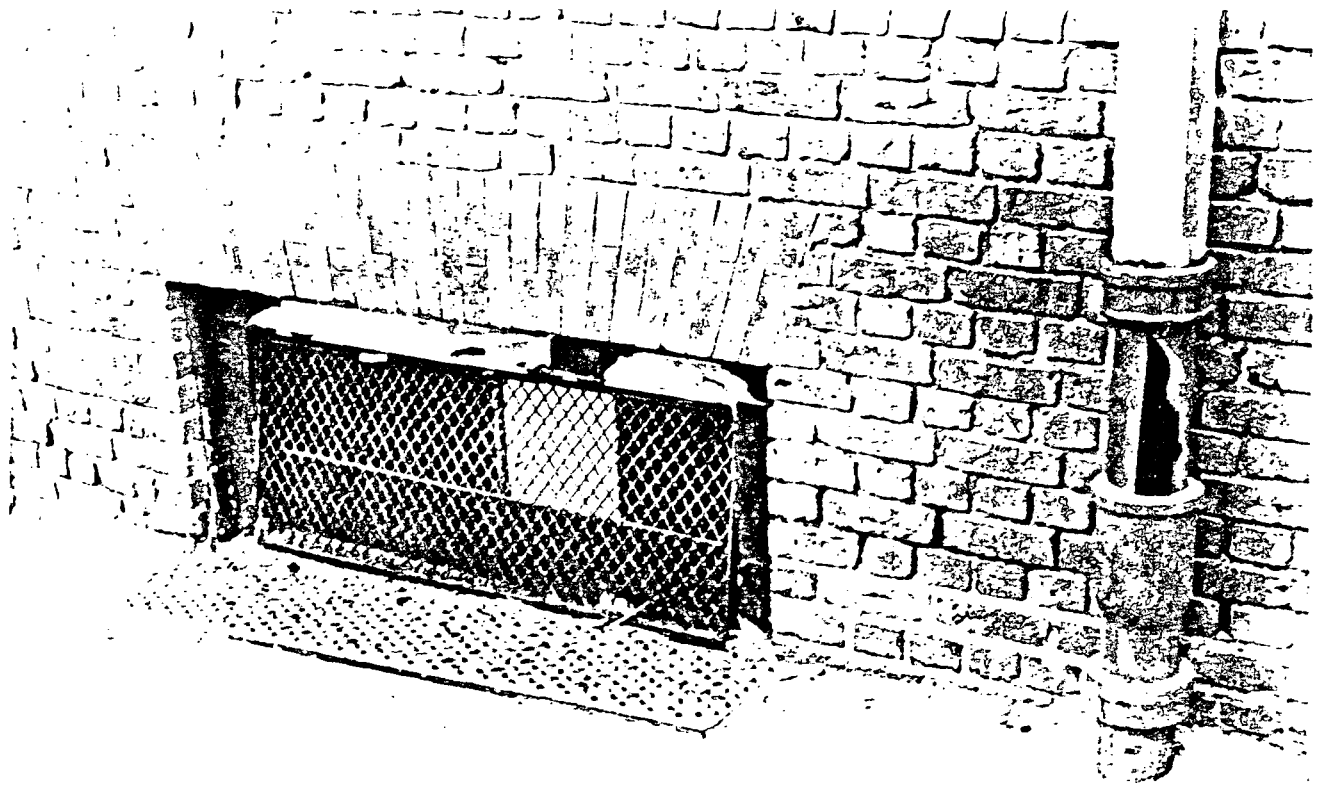
ILLUSTRATION 10. OLD STATE HOUSE: NORTH WALL, WEST END, BROKEN DRAINPIPE, 1977. PIPE CURRENTLY (1987) REPAIRED.

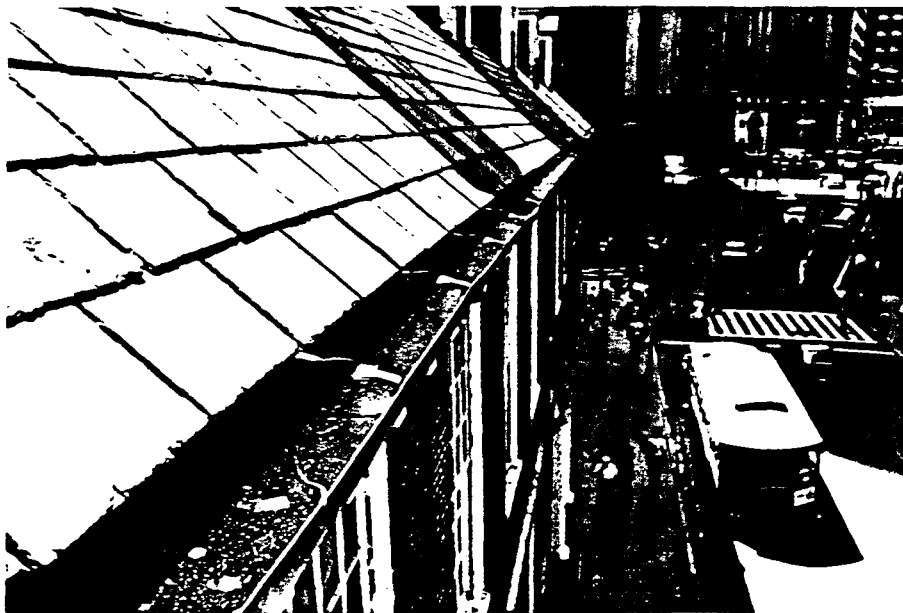
ILLUSTRATION 11. OLD STATE HOUSE: SOUTH WALL, STANDING WATER IN GUTTER, 1987.

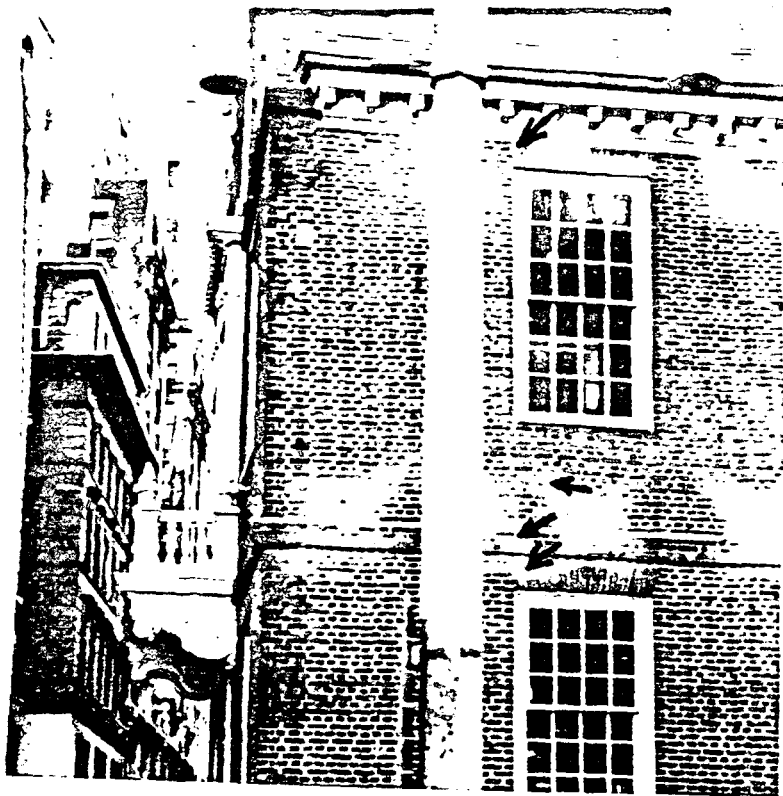
ILLUSTRATION 14. OLD STATE HOUSE: NORTH WALL, EAST END, CRACK IN BRICKWORK (FOLLOWS ARROWS), 1987.

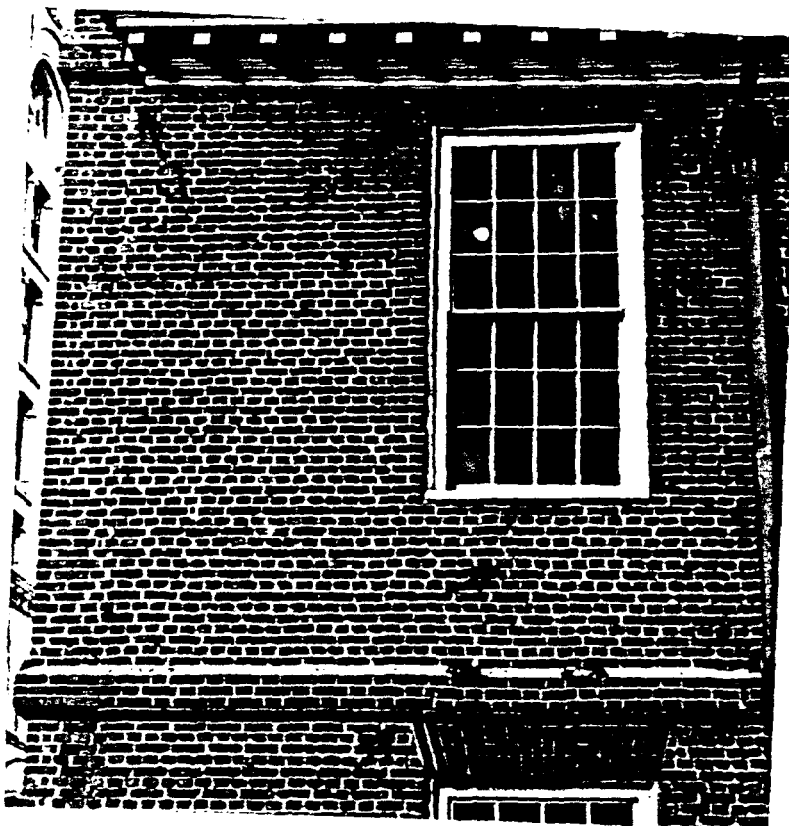
ILLUSTRATION 15. OLD STATE HOUSE: SOUTH WALL, WEST END, CRACK IN BRICKWORK (FOLLOWS ARROWS), 1987.

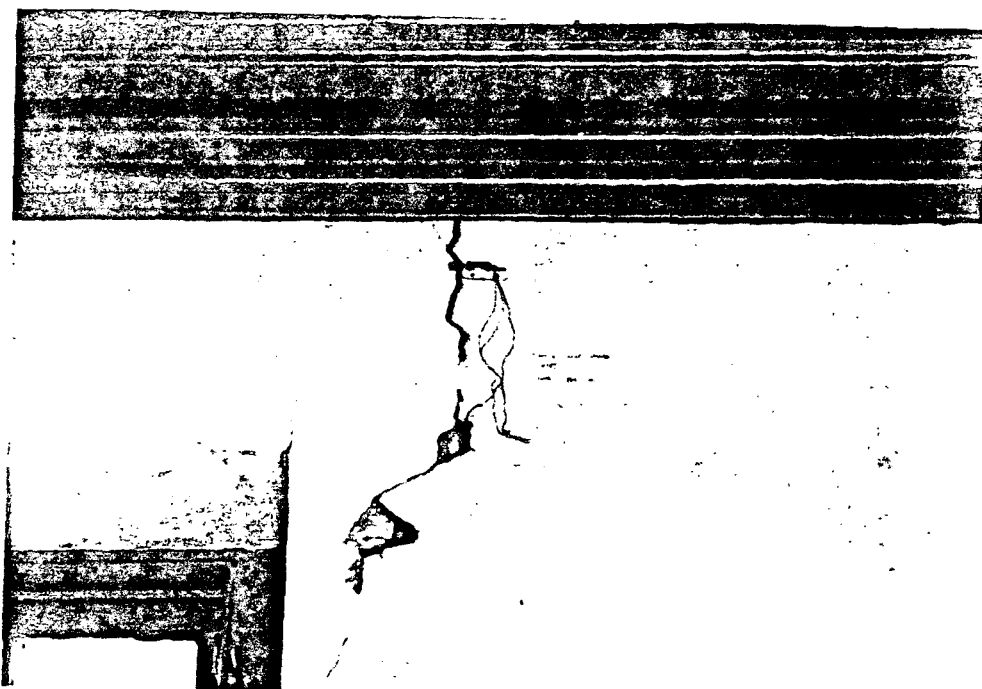
ILLUSTRATION 16. OLD STATE HOUSE: COUNCIL CHAMBER, NORTH WALL, CRACK IN PLASTER, 1987.

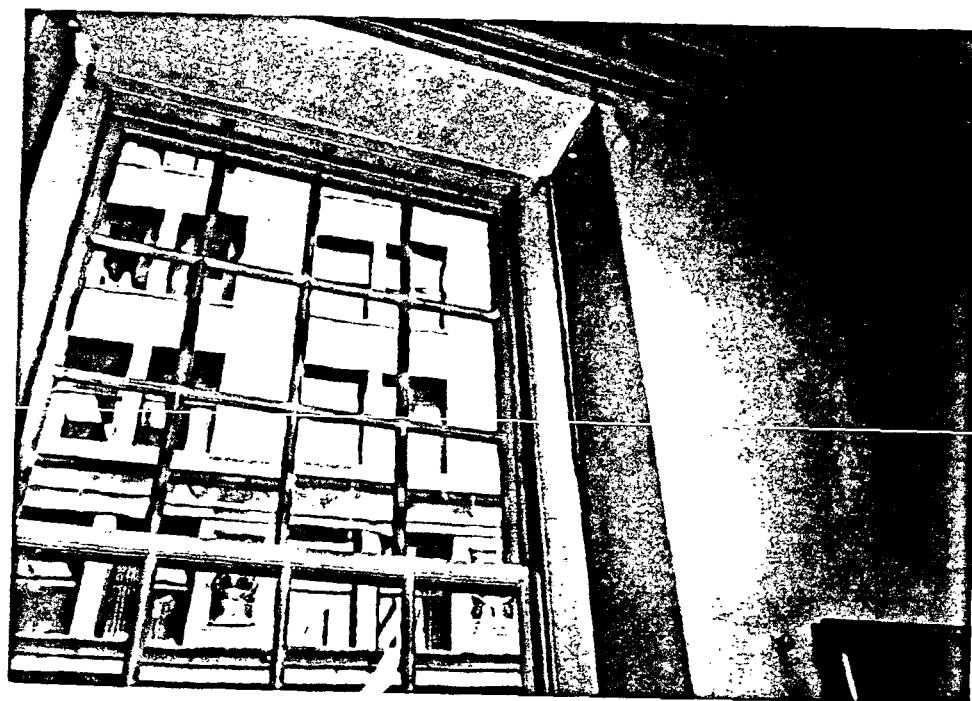
ILLUSTRATION 17. OLD STATE HOUSE: REPRESENTATIVE'S HALL, SOUTH WALL, CRACKS IN PLASTER, 1987.

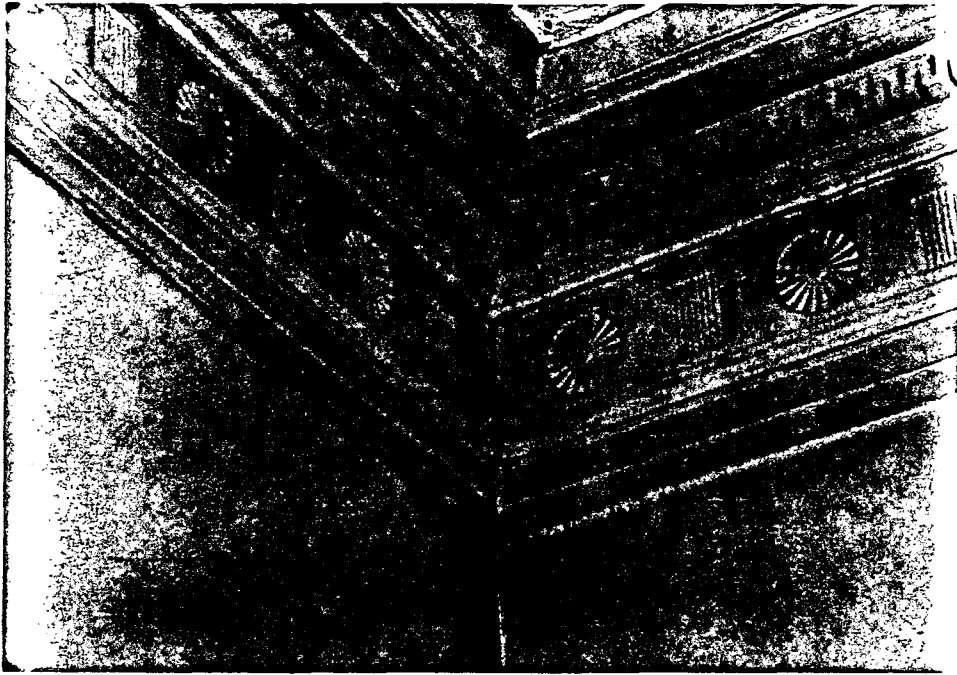
ILLUSTRATION 18. OLD STATE HOUSE: REPRESENTATIVE'S HALL, INTERSECTION OF SOUTH AND WEST WALLS, CHIP OF TWISTED 1975 PAINT, 1987. CONDITIONS SIMILAR.

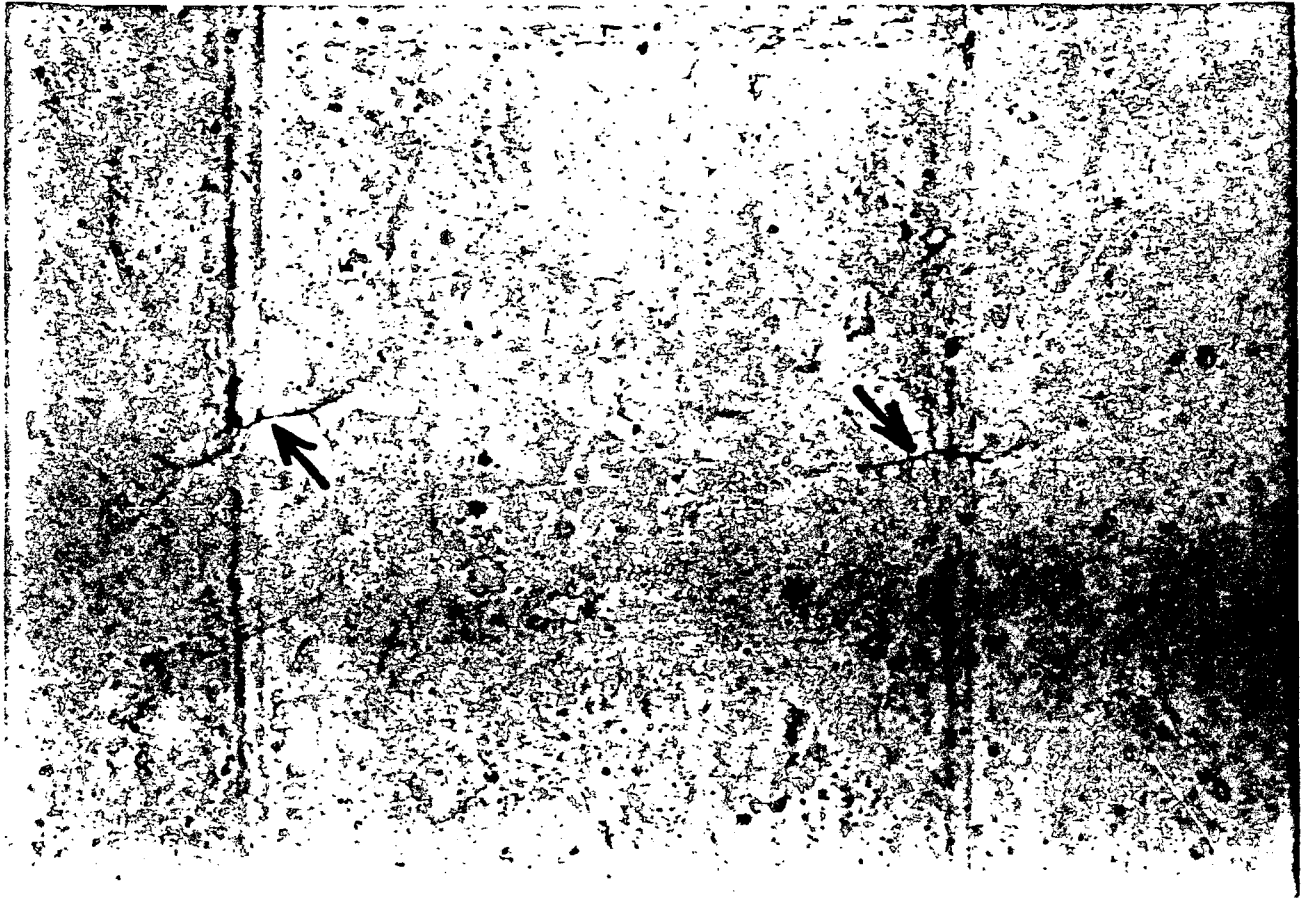
ILLUSTRATION 26. OLD STATE HOUSE: CRACKS IN BALCONY FLOOR, 1977. CONDITIONS SIMILAR TODAY.

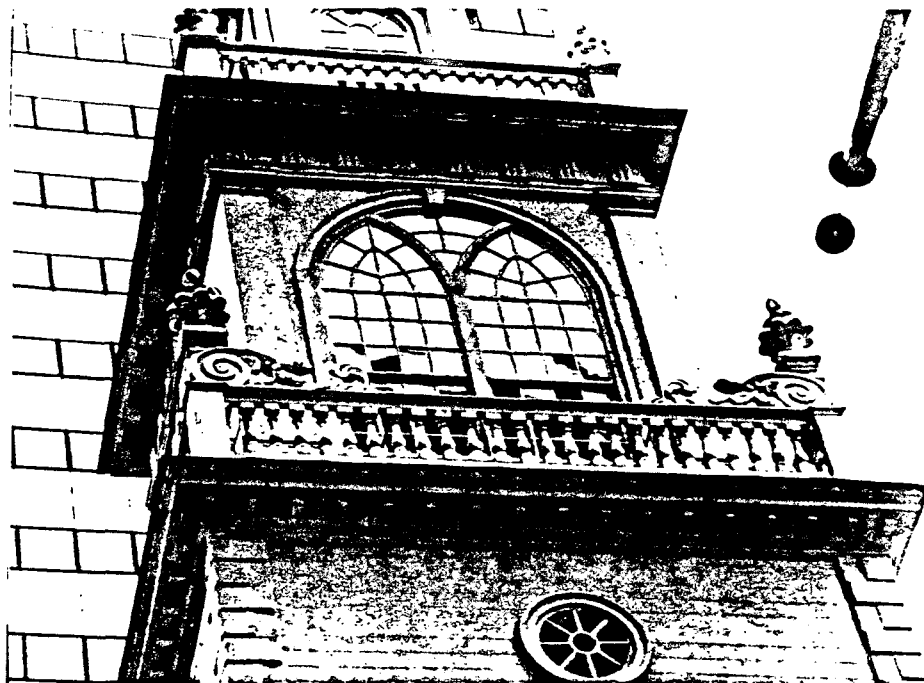
ILLUSTRATION 27. OLD STATE HOUSE: COPPER ROOFS OF TOWER, BENT EDGING AND OPENING OF JOINTS, 1987.

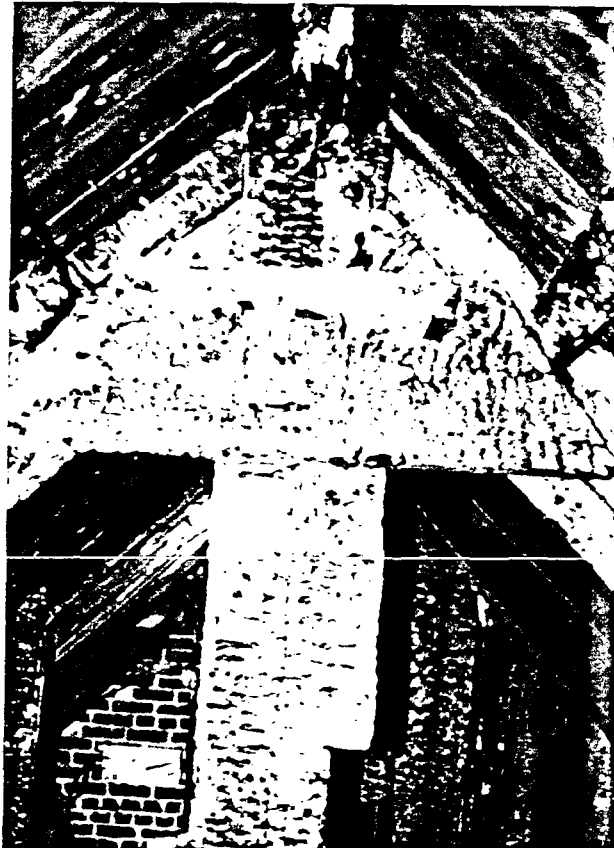
ILLUSTRATION 49. OLD STATE HOUSE: FIRE DAMAGE AT ROOF TRUSS, 1987.

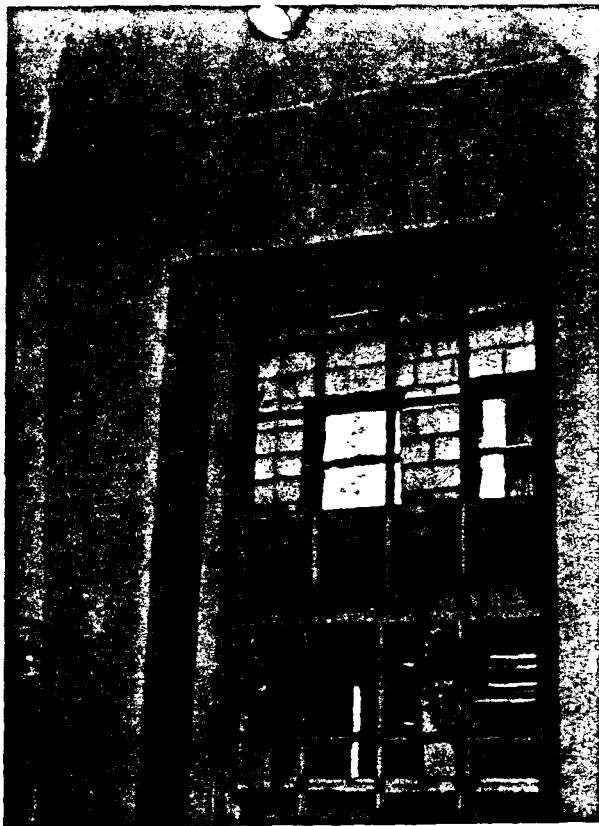
ILLUSTRATION 50. OLD STATE HOUSE: CRACKS IN PLASTER IN PATRIOT'S ROOM, 1987.

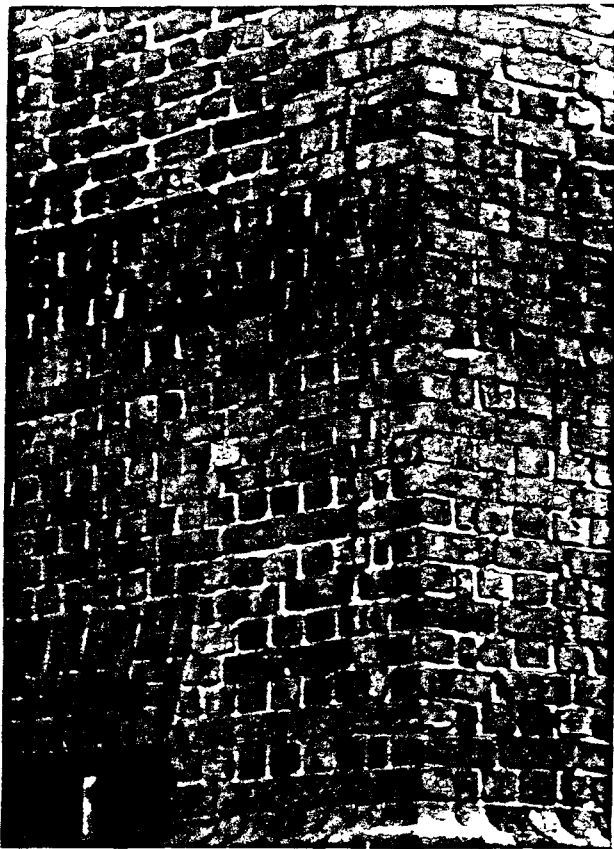
ILLUSTRATION 54. OLD STATE HOUSE: CRACK IN SOUTH WALL AT SOUTHWEST CORNER, 1987.

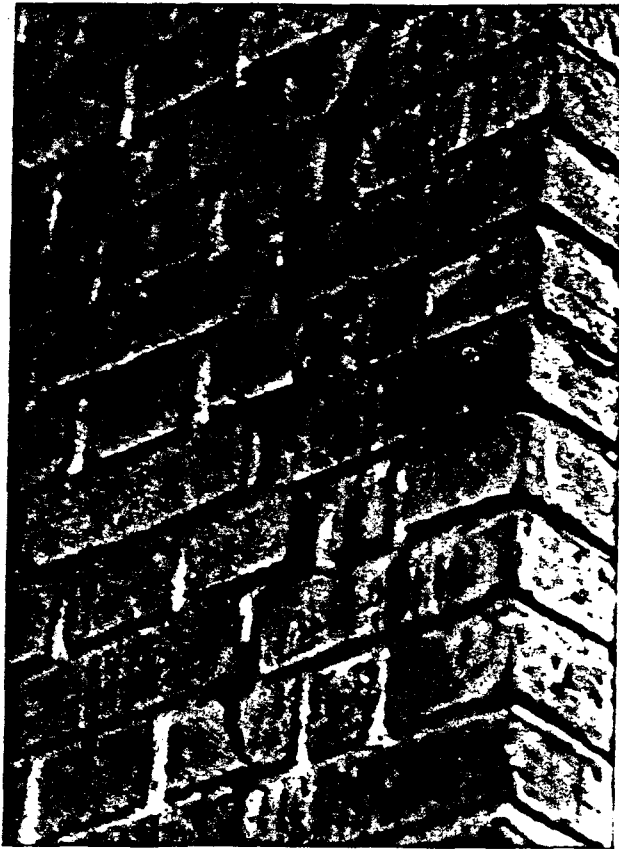
ILLUSTRATION 55. OLD STATE HOUSE: DETAIL OF CRACK SHOWN IN ILLUSTRATION 54, 1987.

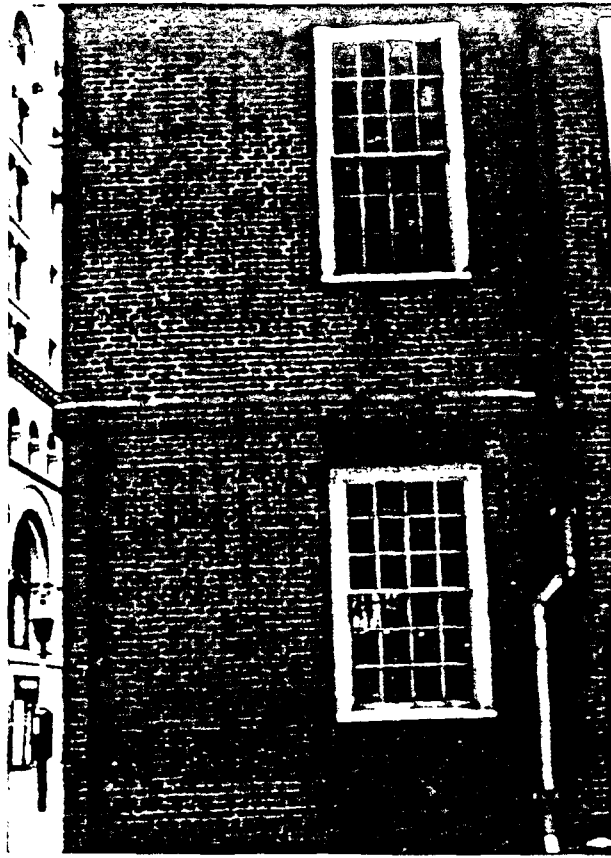
ILLUSTRATION 56. OLD STATE HOUSE: CRACK IN SOUTH WALL AT SOUTHWEST CORNER, 1987.

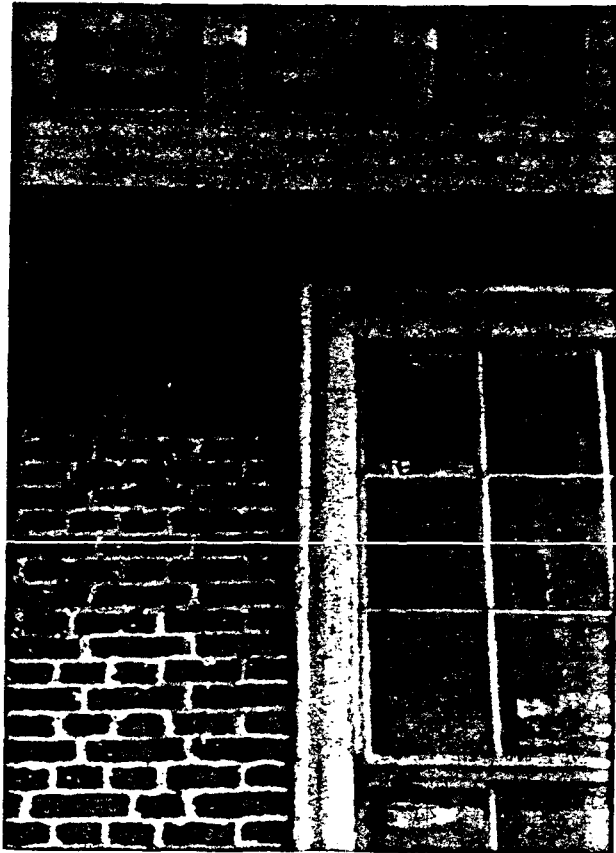
ILLUSTRATION 57. OLD STATE HOUSE: DETAIL OF ILLUSTRATION 56 SHOWING CRACK ABOVE SECOND-FLOOR WINDOW, 1987.

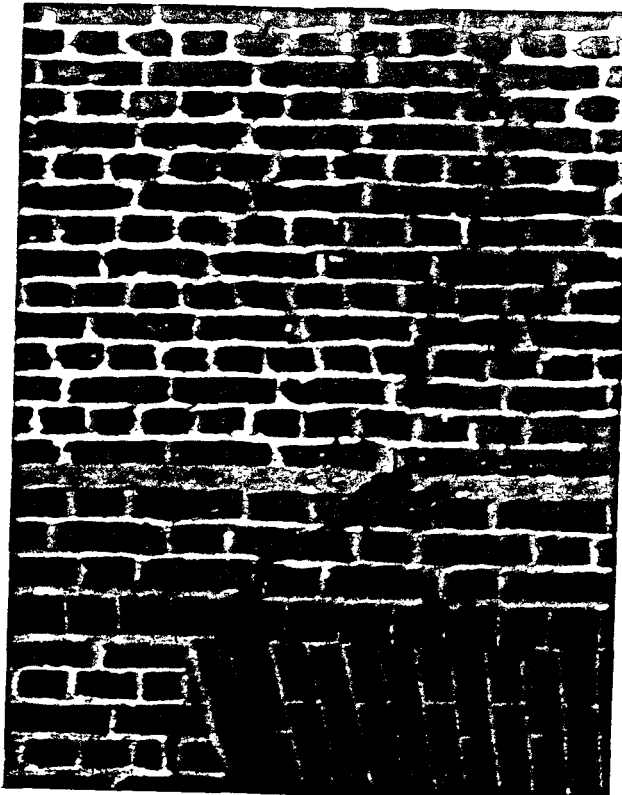
ILLUSTRATION 58. OLD STATE HOUSE: DETAIL OF ILLUSTRATION 56  
SHOWING CRACK OVER FIRST-FLOOR WINDOW, 1987.

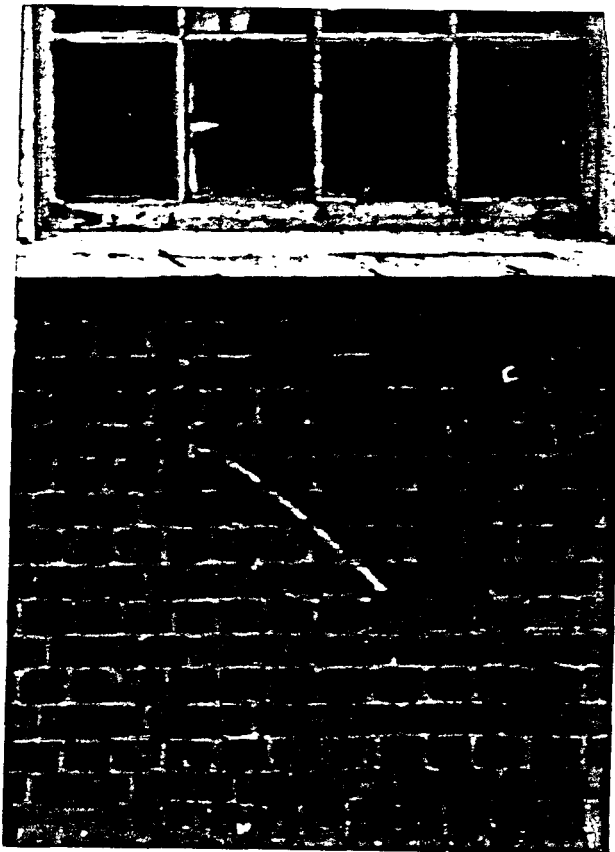
ILLUSTRATION 59. OLD STATE HOUSE: DETAIL OF ILLUSTRATION 56  
SHOWING CRACK UNDER FIRST-FLOOR WINDOW, 1987.

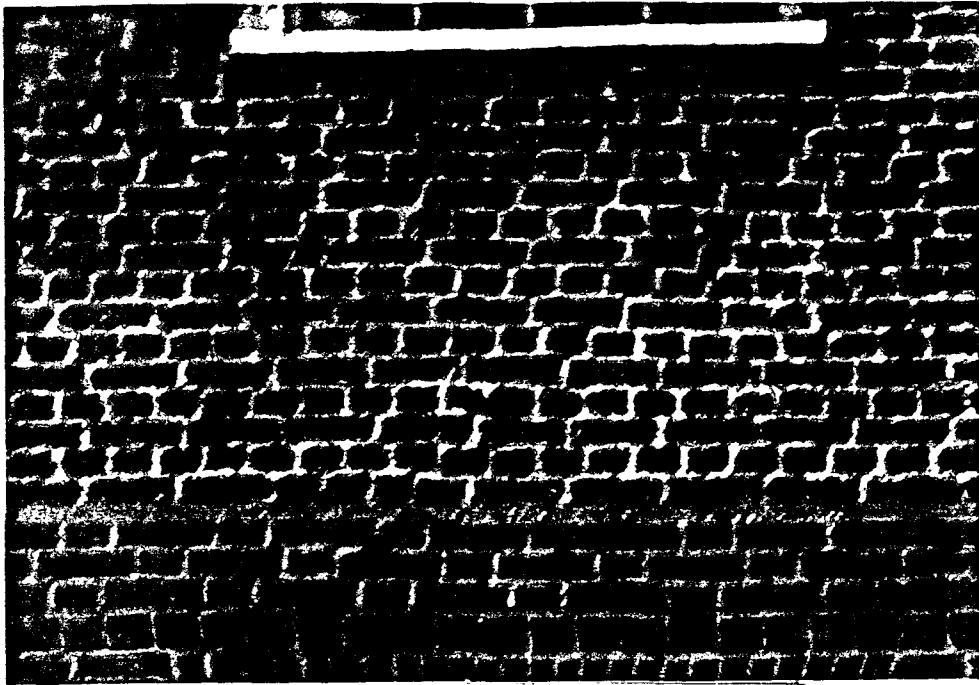
ILLUSTRATION 60. OLD STATE HOUSE: DETAIL OF ILLUSTRATION 56 SHOWING CRACK UNDER SECOND-FLOOR WINDOW, 1987.

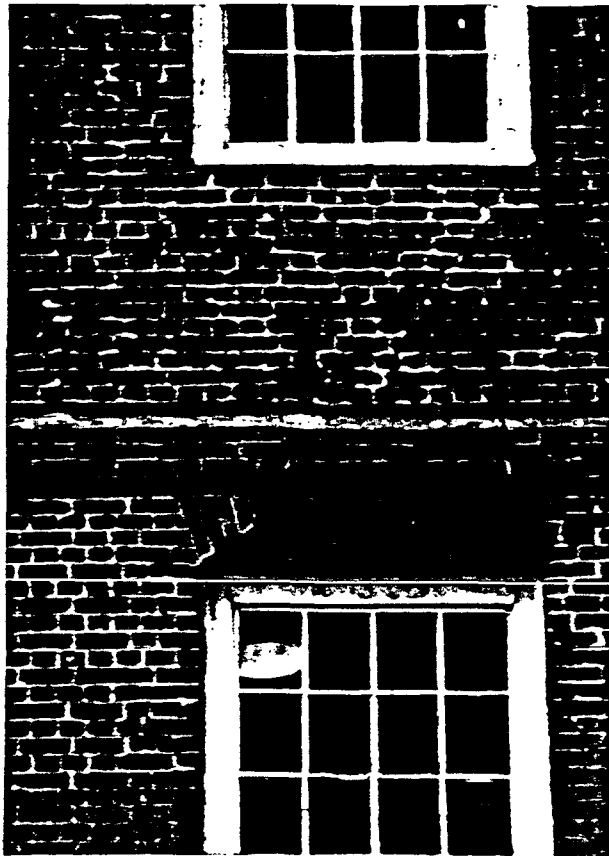
ILLUSTRATION 61. OLD STATE HOUSE: PATCHED CRACK IN NORTH WALL NEAR NORTHEAST CORNER, 1987.

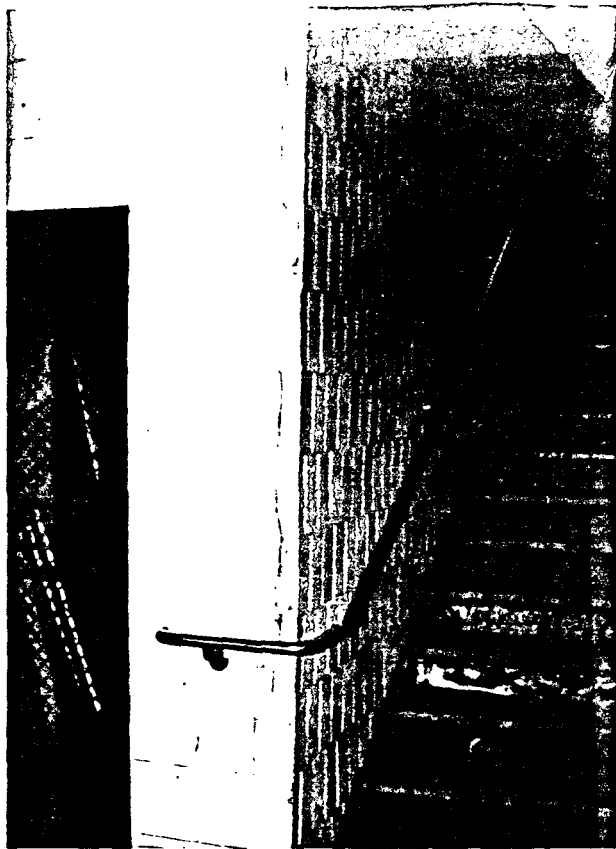
ILLUSTRATION 62. OLD STATE HOUSE: CRACK IN SUBWAY WALL UNDER SOUTHWEST CORNER, 1987.

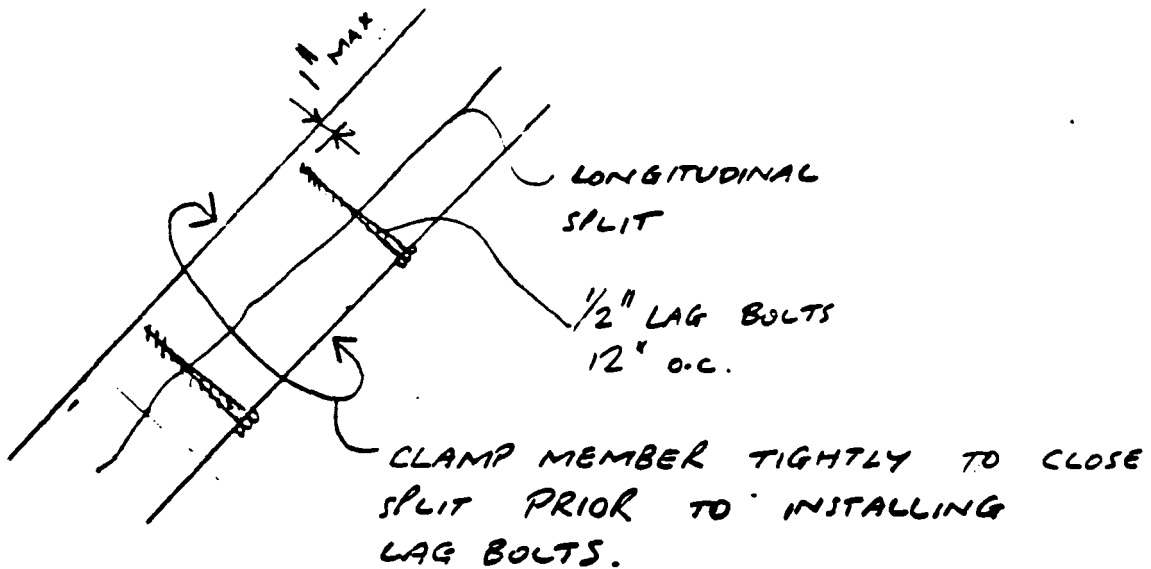
REPAIRS TO SPLIT TRUSS TOP CHORD IN  
ATTIC LOFT

Provide on the following members.

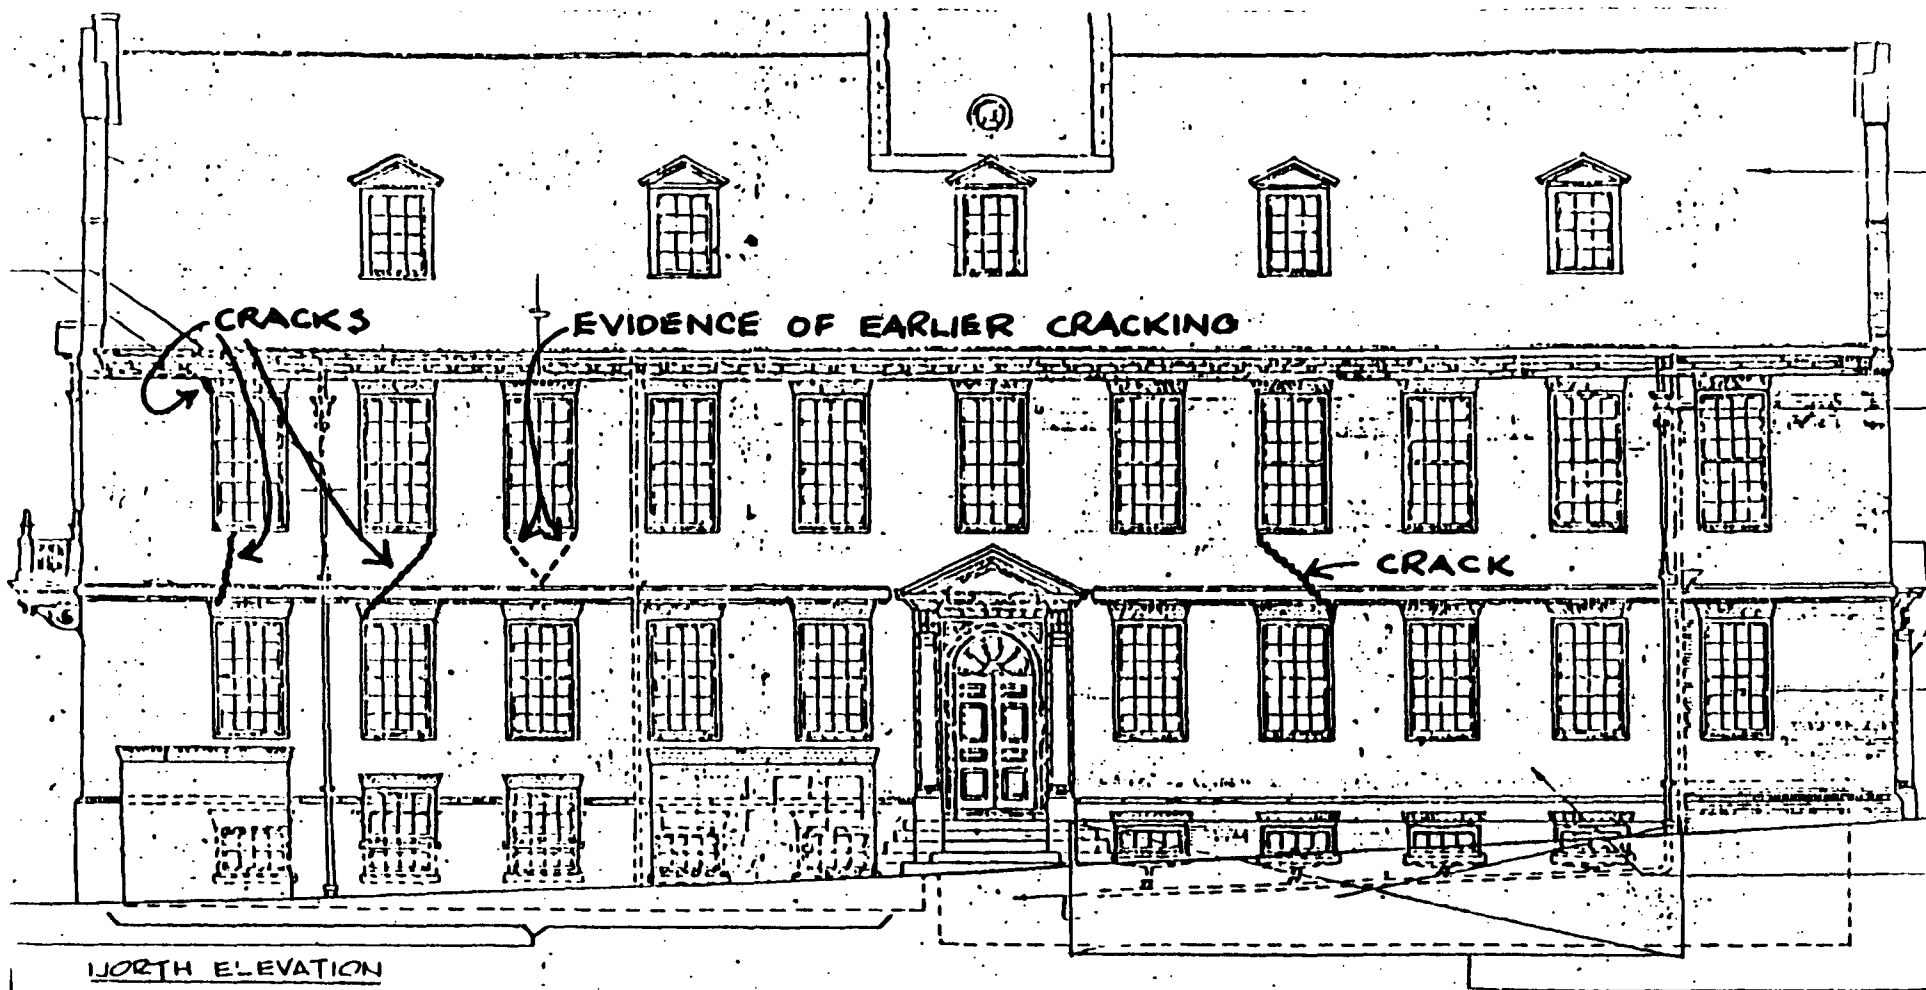
CRACKS SHOWN ARE DIAGRAMMATIC ONLY. NOT TO SCALE.

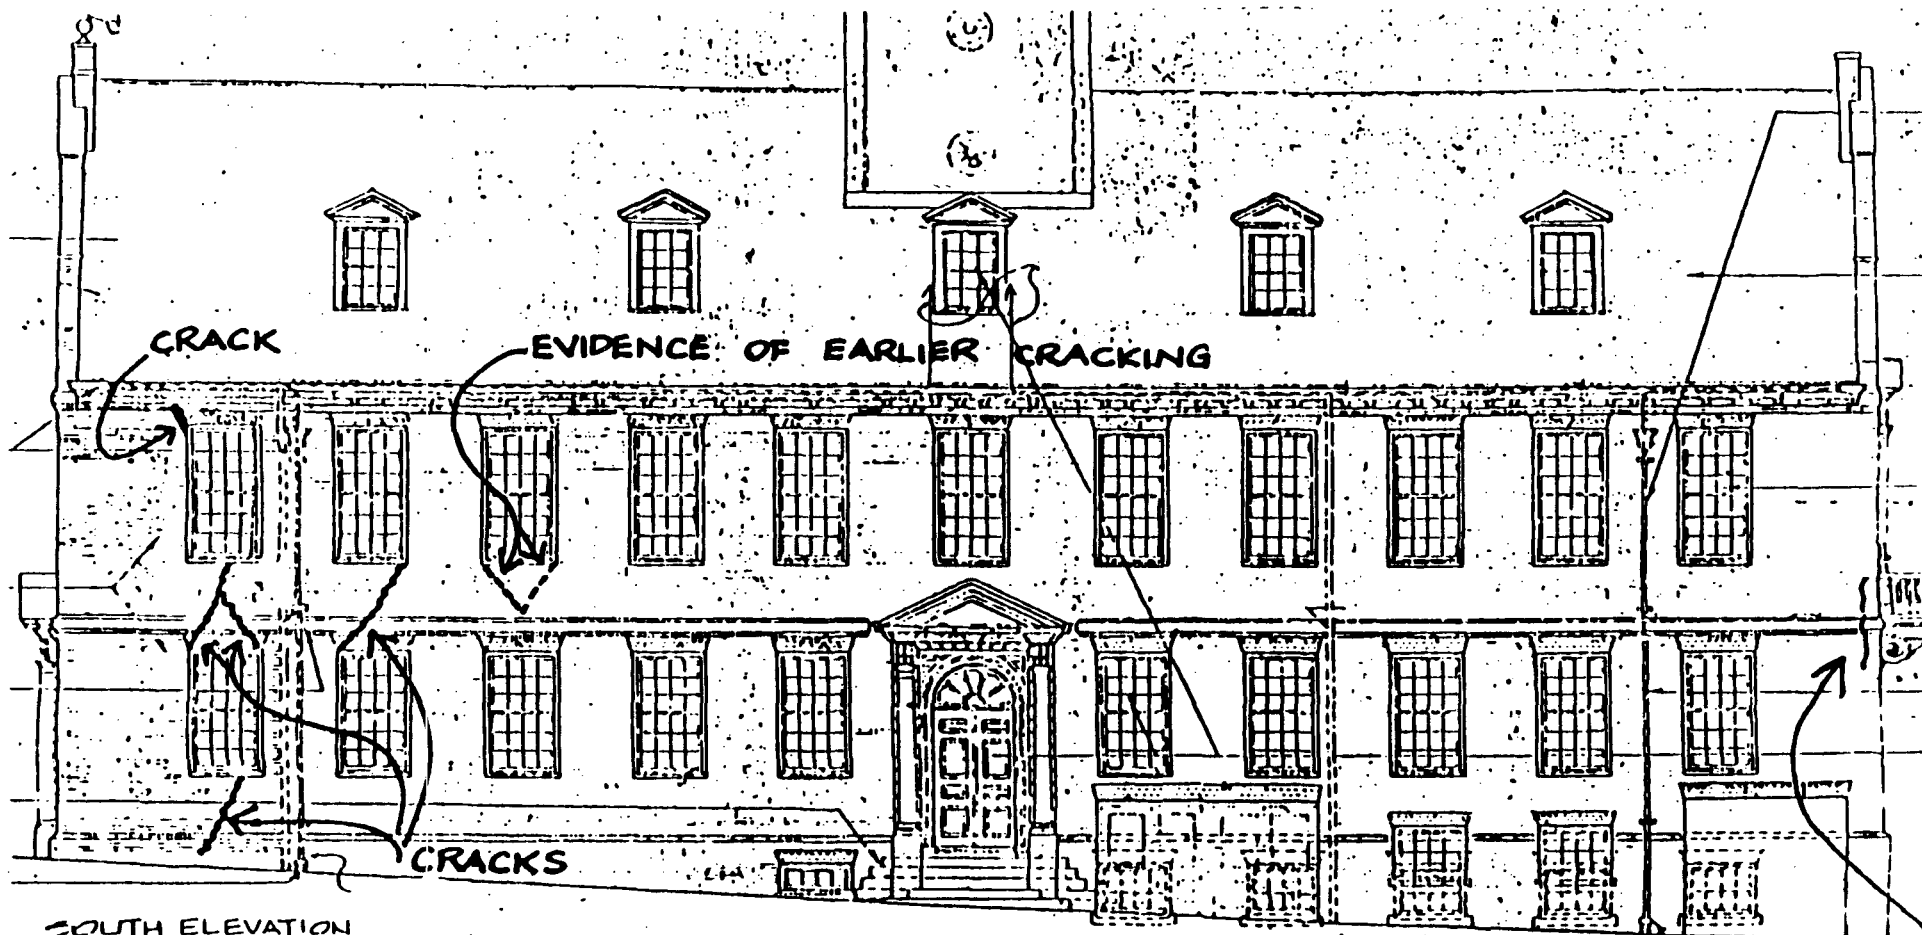
SOUTH ELEVATION

MISCELLANEOUS CRACKING AT THIS END
