DRY DOCK 1

HISTORIC STRUCTURE REPORT

Charlestown Navy Yard • Boston National Historical Park

JUNE 21, 2007

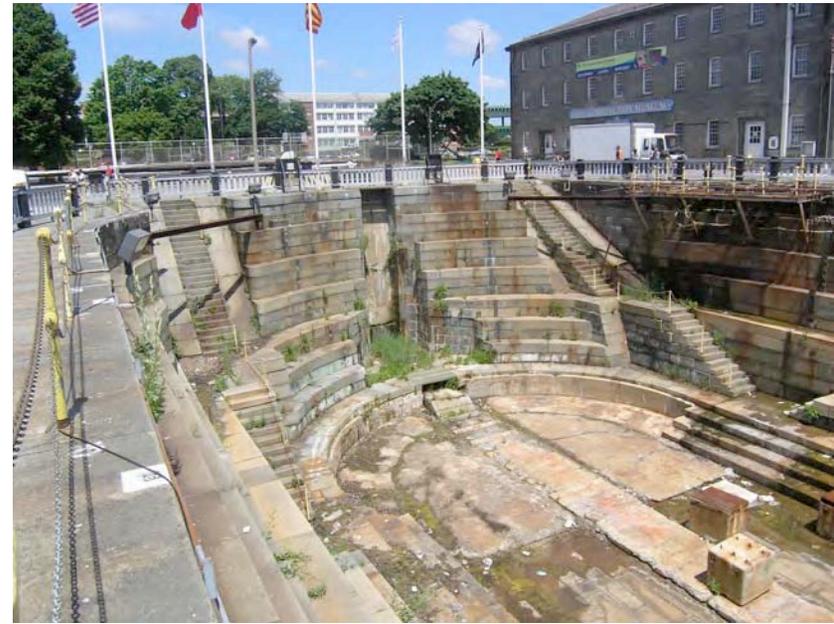
Fig. 7 View of floor at head of dock, showing the concrete slab and concrete ties that extend along the centerline of the dock.

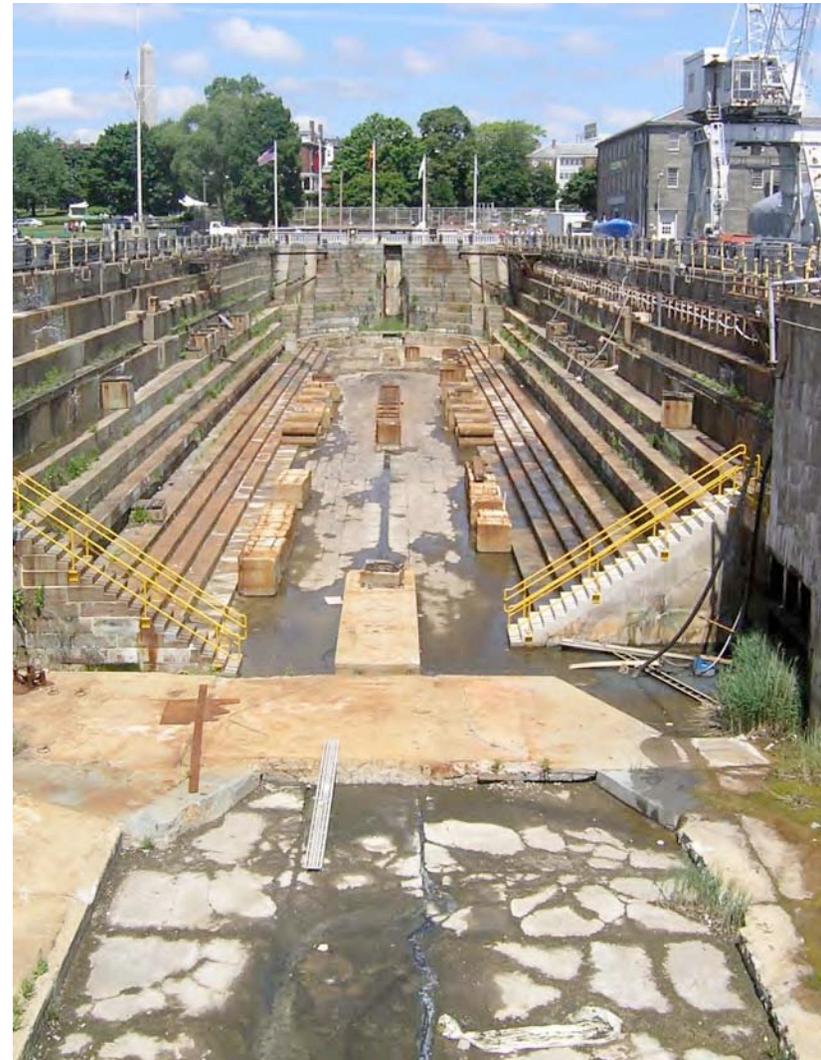
Fig. 8 Detail of propeller pit and cuts made in the granite stone at the seaward end of the dock

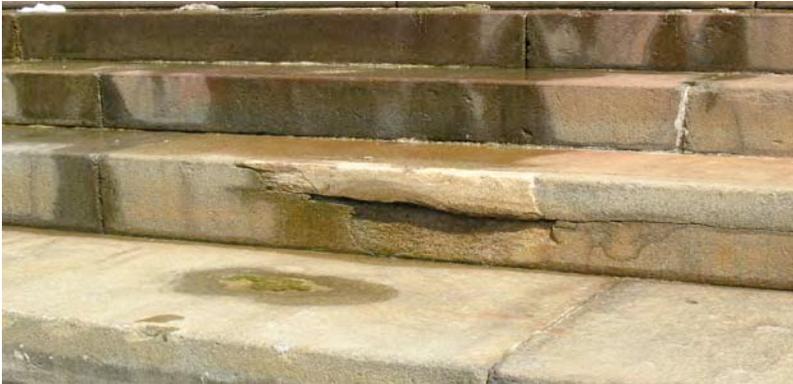
Fig. 10 Detail of cracked and broken granite block in step-back along the west wall that has been repaired with concrete.

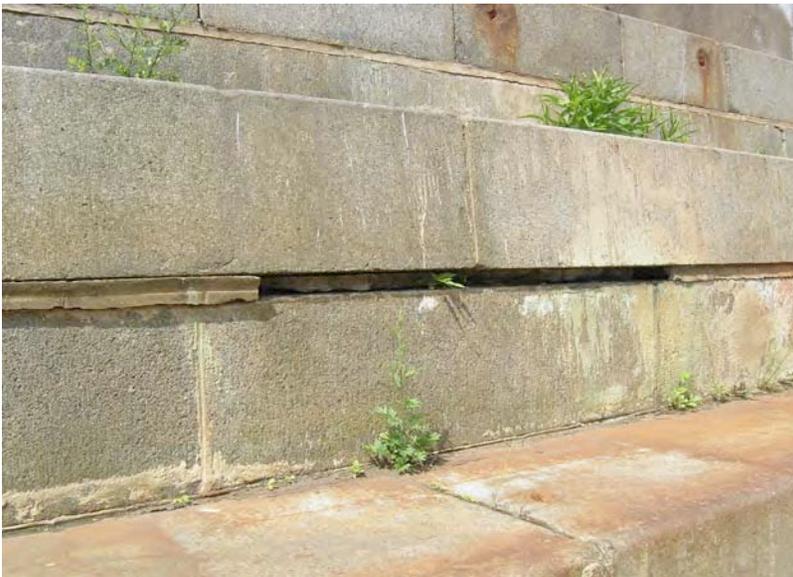
Fig. 11 Detail of vegetation, missing grout, and deteriorated mortar in joints of the lower altars on the west side of the chamber. This condition is prevalent throughout the dry dock.

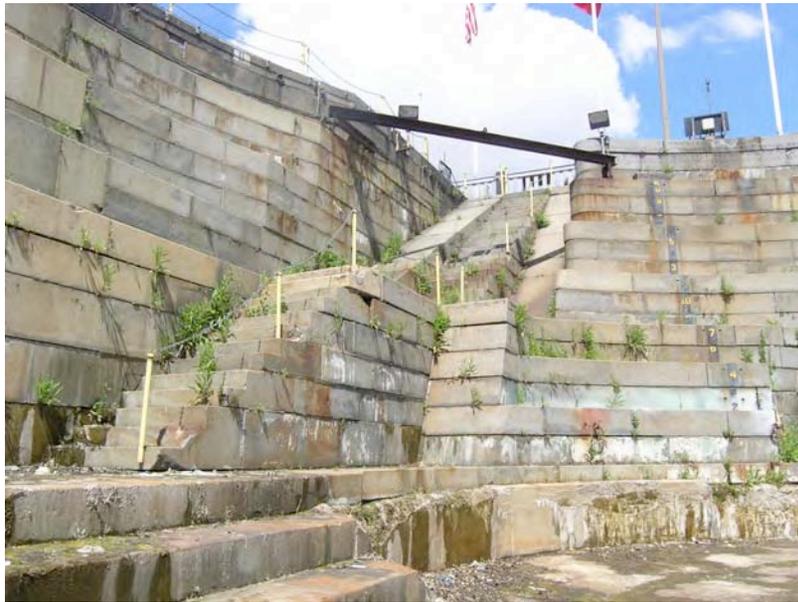
Fig. 13 Lower flight of Stair 3, on west side near the head of dock. Note that the three step-backs of the arc at the head of dock have been removed and replaced with a concrete wall that is now deteriorated.

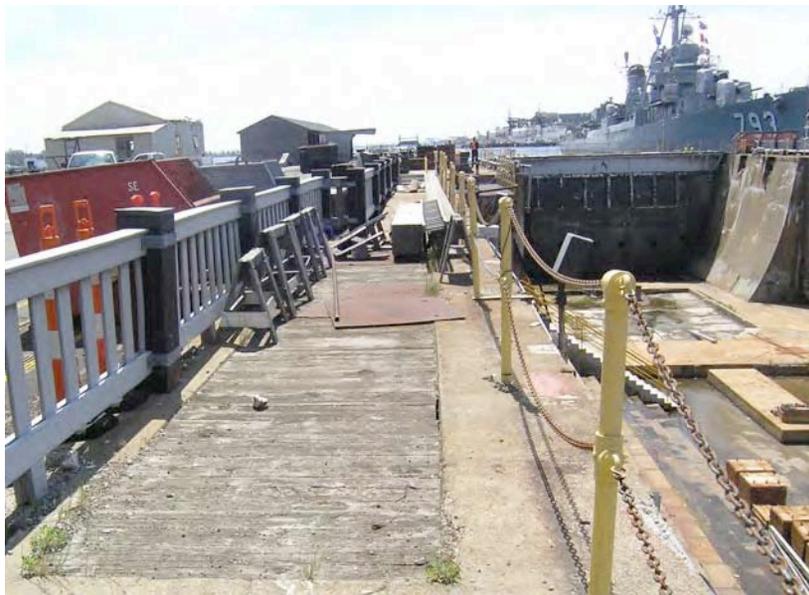
Fig. 15 Detail of blocked entrance to the chamber of Stair 6, near the middle of the dock.

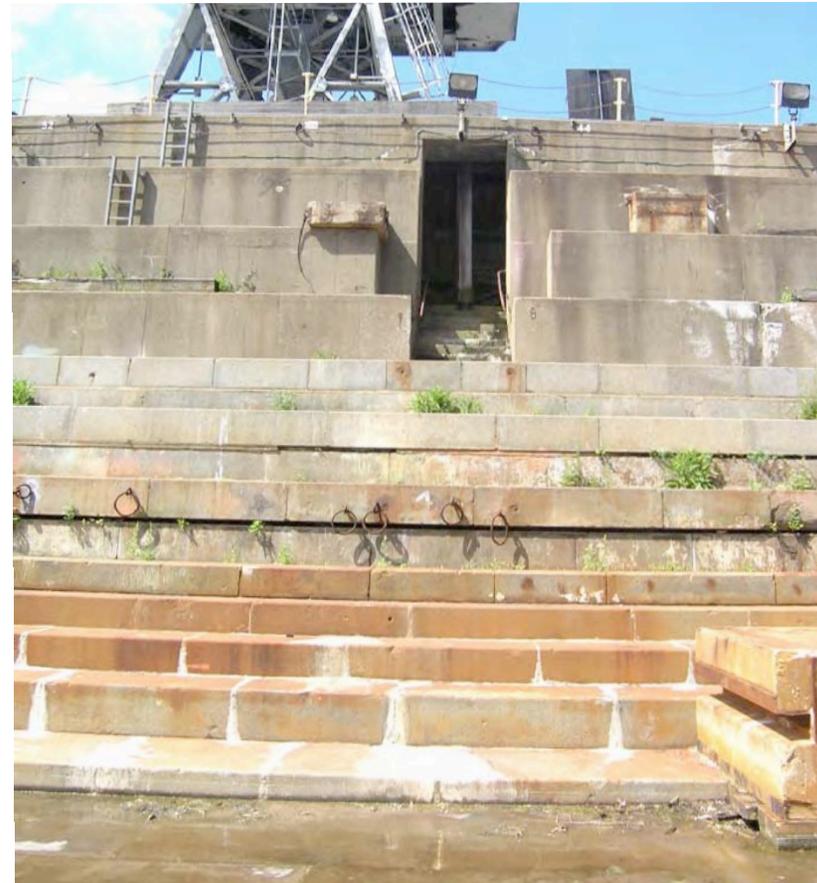
Fig. 16 Detail of entrance to the chamber of Stair 6, near the middle of the dock on the west side. One of the timber posts that supports the timber planking, which blocks off the ground-level entrance to the stairway, is visible in the center.

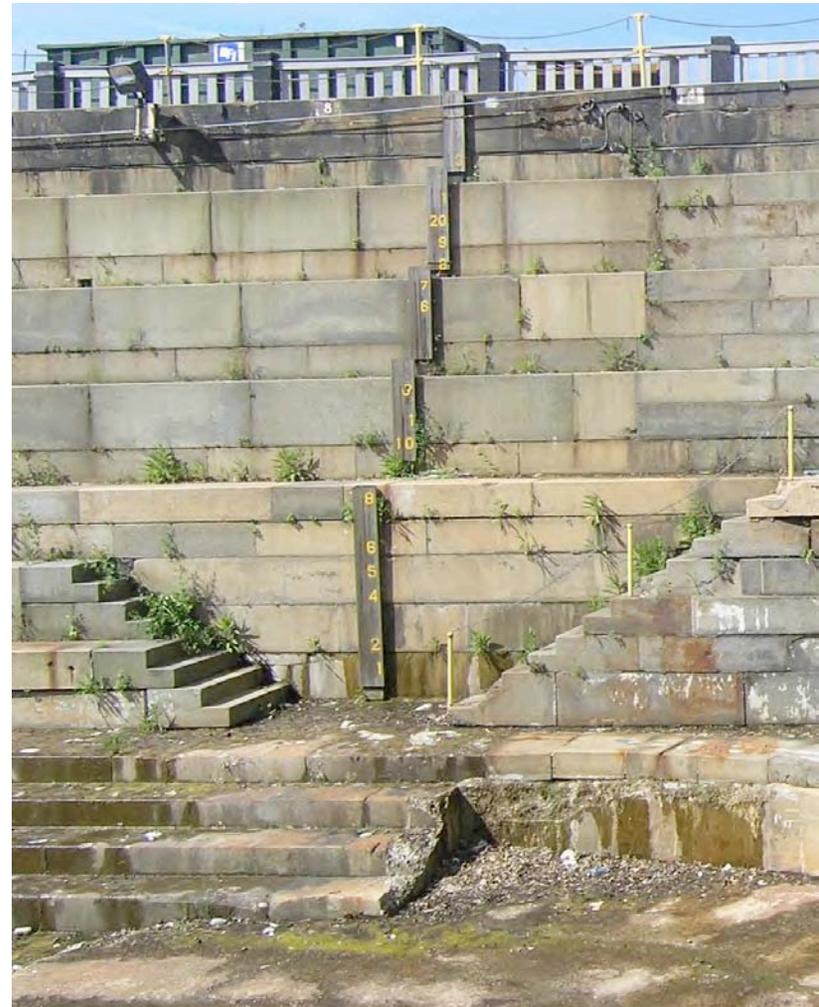
Fig. 17 Granite stairs at lower altars, west side of the chamber. Note that some deterioration has occurred in the lower steps (at lower right) where a section of the lower steps, extending around the arc of the dock's head, were removed and replaced with a low concrete wall that is now in poor condition.

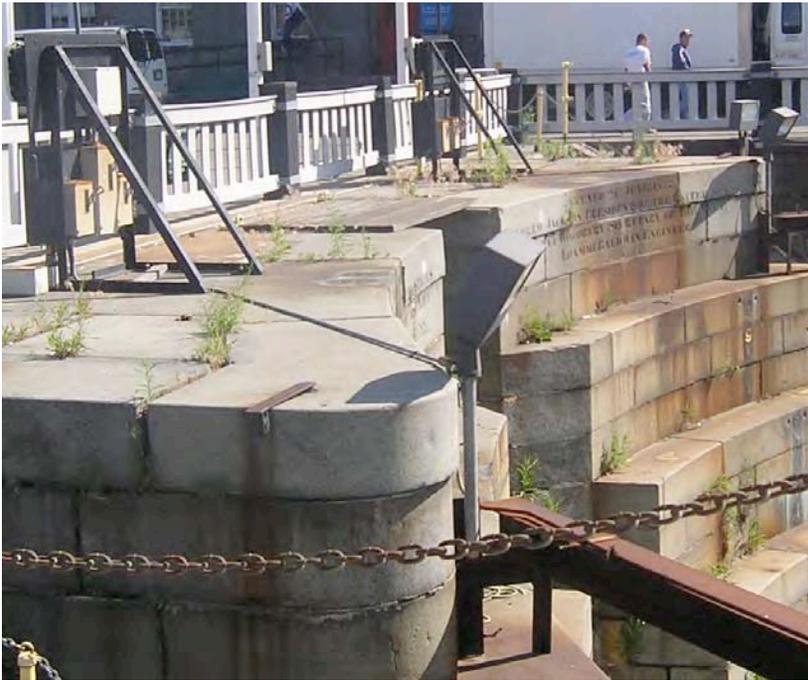
Fig. 21 On top of the head of dock are visually intrusive, non-historic utility boxes (mounted on steel frames) and electrical lines. The timber planks spanning the removed center slide are deteriorated and unsafe. Two iron rings from the 19th century remain in place, as do two small steel pulleys mounted to steel bars.

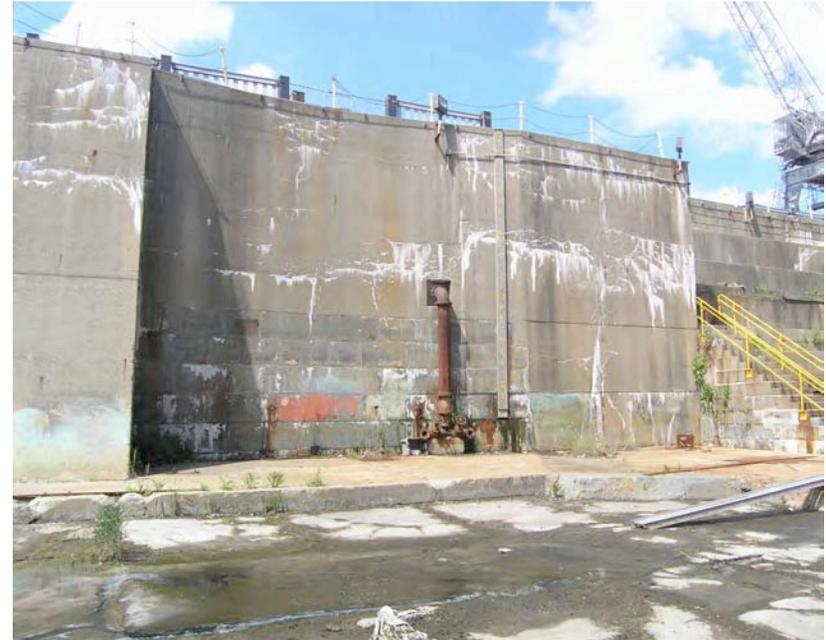
Fig. 25 View of the west wall, showing the condition of the concrete. This was part of the work carried out for the seaward extension in 1947-1948. Note that some of the lower courses of granite, which date from the original construction of Dry Dock 1, that were retained. The rusting steel pipe and valve structure in the center was part of the improved hydraulic system installed at the time of the seaward extension.

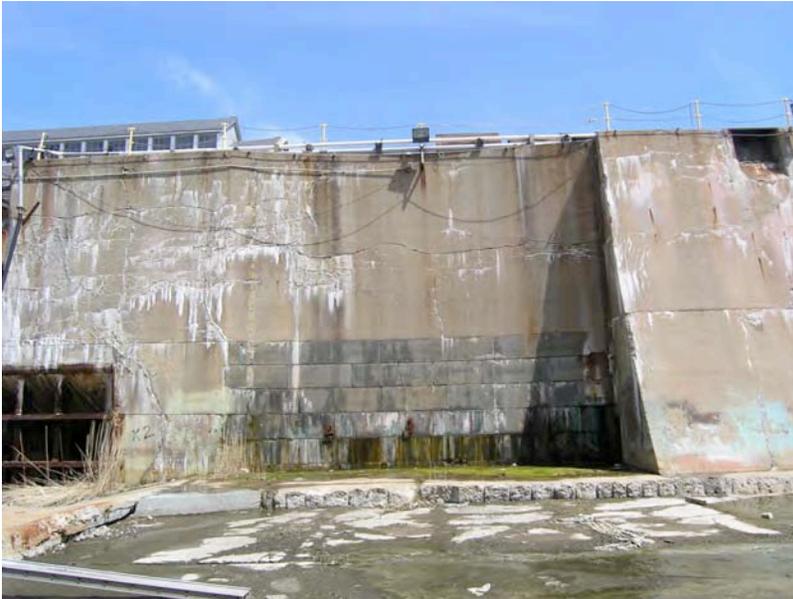
Fig. 26 View of east wall of the 1947-1948 seaward extension, showing deteriorated concrete work. The lower courses of granite that were part of the original turning basin were retained.

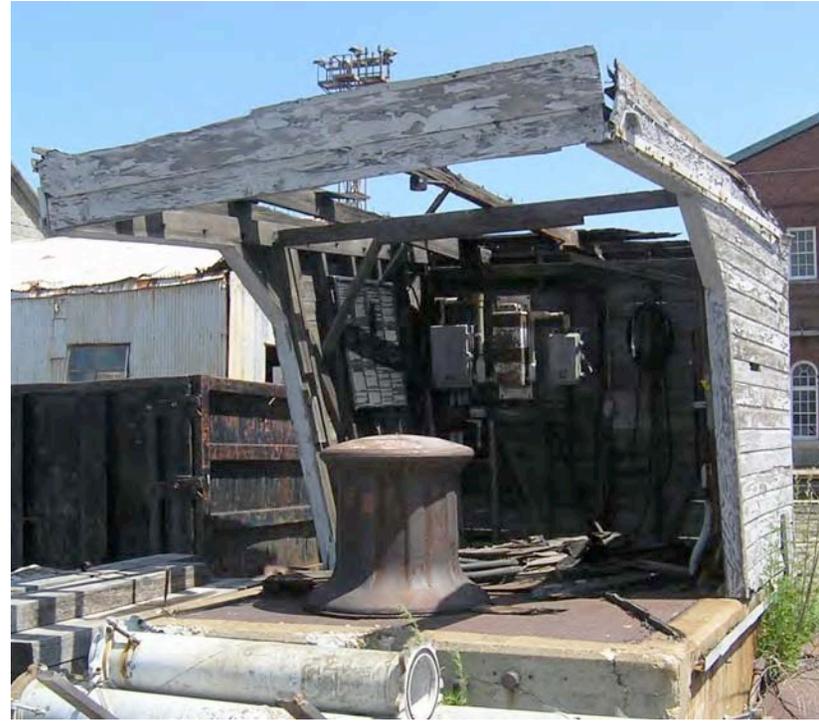
Fig. 30 Capstan No. 3 on the dock's east side near the caisson gate, looking east. The dilapidated wood-frame structure, which contains electrical panels, partially encloses this capstan.

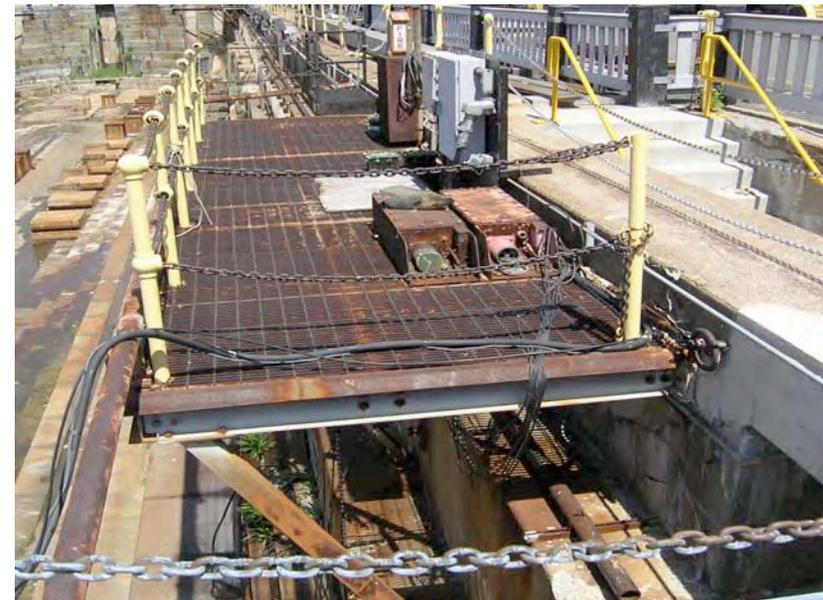
Fig. 33 Work platform, east wall, near seaward end. Note the abandoned utility lines and boxes on the platform.
