HISTORIC STRUCTURES REPORT *CACO.097c.2*  
PART I *CRBIB# 000430*

JEDEDIAH HIGGINS HOUSE

(Bldg. No. 13-13)

Truro, Massachusetts

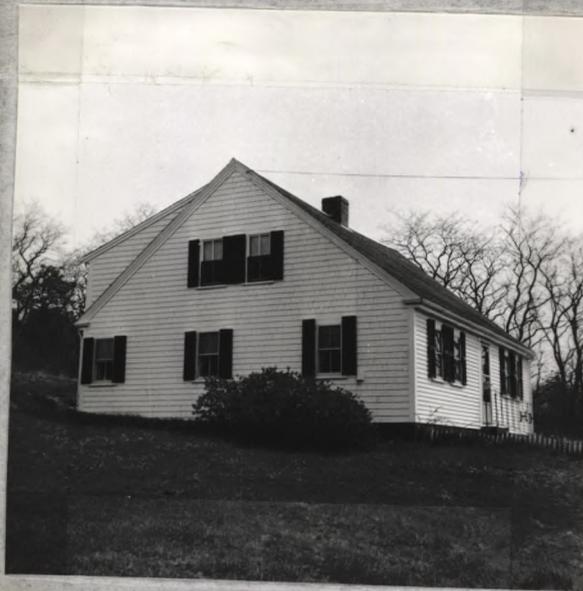
6. Photograph, exterior of house.

3. It is recommended that this house be rehabilitated sufficiently so as to serve adequately as staff quarters (its present function), or be used as an interpretive exhibit later if true restoration is desired. As a last resort, the structure might be sold and moved from the Seashore. Its overall condition is very poor. The house has had a dormer added in recent times--this modern addition destroys the otherwise good lines of this 19th century structure.

- (1) Renew front cornice members, including fascia and wooden gutter, full length of the house. Renew rear gutter where this is rotted.
- (2) Install new stock two-inch diameter galvanized downspouts at end of all gutters, where present downspouts are defective.
- (3) Blinds at front windows are too large for the windows and could be replaced with new stock blinds of the proper height.
- (4) Paint all presently painted surfaces, after proper preparation by removing all loose paint. Should have primer and one coat of House Paint.
- (5) Re-putty all window glass where putty has become loose.
- (6) Replace present front door with similar design stock fir door, cut down to fit present frame. Paint both sides 3 coats.
- (7) Re-grade at rear of house to prevent rain water from running under the house. Grade slopes toward the house at present.

- (1) Re-plaster ceilings of Southwest first floor room and entrance hall also at all other locations where present plaster is defective.
- (2) All outside walls of the house have settled badly due to the fact that the present wooden sills are rotted, causing a slope of as much as eight inches from the level of the fireplace hearth bricks toward the outside walls. Correcting this would be a very expensive operation, requiring that the house be jacked up and new sills and possibly floor joists to be replaced. Suggest that no attempt be
