ENGINEERING STUDY of CAPE LOOKOUT LIGHTHOUSE

May 12, 2005

Project No. 0508-01-00-04

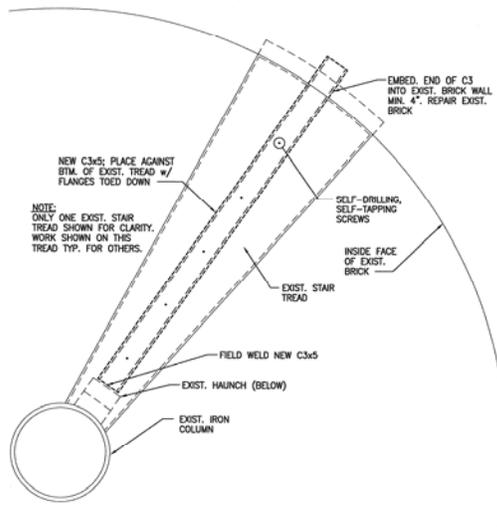
The existing stair treads span approximately 4'-6" between the inside face of the lighthouse wall and a cast iron column located in the center of the lighthouse shaft. They vary in width from approximately 4" at the column, where they bear on a cast iron haunch attached to the column, to approximately 17" at the wall, where their top plates extend into and bear on the wall. The treads have turned-down edges on three sides, which give them the ability to support light foot traffic over the existing span. However, excessive mid-span deflection of the treads is a concern, as is the long-term serviceability of the treads under repeated foot traffic.

One way to reduce mid-span deflection and provide greater resistance to repeated impact loads would be to reinforce the treads with a structural steel member fastened to the bottom of each one. One end of the new member could be welded to the existing haunch and the other embedded into the brick wall. Preliminary analyses indicate that a channel shape, such as a C3x5, could be used as the reinforcing member, as shown in the following figure:

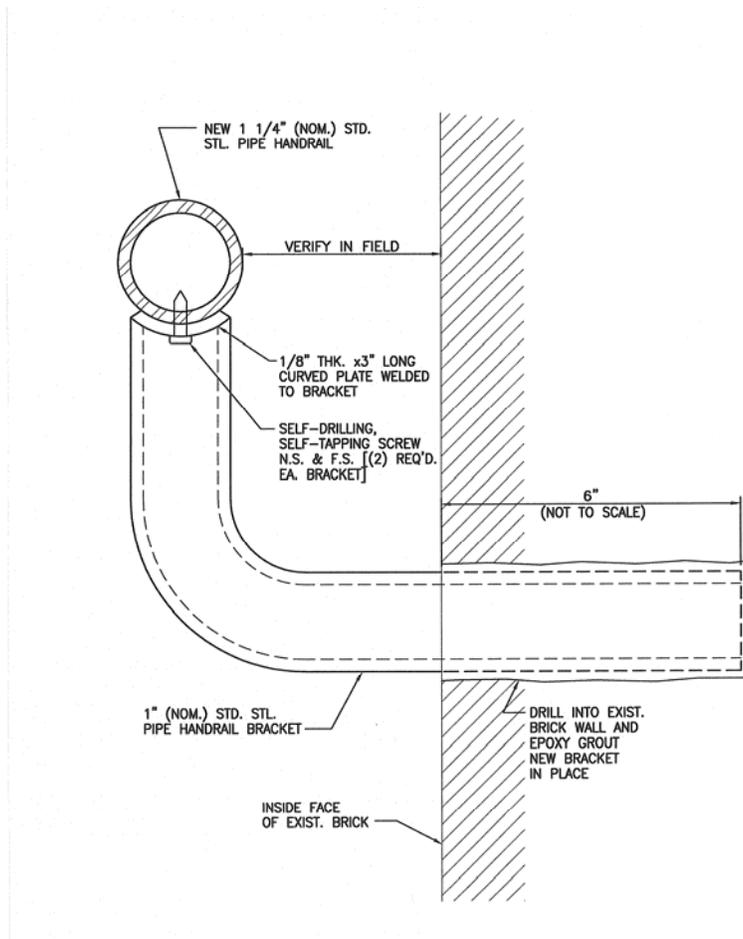
The existing outer handrail is constructed of approximately 1" diameter wrought iron solid bar, supported by wrought iron L-shaped anchors inserted in the tower's brick wall. There are two problems with the existing handrail. First, the diameter is much smaller than required by most building codes (1-1/4" minimum). Second, the distance between existing handrail anchors is such that excessive deflection of the handrail can occur under normal use. There are also some anchors that no longer adequately support the handrail because they have worked loose from the masonry into which they are embedded or have corroded away at their base.

Option 2: We recommend that the handrail be replaced with a 1-1/4" diameter pipe rail with wall anchors as shown in the following figure:

The open ends of the new rail will be closed and turned down so that, visually, the old and new handrails would appear similar.

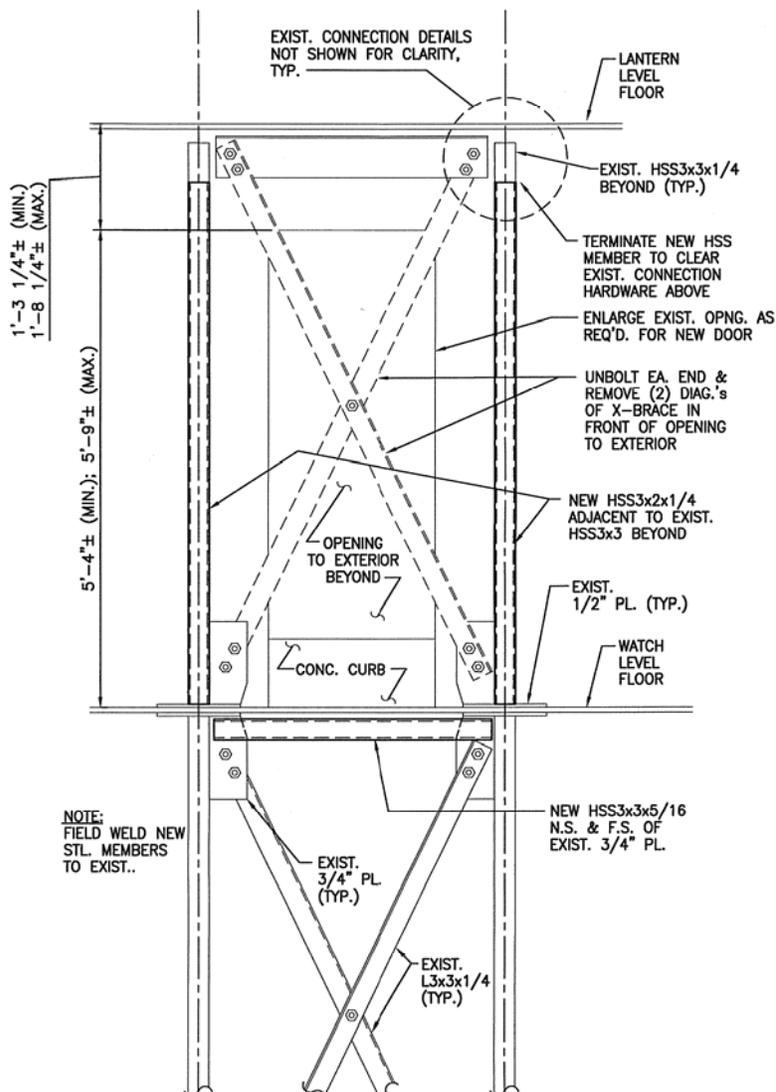
Access to the outdoor gallery from the Watch Level is severely impeded by the X-bracing installed in front of the door opening in the late 1980's.

Our analysis of the X-bracing system around the inside of the upper levels of the lighthouse finds it to be redundant enough to allow removal of the section of bracing at the door opening. The two diagonal angles that block the door opening can simply be unbolted and removed. The vertical members on each side of the opening should then be reinforced and a new horizontal strut constructed just below the Watch Level deck, as shown by the following figure:

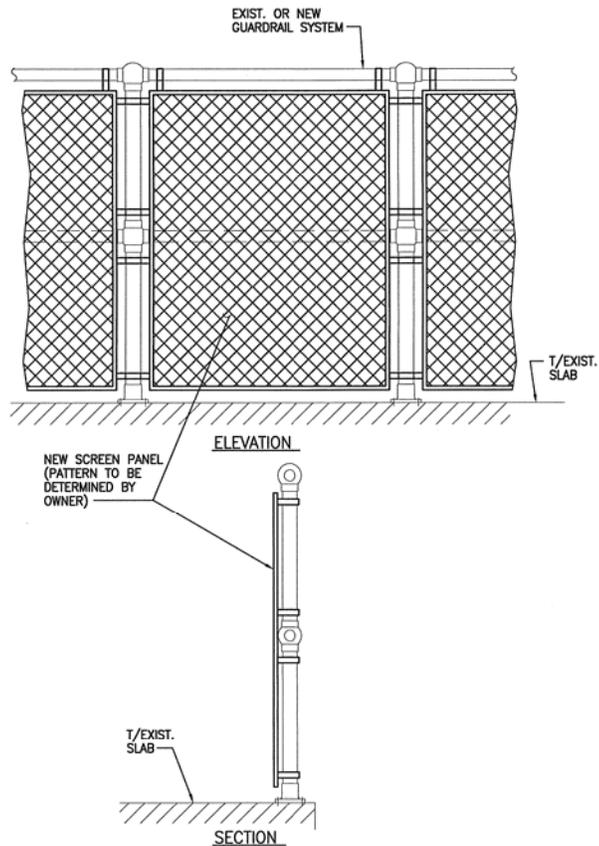
Some of the cast iron posts and rails of the existing guardrail around the outdoor gallery deck are deteriorated to the point of needing replacement. The rest could be cleaned and repainted and remain in use. Any repair of existing guardrail components should be performed in accordance with the "Iron" section of the *Historic Lighthouse Preservation Handbook*, created through cooperative partnership between the National Park Service, the U.S. Coast Guard, and the Department of Defense.

The primary structural concern with the existing guardrail is that each post must be properly anchored to the concrete gallery deck. This concern could be addressed by providing additional anchors at the base of each post.

New post and rail construction should replicate the existing guardrail system. However, in order to meet building code requirements for guardrails in public spaces, modifications to the guardrail will be required. The open spaces between guardrail components must be reduced to less than four inches. This can be accomplished in a number of ways, including installing perforated stainless steel screen panels, expanded stainless steel screen panels or "extruded" anodized aluminum screen panels along the inside of the existing guardrail. The following drawing shows one potential solution to the guardrail problems:
