CAPE LOOKOUT LIGHTHOUSE

Cape Lookout National Seashore
North Carolina

HISTORIC STRUCTURE REPORT

December, 2008

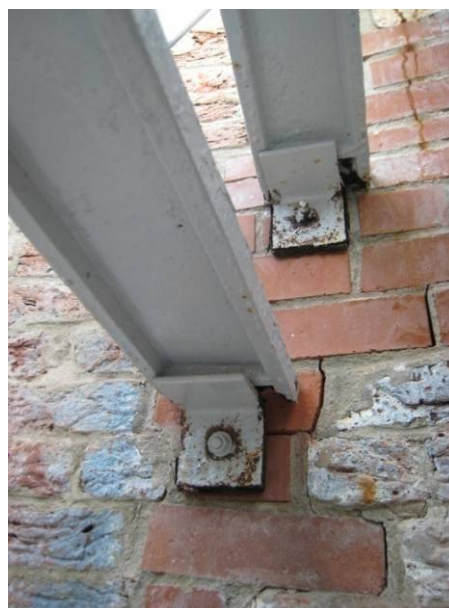
Figure C-8 Modern masonry repairs in Watch Room.

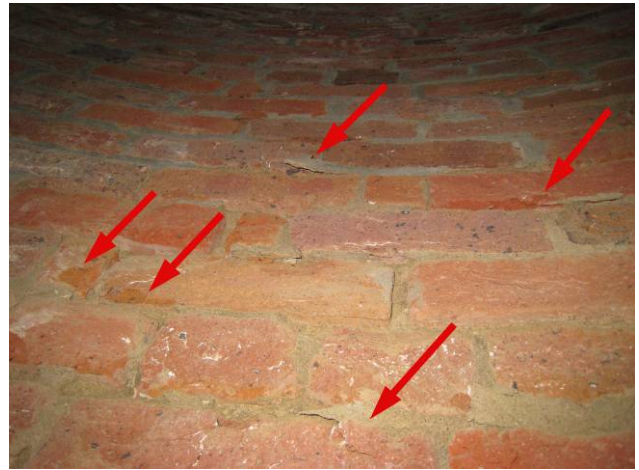
the mortar. Similar spalling has not occurred on bricks adjoining the earlier mortar.

Figure C-10 Spalling brick adjoining Portland cement-rich repointing mortar.

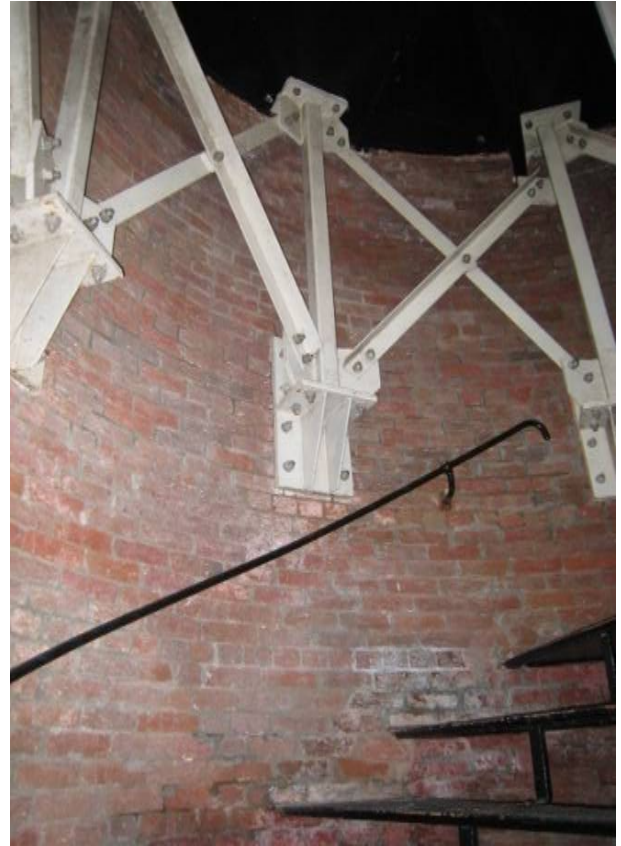
Figure C-16 1989 steel framing at Seventh Floor.

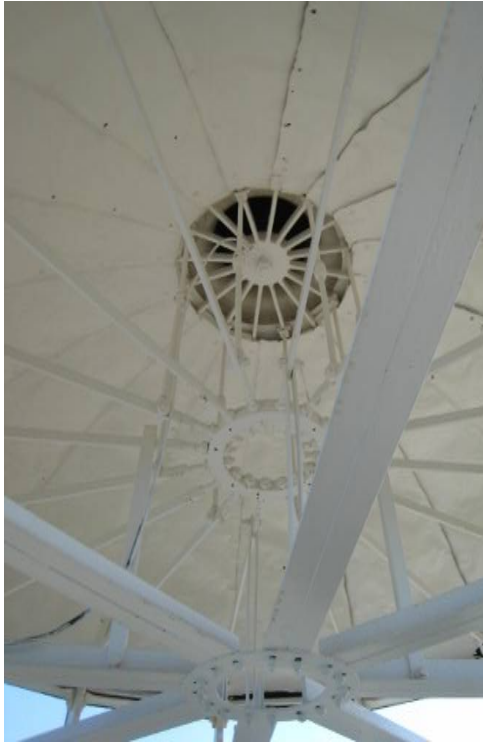
- *Roof Framing:* The sheet metal dome is supported with cast-iron ribs and interconnecting 7/8" diameter iron rods, and rests on a cast-iron wall plate. Seventeen vertical iron-framing members hold glass panels to create a sixteen-sided wall enclosure (Lantern) and to support the wall plate. This iron framing sits on an iron floor plate atop the masonry tower. The cross bracing is copper-based, probably brass. Corrosion is extensive among the supporting iron elements.

Figure C-17 Structural supports and central ventilator of dome.

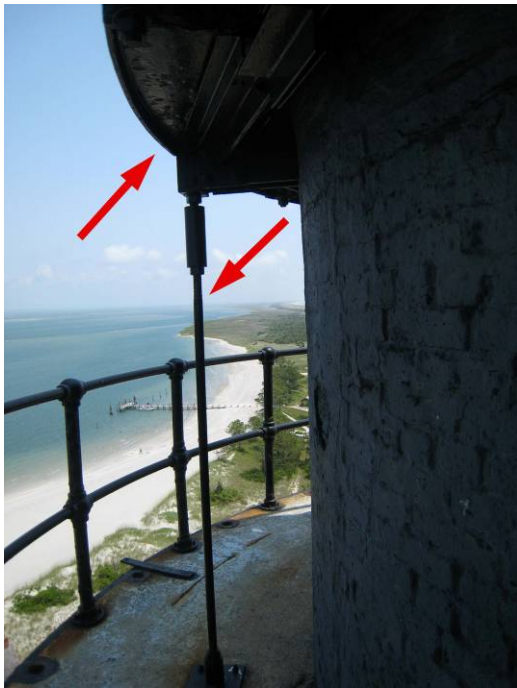
Figure C-18 1989 steel reinforcement of Gallery deck and connecting rod.

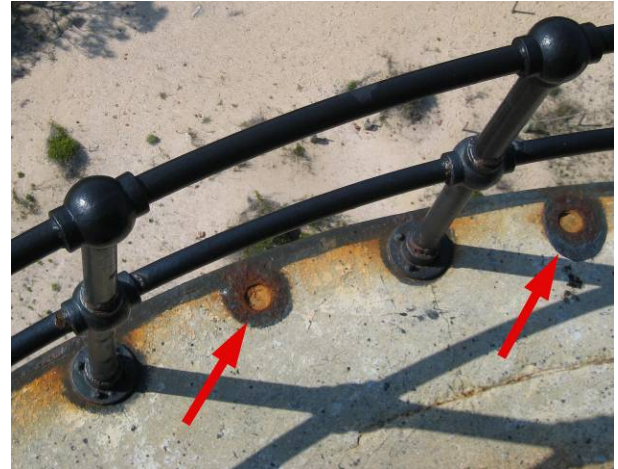
Figure C-25 Remnants of 1914 stanchion anchors and replacement railings of unknown date.

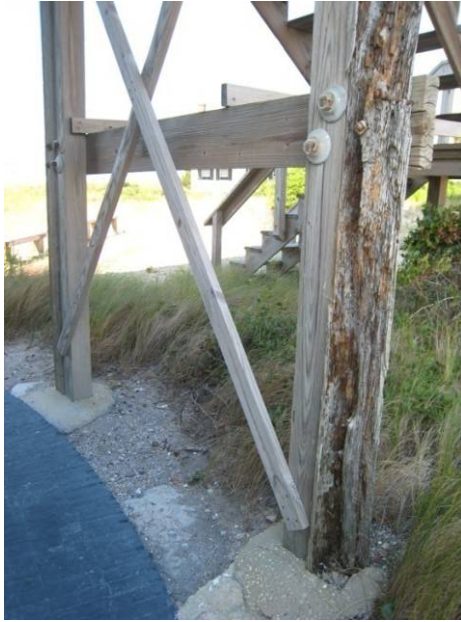
Figure C-34 Two earlier but twentieth-century and severely deteriorated wood posts and one cross beam

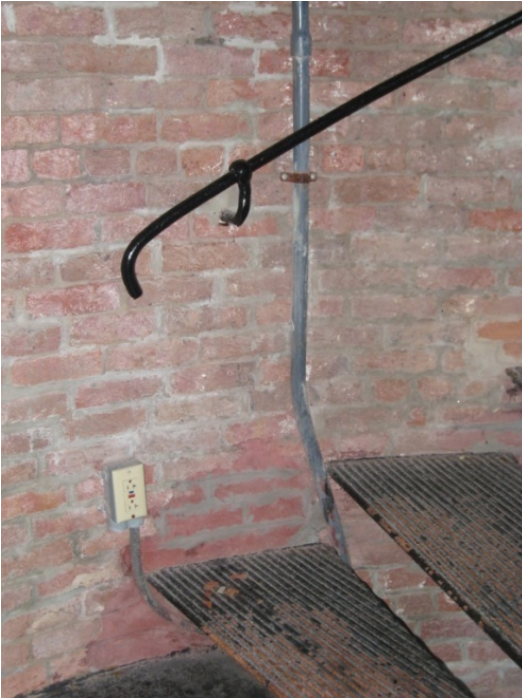
- *Handrail:* Along the outer masonry wall for the run of the spiral staircase, there is a painted, round, iron handrail, 1" in diameter, apparently the original. The handrail is in good condition except for the masonry anchors, several of which are corroded and one has rusted through.

Figure C-46 Original iron handrail of 1-inch diameter.

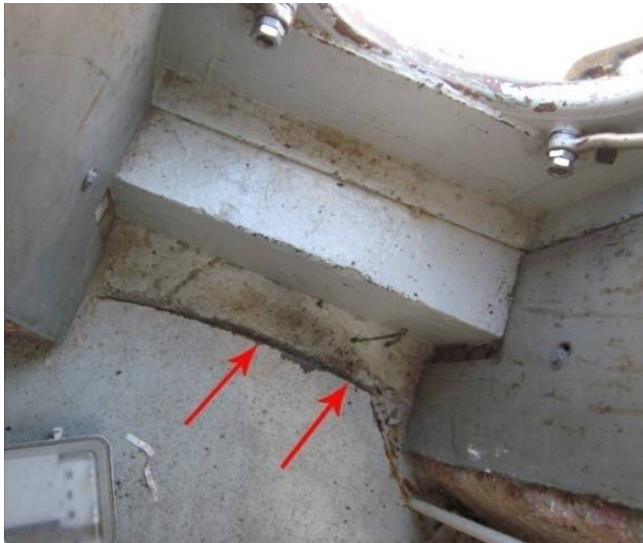
Figure C-85 Jacking of iron floor plate at doorway to Observation Deck.

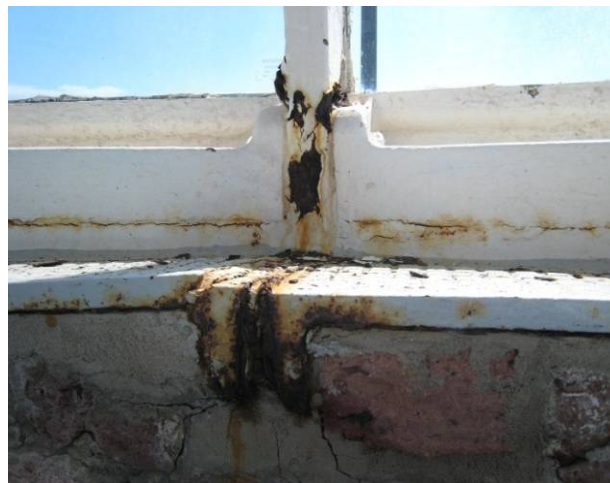
Figure C-104 Extensive corrosion of cast-iron framing.

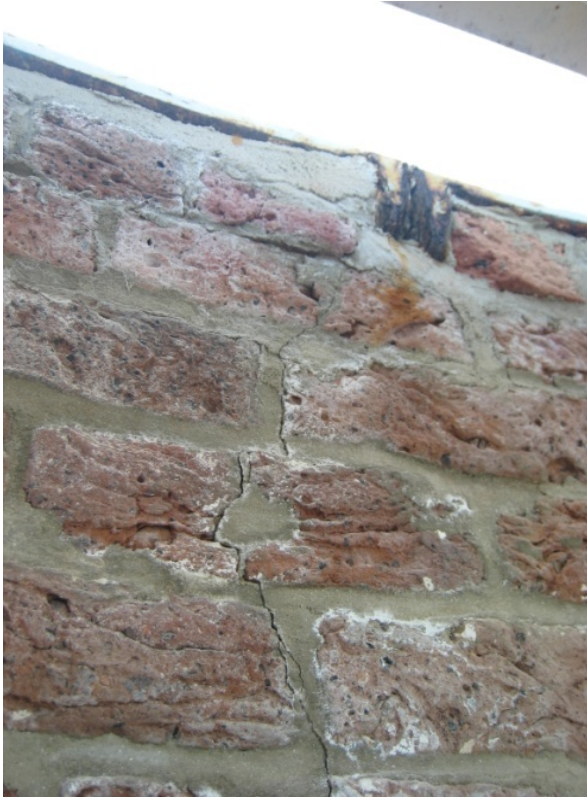
Figure C-105 Through-wall cracks in masonry at top of Tower.

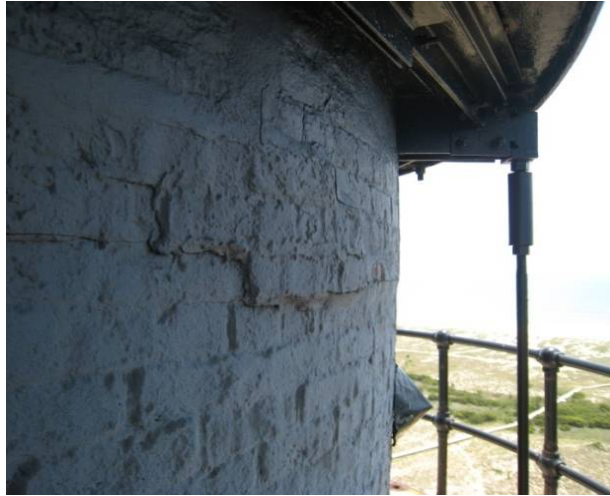
Figure C-107 Displaced masonry and supplemental tie rods.

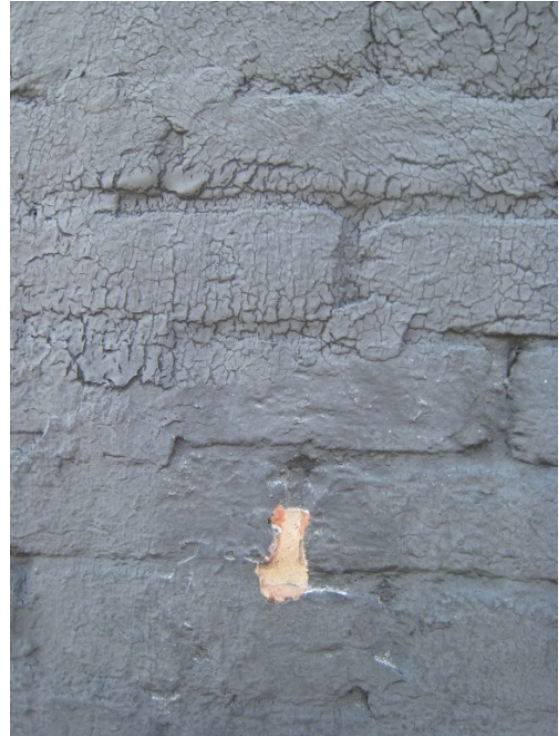
Figure C-108 Non-breathable coating on exterior masonry.

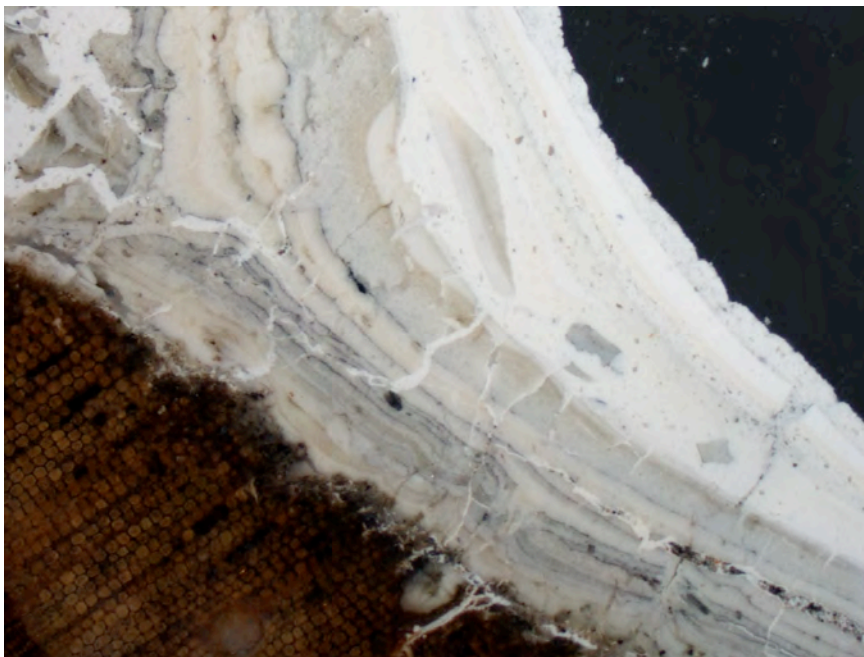
Figure 10. Cape Lookout Lighthouse. Photomicrograph of Sample CALO. SALV.3, which was removed from the exterior face of the salvaged window sash. Between 12 and 18 paint layers were found on the exterior face of the sash and the majority of the layers were off-white, even in the area currently painted black. This evidence suggests that the sash were painted off-white for the majority of the lighthouse's history. Photograph by author, 40x magnification.

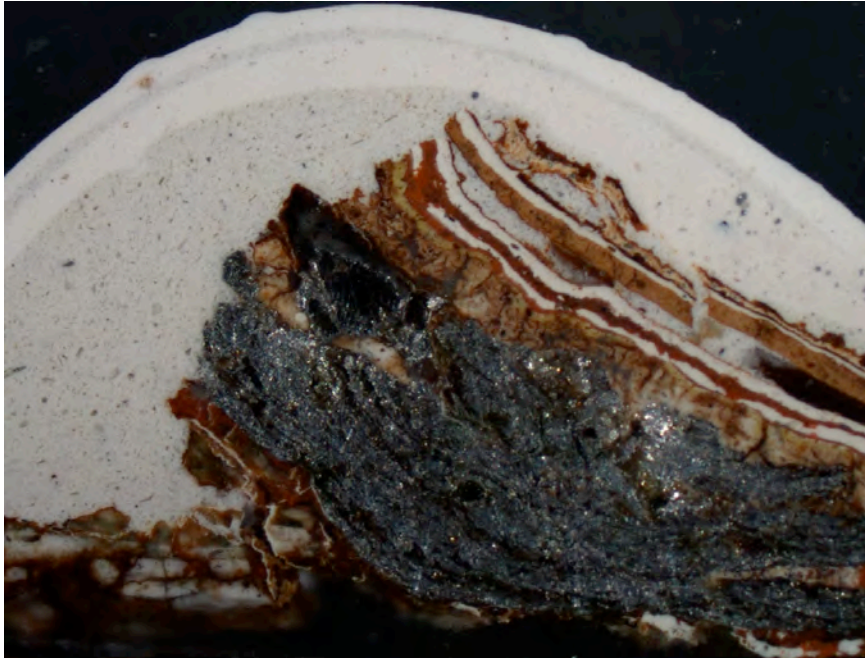
Figure 15. Cape Lookout Lighthouse. Photomicrograph of Sample CALO. 1.22, removed from one of the copper alloy components of the glazed lantern frame. Numerous layers of off-white (as well as primer red) are visible. There is also a thick metallic paint layer that was applied to the lantern interior fairly early in its history but is not original. Photograph by author, 40x magnification.

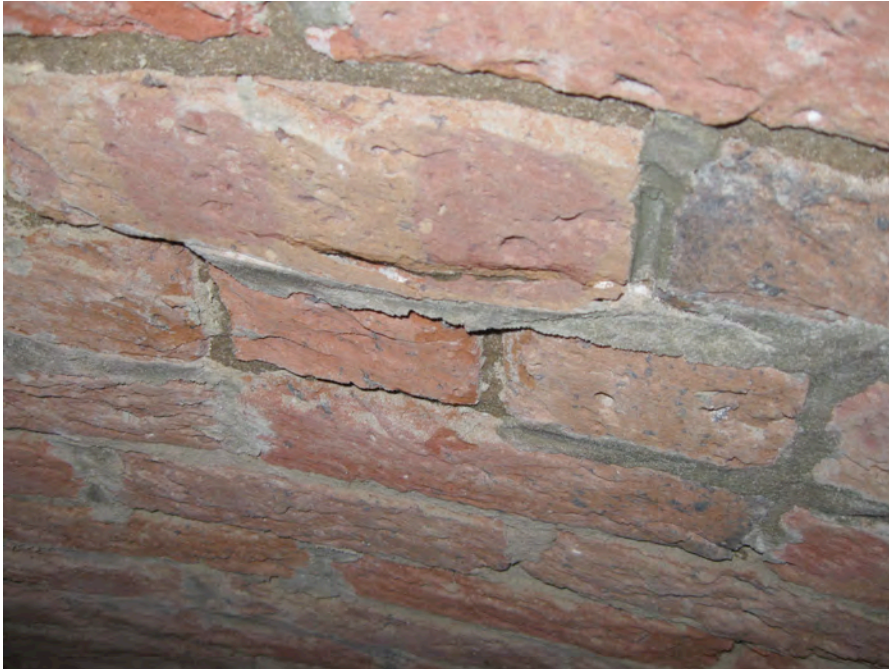
Figure 20. Cape Lookout Lighthouse, September 2008. An area where inappropriate Portland cement based re-pointing mortar has caused the original brick to spall and the original mortar to deteriorate. Photograph by author.
