Tom & Lucy Gilgo House
Portsmouth Village
Cape Lookout National Seashore

Historic Structure Report

December 2015

JOSEPH K. OPPERMAN-ARCHITECT, P.A.

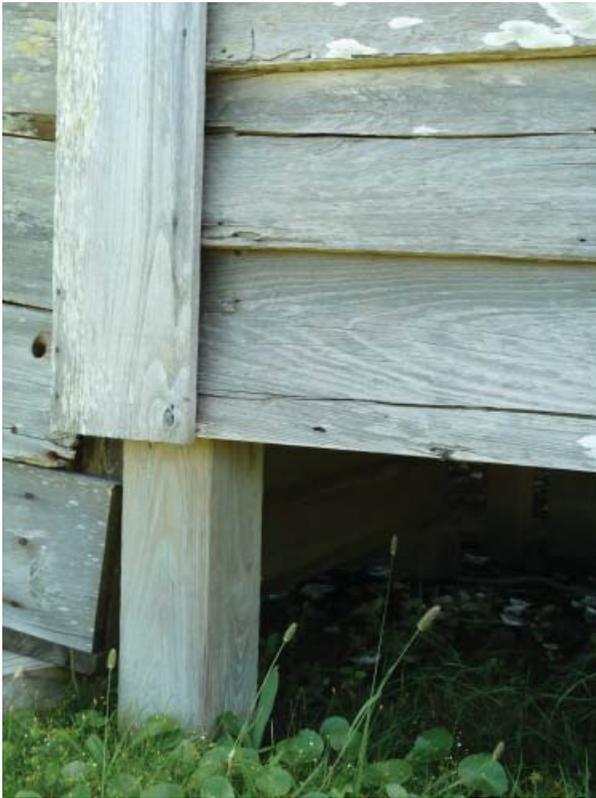
Figure 53. A few early foundation posts of various sizes, milled and unmilled, were able to be reused in the 2002 work. Replacement posts, as seen above, are made of treated lumber and measure 5½" by 5½".

- Keep vegetation closely trimmed near foundation posts.
- Investigate condition of foundation posts on a regular basis.
- Replace foundation posts in-kind as they fail.
- Install termite shields wherever possible.
- Avoid use of ferrous-based fasteners in all construction and repairs.

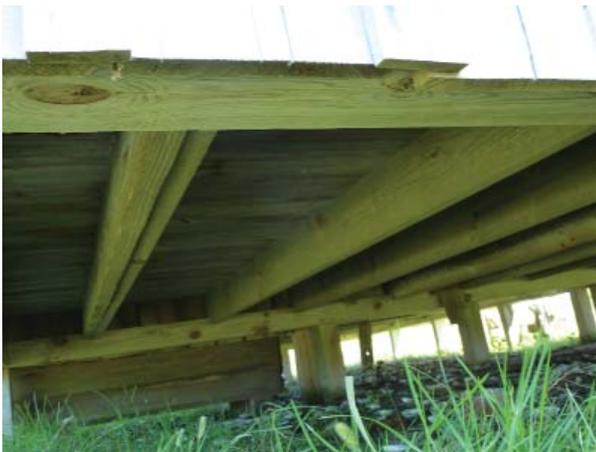
Figure 54. Early floor joists measure 2" by 6" and only a few could be reused (sistered at left). Replacement joists are made of treated lumber and measure 1¾" by 6" and lap at the wall plate.

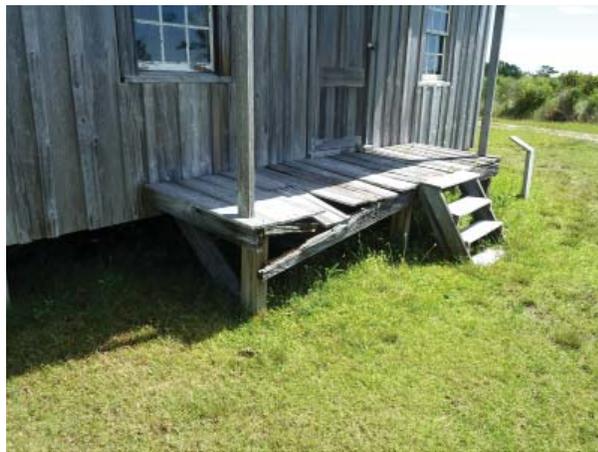
The front porch was also built new in 2002. A porch joist has failed and attached deck boards have partially collapsed.

Figure 93. Broken joist and deck board at front porch.

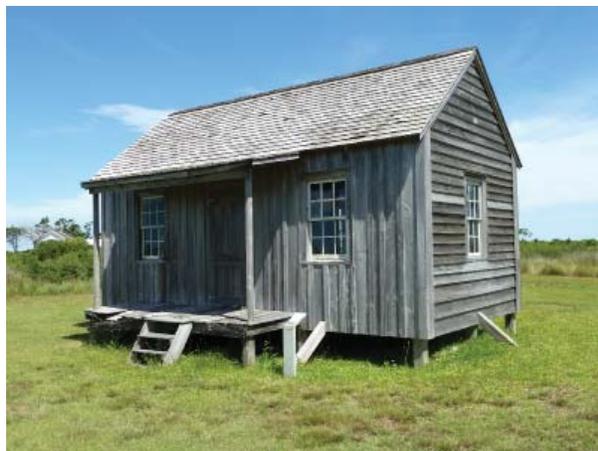
exterior envelope. Salvaged trim pieces of various types were also reinstalled, supplemented by matching new pieces. The new elements are in good condition in general. The salvaged elements are generally sound. None appear to have a protective finish.

Figure 94. Most exterior wood elements are unpainted.

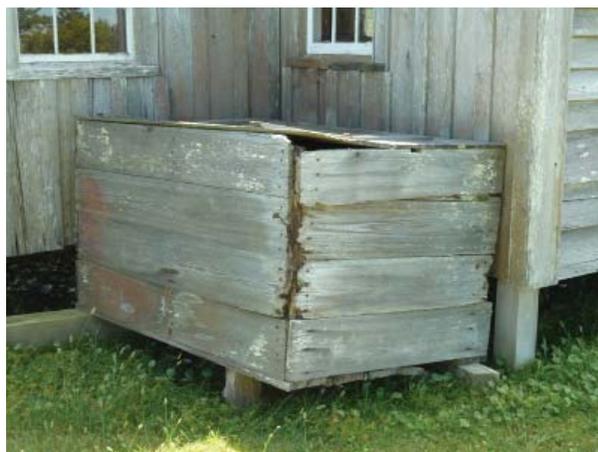
Figure 95. Deteriorated wooden cistern in need of repair.
