Mason-Willis-Dixon House
Portsmouth Village
Cape Lookout National Seashore

Historic Structure Report

December 2015

JOSEPH K. OPPERMAN-ARCHITECT, P.A.

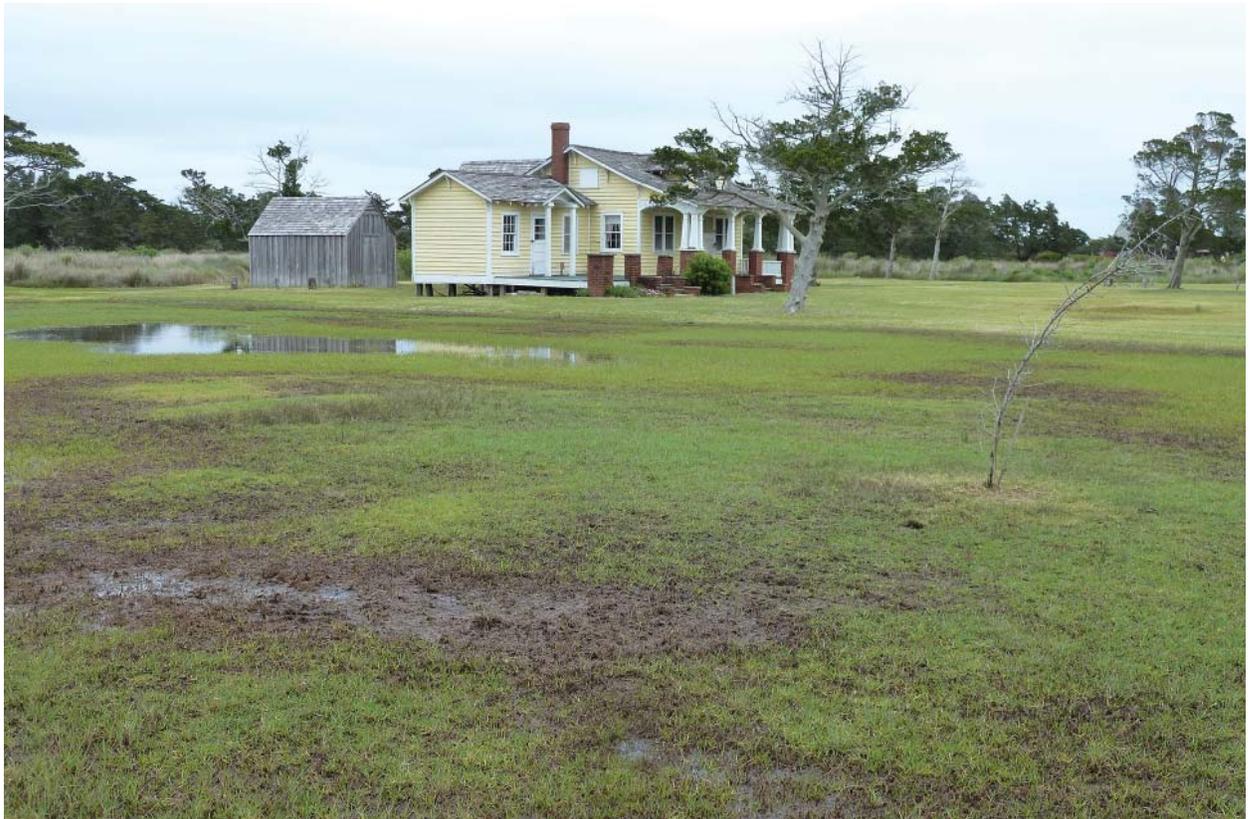
Poor drainage is characteristic of most of Portsmouth, but the natural process of decay of vegetation and generation of new humus has created a bowl-like depression beneath the house, trapping water and keeping the area damp for extended periods of time. This not only contributes to rotting of wood posts but also creates ideal conditions for termite infestation.

Figure 54. Typical site conditions on the west side of the house.

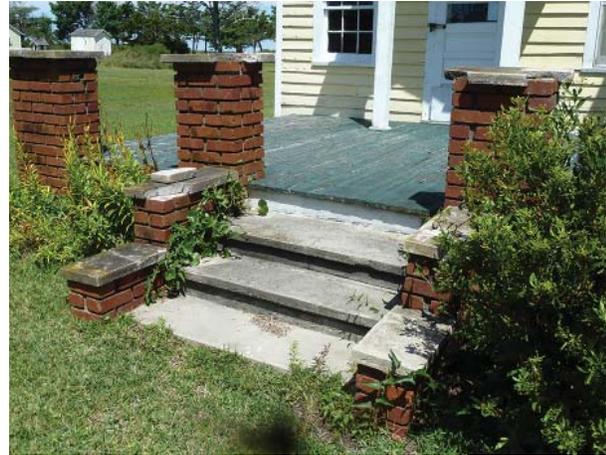
the mortar in the exposed piers on the deck is badly eroded. All but three of the concrete caps on the piers and cheek walls are cracked and broken, with significant material loss in some. The east cheek wall at the steps to the deck leans significantly to the east.

Figure 62. Steps to deck.

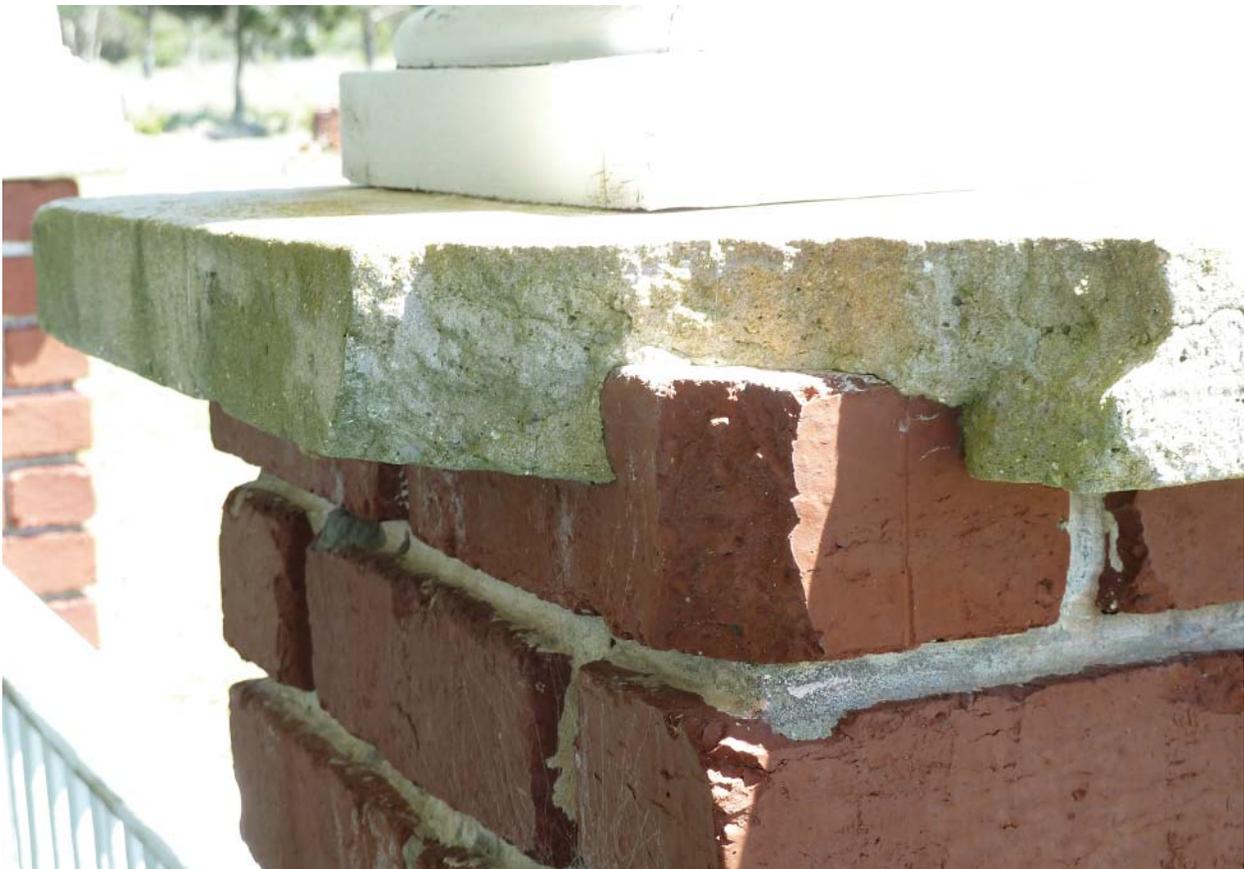
Much of the mortar in the front porch piers dates to their construction but remains in fair condition. The mortar in the exposed piers on the deck is badly eroded. All but three of the concrete caps on the piers and cheek walls are cracked and broken, with significant material loss in some.

Figure 61. Typical materials in brick piers.

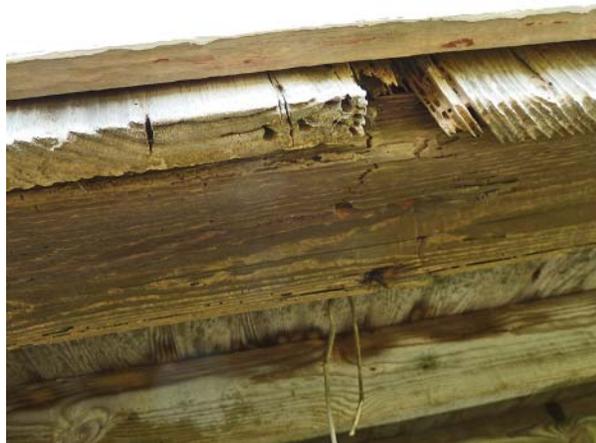
The wood framing appears to be in generally fair condition, and ridge lines remain straight and floors level. Insect damage can be observed in some of the sills, and there is likely to be hidden damage elsewhere in the building. The house is, like many others of the period, under-structured by modern standards, especially in terms of spacing

Figure 66. Typical sill and bottom ends of vertical sheathing on the main block of the house.

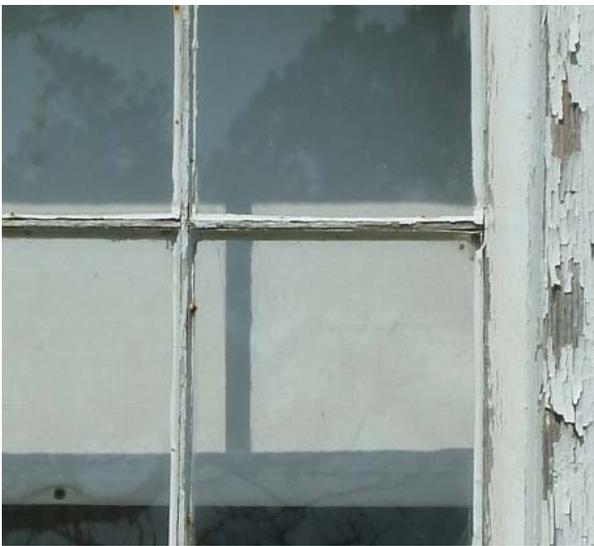
Sash are missing from the windows on the east and north sides of the north wing but most of the rest are in fair condition. Painted finishes are in poor condition with peeling paint and staining from rusting nails. Glazing of windows is in poor condition. Many of the wood-framed screens are missing and those that remain are in poor condition.

Figure 79. Typical detail showing poor condition of many of the windows.
