BADIN-ROQUE HOUSE PRESERVATION STUDY

07/26/2018

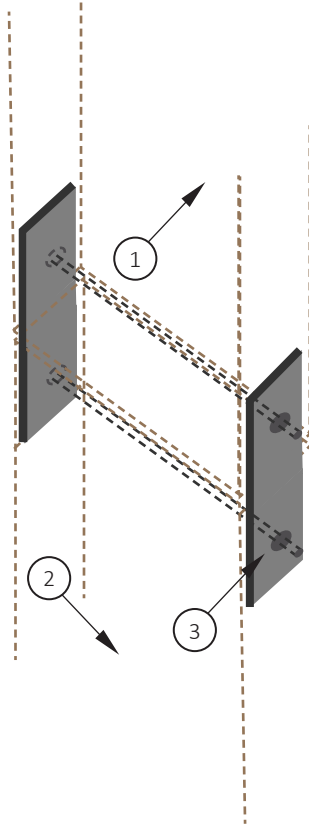
Additionally, we noted that the c. 1990 splices have no mechanical connection; the posts are simply butt-jointed. We recommend a retrofit splice detail similar to the concept sketch shown at right. Furthermore, care should be taken to grade the existing site surface level away from the post ends to promote healthy drainage.

Right: A typical post splice. The upper part is original cypress, the lower part is c. 1990 southern pine.

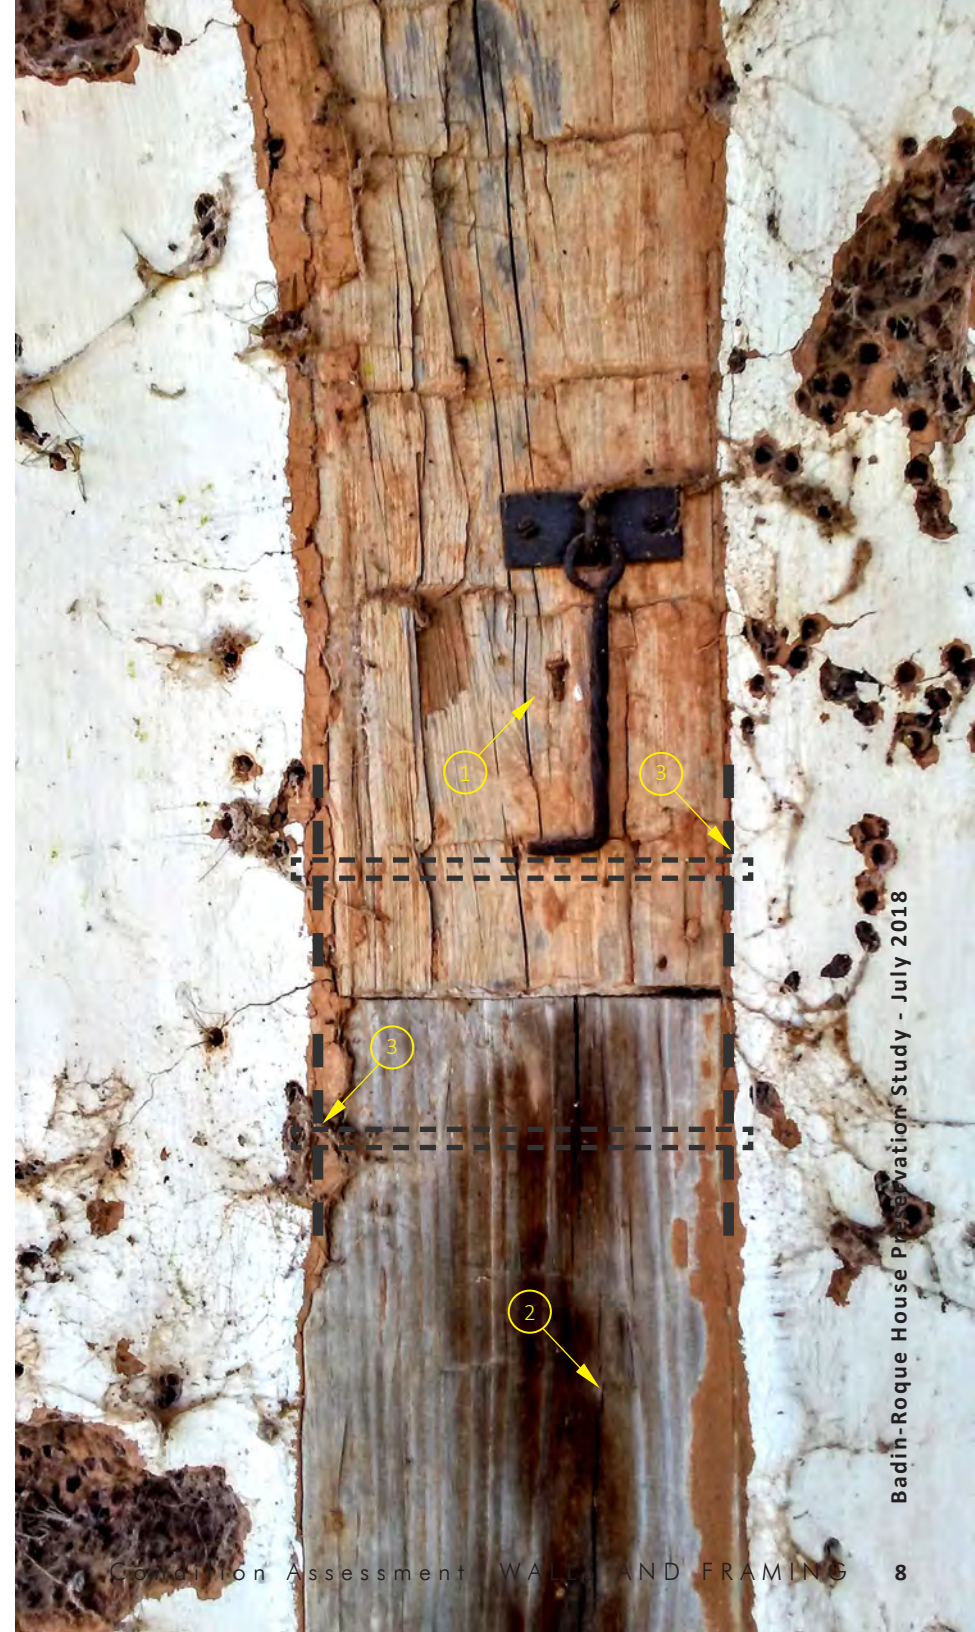
- ① Original cypress post.
- ② c. 1990 southern pine post splice.
- ③ Recommended concealed splice plate.

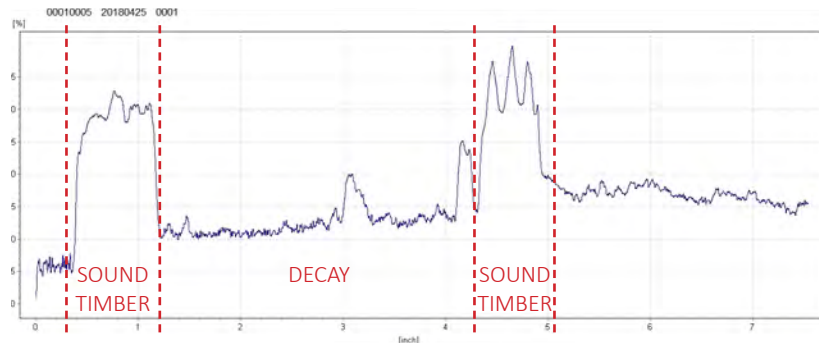
We performed limited testing of the timber using a Resistograph instrument, which gives a graphical indication of the extent of sound wood vs decayed wood, based on the wood's resistance to drilling. Representative test results are shown on the next page. In general, we found that the c. 1990 post ends are decayed below ground level, and that the original cypress posts are not decayed above the splice location.

Above: Typical post decay below ground level.

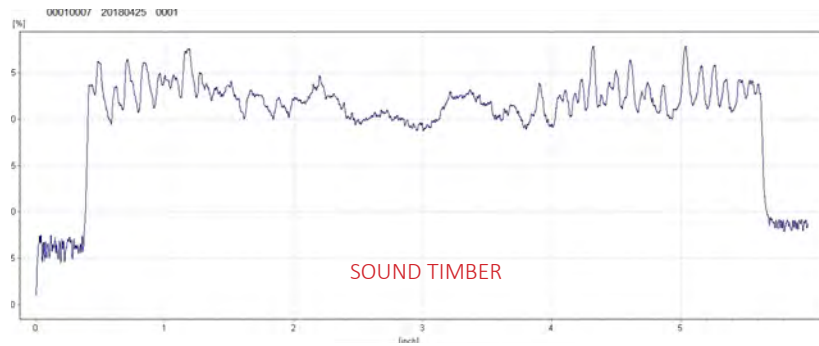
Above: Typical cypress post above existing splices.

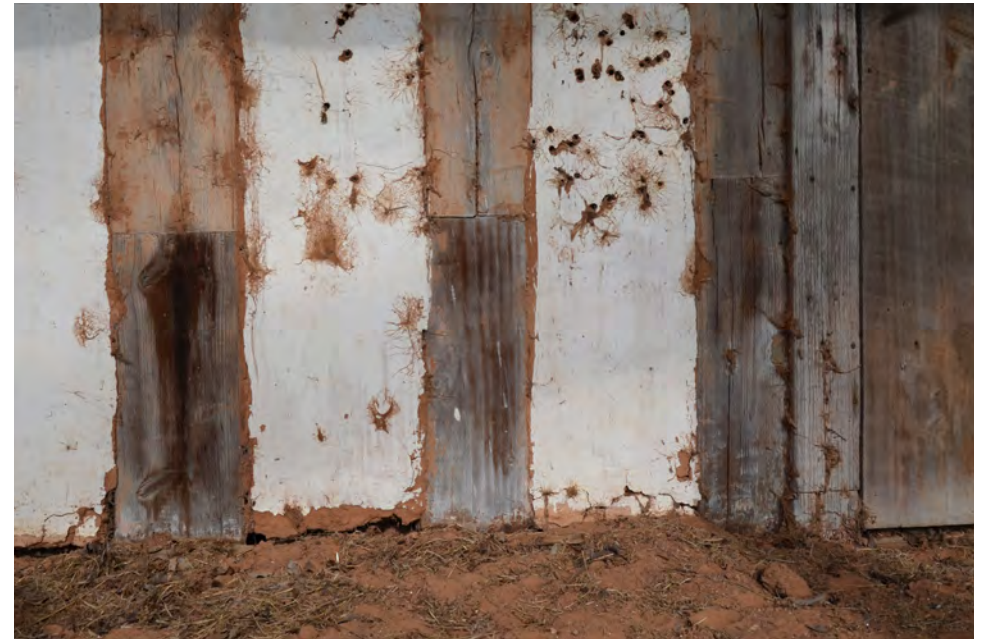
Above: Typical post splices shown at grade. We recommend installing concealed stainless steel side plates at these types of splices (splice plates are diagramed on previous page).

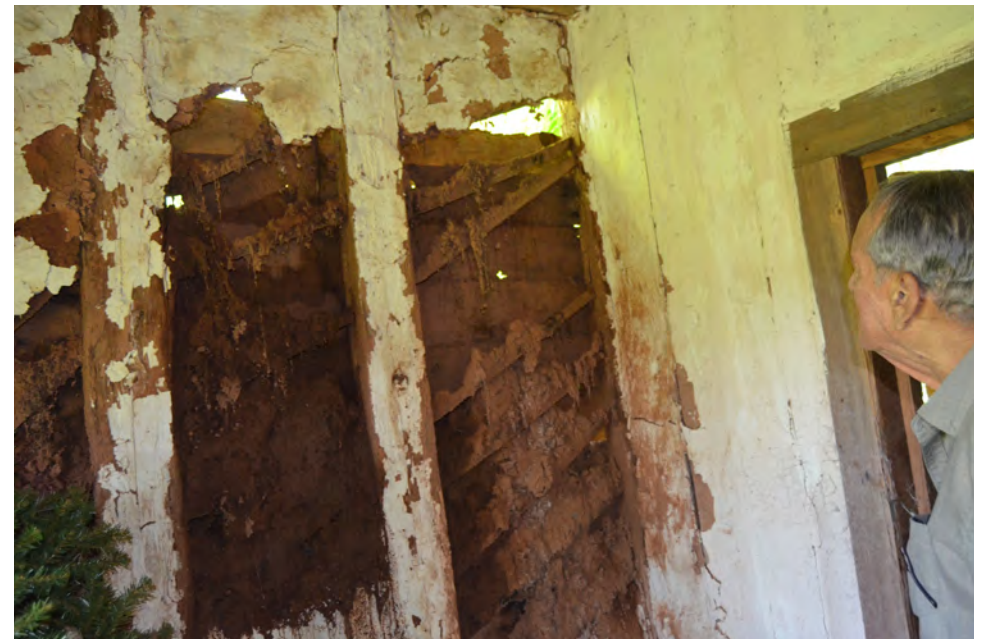
At the rear wall, in Room "D", we did find that several posts were fully decayed and will require complete replacement. These posts were subject to years of water infiltration due to defective gutters.

Right: Deterioration of the posts and bousillage walls in the rear of Room "D". These posts must be fully replaced.

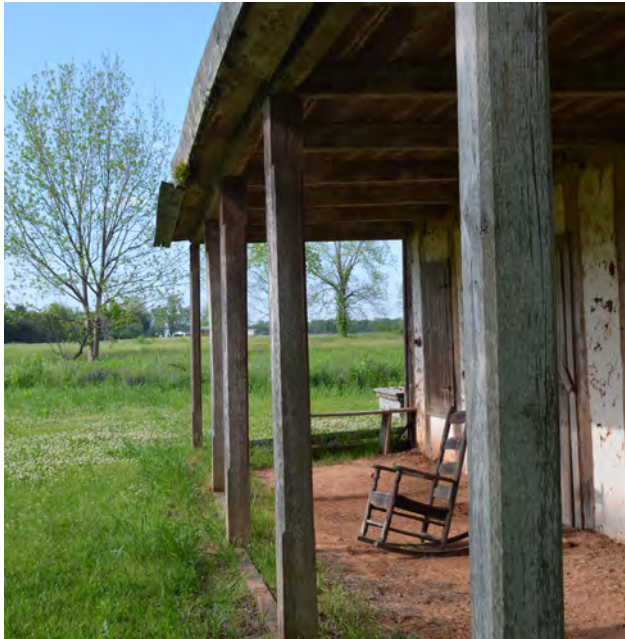
Left: The gutters on the house are causing decay of the framing. They should be removed and replaced with appropriate new gutters.

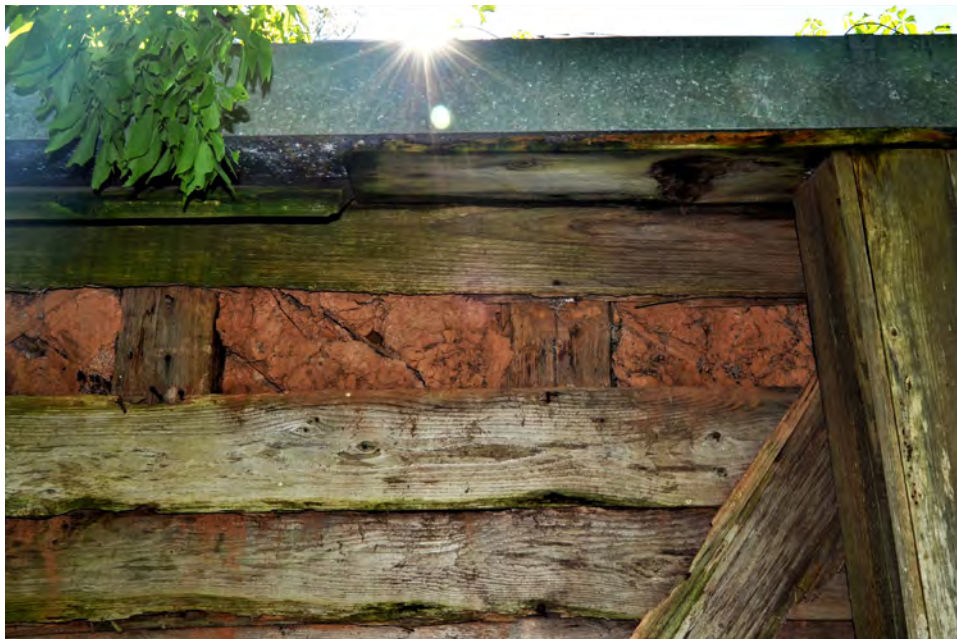
Below: Where the rear gutter has been leaking, several of the vertical posts are completely rotten.

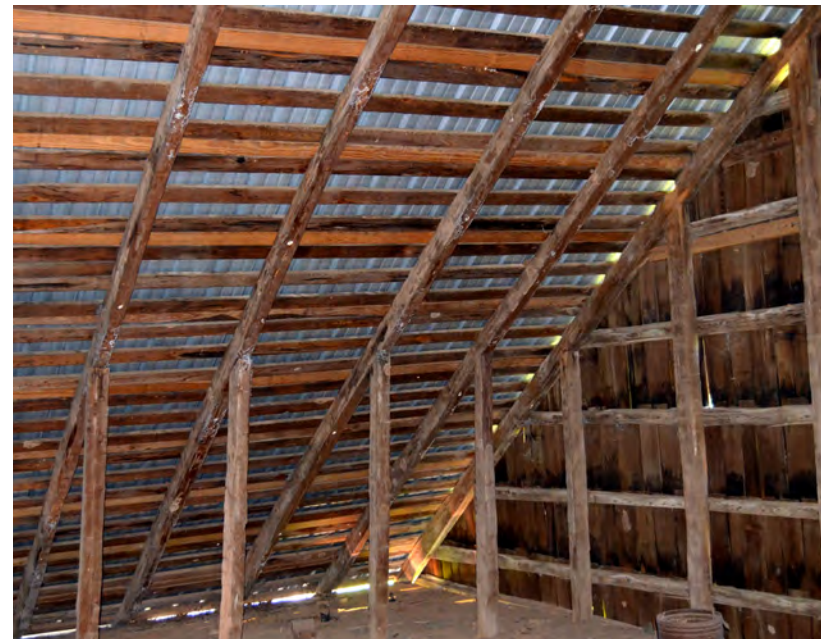
Below: The attic framing lacks sufficient lateral bracing.

We also found that the attic framing lacks sufficient lateral bracing. We recommend adding supplemental bracing in the manner indicated in the accompanying concept sketch below.
