Magnolia Plantation
Gin Barn

Historic Structure Report

CANE RIVER CREOLE NATIONAL HISTORICAL PARK
MAGNOLIA PLANTATION

~ GIN BARN ~
HISTORIC STRUCTURE REPORT

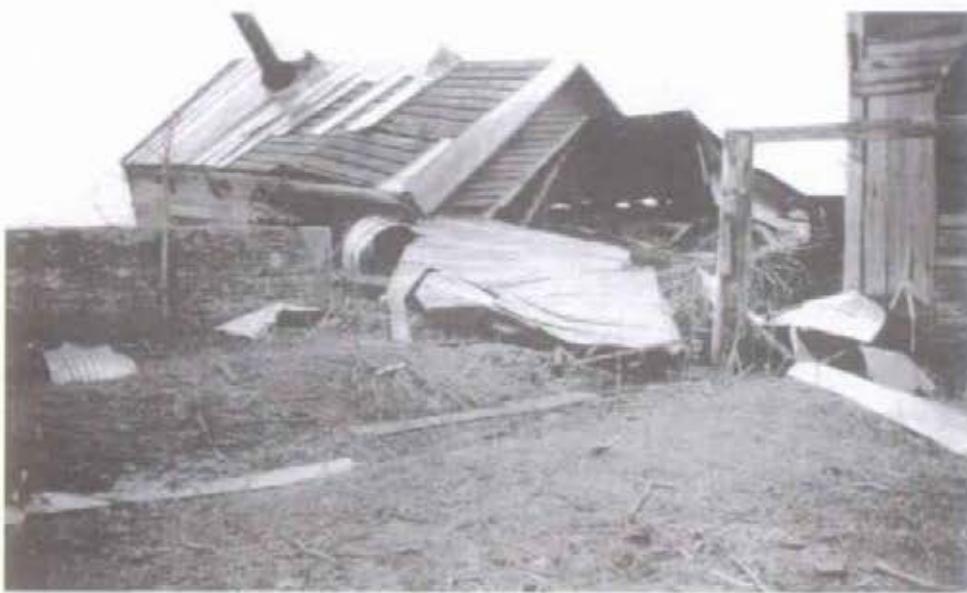
Figure 6 View of destroyed engine house at Gin Barn after 1939 tornado. The barn is partially visible at right. (Hertzog Family Collection, Magnolia Plantation)

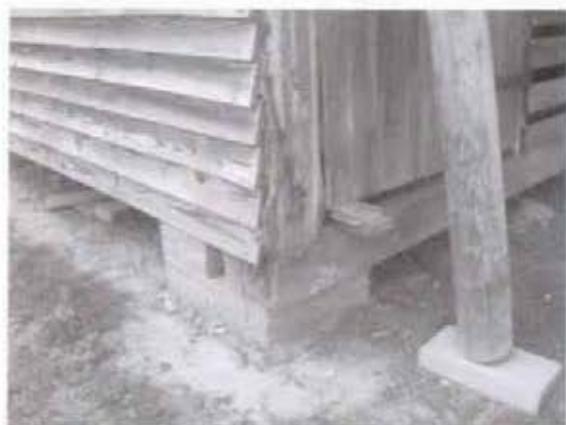
Figure 18 View of northeast corner of barn, showing brick pier rebuilt in 1996. (NPS-SERO-CRS, 2001)

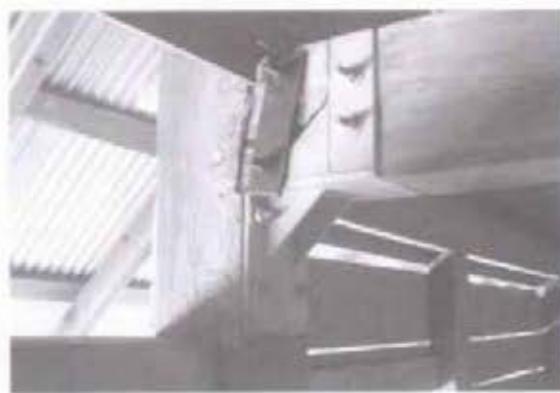
Figure 20 View of typical beam/post connection, reinforced with metal brackets in 1996. (NPS-SERO-CRS, 2001)

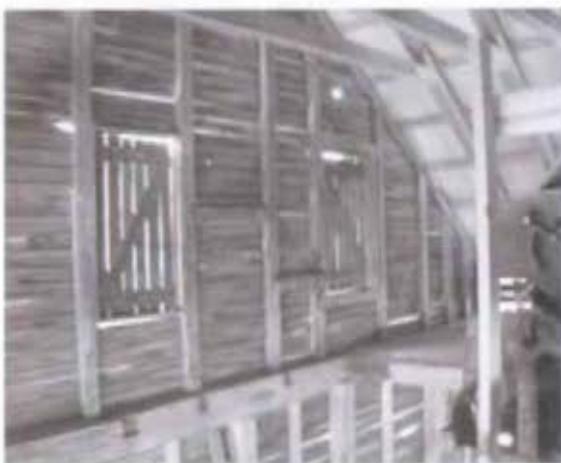
Figure 26 View to southeast showing part of east end of barn; note empty mortises for framing around missing stairway. (NPS-SERO-CRS, 2001)

- Replace all missing framing and flooring at second level; replace missing flooring in lint room and on south side of east end of first floor as indicated on plan.
- At the second floor, preserve all existing flooring, adding flooring on top of the historic material if necessary to provide a safe route for visitors.
- Rebuild part of east wall of lint room; repair remainder of walls in lint and seed rooms.
- Rebuild wall on second floor above west wall of lint room or install railing at that location.
- Install railing around perimeter of former seed room floor.
- Reconstruct historic stairs at northeast corner of building; remove stairs at southeast corner of building.

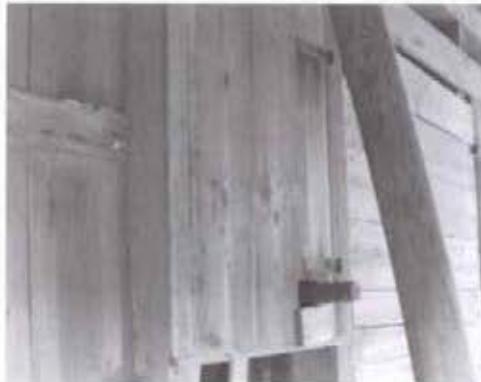
Figure 36 View of window H, which originally had sash but was closed when existing gin machinery was installed c. 1900. (NPS-SERO-CRS, 2001)

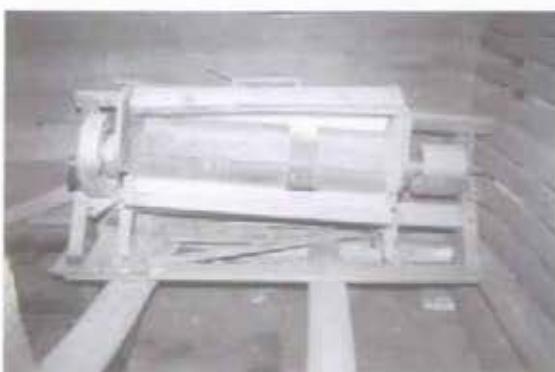
Figure 39 View of disassembled Eagle gin stand in northwest corner of first floor. (NPS-SERO-CRS, 2001)

- Engage conservators and specialist in early twentieth century gins to guide conservation, re-assembly, and display of existing gin machinery, including the old Eagle gin.
- As part of overall exhibit design for the building, determine how much recreation of missing ductwork, drive shaft belts, and other missing components is necessary for good interpretation of the ginning and pressing operation.

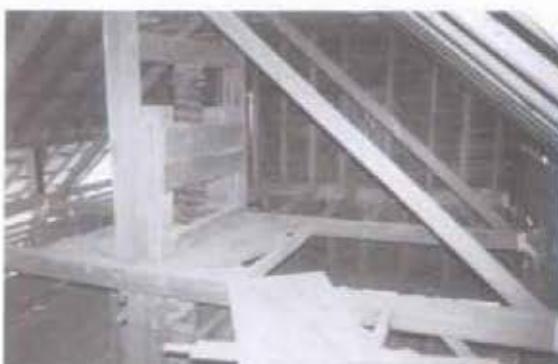
Figure 45 View of top frame of wood-screw cotton press, which would have originally been surrounded by flooring. (NPS-SERO-CRS, 2001)

- Determine character and condition of press footing through archaeological investigation.
- Brace press with modern materials if necessary to insure structural stability.
- Avoid any disassembly or replacement of historic materials.
- Do not operate historic press; construct working scale model to demonstrate its operation to visitors.

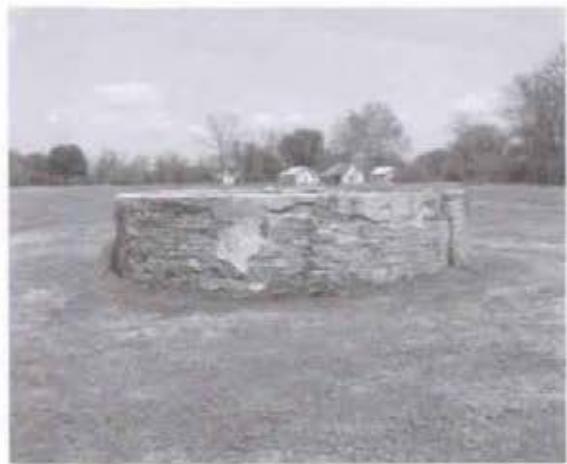
Figure 47 View to northeast of cistern at Gin Barn. (NPS-SERO-CRS, 2001)

- Conduct complete archeological investigation around and within footprint of present building.
- Repair and repoint cistern; preserve engine base.
- Define appropriate routing of visitors around building.
- Keep perimeter of building free of vegetation.
