Barn Complex
Carl Sandburg Home National Historic Site
Historic Structure Report

December 2014

JOSEPH K. OPPERMAN – ARCHITECT, P.A.

Goat Barn: HS-16, LCS 005161, FMSS 69819
Milk House: HS-16A, LCS 005162, FMSS 69690
Horse Barn: HS-17, LCS 005163, FMSS 69863
Silo: HS-20, LCS 005166 (s-o-w gives no FMSS)
Shavings Shed: HS-19, LCS 005165, FMSS 69691
Cow Shed: HS-18, LCS 005164, FMSS 69697
Buck Kid Quarters: HS-15, LCS 005160, FMSS 69689
Corn Crib: HS-14, LCS 005159, FMSS 69698
Barn Garage: HS-13, LCS 005158, FMSS 69895
Isolation Quarters: HS-12, LCS 005157, FMSS 69817

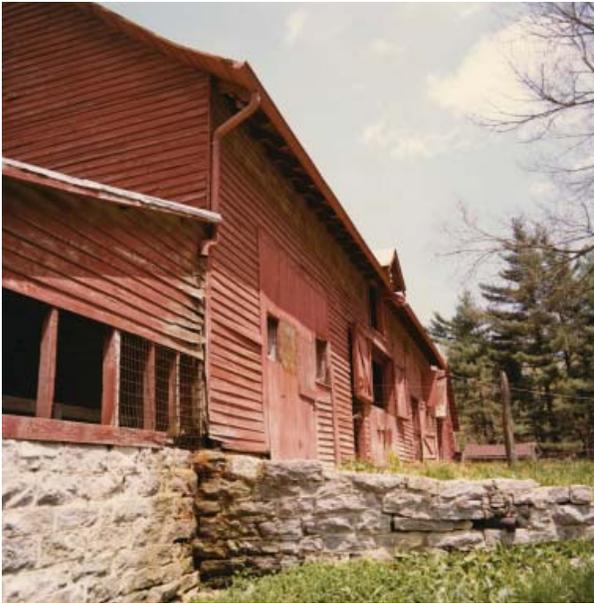
Figure 54. Barn in 1971 before work began, showing overall condition and damage from missing downspout. Tom Gray, photographer, NPS. (CARL 4009-2-1-G-110)

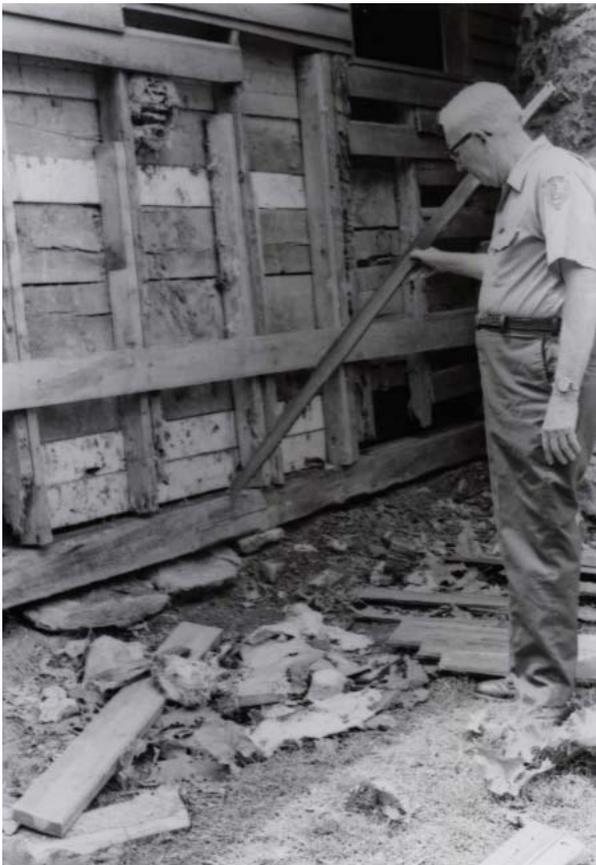
Figure 78. “Charlie Hamn, NPS Maintenance Superintendent, at the north wall of the Horse Barn near the silo, examining the decay of the siding and sill “prior to restoration;” 29 June 1978. Warren Weber, photographer, NPS. (CARL 4008-19-14P)

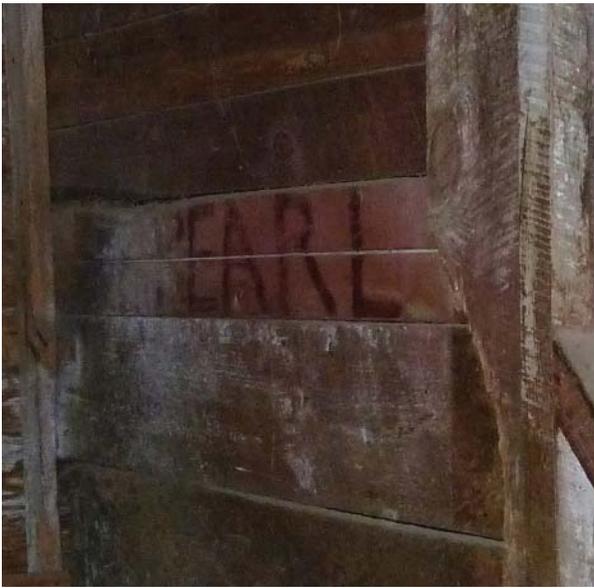
Figure 80. Stall board with hand-painted name and the pink stain applied by error in 2003. 2011 photograph.

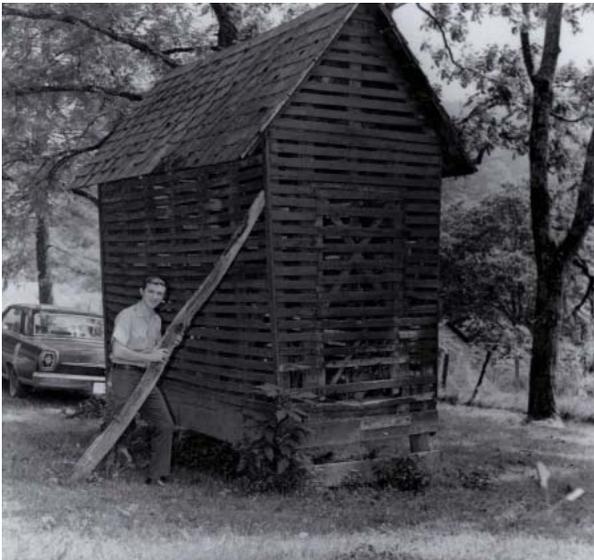
Figure 102. The corn crib in July 1971, showing its condition before NPS repairs. The wood feed trough is missing. At the diagonal support is Gordon Gay, first park curator who served from 1971 to August 1973. Jim Kretschmann, photographer. (CARL 4008-15-02P)

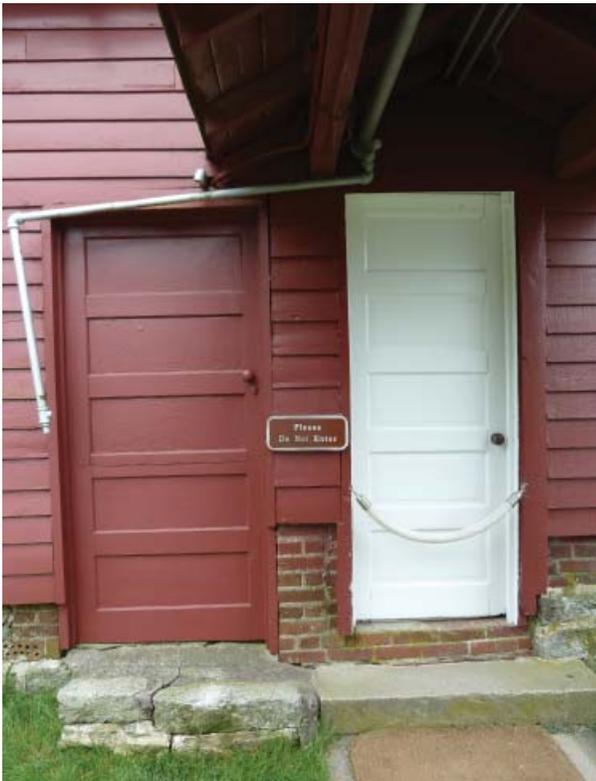
Figure 157. Goat Barn: two five-panel doors added by Sandburg for Mechanical Room (L) and Milk Parlor (R). Stone foundation wall rebuilt with brick.

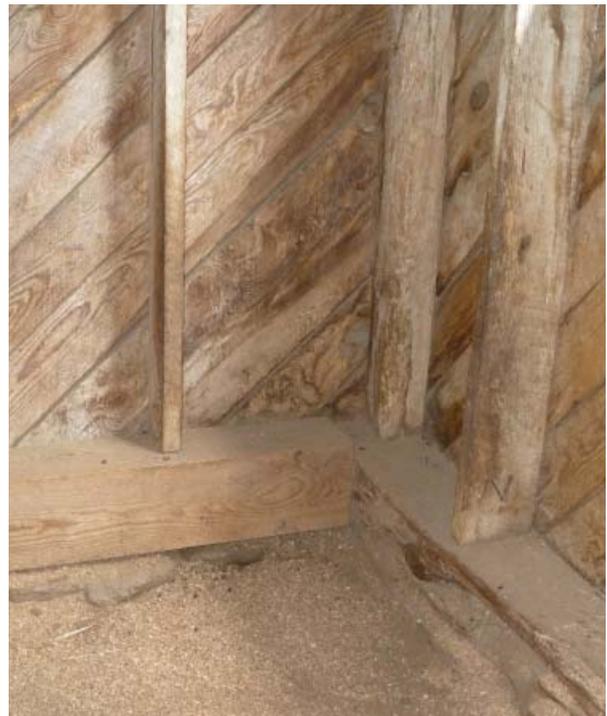
Figure 190. Goat Barn: modern replacement sill (L) abuts deteriorated south wall sill (R). Both sit on a low foundation wall of mortared granite stone.

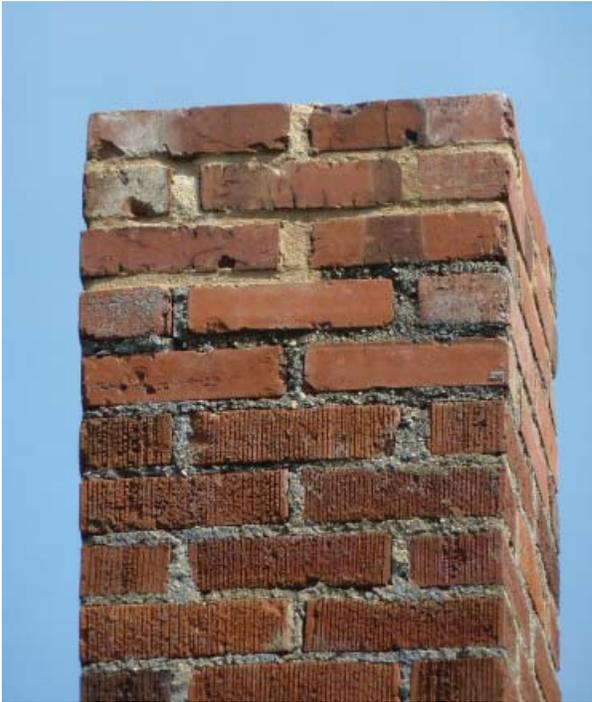
Figure 256. Milk House: top five courses of brick have been replaced as indicated by contrasting brick and mortars.

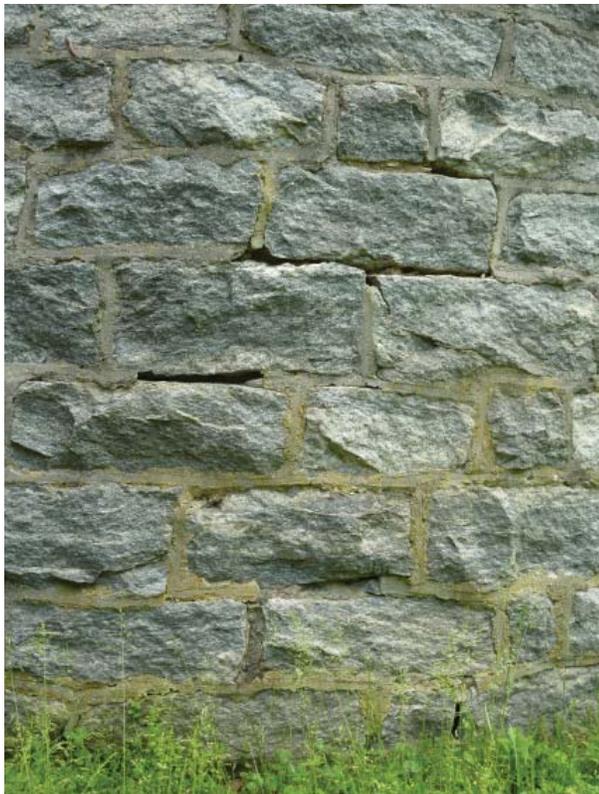
Figure 287. Silo: sporadic instances of deterioration of mortar joints.

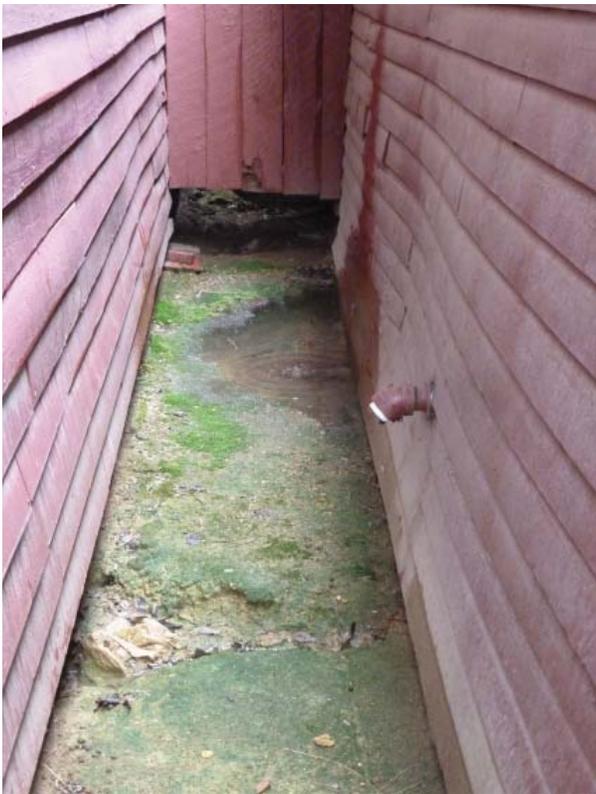
Figure 298. Horse Barn: shaded west area remains wet.

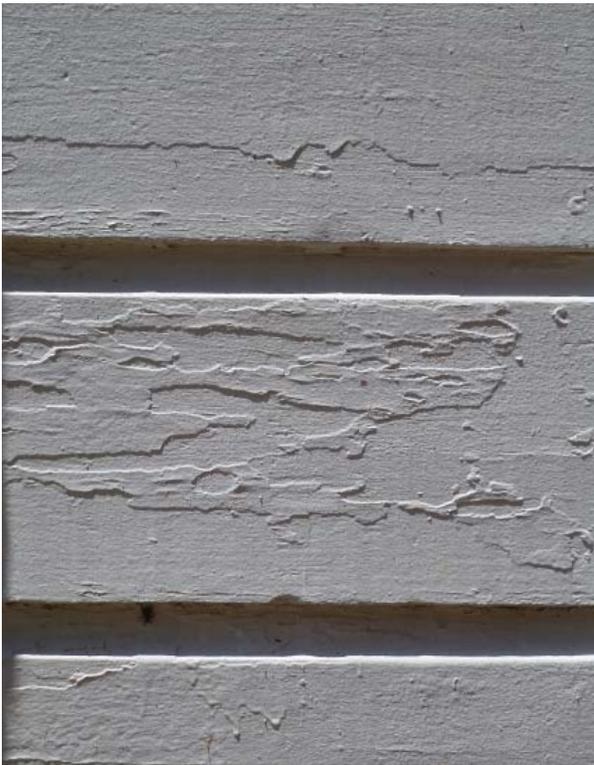
Figure 343. Barn Garage: Paint failing between paint layers, indicative of poor surface preparation before repainting.

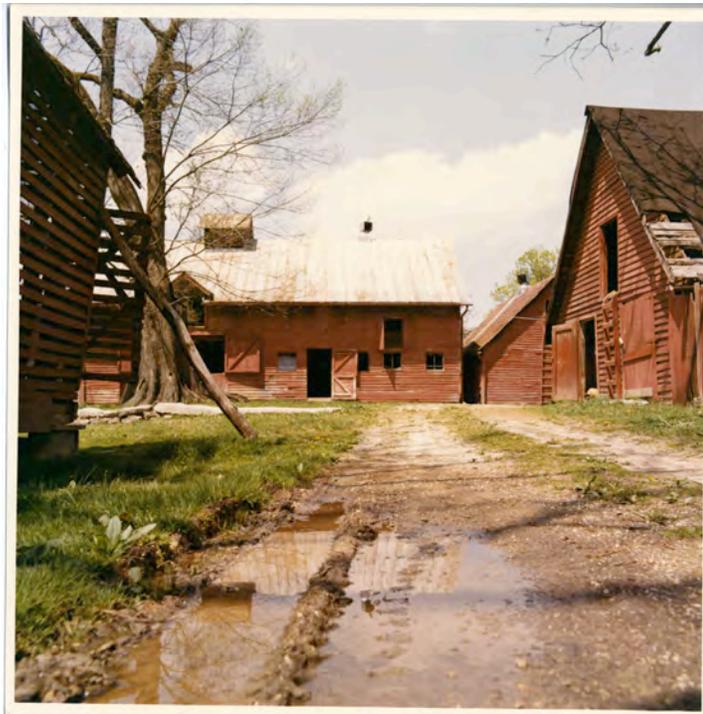
Image 12. The Goat Barn, circa 1971, once the NPS acquired the property. Note the red color on the barn and its deteriorated condition. (CARL 4009-2-1-G-84)
