Chesapeake & Ohio Canal National Historical Park
Potomac, MD

Great Falls Tavern Historic Structure Report

Final Submission

July 2020

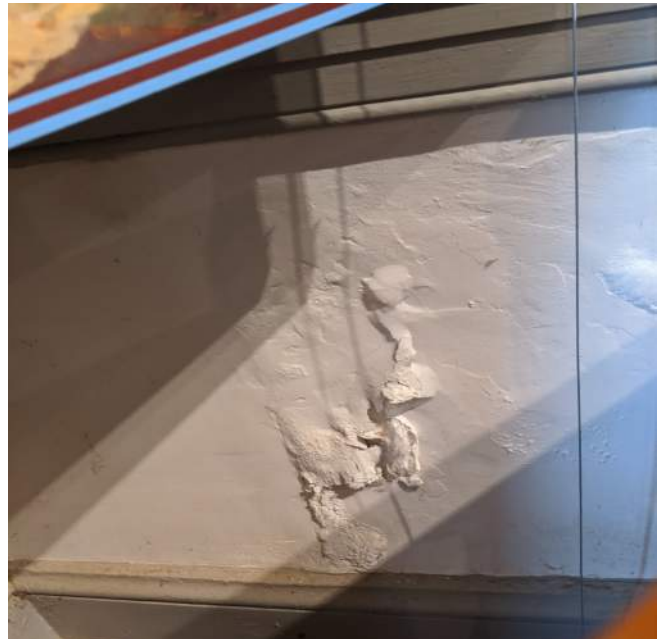
Figure 131: North Wing First Floor, Water Damaged Plaster at Northeast Corner (BBB 2019)

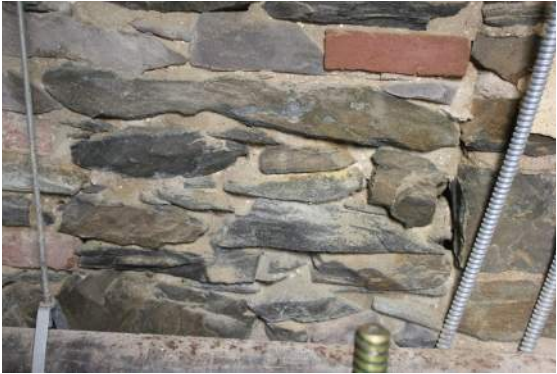
<p>Figure 189: Mortar Loss in South Wing Cellar (Silman 2019)</p>

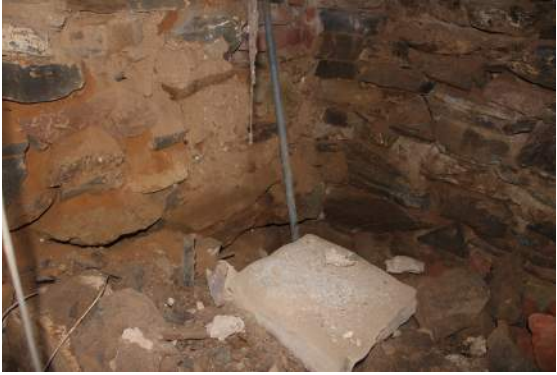
<p>Figure 190: Mortar Loss in Cellar Below East Porch (Silman 2019)</p>

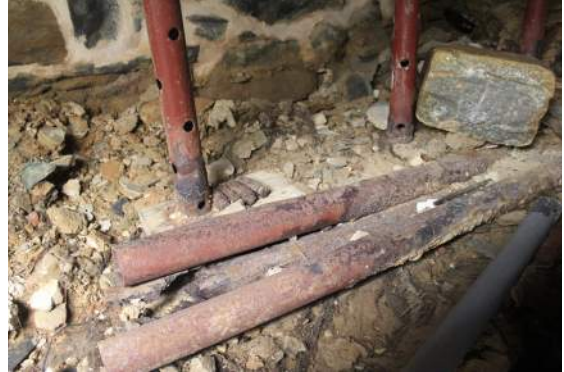
Figure 192: Corroded Shoring Posts at West Wall in Cellar of Center Section (Silman 2019)

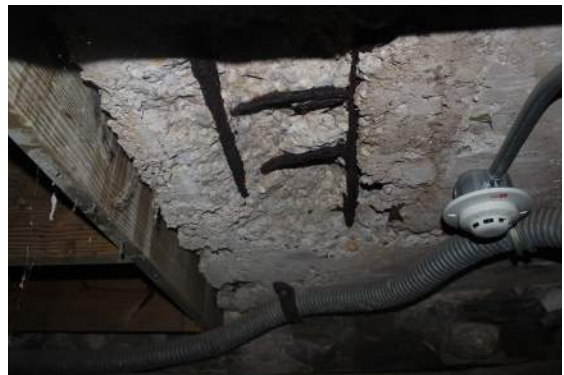
Figure 193: Concrete Slab in Poor Condition (Silman 2019)

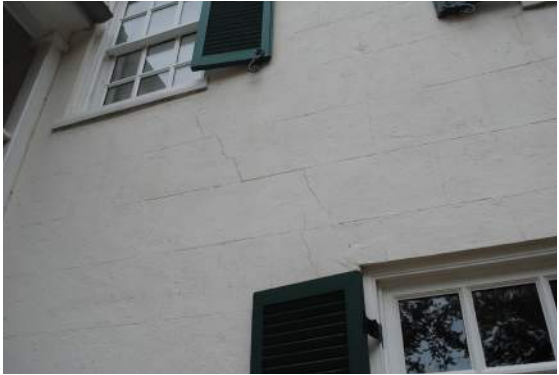
<p>Figure 196: Step Cracking Between First and Second Story Windows, South Elevation, North Wing (BBB 2019)</p>

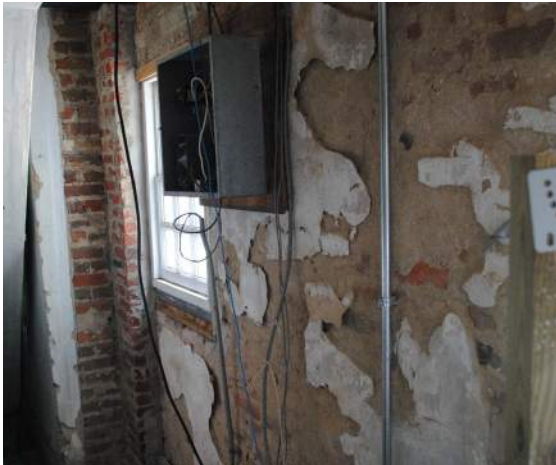
Figure 197: Mortar and Plaster Loss at Interior of North Wing Third floor, North Wall (BBB 2019)

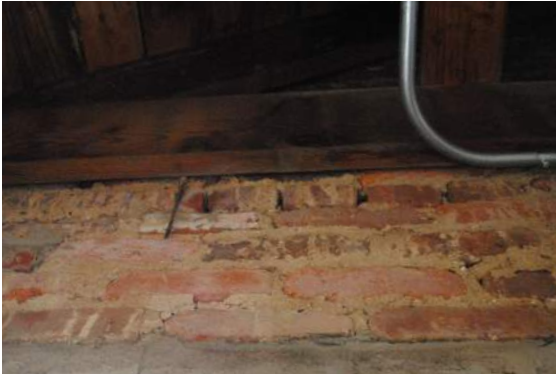
<p>Figure 198: Mortar Loss and Brick Spalling at Interior of North Wing Third floor, North Wall (BBB 2019)</p>

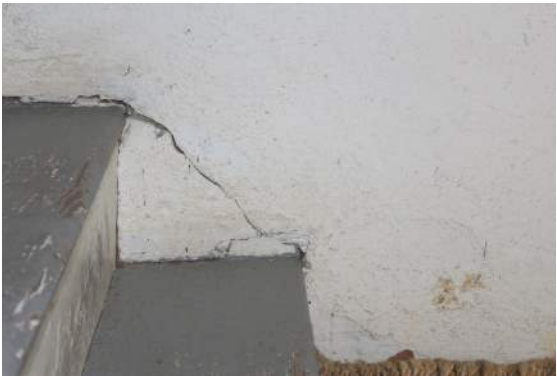
<p>Figure 199: Cracking in East Porch (Silman 2019)</p>

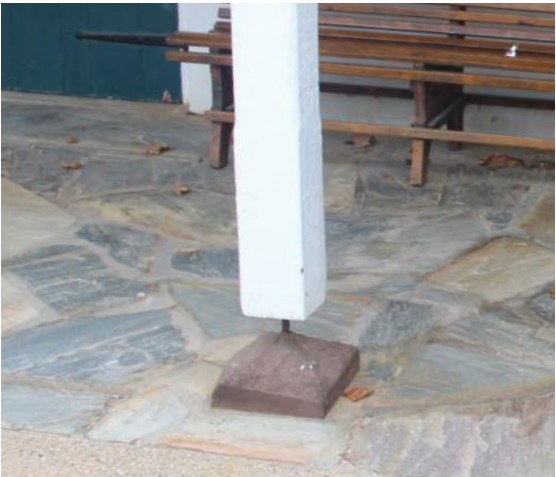
<p>Figure 200: West Porch Post Base (Silman 2019)</p>
	<p>Along the west elevation, porch posts have been retrofit with a detail including a metal bar and small 3"x3" baseplate. The metal bars supporting the posts were observed to be corroding.</p> <p>Recommendations: If no longer required for mechanical equipment or ventilation, the cellar opening should be infilled. The minor cracking likely does not require structural repair, but it may be included as a long-term repair item. During a future larger repointing campaign, the stucco should be removed at areas of cracking to allow for localized repointing. At the porch, the post supports should be replaced with larger sandstone bases to meet the bottom of the wood posts. Alternatively, the wood posts may be replaced with longer members to bear on the existing sandstone bases.</p> <p>Previous paint and whitewash treatments have contained latex, which is non-permeable. No known hazardous materials testing has been conducted on exterior surfaces; however, it is assumed that paint and whitewash treatments performed in or prior to 1949 contain lead. If stucco is to be removed from the exterior, the stucco and paint should be tested for lead and asbestos and removed under containment if needed. If the stucco remains in place, lead may need to be encapsulated prior to any repair.</p>

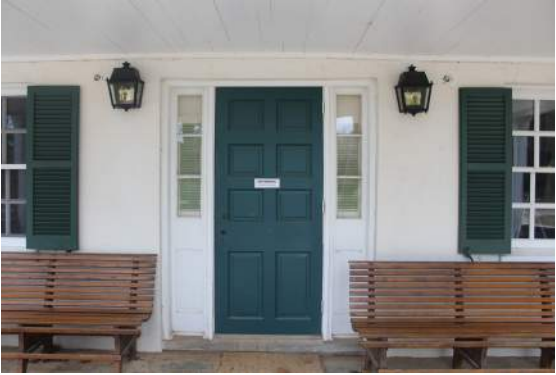
<p>Figure 201: Door at South Elevation; Note the Lintel Deflection (Silman 2019)</p>
	<p>Description: Walls at the south wing are brick masonry built over rubble masonry cellar walls. Steel lintels were installed at all openings during the 1949 restoration.</p> <p>Above grade, the south wing walls are in fair to good condition. Hairline vertical cracking was observed near window openings, typical of buildings this age. A crack was also observed at the north elevation of the south wing, within the east porch. This cracking may be attributable to deterioration of the concrete slab below this area. A noticeable lintel sag was also observed at the first-floor door of the south elevation, indicating corrosion of the steel lintel or an inadequately sized member (Figure 201).</p>

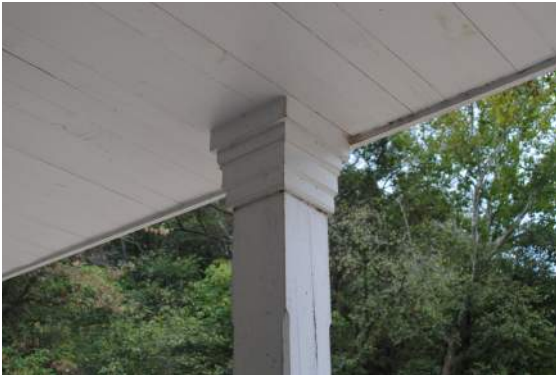
<p>Figure 202: Check in Wood Post at South Wing Porch (BBB 2019)</p>
<p>Porch framing at this area is also in fair to good condition. The structure of the porch was entirely reconstructed in 2007 with pressure treated lumber. The support detail with a small 3"x3" baseplate was also maintained at this elevation. Some deterioration of the second floor tongue and groove flooring was observed during the 2019 field surveys, likely due to moisture and temperature expansion of the wood. Checks have also developed in the wood posts due to the new pressure-treated timber drying out. The checked members do not compromise the structural integrity of the porch but do pose aesthetic and longevity issues as water can infiltrate through the checked areas.</p> <p>Recommendations: Like the north wing, façade cracking should be repaired by removing stucco and locally repointing the brick masonry. Replace lintel with new steel member to correct deflection of the door frame. See section regarding north walls for additional discussion of mortar testing and masonry repairs. The porch support detail should also be replaced as described in B2010 for the center section. Checks in wood posts should be sanded, wood filler applied, and repainted.</p> <p>Previous paint and whitewash treatments have contained latex, which is non-permeable. No known hazardous materials testing has been conducted on exterior surfaces; however, it is assumed that paint and whitewash treatments performed in or prior to 1949 contain lead. If stucco is to be removed from the exterior, the stucco and paint should be tested for lead and asbestos and removed under containment if needed. If the stucco remains in place, lead may need to be encapsulated prior to any repair.</p>

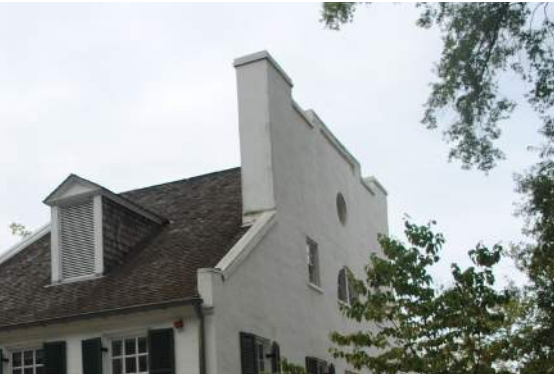
<p>Figure 203: North elevation parapet (BBB 2019)</p>
<p>Description: The north wing features a tall brick parapet at the north elevation and three chimneys; two integral with the north parapet and one at the south elevation of the north wing. The 2015 investigation noted that the north wing parapets are two wythes deep with a stucco coating. Displacement and cracking of parapet and chimneys was observed. The brick structures were observed to have tilted to the north, and cracking was observed at the east, west, and north sides of the tall slender brick structures. Extent of displacement could not be accurately determined from the ground. It is unknown if the damage was caused by the 2011 Mineral Earthquake.</p> <p>Recommendations: Cracking of the parapets and chimneys should be monitored for continued movement. In the short-term, cracking and displacement should be visually monitored. In the near term, inexpensive tell-tale crack monitors should be installed across existing cracks and visually monitored by Park staff to determine if the parapets and chimneys are actively moving. For cost estimating purposes, it can be assumed that six monitors should be installed. See field notes in appendix for suggested location of crack monitors.</p>

<p>If more than 5mm of movement is observed, the Park should engage a structural engineer to investigate further and develop appropriate repairs. Crack monitors can also be installed to accurately quantify continued movement of the chimneys. Existing cracking should be repaired by removing the stucco and repointing deteriorated areas. Given the extent of cracking, it would also be appropriate to rebuild sections of the brick masonry to address existing conditions during a future long-term restoration project.</p> <p>Unreinforced masonry parapets and chimneys are typically not seismically compliant. In order to achieve seismic compliance and increase the site's safety during a seismic event, the chimneys and parapet should be reinforced or reconstructed as a reinforced wall.</p> <p>A seismic analysis of the existing chimneys and parapets following current code requirements shows that the chimneys will experience 20 - 30psi of tensile stress in a design level seismic event. A brick masonry chimney in good condition may be able to withstand these tensile forces, but given the observed exterior condition and typical masonry deterioration in a chimney flue, we recommend planning for chimney reinforcement within a long-term restoration project. Similarly, the parapet at the north elevation may experience upwards of 100psi in a design level seismic event, exceeding the capacity of unreinforced masonry.</p> <p>Options for chimney and parapet reinforcement include adding a brace point at the mid-height of the parapet, such as a kicker supported on the roof framing. The chimneys could also be reinforced by infilling the flue with reinforced concrete that extends down past the roof height.</p> <p>Previous paint and whitewash treatments have contained latex, which is non-permeable. No known hazardous materials testing has been conducted on exterior surfaces; however, it is assumed that paint and whitewash treatments performed in or prior to 1949 contain lead. If stucco is to be removed from the exterior, the stucco and paint should be tested for lead and asbestos and removed under containment if needed. If the stucco remains in place, lead-based paint may need to be encapsulated prior to any repair.</p>

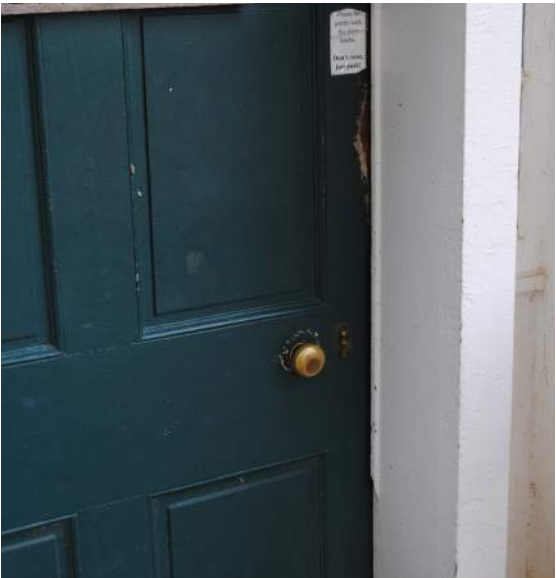
<p>Description: Several of the paneled wood exterior doors are damaged. Batten wood doors are in good condition. Many molded wood door stops are damaged or missing. Many doorknobs are loose or broken; some are missing altogether. Insect deposits are also present at many of the exterior door frames. Existing hardware does not meet ABAAS and many doors lack ABAAS required clearances.</p> <p>Recommendations: Clean doors and remove insect deposits; Repair damaged doors; Replace missing or damaged wood door stops; Repair damaged doorknobs and locksets. Replace door knobs with ABAAS compliant levers.</p>				<p>Figure 207: Main Entrance, North Elevation Showing Damage to Door, Doorknob, and Door Stop (BBB 2019)</p>
B2030 Exterior Doors	Cellar Door	Poor	Critical

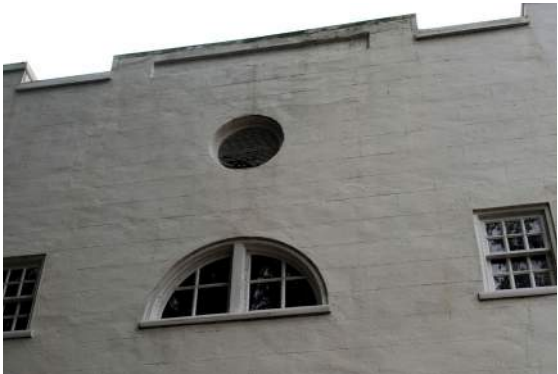
<p>Figure 210: North Elevation Parapet with Failed Flashing (BBB 2019)</p>
<p>Description: Flashing at the center of the parapet on the north elevation appears to be failing. Downspouts at the north addition are in poor condition and should be replaced. Gutters are also failing in some locations, such as at the second floor of the center portion on the west elevation, as evidenced by staining of the masonry walls below.</p> <p>Recommendations: Replace flashing at center on parapet on north elevation. Replace downspouts as needed and clean gutters seasonally.</p>

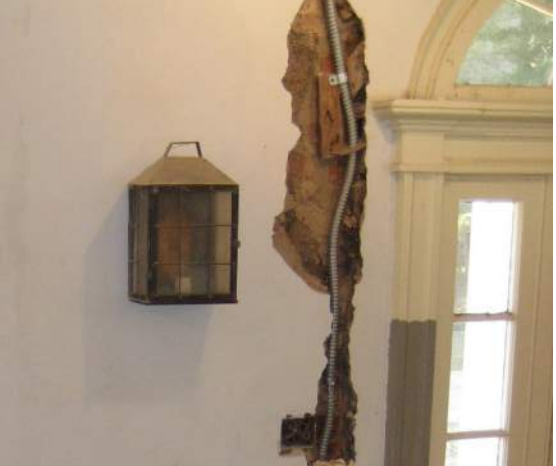
<p>Description: Most of the walls within the Tavern are replacement plaster on expanded metal lath. At the exterior walls in the north wing first floor, photos taken during construction in 2007 show the plaster applied to metal lath instead of directly to the masonry. The south wall is furred out and clad with gypsum boards.</p> <p>Within the first floor, finish distress was observed including bubbling of the plaster and some crazing and cracking, indicating water infiltration issues. Plaster delamination was concentrated at the north-east and northwest corners suggesting that moisture issues may be related to the building's gutter and downspout systems.</p> <p>The wood baseboard on the first floor of the north wing has unpatched openings where cuts were made in the baseboard to install building systems that have since been removed or abandoned.</p>

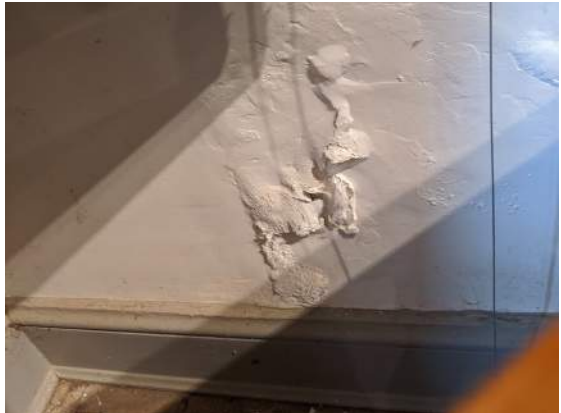
Figure 214: Plaster Delamination Below Chair Rail in North Wing, First Floor (BBB 2019)

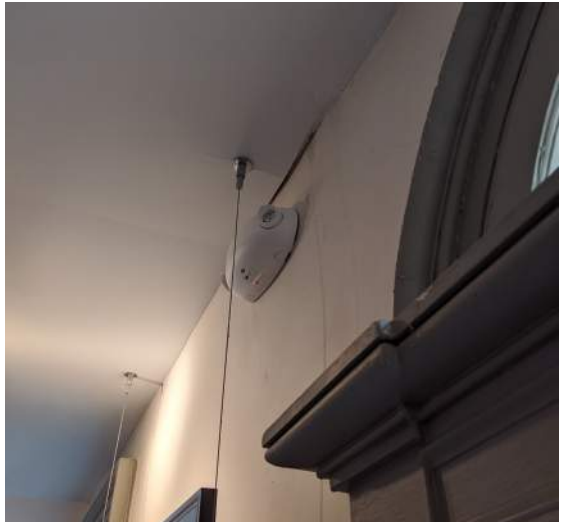
Figure 220: Sagging Ceiling at North Wall, First Floor North Wing (BBB 2019)

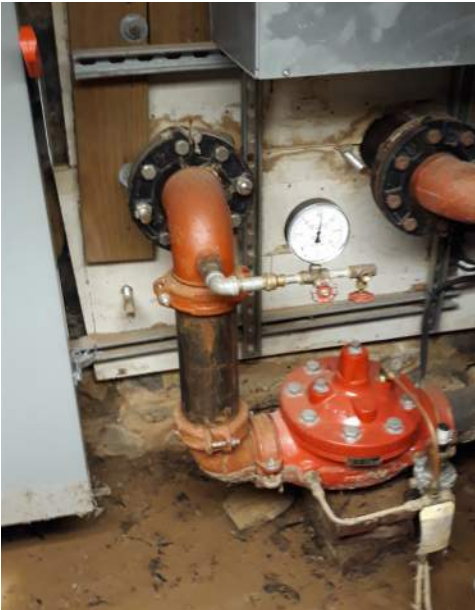
<p>Figure 223: Water Service Entrance (JPA 2019)</p>
<p>Description: The building's water supply consists of a 4" combination fire/water service. Once inside the building, the service splits into a 4" fire service and a 3/4" domestic water service.</p> <p>The domestic water system piping includes a pressure reducing valve and a water meter. No backflow prevention device or strainer is installed on the domestic water main serving the plumbing fixtures in the building. The domestic water piping system consists of copper piping and fittings. The fire service entrance piping included a double check valve backflow preventer.</p> <p>The domestic water piping main enters the building in the cellar and is routed a few inches above the floor. The 4" piping main is steel with grooved ends.</p> <p>The cellar experienced flooding recently, and the service entrance piping mounted near the floor was exposed to the water. No visible damage was noticed; however, piping was covered in dirt and mud from the flood (Figure 223).</p> <p>The shut-off valve on the inlet of the fire service backflow preventer was leaking at the stem (Figure 224).</p>

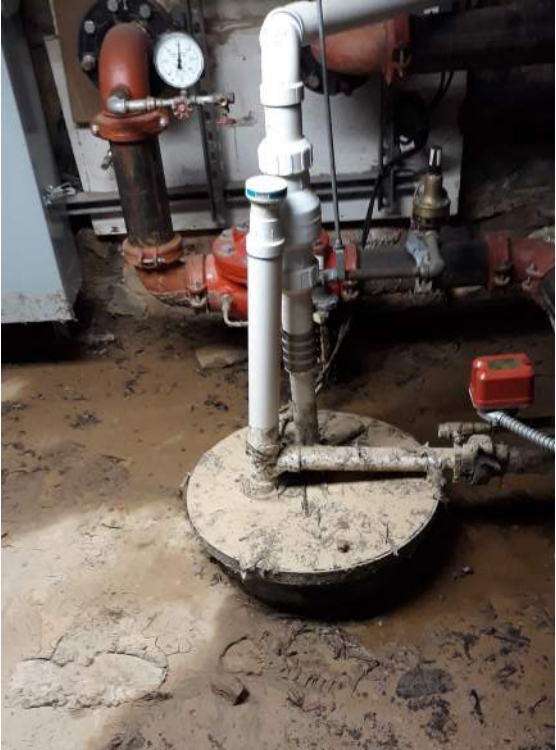
<p>Description: 3" PVC waste piping extends from the cellar up to the fixtures on the second floor. PVC piping is used for all fixture connections. No visible deformities were noticed.</p> <p>In the cellar, the piping transitions to cast-iron before exiting to the site utility. It is believed that this pipe was installed prior to the 2007 renovation.</p> <p>The 3" sanitary service is sufficient for the current connected load, however, will limit the number of fixtures that could be added to the facility and the type of fixture that could be added. The existing sanitary main will be insufficient if water closets with flush valves are added in the future, for example.</p> <p>PVC vent piping is used for all plumbing fixtures the facility. The piping is exposed in the third floor and vents through the roof.</p> <p>The sump pump basin, located in the cellar, is vented by a PVC vent pipe. The vent is terminated with an air admittance valve. It appears that damage has occurred to the vent pipe connection to the basin, possibly from the cellar flood (Figure 226).</p> <p>Recommendations: Due to the age of the existing sanitary main routed in the cellar, it is recommended that the piping be scoped to identify any deformities before any new fixtures are added or any future renovation occurs. The vent piping connection to the sump pump appears to be damaged from the July 2019 flood and should be repaired.</p>

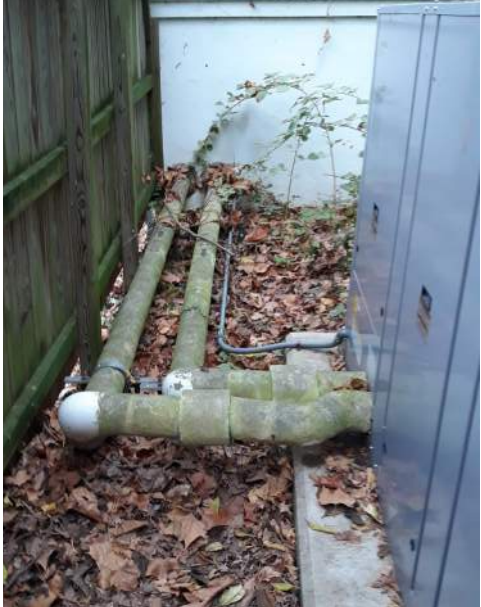
<p>Figure 230: Exterior Chilled Water Piping (JPA 2019)</p>
<p>Description: The chilled water system for the Tavern consists of an air-cooled chiller, pumps, an ethylene glycol feeder, and buffer tank. The entire system was installed in the 2007 renovation project.</p> <p>The air-cooled chiller is mounted to a concrete pad and is located outside of the boiler house. Chilled water piping extends from the boiler house and routes, above grade, to the machine. The chiller has a nominal 20-ton cooling capacity and operates with a 30% ethylene glycol solution as the fluid.</p> <p>Located within the boiler house are the chilled water pumps, expansion tank, buffer tank, and ethylene glycol feeder. It is recommended that the chiller, expansion tank, glycol feeder and buffer tank all be replaced in the next 5-7 years.</p> <p>The piping has more useful life remaining than the chilled water system equipment. Although the piping is expected to have at least 20 years of life remaining if proper water treatment is maintained, the exterior piping is recommended to be re-insulated at the time of chiller replacement (Figure 230).</p> <p>Recommendations: Replace chiller within 5-7 years. Re-insulate exterior piping when chiller is replaced.</p>
