HISTORIC STRUCTURES REPORT

**SURVEY REPORT FOR
THE LOCK #66 COMPLEX**

Chesapeake and Ohio Canal

Prepared by
Archie W. Franzen
Architect
December 1967

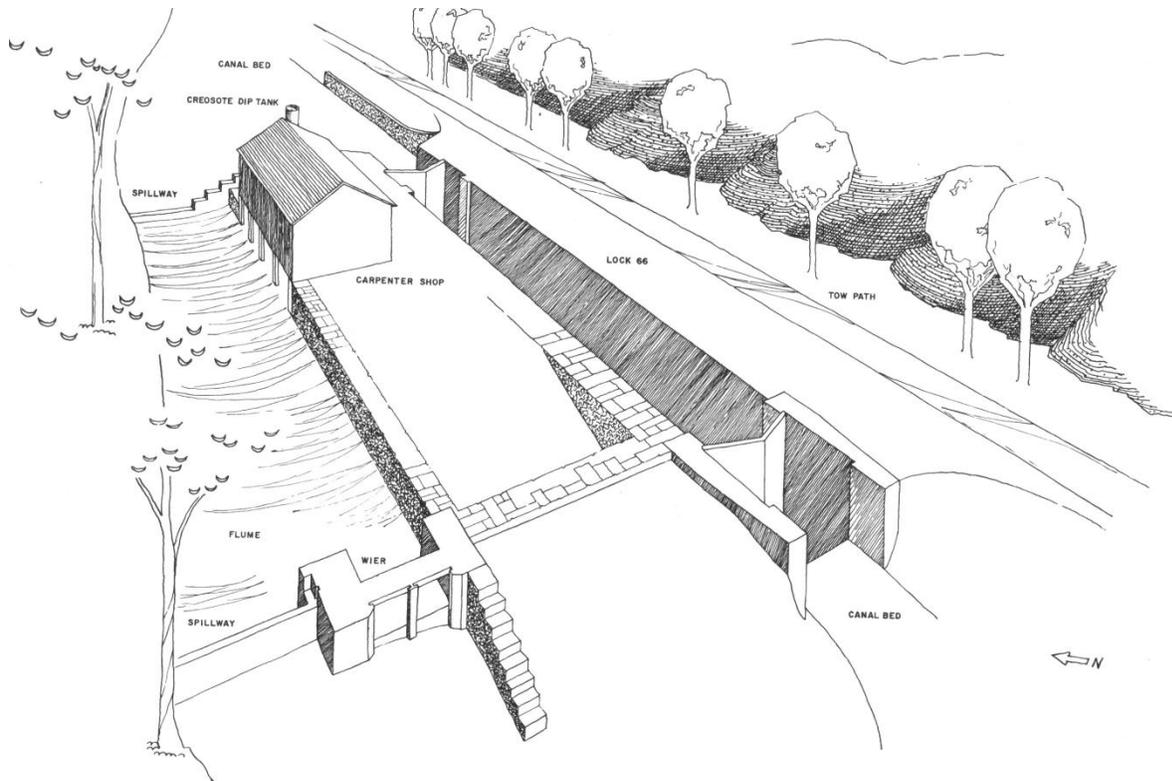
Illustration 2: This perspective was constructed from a viewpoint to show the entire complex. The depression between the lock and flume and behind the wall connecting the lock and weir was probably caused by erosion resulting from a break in the flume wall. It was shown, however, as it might have been a timber soaking pond. The height of the creosote tank has been exaggerated to show its location. The spillway in the foreground had notches at its ends to receive timbers. Why this was done immediately adjacent to the weir is not understood. The object of the flume was to pass surplus water on to lower levels along the canal using the weirs to maintain a proper level of water in the level above. Sketch: A. W. Franzen, September 1967.

The contiguous wing walls, retaining walls, weir and spillways should be repaired to accommodate the re-watering of the canal through the tunnel.

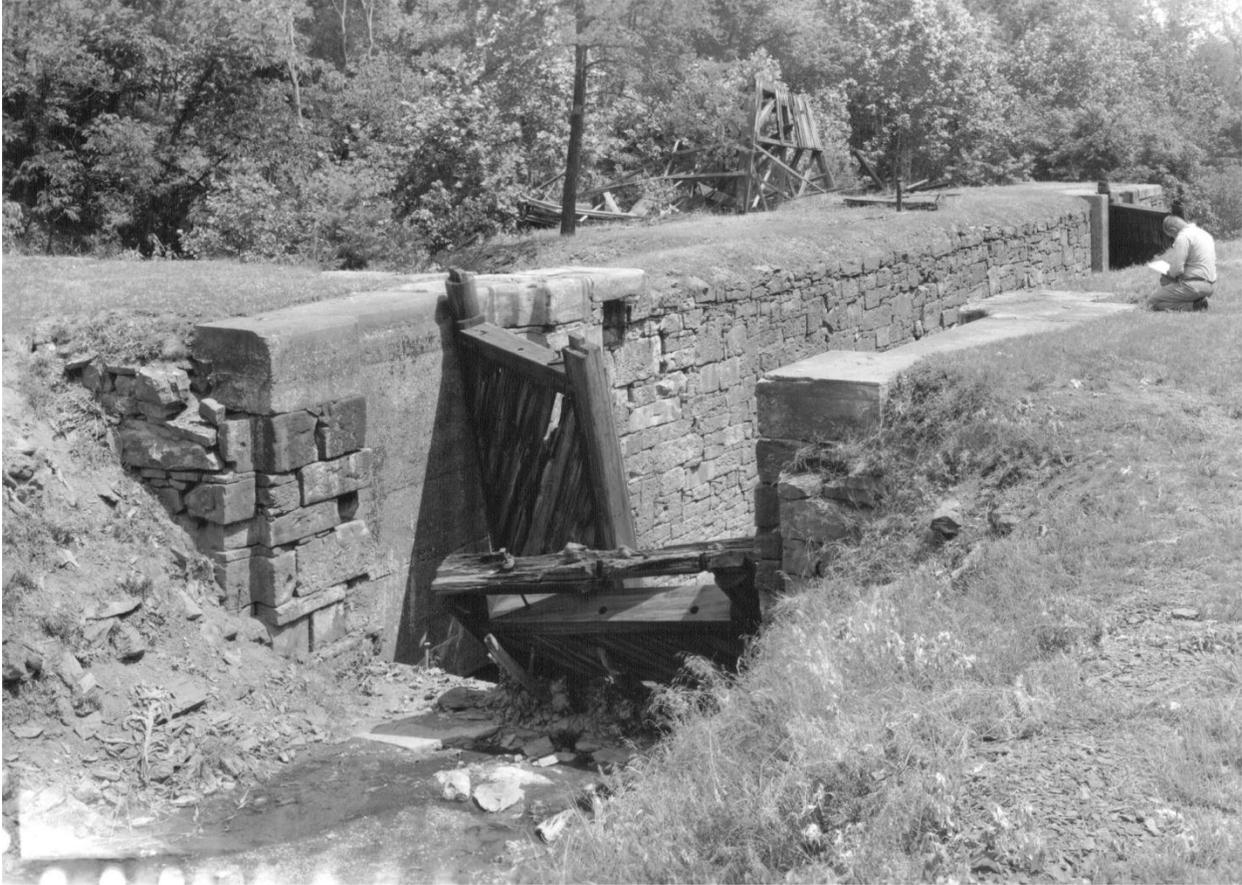
Illustration 3: View of Lock #66 from the towpath at the upstream end. The character of the stone can be seen and how it was reinforced with concrete in the gate pockets. What is left of the carpenter's shop can be seen in the background. The lock is 99'-6" long between gates and 16'-8" wide between the masonry of the sidewalls. Photo: A. W. Franzen, August 1967

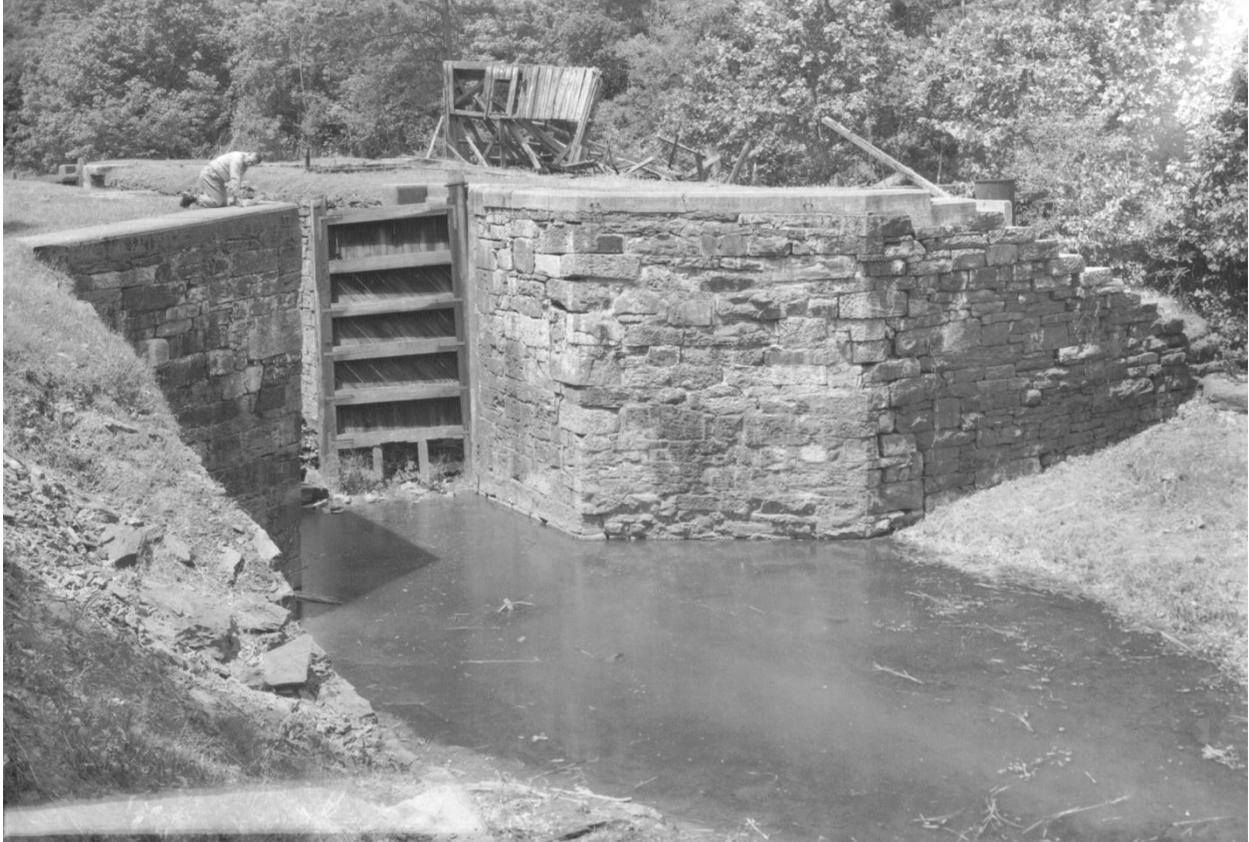
Illustration 4: View of lock from downstream showing size and extent of wing walls. To the right can be seen the top of the creosote dip tank. For scale, it is eighteen feet from the top of the lock to the water in the foreground. Photo: A. W. Franzen, August 1967

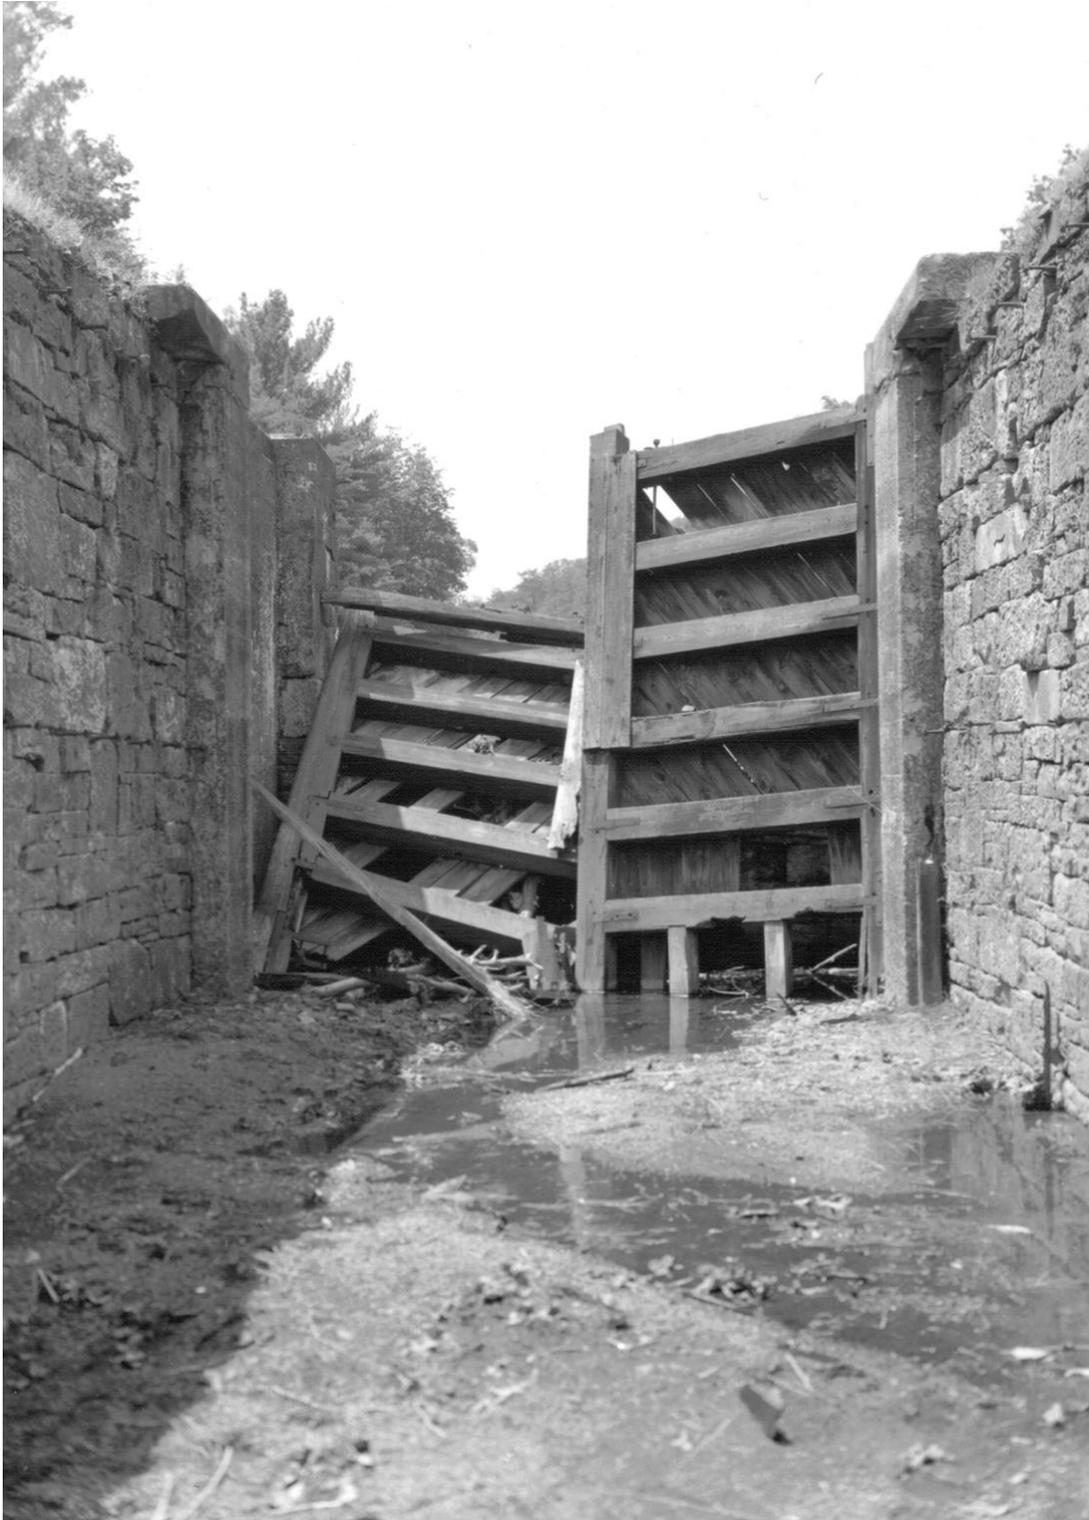
Remnants of the wood gates at both the upstream and the downstream ends of the lock still remain. Their bottoms are lodged in silt and for this reason it cannot be determined, at this time, if

it would be possible to rehabilitate them or not. Some portions of all of the gates have sustained severe damage due to rotting. Most of the gate hardware is missing.

Illustration 5: Looking upstream from within the lock. This view gives a good idea of the condition of the lock gates and their size. They are approximately fifteen feet high. Note how silt has amassed at the bottom of the gates. Photo: A. W. Franzen, August 1967

If after uncovering the existing gates it is found that they warrant refurbishing this should be done. Otherwise, new gates should be fabricated. It is felt that with development of visitor accommodations planned for the area at the south end of the tunnel that this lock should be made operable. This would give the visitor a rest stop feature to view after hiking through the tunnel.

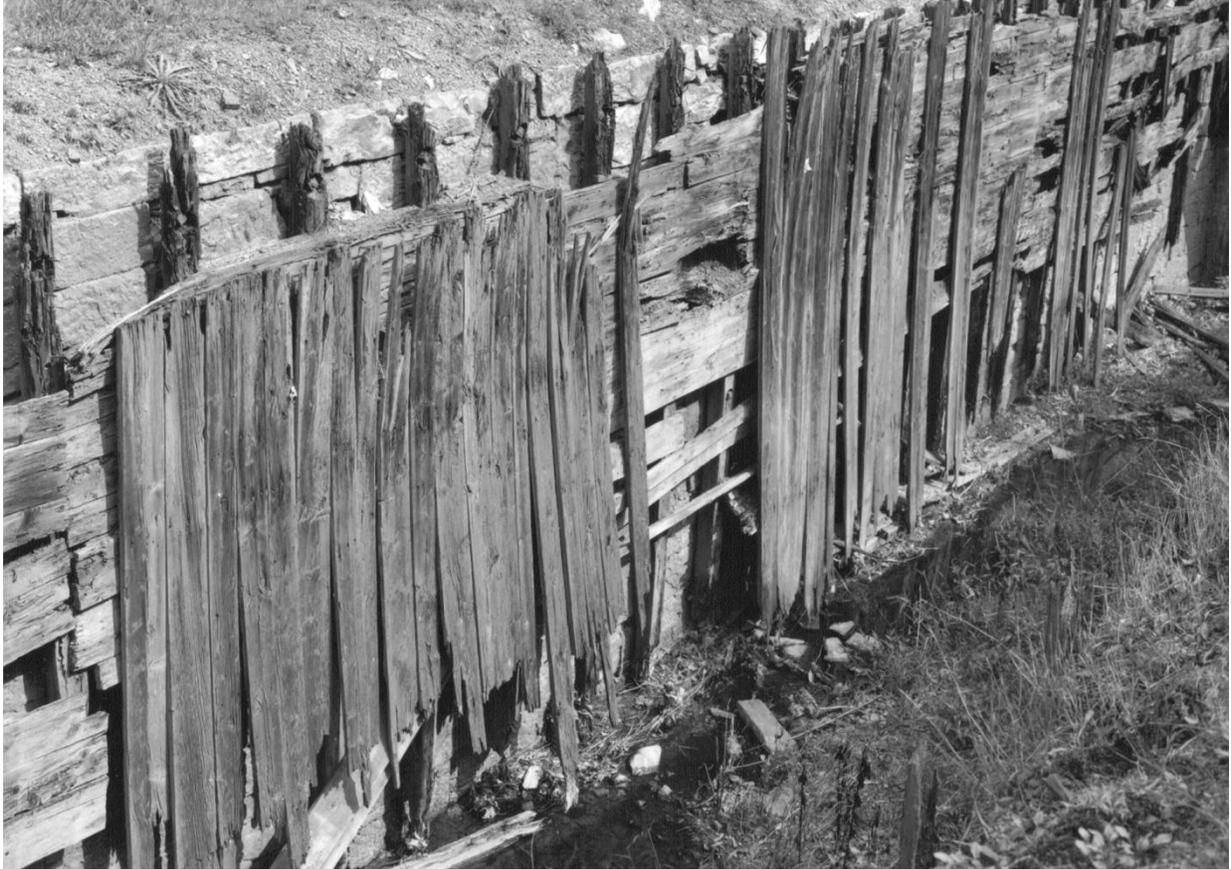
Only the bolts and a stud or two survive at Lock #66, but a good portion of the planking exists in place, a tenth of a mile downstream, at Lock #64-2/3. This planking is in a dilapidated condition.

Illustration 6: View of wood lock sheathing at Lock #64-2/3. Similar construction was employed at Lock #66. The missing capstones would have overhung the wood construction to protect it and prevent trash from falling down in the space between studs. Photo: A. W. Franzen, August 1967

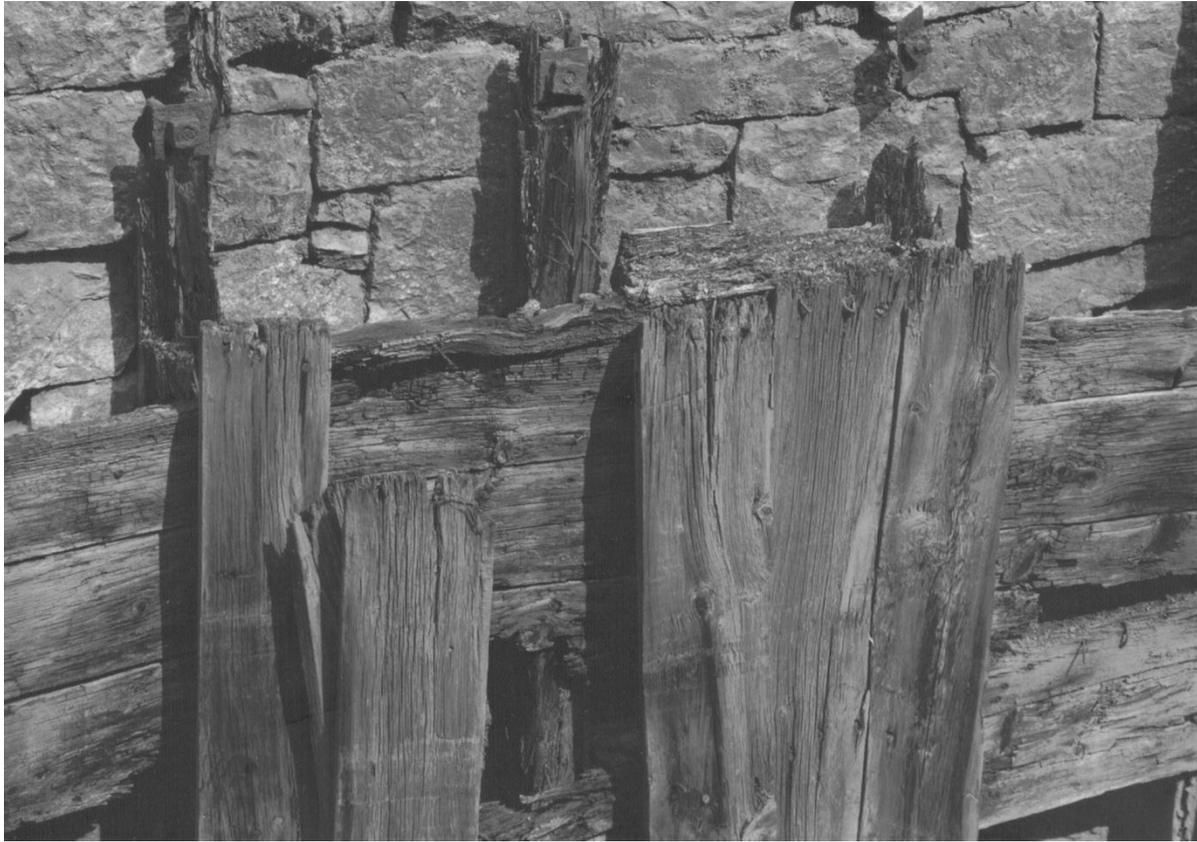
Illustration 7: This close-up shows the square washers on the rods that held the vertical studs in place. Many of the nails appearing in this view are wire nails and suggest that the sheathing had to be replaced in recent years. Taken at Lock #64-2/3. Photo: A. W. Franzen, August 1967

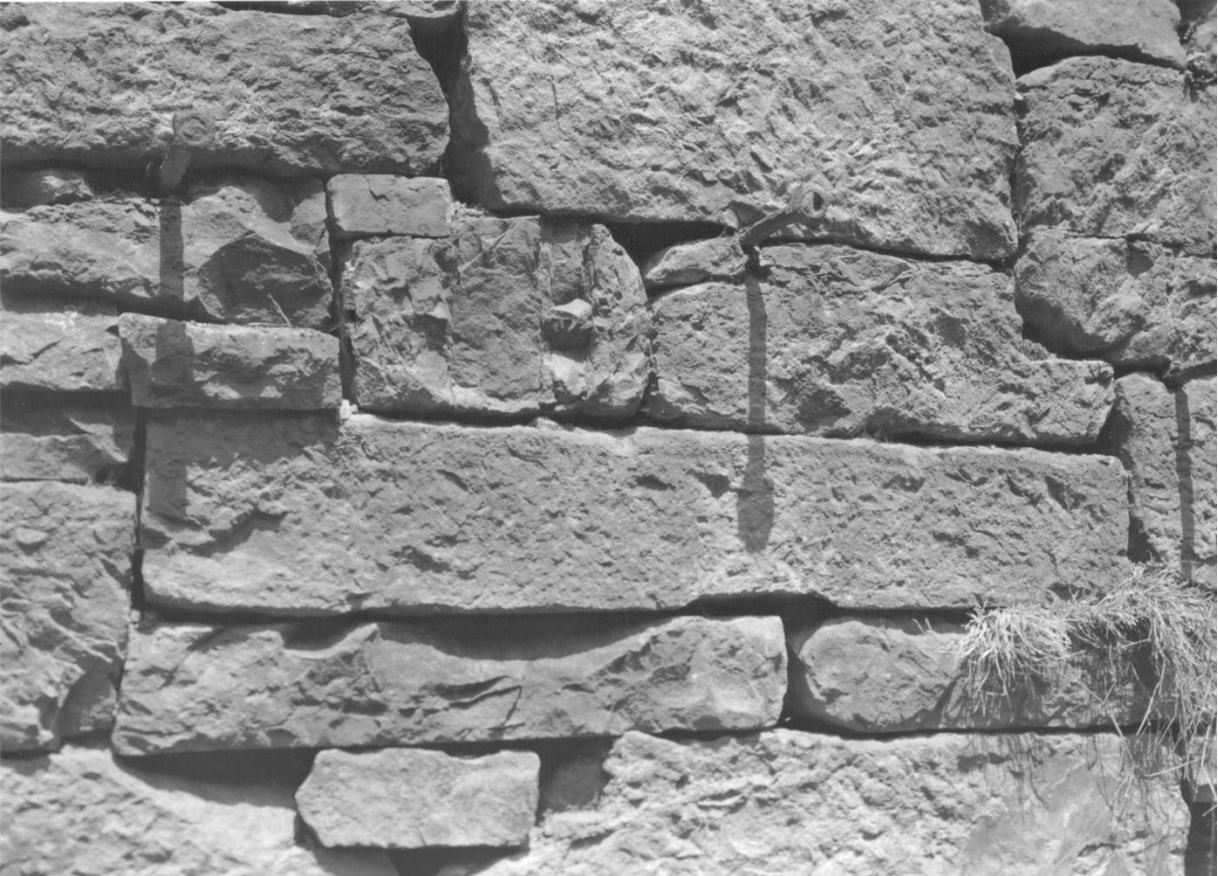
Illustration 8: Close-up of the stonework of the lock sidewalls. Two of the stud fastening rods appear as they protrude from the stonework. It is obvious from their condition that the rods will have to have their ends cut and replaced. The rods are four feet long and would be next to impossible to pull loose. The rods are roughly thirty inches apart and give an indication of the size of the stone and how it was laid up. Photo: A. W. Franzen, August 1967

The lock should be cleaned of silt and trash to below the mud sill level of the downstream gate. The masonry sidewalls should have any loose stone reset and any missing stone replaced, including the missing capstones. The corroded ends of the steel bolts that fastened the wood lining should be burned off with new threaded ends welded in their place. This will make it possible to replace the wood lining.

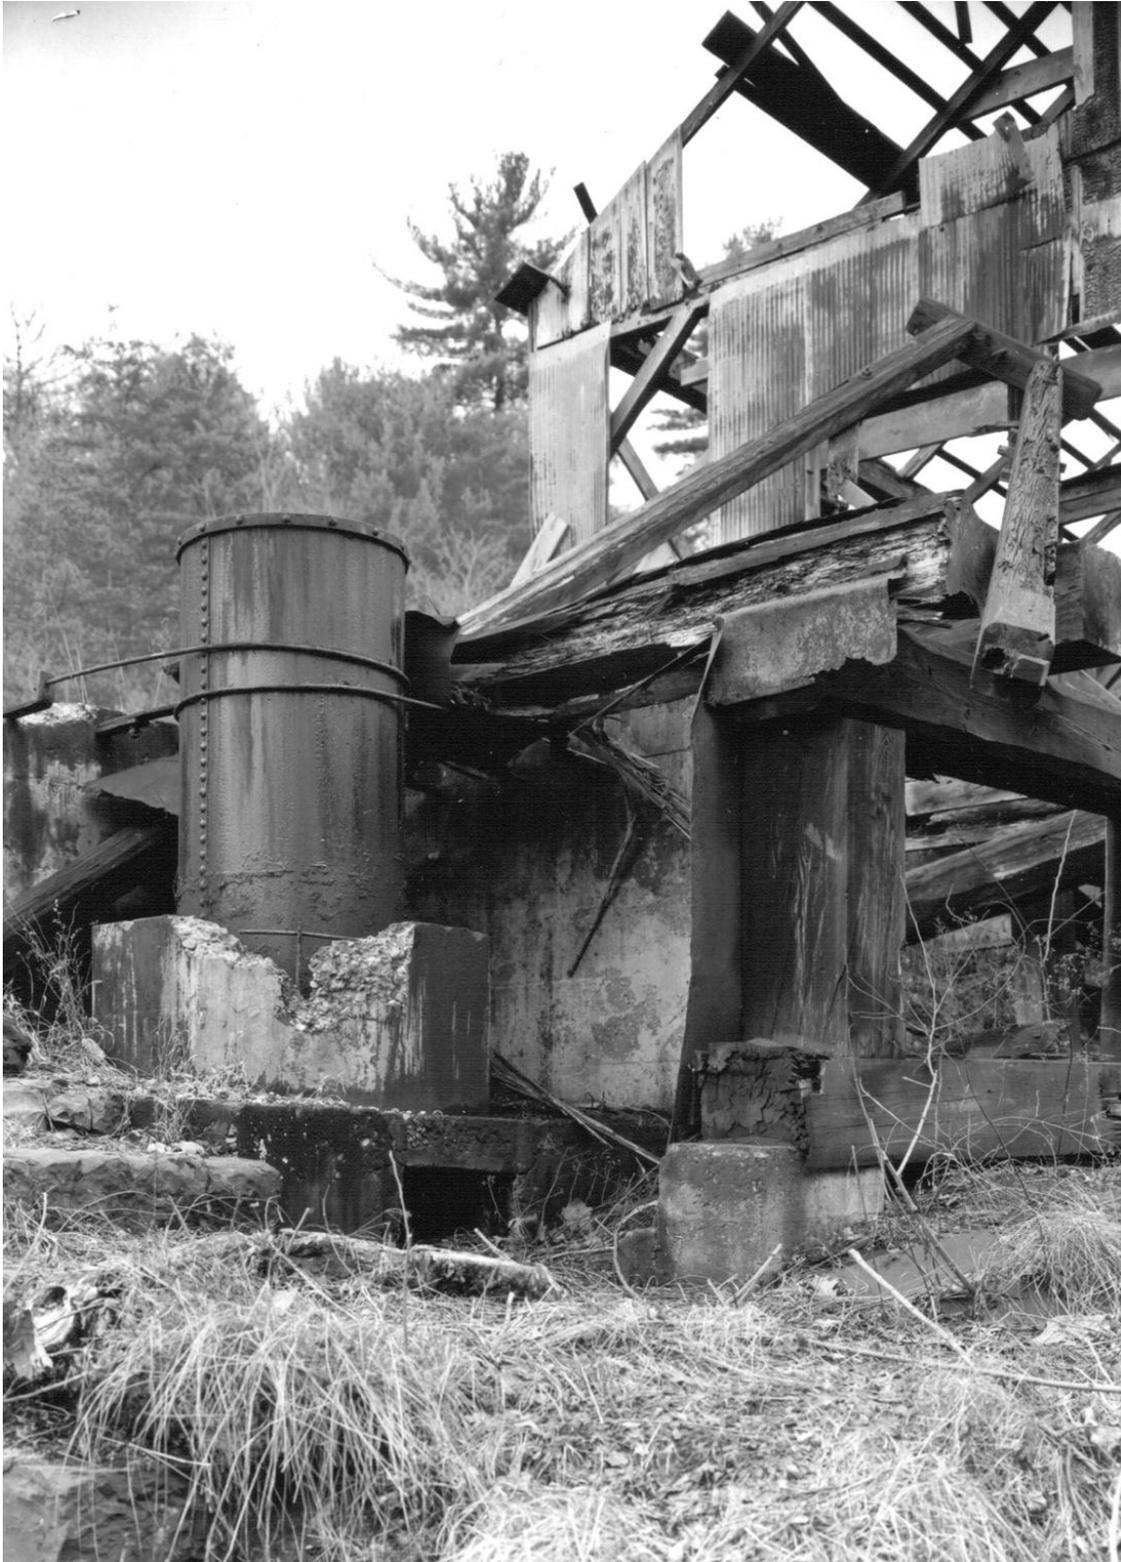
A creosote dip tank was located at the north end of the shop building. It was made of 3/16" thick steel plate and had a diameter of 28-1/4" outside. It was approximately six feet high and was shielded from the wood building by a concrete wall on two sides. The top of it was roughly level with the ground level between the lock and building.

The creosote treatment was apparently a non-pressure process with the timber heated and allowed to cool in the tank. To accomplish this the tank is supported at its base by a concrete slab and under which there is a space to build a fire for heating the tank. Some form of boom or A-frame must have been used to lower the ends of the heavy timbers into the tank, but such an arrangement has vanished.

Illustration 9: Near view of creosote dip tank. Heat was applied beneath the tank to accelerate the absorption of the creosote. The concrete dike at the base of the tank kept spillage from reaching the fire. Photo: Jack Boucher, December 1960
