CRATER LAKE NATIONAL PARK

Historic Structure Report & Rehabilitation Guidelines:

Employee Stone Houses #24, 25, 28, 30, 31, 32

Prepared by Patience Churchward
September 4, 2009

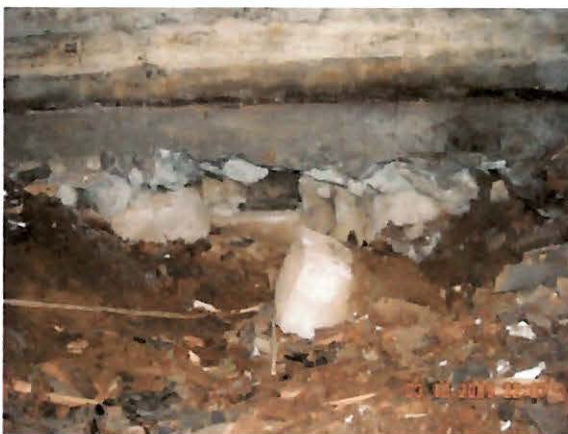
Deteriorated masonry foundation

- New **footing piers** were built in #31, and a new concrete **stemwall** was poured along the outer edge to stabilize the foundation where the previous masonry had eroded. The stemwall footing was reinforced with rebar that was drilled into the stone. This excavation and foundation work likely could not take place in the other houses without removing the existing flooring system.

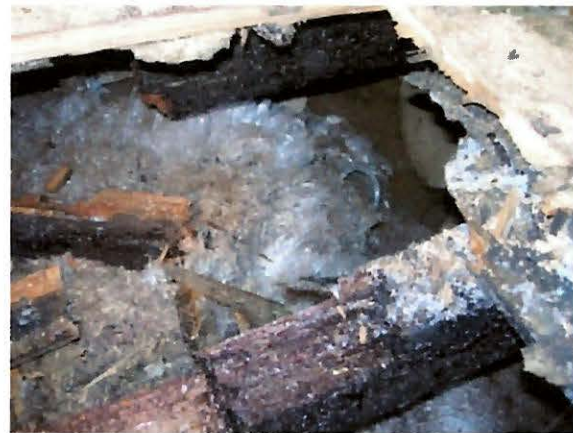
Rotten floor joists from freeze and thaw of moisture in crawlspace

- Several of the **floor** joists were rotten in House #31 caused by a leaky roof. The entire floor was removed and replaced. After the floor was removed, the crawlspace was excavated by approximately one foot, allowing for enough space to actually move around under the house. Roughly three cubic yards of earth were removed in this process.

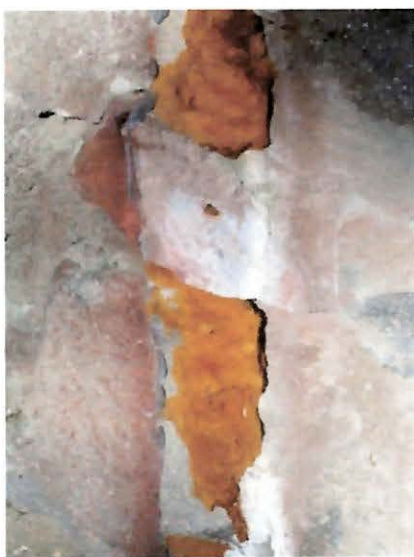
- Some of the masonry, particularly on Building #30's patio half-wall, has been repaired with an orange spray foam. This was likely to fill holes and protect the building from rodent infestation, but today, these spots are unsightly and highly incongruent with the rest of the masonry veneer.
- Some of the masonry joints, particularly on Building #30, have been covered with a soft black silicone. This was likely to connect the snow tunnels to the stone buildings. The materials are quite dissimilar and can easily be separated and peeled from the stone surface.
- The mortar is not recessed as it should be, but protrudes in many places, creating more surface area for moisture to penetrate the joint. The joints should be tooled back ½" from

Spray foam in masonry joint

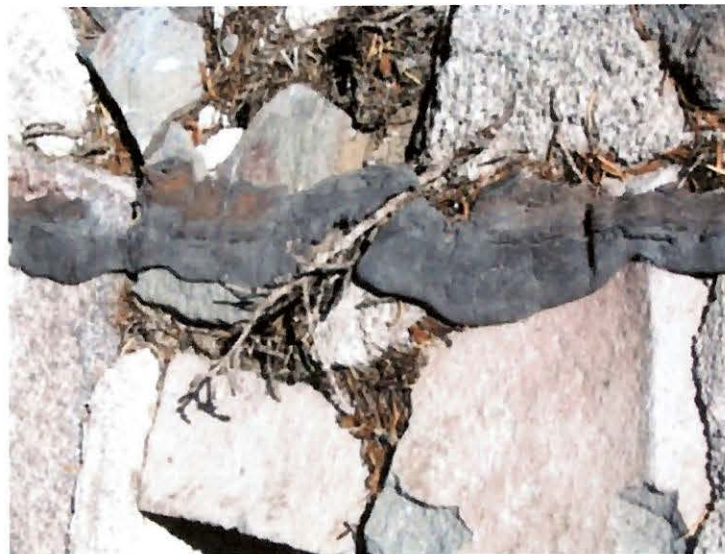
Black silicone used for attaching snow tunnels on patio wall

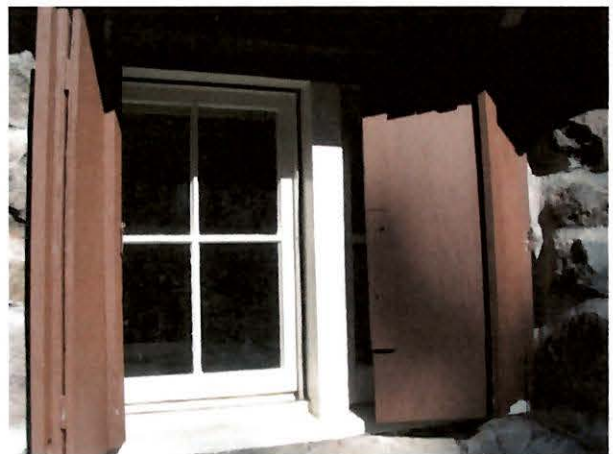
- **Permanent shutters** were installed in the recent past as a way to save time in maintenance every year. They are bi-fold style and are held open and closed with wood or metal stops or hooks, causing no or very little harm to the window frames. If other shutters are to be used in the future, never nail into the window frame. This has occurred in the past and can be highly detrimental to the window system. The rehabilitation plan calls for new modern wood mesh screen shutters that match the rest of the district and need to be installed and removed every year. These may not be necessary, especially if the houses will experience more frequent use during heavy snow fall months. The current bi-fold shutter system could be more “neatly” finished for aesthetic purposes. The addition of wood storm windows, with these

Bi-fold plywood permanent shutters

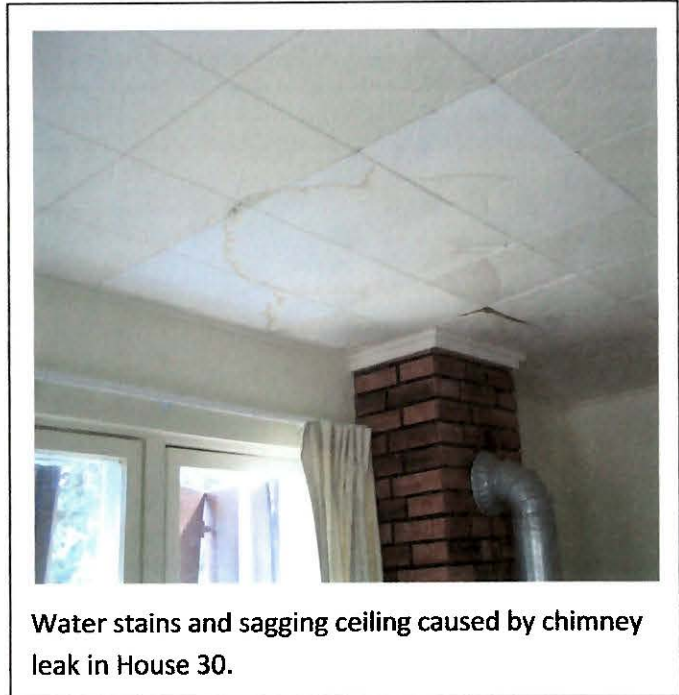
Water stains and sagging ceiling caused by chimney leak in House 30.

- Check for and maintain adequate capping, sealing, and flashing on chimneys every year.
- House #31 required significant **crawlspace excavation** to mitigate severe snow infiltration and make room for added insulation and HVAC equipment. The roof and walls leaked and high levels of moisture accumulated in the crawlspace. The freeze-thaw cycle caused the floor joists to rot, requiring a full overhaul as part of the building rehabilitation. It is a critical priority to assess and prevent similar disasters from occurring in the other houses, especially because this sort of repair requires a complete removal and overhaul of the floor and foundation system.

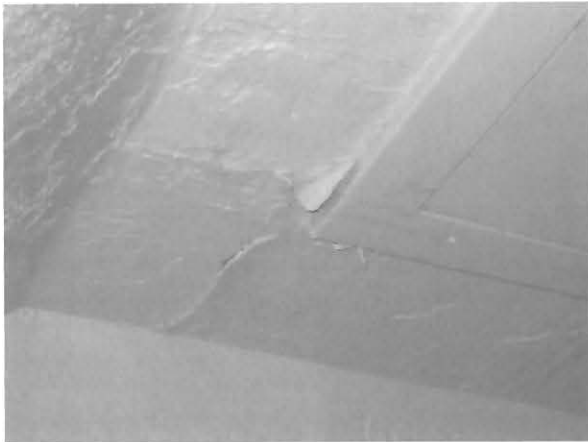
- There is evidence of **plaster patchwork** in House #28 that appears to have been done incorrectly. According the NPS *Technical Preservation Series* Brief #21, three coats of plaster are necessary for maximum strength and durability, and also

Cracked and spalling plaster on ceiling

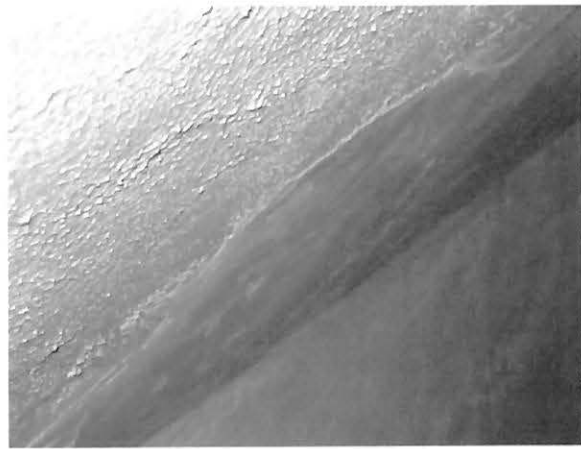
Incongruent smooth plaster patchwork next to properly textured plaster with added aggregate

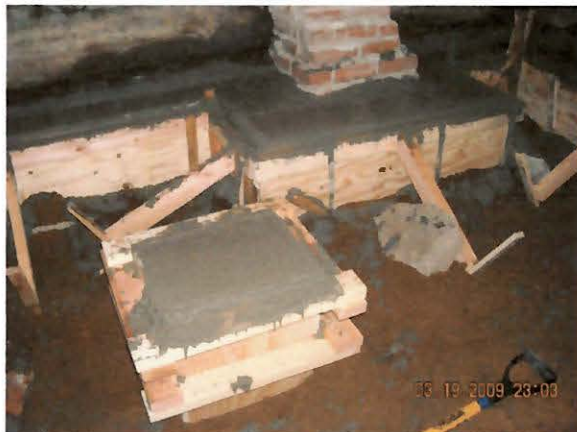
New concrete pier and stem-wall foundation

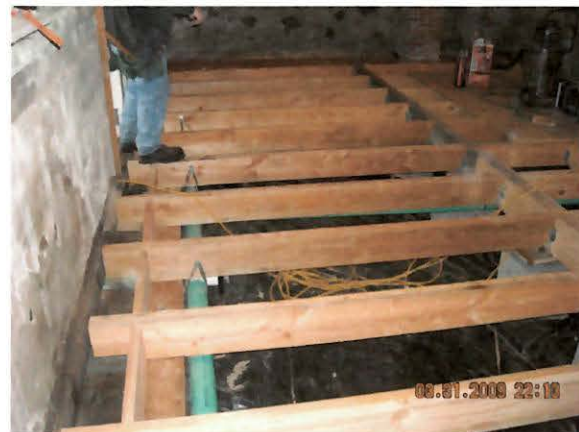
New floor joists to replace rotten flooring system
