# KEANE WONDER MINE AERIAL TRAMWAY STABILIZATION

Death Valley National Park

Prepared for  
National Park Service  
Vanishing Treasures PMIS 116962  
April 2010  
Revised April 2011

by  
School of Engineering, University of Vermont

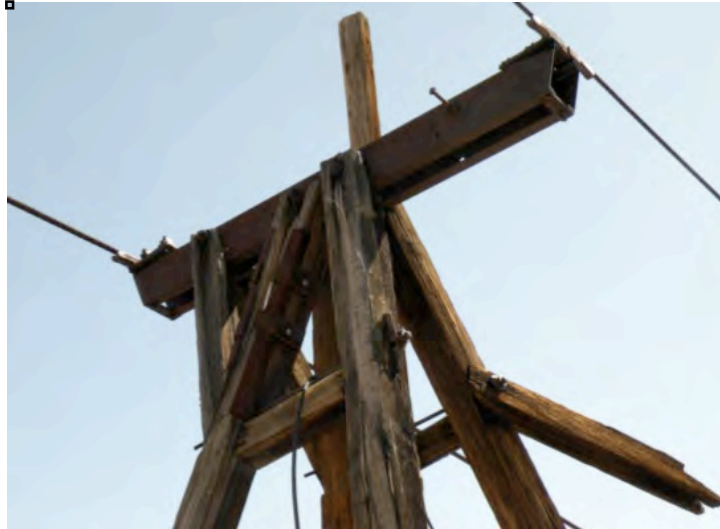
Tower 6 is in poor condition (Figure 1). While the tower is characterized by deterioration conditions that are fairly typical of many of the tram towers, the level of deterioration combined with proximity to the cliff and the length of the cable span put the tower at risk. Conditions at the tops of columns and saddle beam braces are more severe than with most of the other towers. The northeast column is split in two places, and repairs have been attempted with bolts and steel angles; the split near the top of the column has compromised the bolted connection at the saddle. On the west elevation, one of the saddle beam braces is missing and the other is detached and performs no structural function. Relish is inadequate at all of the remaining columns and braces. Rotation of the saddle beam due to eccentric loading is apparent.

The north sill has a half-lap splice at midspan that has been reinforced with bolts and steel plates. The sill is decayed below the northwest column, and bearing plates are positioned so that they support the sill on either side of the column rather than below it. The built-up timber pier at the northeast corner is partly undermined due to its proximity to the cliff edge. The sill on the south elevation is in good condition, though displaced from its original position. Bearing plates appear to be mildly decayed.

On tower 6, diagonal bracing has been notched at overlaps. This differs from the construction of the other towers, and the reduction in thickness at the lap has resulted in failure of one of the braces on the north side. The other diagonal brace on the north elevation has lost its relish at the connection to the northwest column base. Diagonal bracing on the south elevation is attached to the sill rather than to the column bases, the horizontal tie-column connection has been lost, and the southwest column is displaced several inches from its original position on the sill as the result of sill movement. The horizontal tie at the base of the west elevation has failed, and many of the diagonal braces on the tower are split at bolted connections to columns.

Figure 1. Top of tower 6, showing dangling southwest saddle beam brace. Photo: UVM School of Engineering

Tower stabilization is of the highest priority and will involve improvement of foundation support at the northeast column and repositioning of the bearing plates at the northwest column; repair / replacement of diagonal braces and horizontal ties on the north, south, and west sides; connection of diagonal braces to columns on the south elevation to correct displacement of the southwest column and to recover and maintain original geometry at the tower base; restoration of brace and tie connections and repair of relish at the saddle beam connections using shear plates, and re-seating of the saddle beam in the column and brace housings.

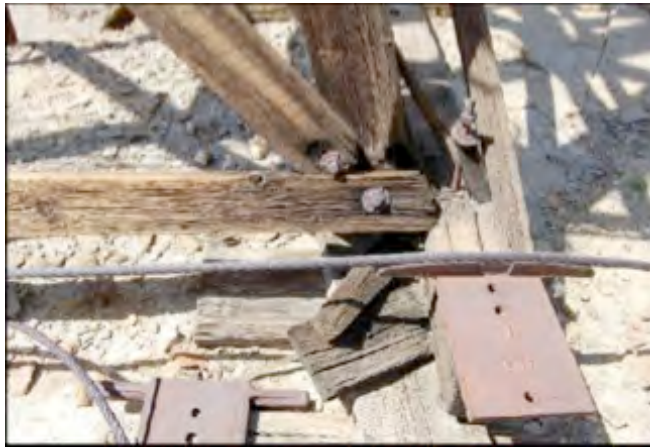
Tower 8 is in poor condition and is in imminent danger of collapse, largely due to failure of the framed support on the west side (Figure 2). Because the tower terminates a long cable span and is connected by that span to another high priority tower (tower 9), the level of urgency is increased; the collapse of one tower may result in the collapse of the other. The timber girt in the secondary frame supporting the west side of the tower has split at both girt-sill connections. Due to rotation of the northwest column in the secondary frame, tower loads are partially taken up by cribbing beneath the north sill, resulting in deflection of approximately 1½ inch between the northeast and northwest corner columns. The bolted connection between the northeast corner column and the north sill has failed, and the column has fallen off the sill timber (Figure 3). Moderate to high levels of decay are found at southeast, northeast, and northwest corners, resulting in deterioration of column-sill, column-horizontal tie, and column-diagonal brace connections. Diagonal braces on the north and south sides are fastened to the sills rather than to the corner columns and do little to reinforce deteriorated column-sill connections. A slope of grain failure in the southwest column above the traction rope carriage has been repaired with 2x8 sisters fastened with nails. The heavier track cable has fallen from its saddle on the east side, and the tower is rotating in the direction of the load imposed by the west cable. The northeast

column-saddle beam connection is without relish, due in part to the separation of the column from the north sill. The northeast saddle beam brace is missing, and the surviving braces have largely lost their relish.

Figure 2. Tower 8, northeast column, shown fallen from its sill. Photo: UVM School of Engineering

Tower stabilization is of the highest priority and will involve repair of foundation support on the west elevation, including replacement of the secondary sill and restoration of braced frame connections; repair of decayed column bases and restoration of sill, brace, and tie connections to columns to correct displacement of the northeast column and to recover and maintain original geometry at the tower base; repair / replacement of damaged diagonal braces and horizontal ties, and installation of new bolted connections between diagonal braces and north and south columns; repair of the slope of grain failure in the southwest column using bolted sisters; reinstatement of the northeast saddle beam brace, repair of relish at the saddle beam connections using shear plates, and re-seating of the saddle beam in the column and brace housings.

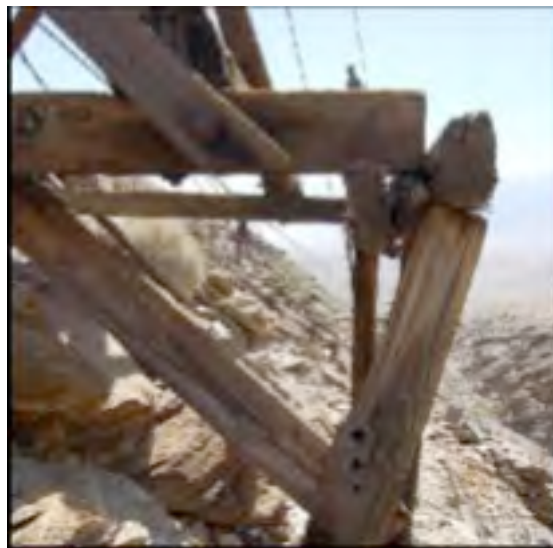
Figure 3. Tower 8, northwest corner of secondary frame showing failure. Photo: UVM School of Engineering

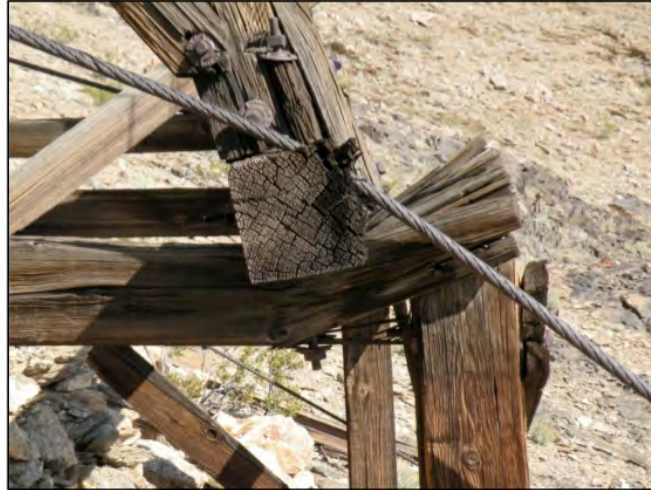
Tower 9 is in poor condition and is in imminent danger of collapse. Column failures, the generally poor condition of diagonal braces, and failures in secondary sill timbers make this tower one of the highest priorities for repair. Because the tower terminates a long cable span and is connected by that span to another high priority tower (tower 8), the level of urgency is increased; the collapse of one tower may result in the collapse of the other. There is little or no relish remaining on saddle beam braces and at the tops of the south columns. The north columns are deflected at scarf joints; this is at least partly due to a slope of grain failure at the northeast column joint. Gaps between the saddle beam and column and brace housings also indicate that the upper portion of the tower has settled with the north (uphill) bent more nearly vertical than perpendicular to cable loads.

Column bases and sills on the north elevation are severely decayed. At the base of the northeast column, connections are intact but there is crushing of the sill. At the northwest column, sill and column base are decayed and have shifted off the secondary sill. This movement has apparently resulted in a shifting of the south sill, so that southwest column loads are positioned over the west secondary sill several inches from the column that supports it. The secondary sill has failed, putting tower 9 at a high risk for collapse (Figure 4). In addition to failure of the west secondary sill, bearing blocks or plates that support the braced frame are decayed, and diagonal bracing of the frame on the south elevation has failed.

Tower bracing is in poor condition. One of the diagonal braces on the north elevation has been replaced with a 2 x 8 member; the surviving brace is of very poor quality due to large clusters of knots. On the west elevation, the diagonal brace once connected to the base of the northwest column has failed and the horizontal member at the top of the cross bracing has lost its connection at the north column. Diagonal braces are still attached on the east elevation though are ineffective in preventing deflection of the northeast column due to the slope of grain failure in the column. Horizontal members have failed on east and west elevations and tower roller carriages are collapsing.

Figure 4. Failure of west secondary sill, tower 9. Photo: UVM School of Engineering

Tower stabilization is of the highest priority and will involve repair of foundation support on the south elevation, including replacement of the secondary sill on the west and restoration of braced frame connections; repair of decayed column bases and restoration of sill, brace, and tie connections to columns to correct displacement of the northwest column and to recover and maintain original geometry at the tower base; repair / replacement of damaged diagonal braces and horizontal ties; repair of the slope of grain failure in the northeast column using bolted sisters; repair of tower roller carriages; and repair of relish at the saddle beam connections using shear plates, and re-seating of the saddle beam in the column and brace housings.

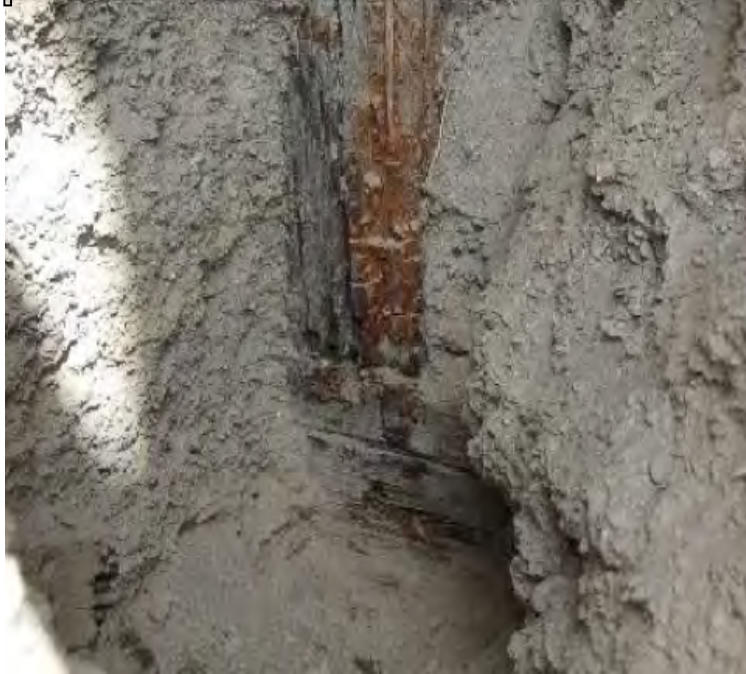
Several of the girts and joists that support the upper deck have reduced capacity due to decay and/or slope of grain failures. Floor beams supporting track cable sheaves have failed and were stabilized with steel sisters in the 1980s repair campaign. Deck flooring is badly deteriorated in places and unsafe for public use. The upper deck can be accessed at grade at the north end of the terminal, but is more than 30 feet above grade at the southern end, and requires a guardrail if the site is to be opened to visitors. On the lower level, the tall columns near the south end of the terminal are slender for the long, unbraced spans. Some of the braces are decayed at lower fastener locations. Conditions of column bases and bearing members are dependent to a large extent on the nature of the supporting structure. Where columns are supported on concrete foundation walls, they tend to be relatively dry and undamaged. Where columns and wooden bearing members have been covered by soil and debris, moisture contents tend to be high and decay of wooden elements relatively common (Figure 5).

Figure 5. Base of column D8 prior to treatment, buried and severely decayed.

While the condition assessment listed the overall preservation priority of the Lower Terminal as Medium, some of the individual repair needs rise to the level of High Priority, in part due to the proximity of the Lower Terminal to a publicly accessed trailhead. Terminal stabilization will involve reinstatement of missing bracing, consolidation of column bases and selected decayed bearing members, replacement of decayed bearing blocks and plates, and repair / replacement of deteriorated floor joists and decking.

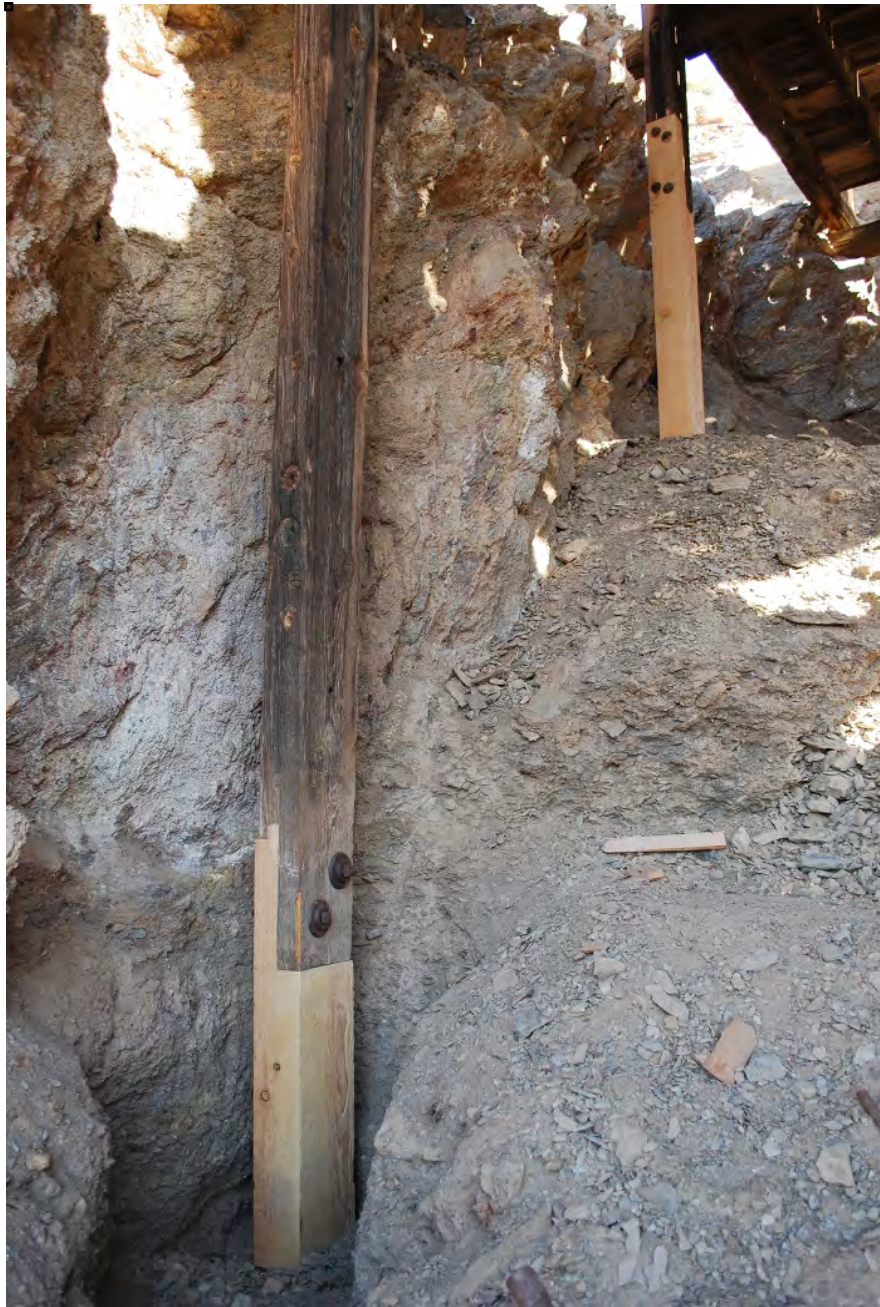
Figure 6. Column repairs at D8 (left) and D7 (right) at the Lower Terminal.

Columns D7 and D8 (Figure 6) are located directly adjacent to a rock wall, making access difficult. The repair to column D7 used an existing half-lap joint; the joint was unfastened and the decayed lower portion of the column was removed. A new timber was cut to length and a matching half-lap was cut. Four bolts were used to secure the joint and historic ogee washers were reused.

The repair to column D8 used a bladed scarf joint with a single nose; this created a stronger mechanical joint than a half-lap, but made the process of fitting the new timber simpler than fitting a double-bladed scarf, as the surrounding rock restricted movement. A four-foot section of decayed timber was removed and a joint was cut and fitted on both members. Two bolts were used to secure the joint and historic ogee washers were reused.

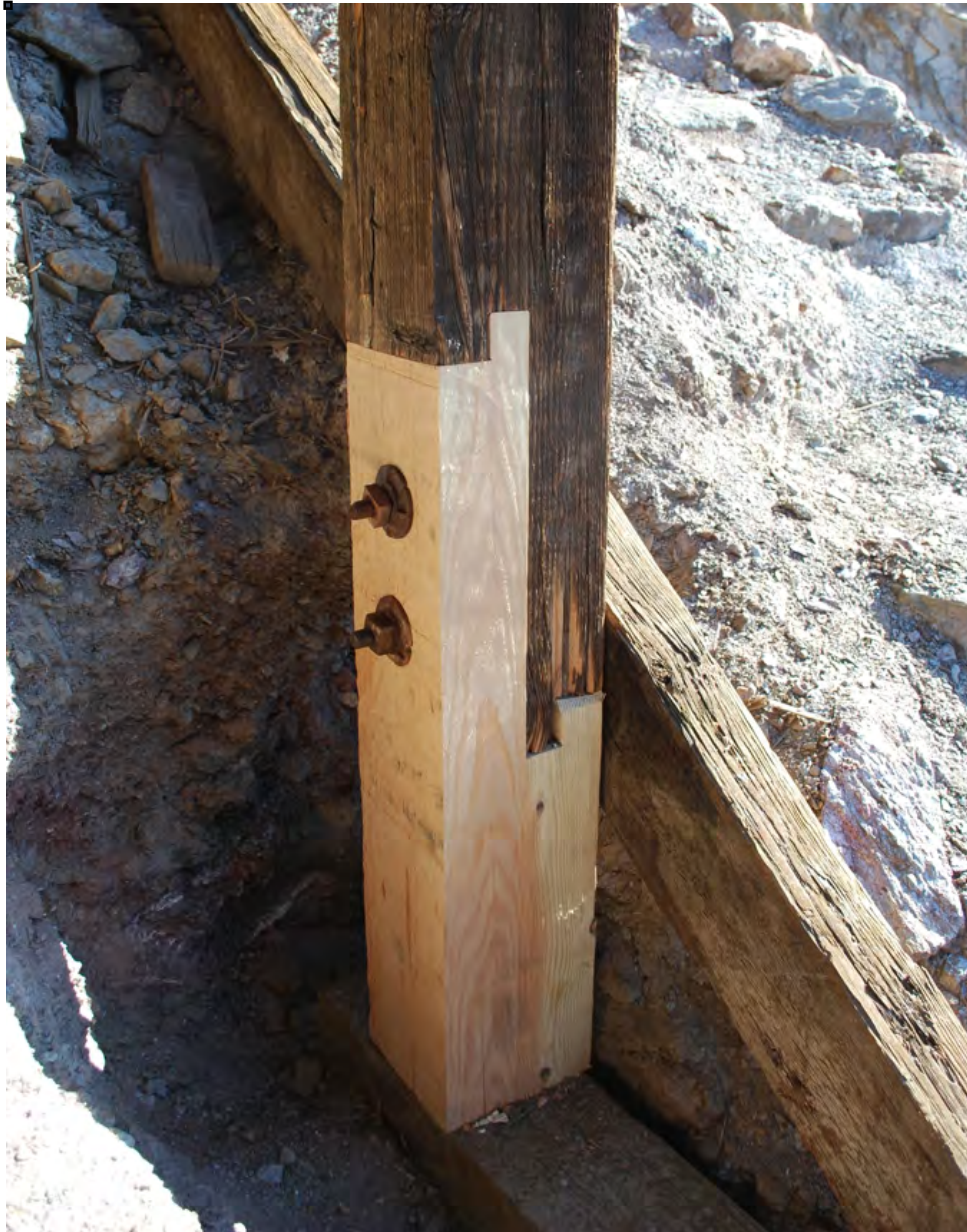
Figure 7. Column repair at A2, Lower Terminal.

Column A2 was easily accessible, and a double-bladed scarf joint was used to make the repair. A two-foot section of decayed material was removed and a replacement was cut to length. The joint was cut and fitted on both members and secured using two bolts with historic ogee washers.

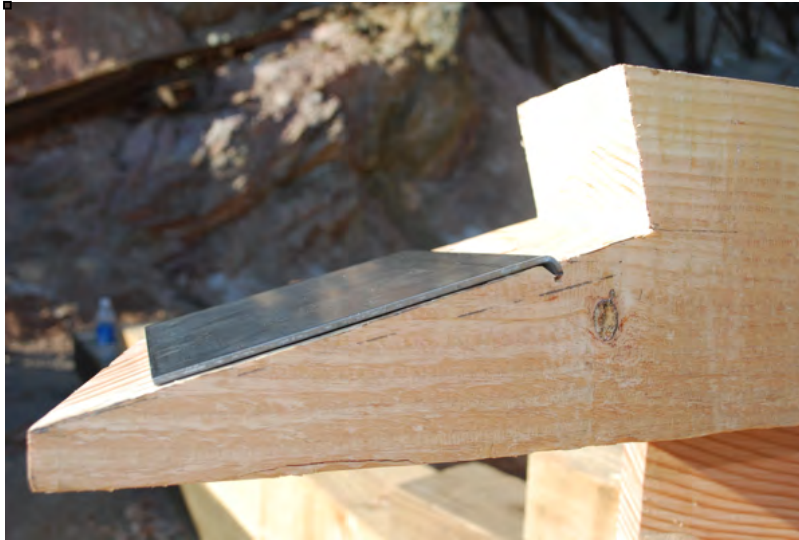
Figure 8. Replacement saddle beam brace with shear plate installed.

A complete repair kit was cut for tower 6, which included replacement saddle beam struts (Figure 8). These will be reinforced with steel shear plates fabricated for the project in order to prevent recurrence of the loss of relish found on a number of the historic saddle beam braces.

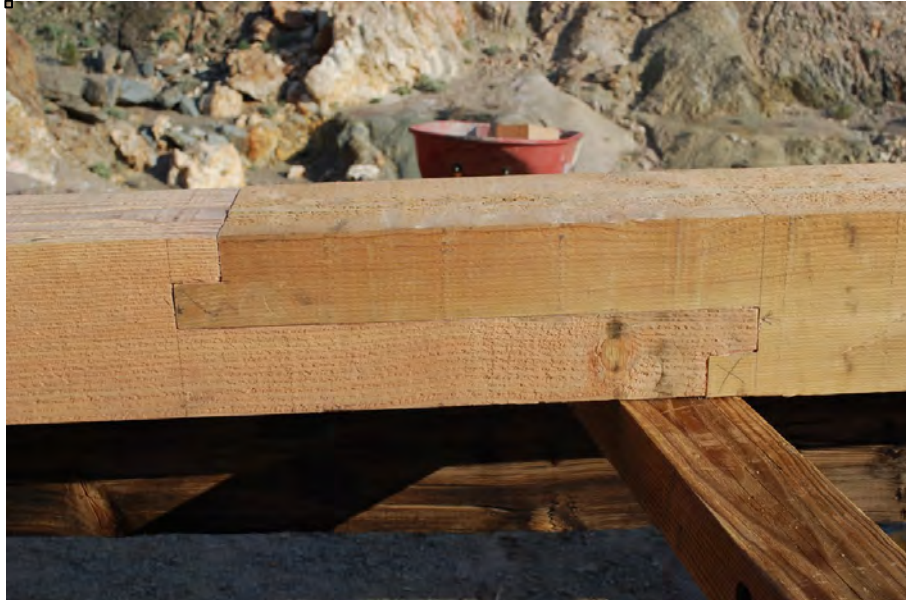
Figure 9. Bladed scarf joint splice for replacement column, tower 6.

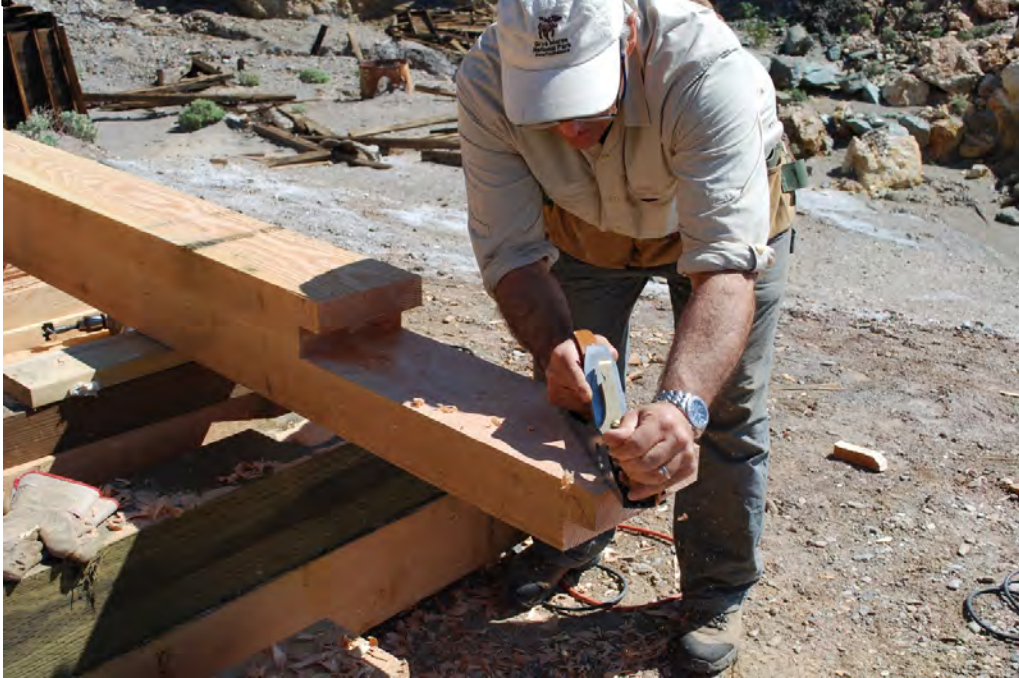
Figure 10. Planing face of scarf joint, replacement timber for tower 9

A partial repair kit was also cut for tower 9. Sills were not fabricated, as they did not require cutting. Two replacement timbers were cut for the northwest and northeast columns, each with one side of a double-bladed scarf joint pre-cut at its end (Figure 10).
