# Redwood Preservation at Scotty's Castle Death Valley National Park

School of Engineering, University of Vermont  
Cooperative Agreement No: H8W07060001  
Task Agreement No: J8W07070030

## Redwood Preservation at Scotty's Castle, Death Valley National Park

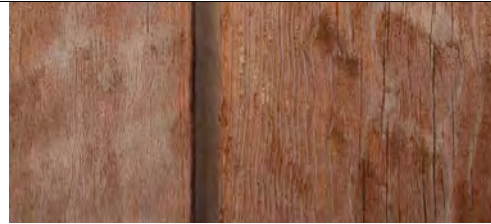
Fig. 1

Fig 1 shows a crazed surface at an early stage, with pronounced clouding in several regions; in Fig 2, cracks penetrate the entire thickness of the film and the coating has begun to detach from the substrate. Fig 3 shows a relatively unaffected surface under magnification; "ridges" are due to wire-brushing of the surface during the finishing process. In Fig 4, the film is entirely compromised and the wood surface has begun to disgregate.

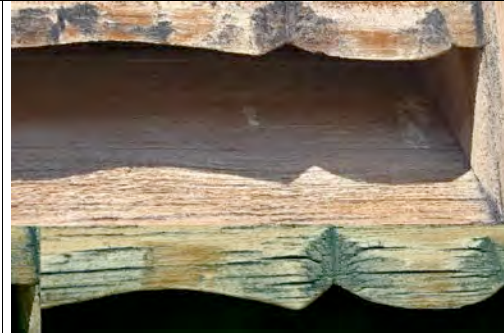
Fig. 1

In Fig. 1, wood surfaces exposed to sunlight are noticeably eroded while shaded surfaces are smooth and largely intact. Under magnification, damage to the wood structure and disgregation of wood fibers from the surface are evident (Fig. 2). In Fig. 3, erosion is pronounced around the system of small checks that has developed on the end grain, as well as along earlywood layers of the wood surface.

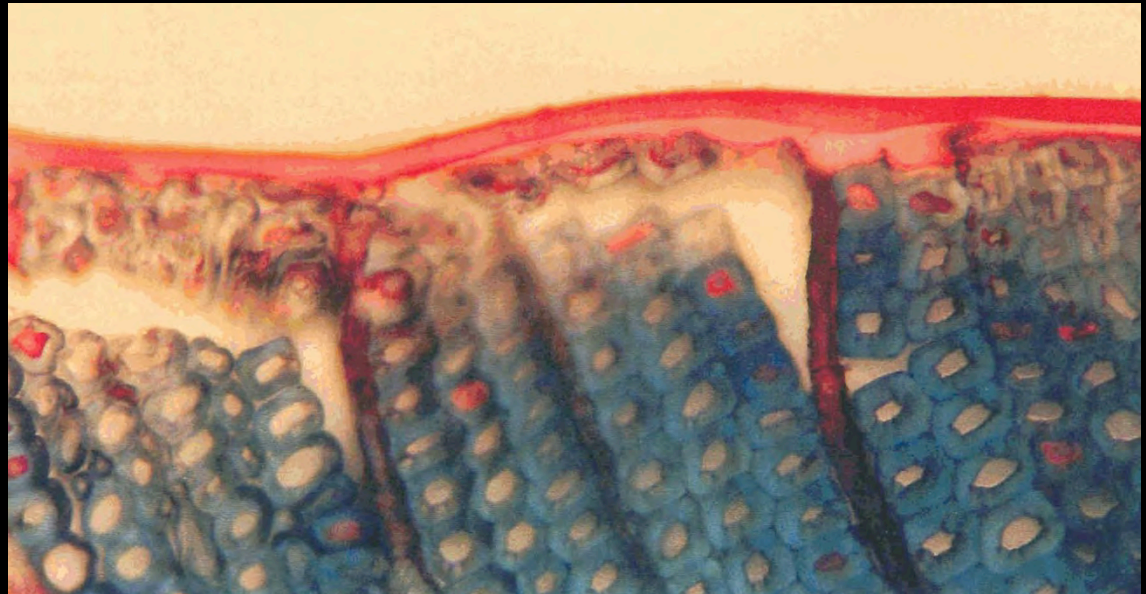
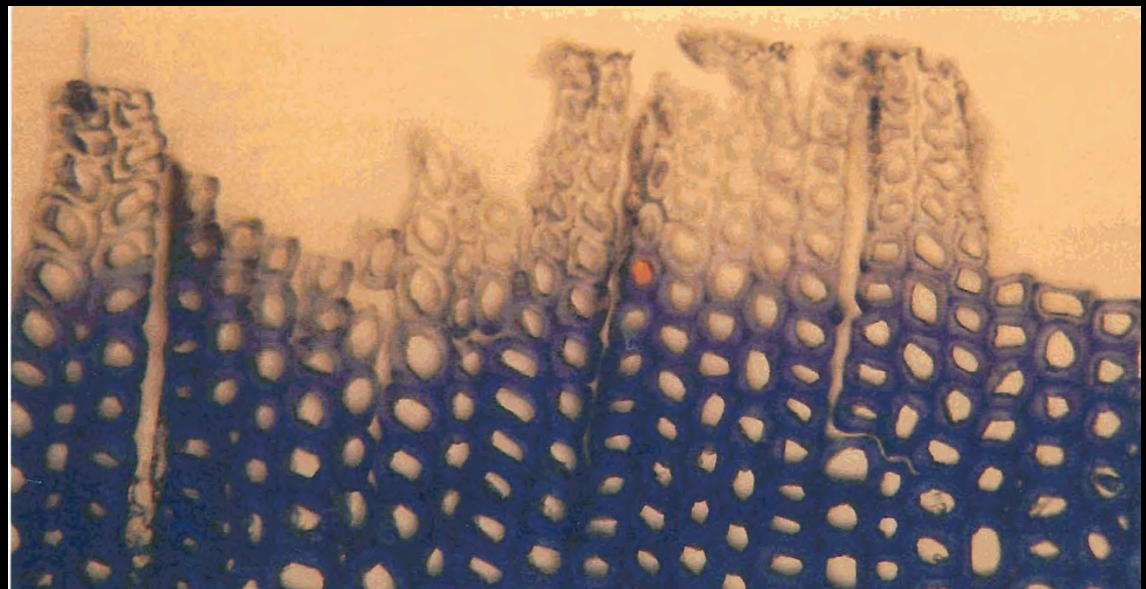
Deterioration of the coating and the substrate occur simultaneously.  
Varnish detachment and loss:

A. The lignin is degraded through the clear coating and the surface begins to disgregate (top)

B. The coating is lost along with many of the deteriorated cells (bottom)

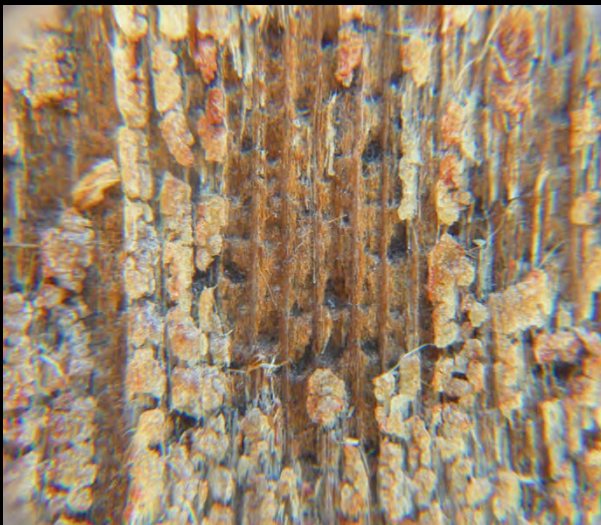
Before varnish removal

Dry cleaning (with a nylon-bristle brush) left a surface relatively free of old varnish, but disgregated as the result of UV exposure.

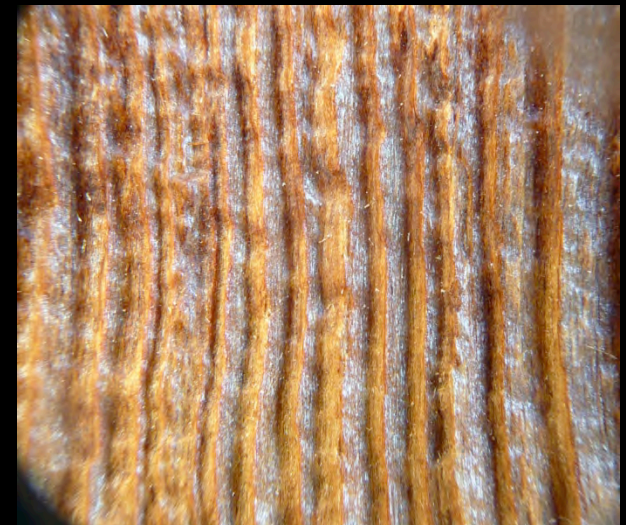
After consolidation

The consolidant treatment resulted in the binding of detaching wood fibers to the surface. Note that the surface displays preferential erosion of earlywood layers.

At Scotty's Castle, where the existing coating(s) had failed completely, application of the consolidant resulted in visible improvement of the surface.

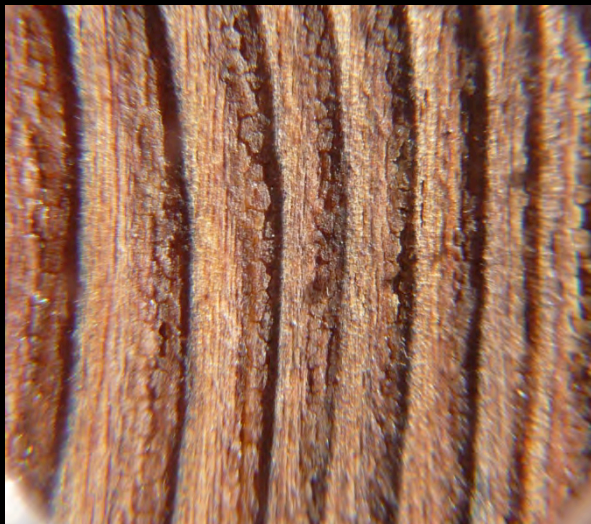
Before consolidation

In the early stages of failure, embrittled coatings develop cracks that admit water to the substrate, promoting dimensional instability associated with changes in moisture content, and subsequent detachment of the coatings.

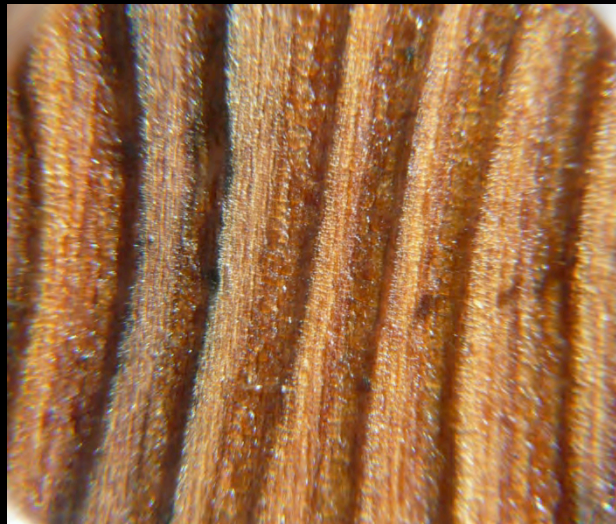
After consolidation

The consolidant fills these cracks, reducing moisture infiltration.

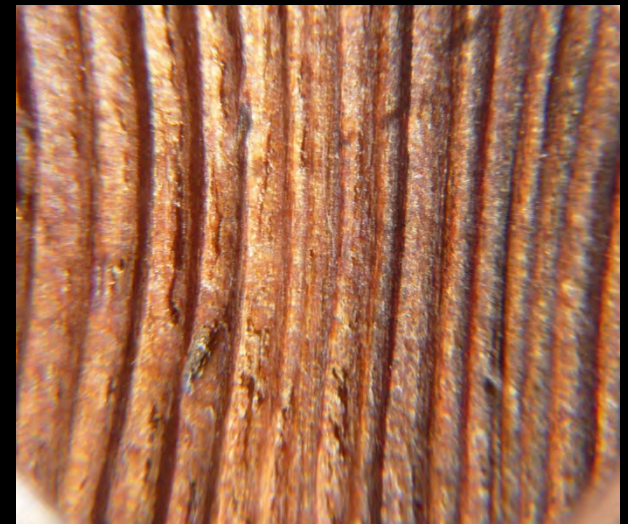
After B-98 removal

The consolidant can be effectively removed without adversely affecting the existing coatings by carefully selecting solvents (for mixing and cleaning) that do not dissolve the original varnish(es).
