HISTORIC STRUCTURE REPORT

DE REMER HOUSE

Delaware Water Gap National Recreation Area

March, 1994

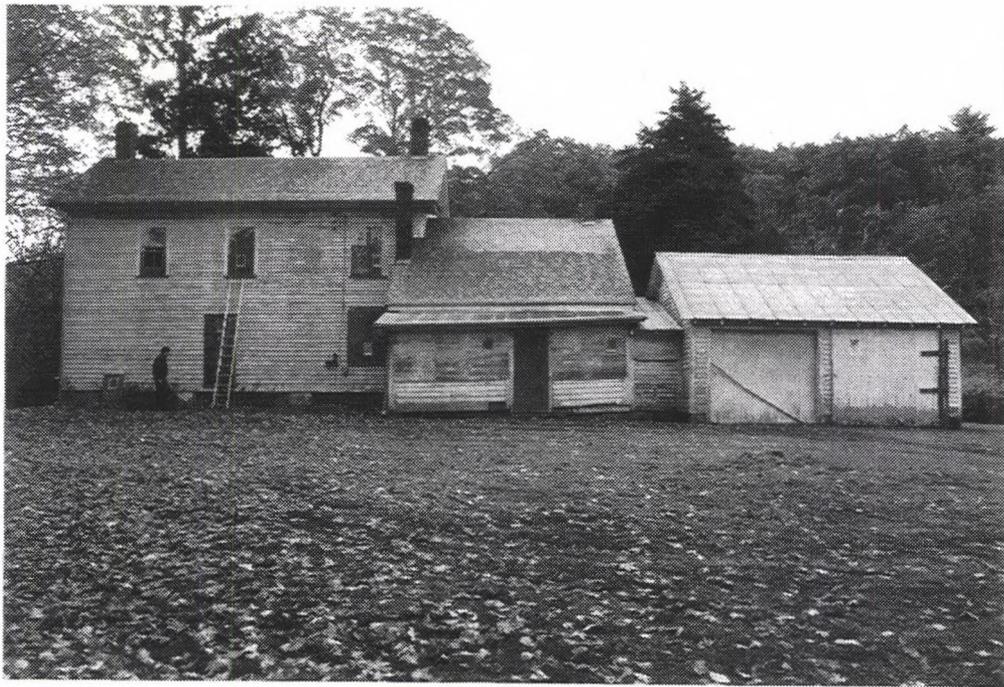
FIG. 3

Condition: Roof sheathing appears to be in good condition. The roof framing on the rear lean-to appears to be twisting (See Figure #3).

West Elevation

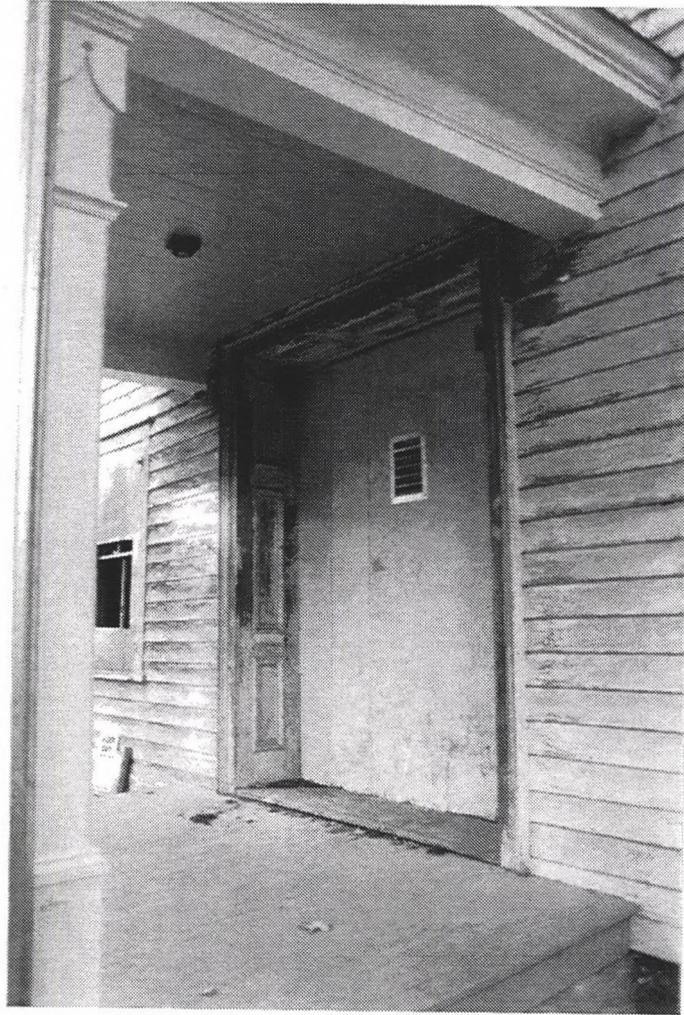
FIG. 5

- Description: * The recessed front door in the main structure is trimmed with an eared architrave. The reveal sides and soffit are each decorated with three panels with molding trim (See Figure #5. On either side of the door are side lights with three (3) lights each. Above the door is a glazed 3-light transom. The kitchen wing entry is trimmed with simple wood trim; the simple wood threshold is several inches above the porch.
- Condition: Paint is failing. All wooden surfaces need scraping and repainting. Glazing putty has deteriorated.

Paneled Trim at Front Door

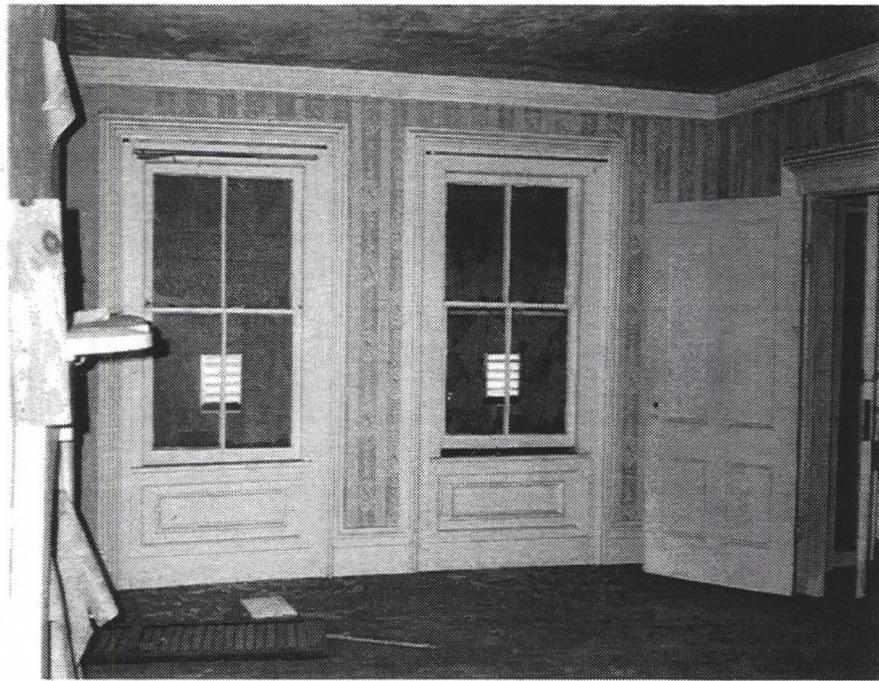
FIG. 8

- Description: The plaster walls are partially wallpapered. (See Figure #8).
- Condition: The walls are approximately 50% wallpapered. The remainder of the walls are painted plaster. The plaster is water damaged and discolored. It is delaminated, spalled and cracked. The wallpaper is discolored, bubbled and peeling at seamed joints.

Room #101; Note Wood Wainscot Panels Below Windows and Additional
Decorative Trim

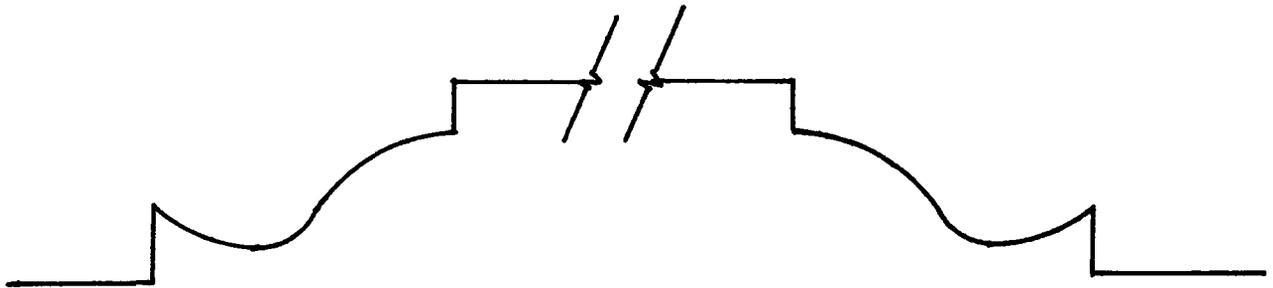
FIG. . 11

- Description: * See panel profile. Painted wood below window sills. The panel measures 12" x 32". (See Figure #11).
- Condition: The wainscot is relatively intact and in good condition. The paint is soiled and cracked in areas. There are minor scratches.

Room #101; Window Panel Profile

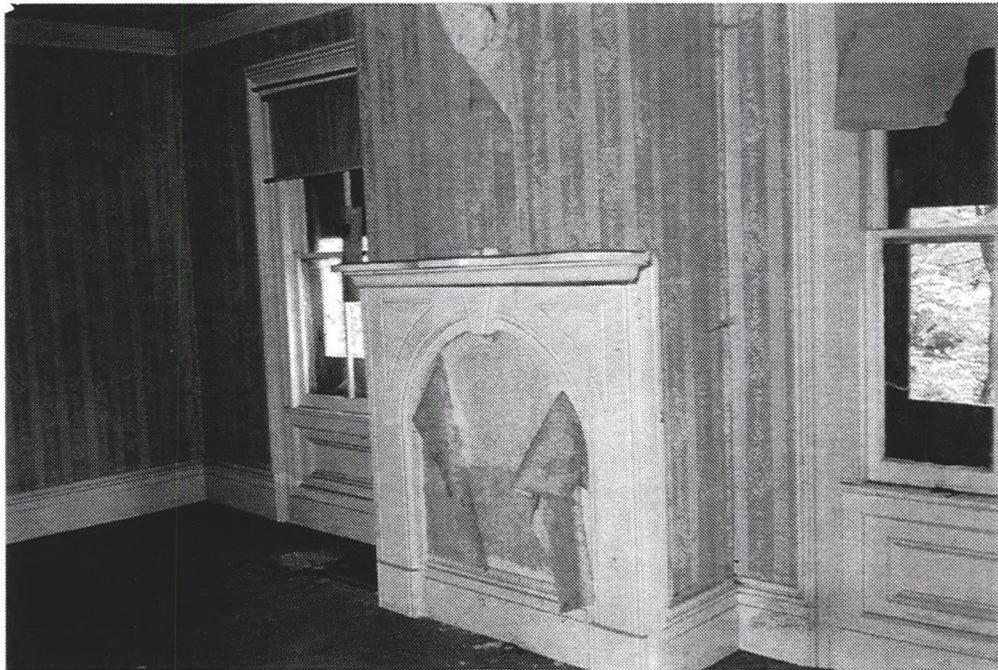
FIG. .12

- Description: * Plastered and wallpapered chimney and fireplace. (See Figure #12). The firebox is enclosed. A wood mantel, surround and baseboard have been applied. A stovepipe was installed and subsequently removed - the plaster patch is evident in the chimney breast. As the baseboard matches the rest of the baseboard in Room #101, it is possible it never was a working fireplace. No evidence of a hearth.
- Condition: As the stove was removed, the flue is no longer used. Wood mantel is in good condition.

Room #101; Fireplace

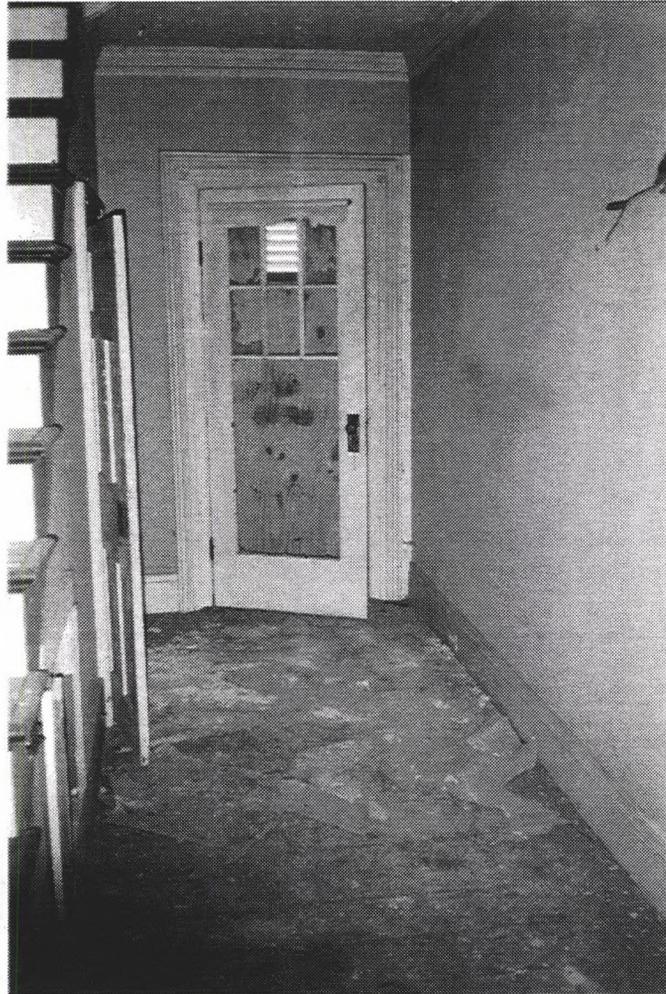
FIG. 14

The rear, west facade, door is missing all of its glass. (See Figure #14). The only extant mullions are the top two rows. The door knob and the hinges are in place.

Room #102; Note Rear Door, Originally a 3/5 Light Configuration

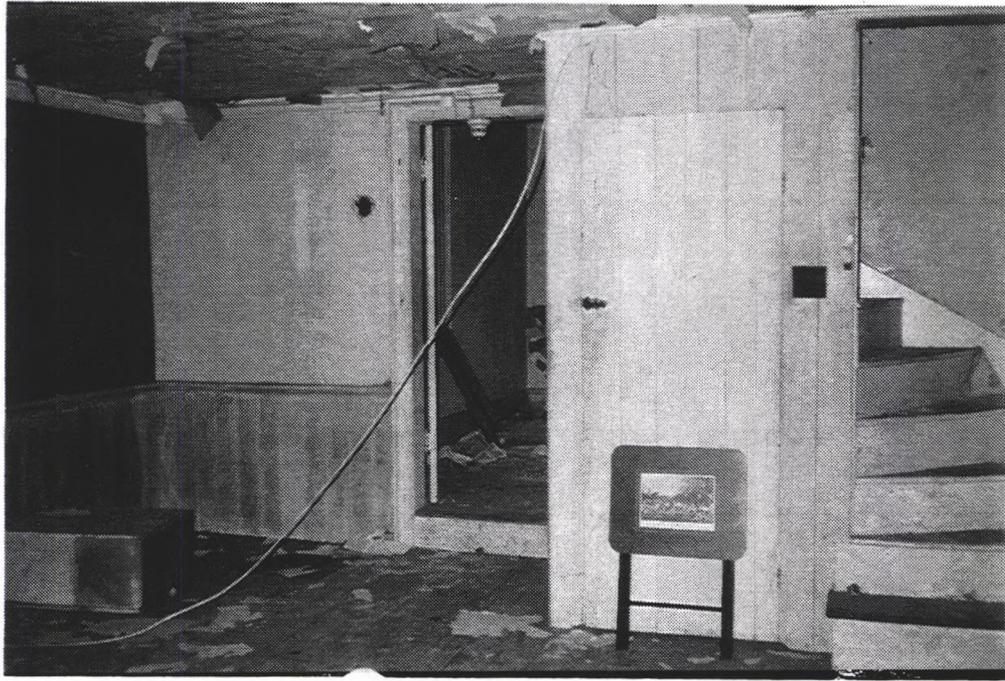
FIG. 17

- Description: The walls are a painted, beaded board wainscot at 33-1/2" high, above the wainscot, the walls are wallpaper over plaster. The wall within the enclosed winding stair is wallpapered. (See Figure #17).
- Condition: The wainscot is weathered and worn. The paint is peeling and alligatored. The wallpaper is stained and peeling at the seams. There are missing pieces of wallpaper and plaster where it appears that wall sconces were attached and subsequently removed. The wallpaper within the enclosed stair is partially loosened from the wall, stained and ripped.

Room #104; Note Wood Wainscot, Winder Stair to 2nd Floor

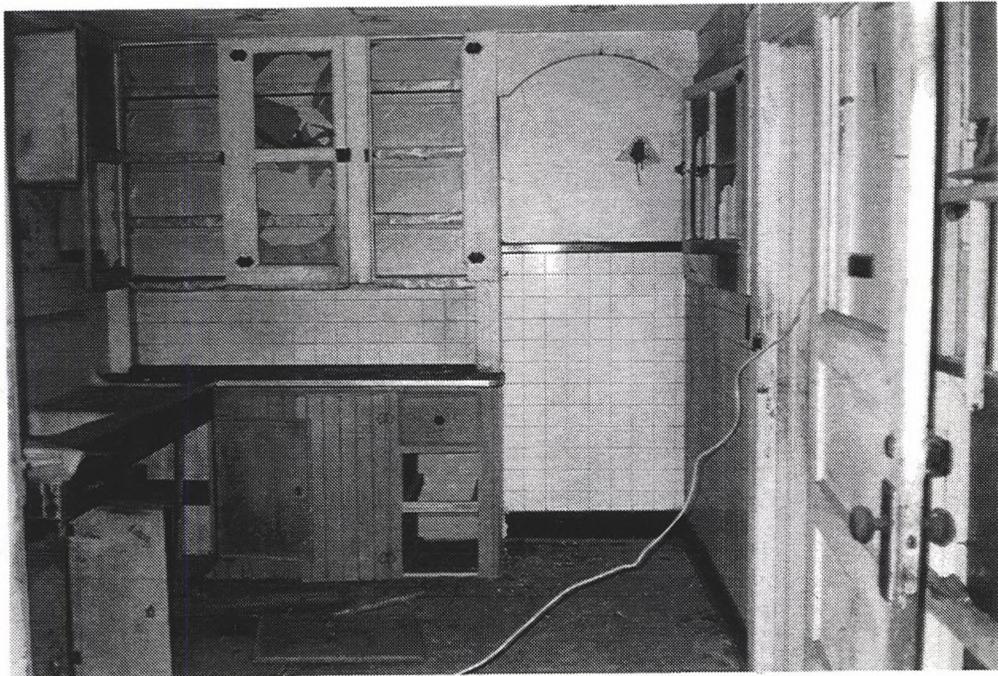
FIG. 19

Description: The walls are covered with a 4'-7" high wainscot, composed of a tile-look composition material. The walls are plaster with several layers of wallpaper visible. The built-in cabinets are wood with stainless steel hardware. The base cabinets cover the original plaster walls and wood baseboard. (See Figures #19 and #20).

Condition: The overall wall condition is poor. The wainscot "tile" is chipped, stained, cut and gouged. The upper walls are losing their wallpaper layers. The north wall has a hole,

Room #105; Note Original Wood Baseboard Visible Inside Base Cabinets

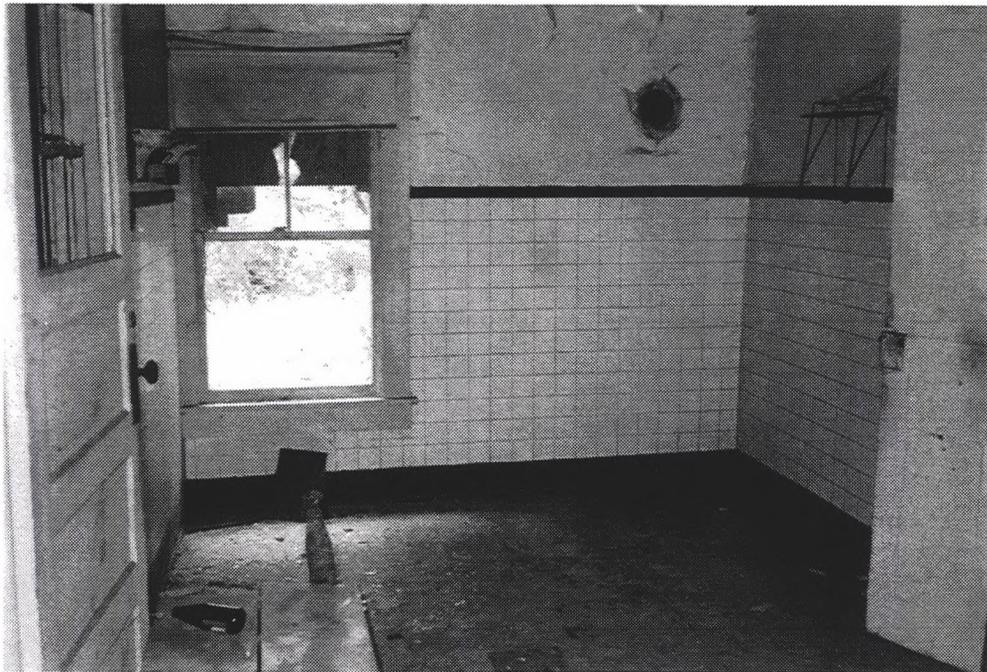
FIG. 20

Room #105; Note "Tile" Composition Board with Black Cap and Hole in Wall
from Stove Pipe

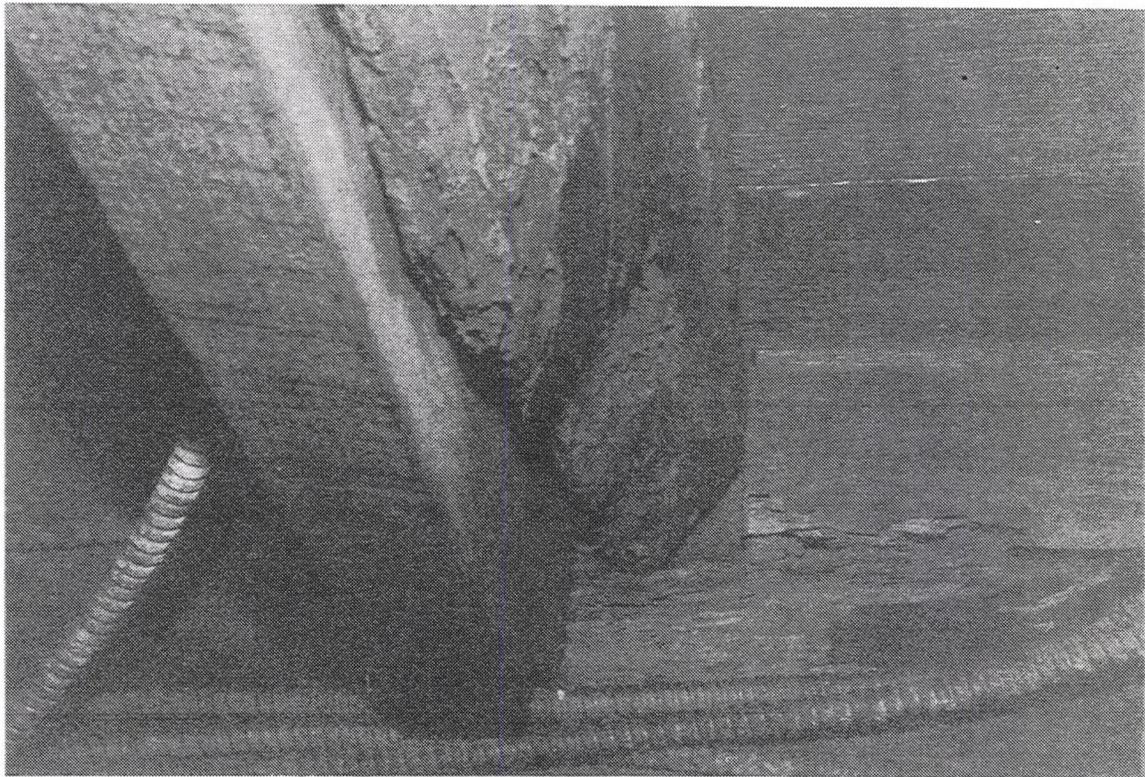
FIG. 34

Typical Damaged Floor Joists Under Rooms #101, #102 and #103

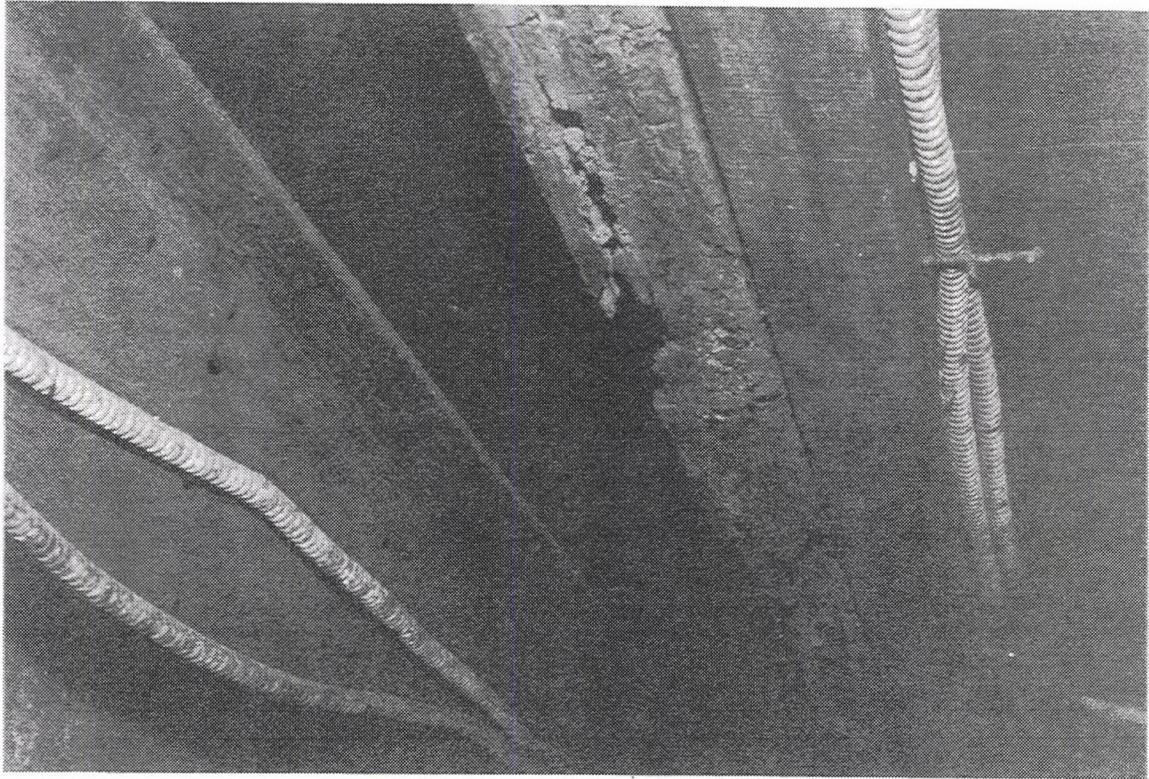
FIG. 35

Basement, Damaged Joists Reinforced with New

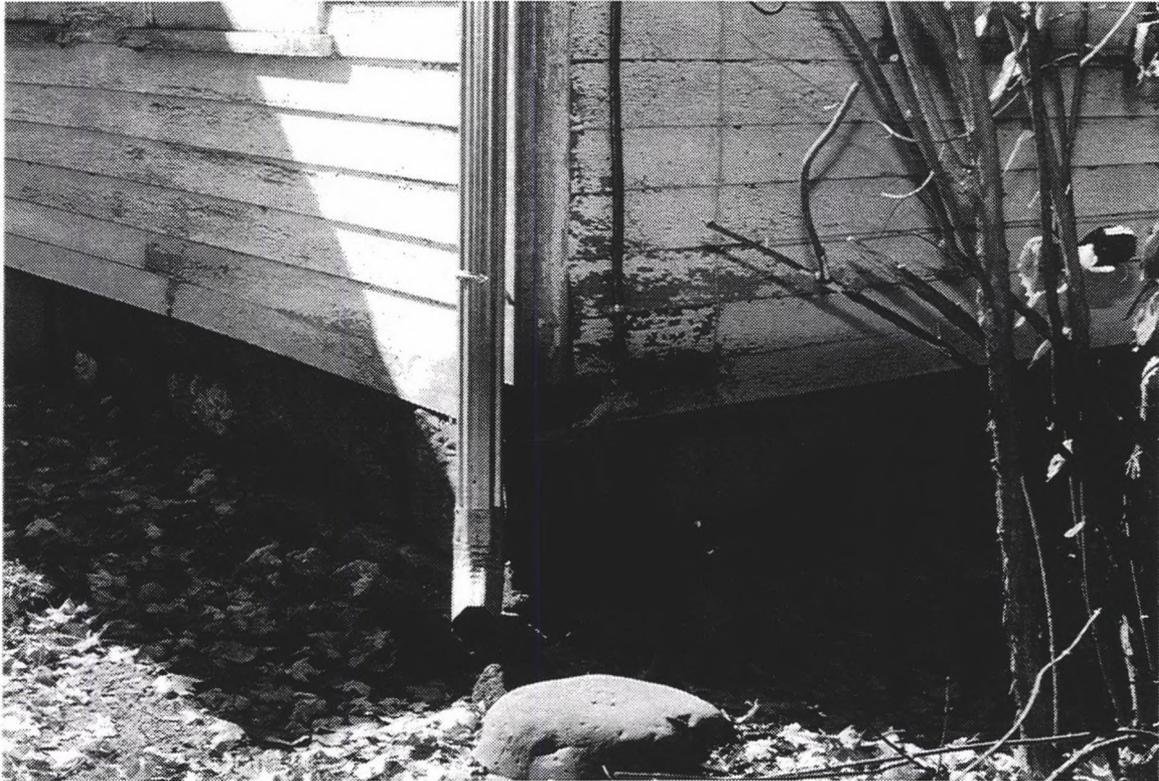
A Possible Source of Water Infiltration into Basement
