HISTORIC STRUCTURE REPORT

THE ROBERTS FARMHOUSE

Delaware Water Gap National Recreation Area

March, 1994

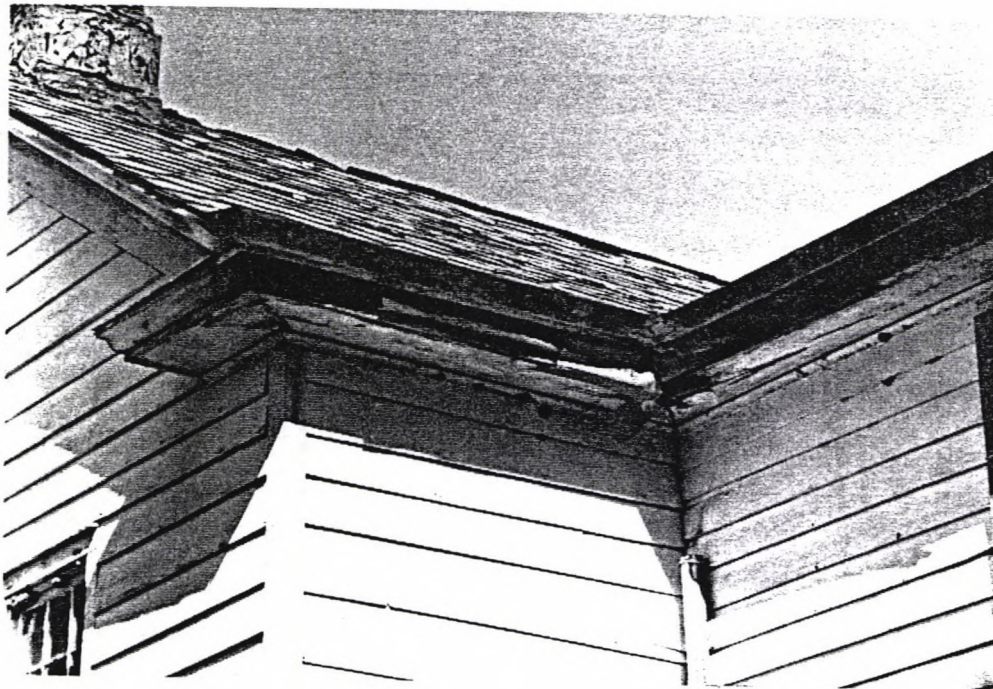
FIG. 14

Condition: Painted finish is in very poor condition. Lack of maintenance has contributed to deterioration of wooden soffits (See Figure #14). Insensitive repairs have been made. Leaders are broken, disconnected or missing. Wasp nests are attached to soffits.

Deteriorated Wood Cornice, Southwest Corner.

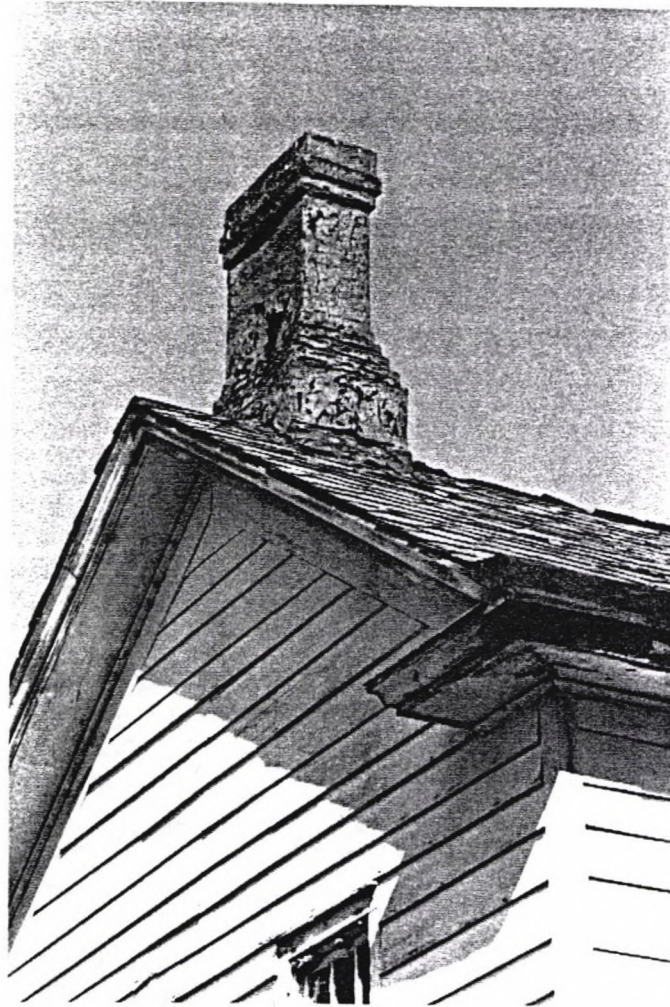
FIG. 15

Condition: The chimney on the stone kitchen was repointed and reflashed in 1993. The other chimneys are in poor condition. Mortar joints are washed out, brick is spalling. The west chimney in Section B is coated with a waterproofing coating which is peeling (See Figure #15).

Chimney, West Gable, Section B.

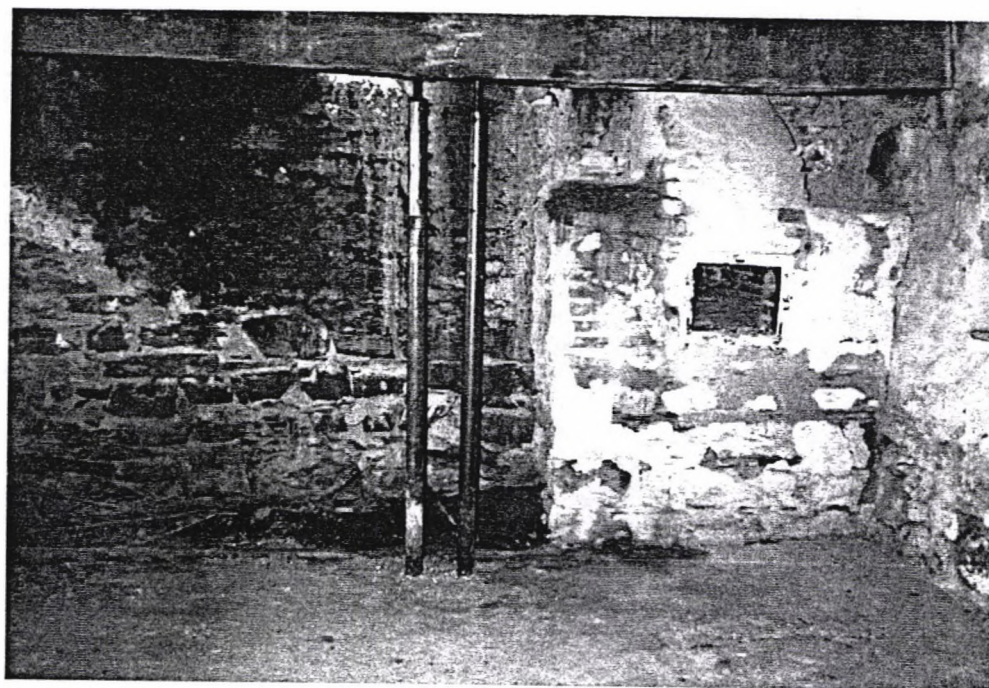
FIG. 18

Room #101; Stone Kitchen, View Towards Fireplace and Beehive Oven
Note Shoring Jacks Supporting Lintel.

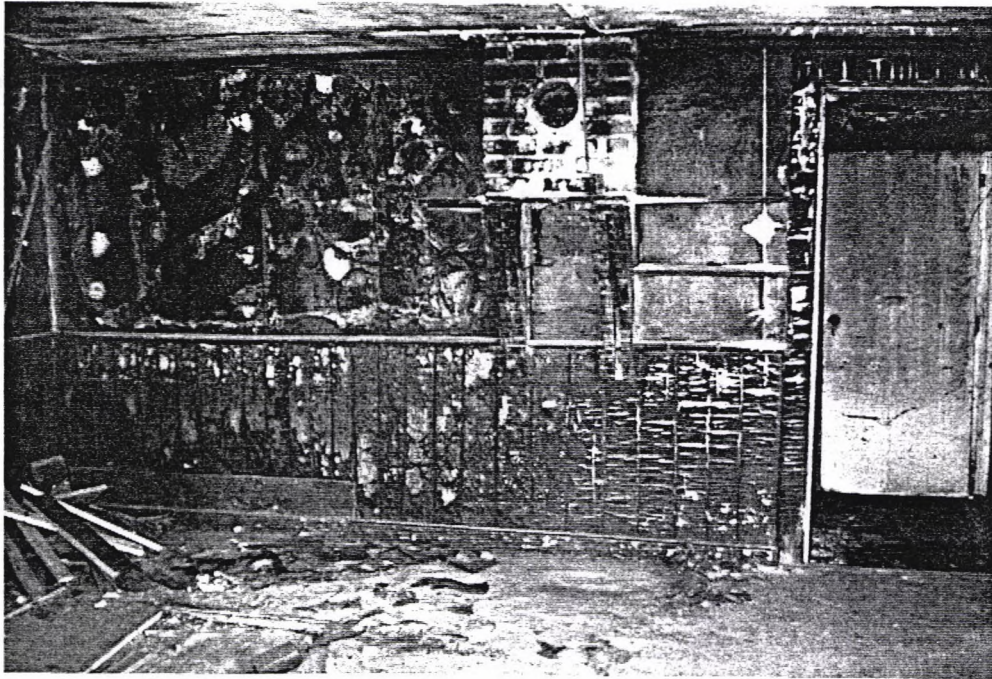
FIG. 21

Condition: Poor, due to fire and smoke damage. (See Figure #21).

Room #102; West Wall. Note Fire Damage and Brick Flue Opening.

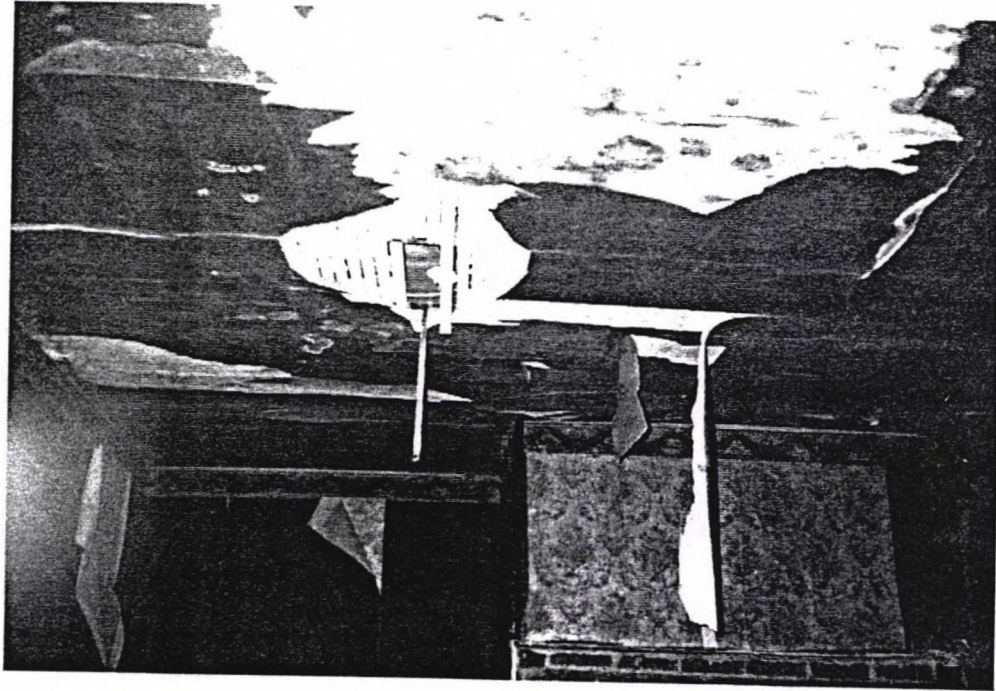
FIG. 23

Condition: Poor, due to fire water and water damage. Amount of damage to plaster cannot be determined without removing wallpaper. In several spots plaster has completely released. (See Figure #23).

Room #103; Ceiling .

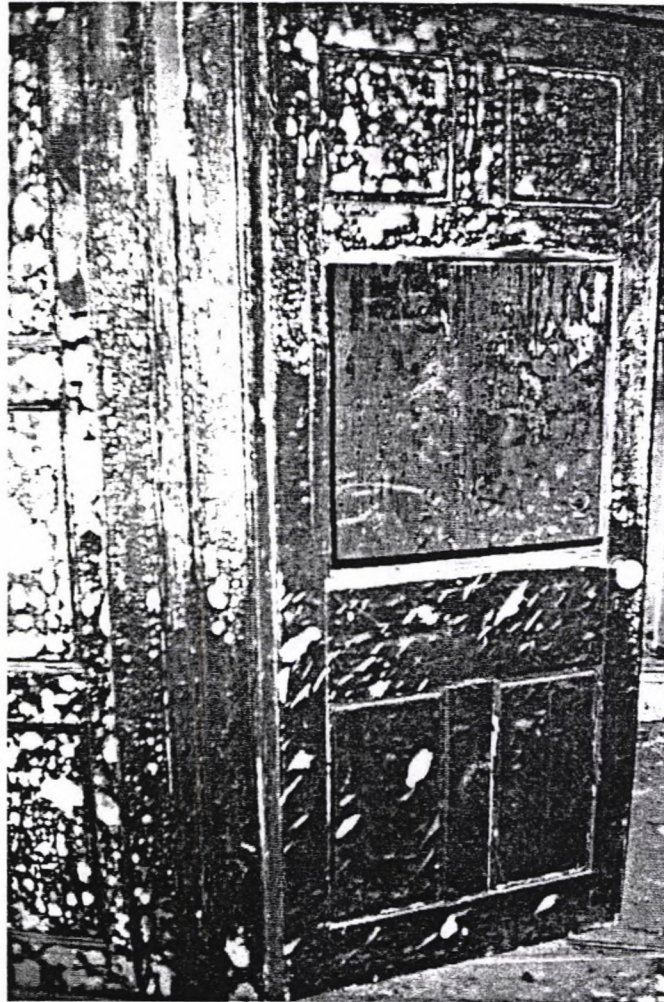
FIG. 27

Condition: Door badly charred from fire. Center style and panels missing. Finish is badly damaged. (See Figure #27).

Room #104 (Hall); Door to Room #102.

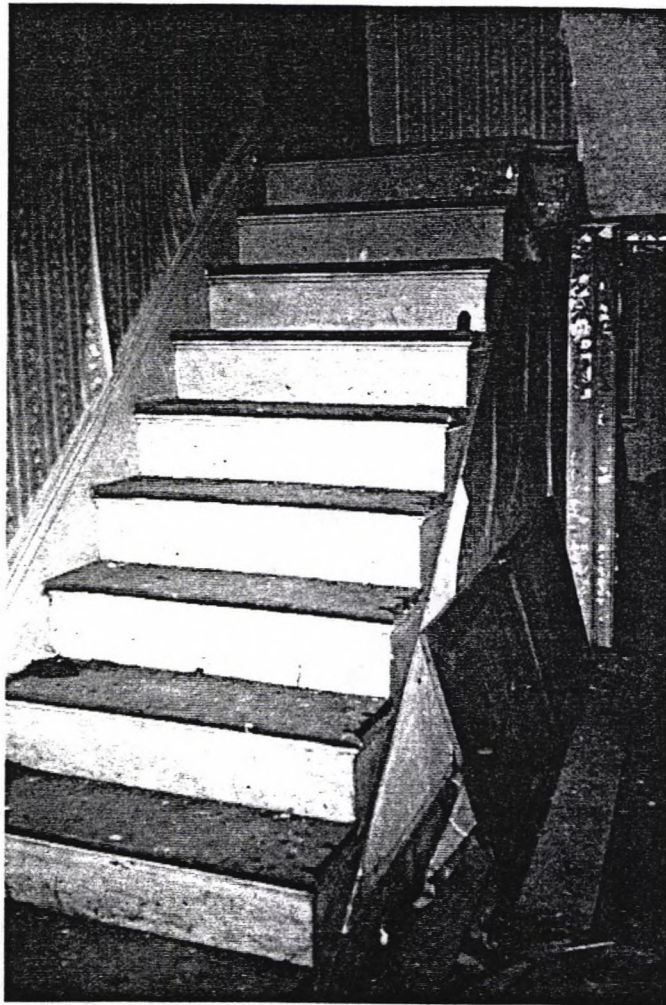
FIG. 30

Condition: Railing, balusters and newel posts are missing. Stair tread and riser finishes are soiled and deteriorated.

Room #104 (Hall); Stair to Second Floor.

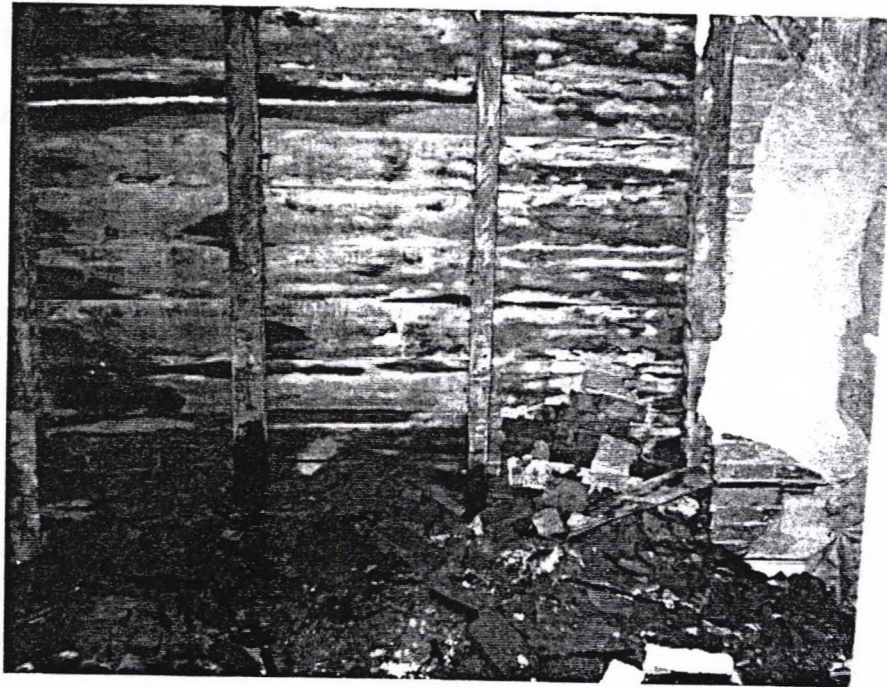
FIG. 33

Room #108; North Wall. Note Nogging Fallen Out of Wall.

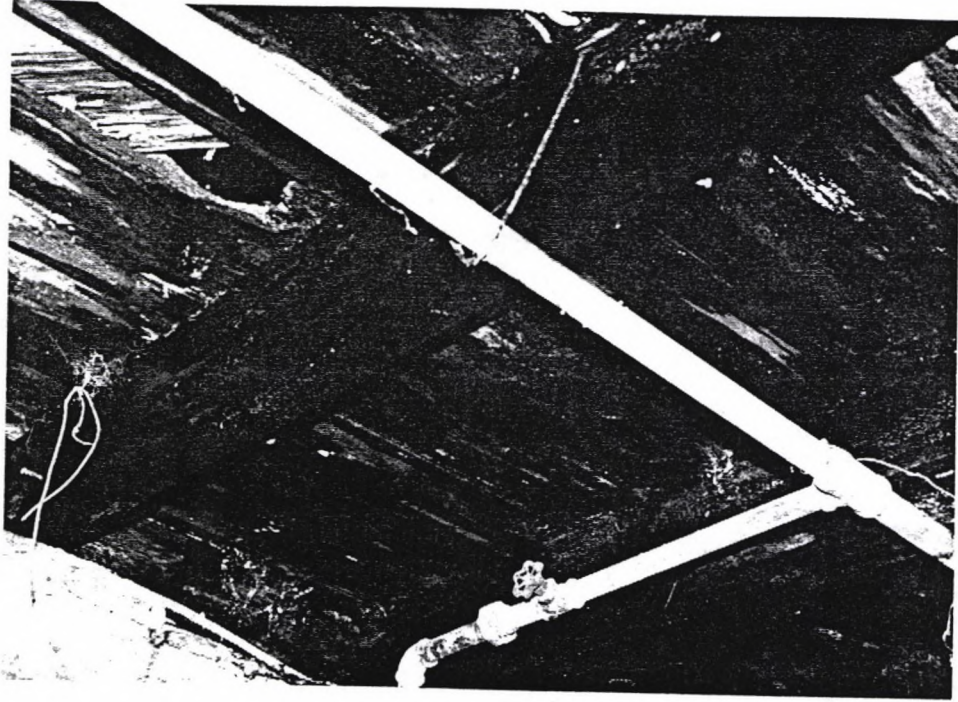
FIG. 44

Damaged Floorboards and Joists under Rooms #107 and #108.

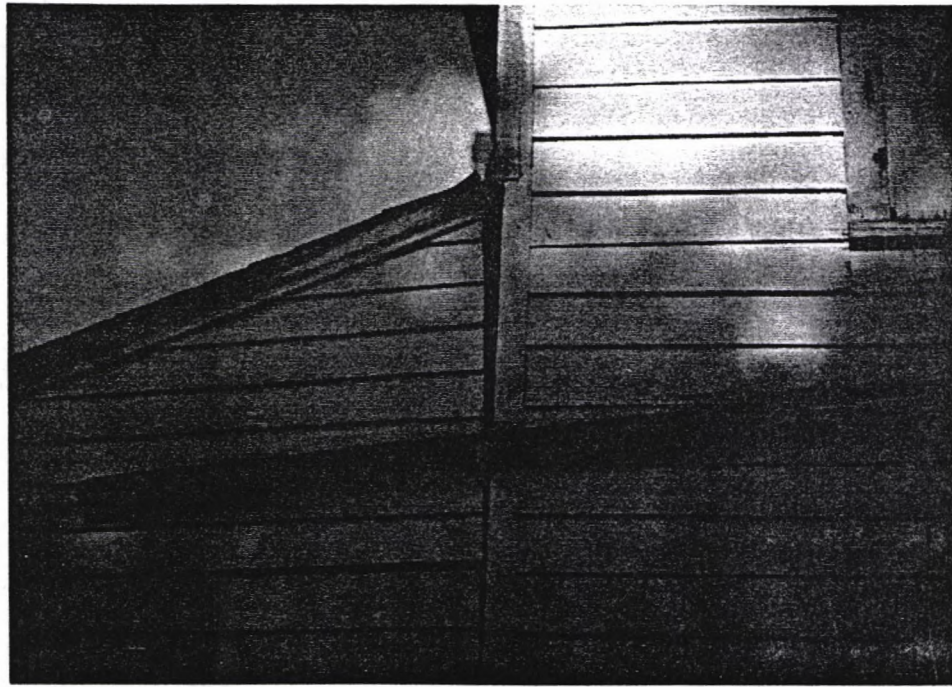
FIG. 46

Room #109; Framing Pulling Away From Main Structure.

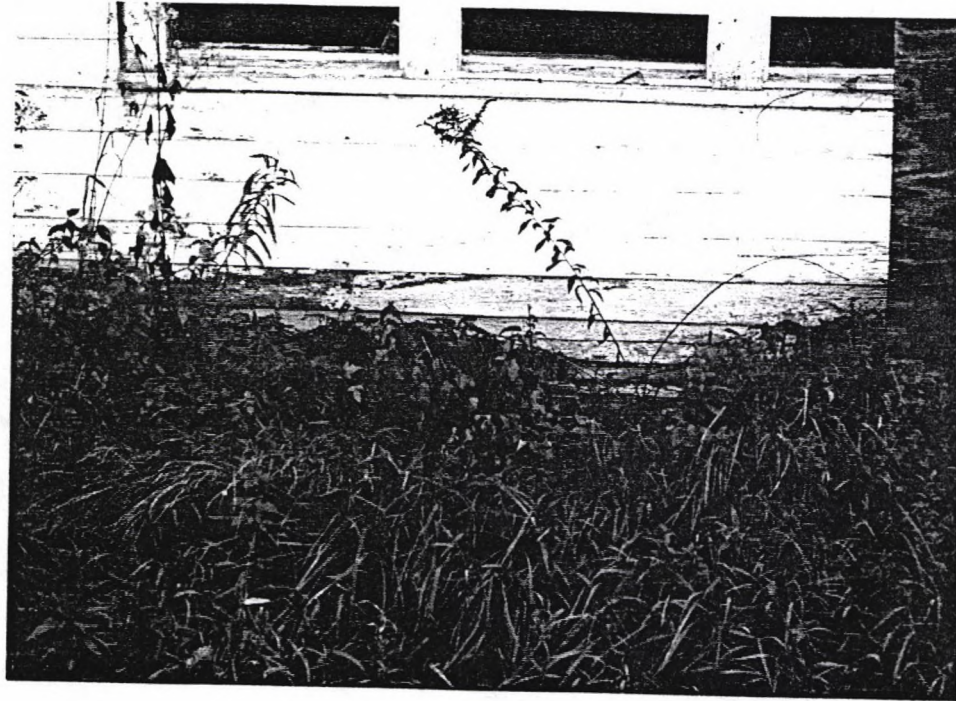
FIG. 48

North Wall, Exterior of Room #102, Exterior Grade too Close to Finish Floor.

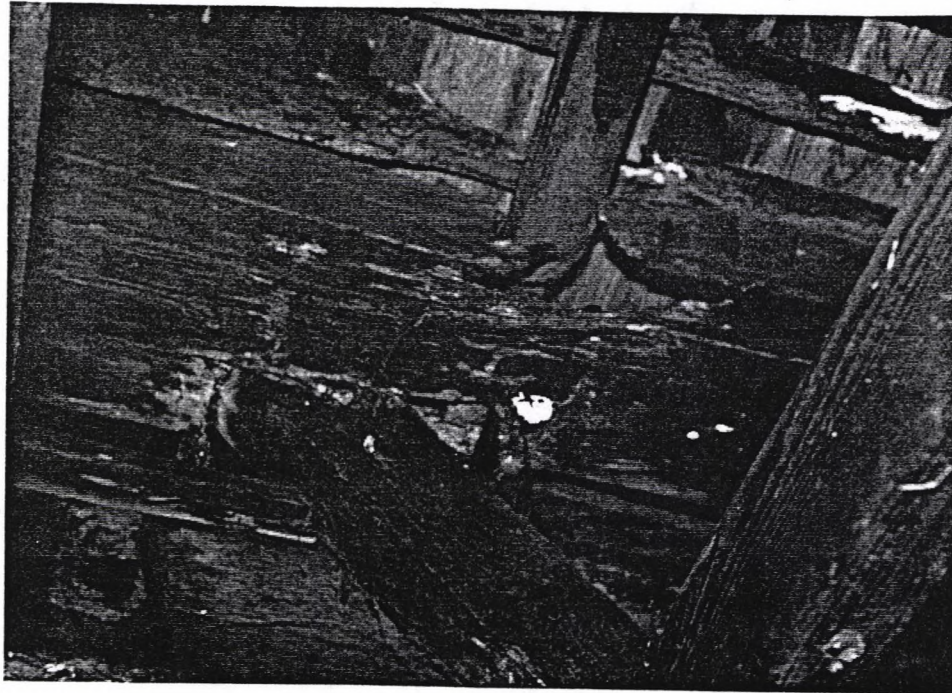
FIG. 50

Room #106; Water Infiltration Through Roof.

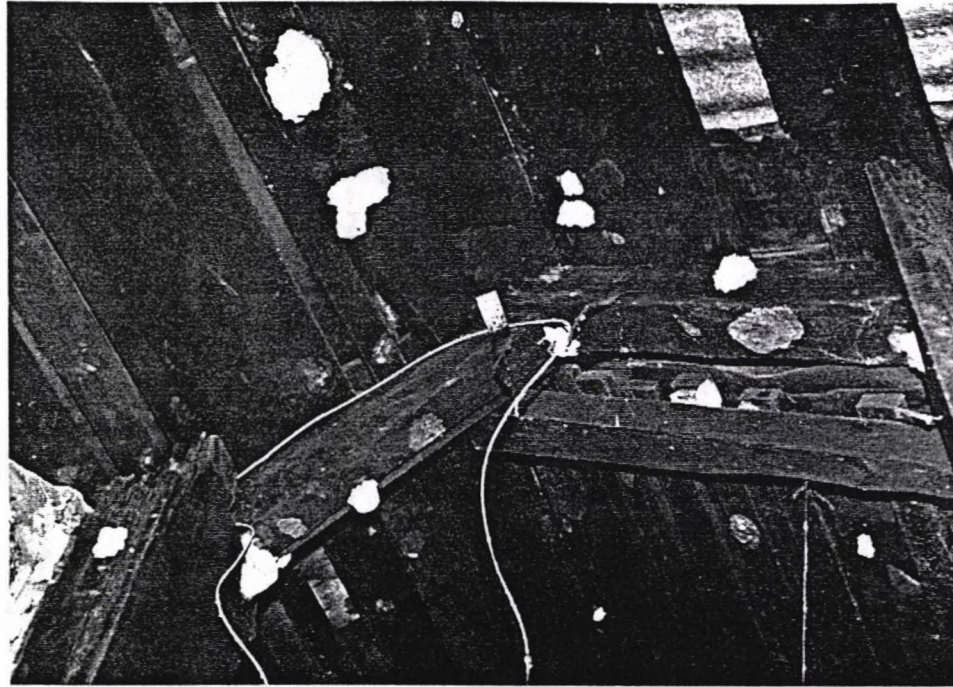
FIG. 51

Room #106; Water Infiltration Through Roof has Caused Damaged
Roof Framing.

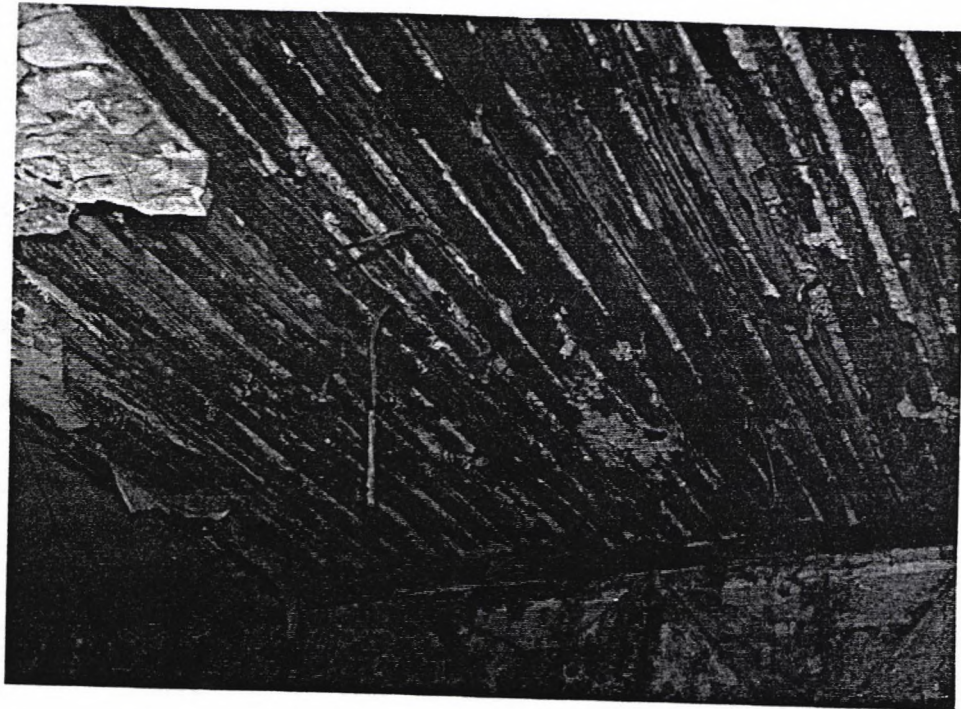
FIG. 52

Room #202; Damaged Plaster Ceiling.

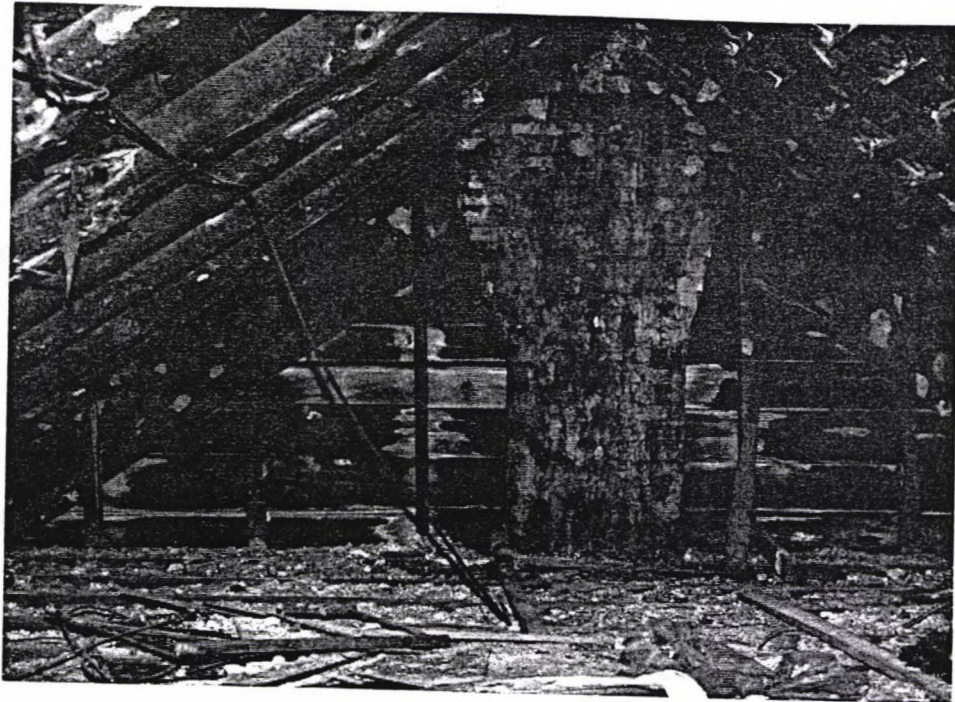
FIG. 55

Attic, View Toward West Wall. Note Staining on Chimney.
