HISTORIC STRUCTURE REPORT

**THE
RUNDLE FARMHOUSE**

**Walpack Township,
Sussex County, New Jersey**

1994

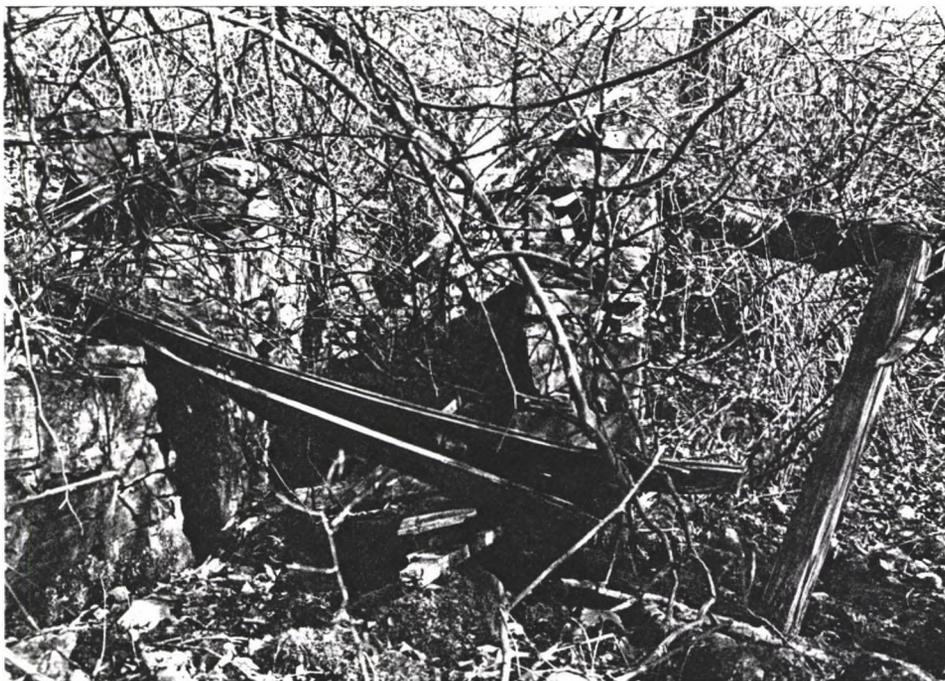
Once the cornerstone of a large working farm, the house was originally supported by numerous outbuildings, including a barn, a carriage house, a frame tenant house, a stone spring house, an ice house, corn cribs and sheds. (Refer to the historic photographs in Appendix C.) After the property was sold to the Federal government, the barn and carriage house were burned by arsonists.¹⁴ The sole remaining out-buildings are a dilapidated, three-bay frame shed which is located to the southeast of the house, and the spring house. Little remains of this small stone structure, constructed on the stream to the northwest of the house; much of the roof framing has been destroyed by falling branches, and as a result, the unprotected walls have begun to tumble (*Photo 1*).

Photo 1. Remains of stone spring house.

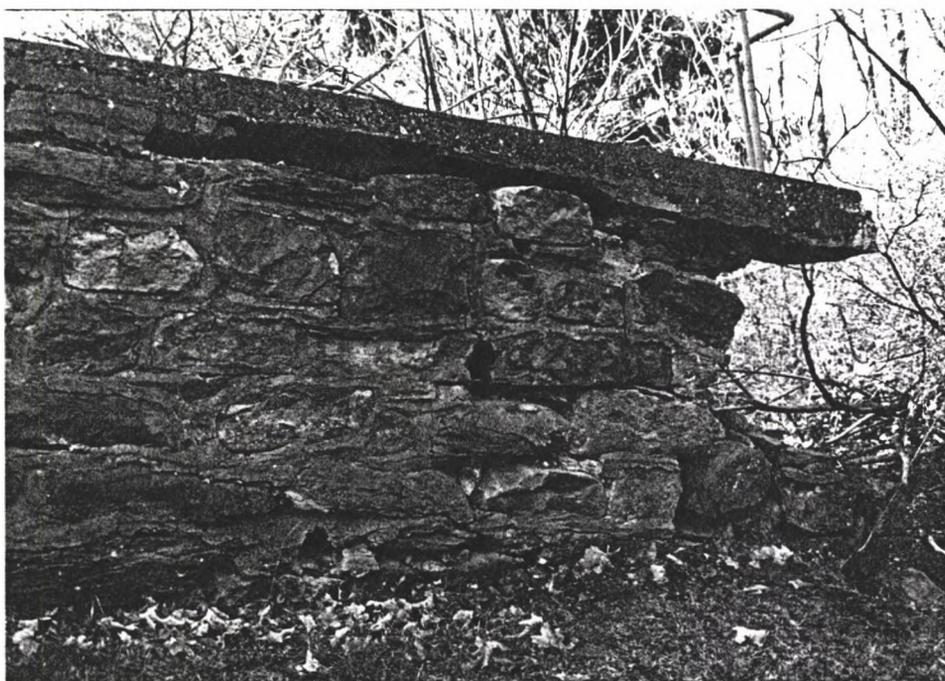
Photo 2. Concrete-capped stone retaining wall near stream.

At the northwest corner of the house is a fieldstone retaining wall which has been capped with a layer of concrete and edged with pipe railings. Due to the settlement of the ground at the west end, near the creek bed, the stonework has collapsed and the concrete has buckled, creating a hazardous situation (*Photo 2*). A second concrete slab covers the ground at the rear of the house. The poor condition of this pad contributes to the on-going deterioration of the structure, as the broken pieces of concrete are positioned in such a way as to channel water toward the house, rather than away from it. An additional concrete slab is located to the northeast, which was used when slaughtering pigs.

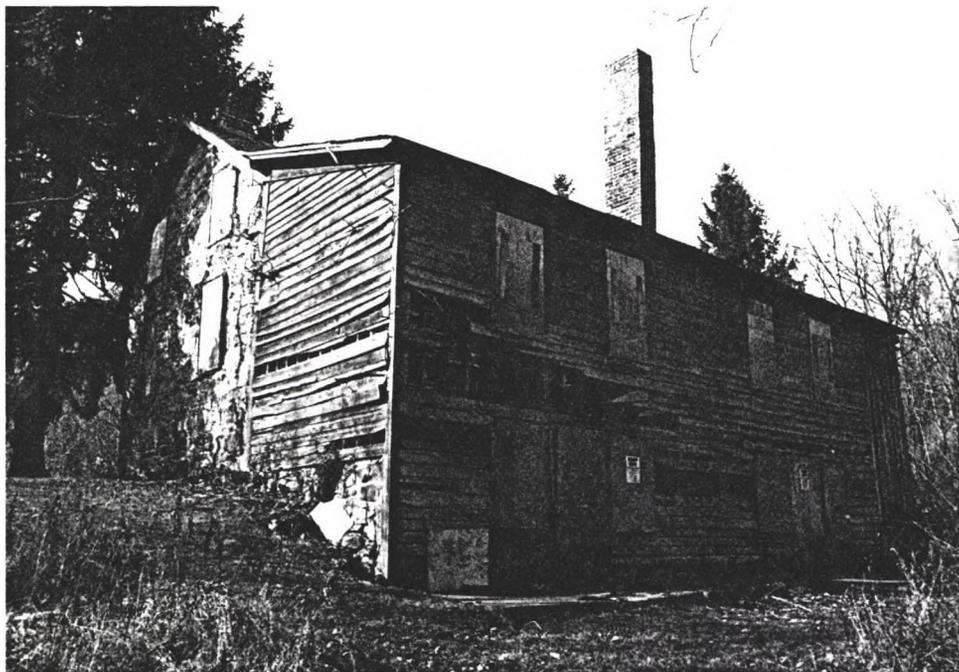
The stone foundation for the frame extension is visible on the east elevation, where it is exposed as much as 4'-8" due to the bank construction. The masonry is in good repair. On the north and west elevations the foundation is below grade, and not visible. However, the sills, which sit directly at ground level, are extremely deteriorated.

Photo 5. View of frame addition from northeast.

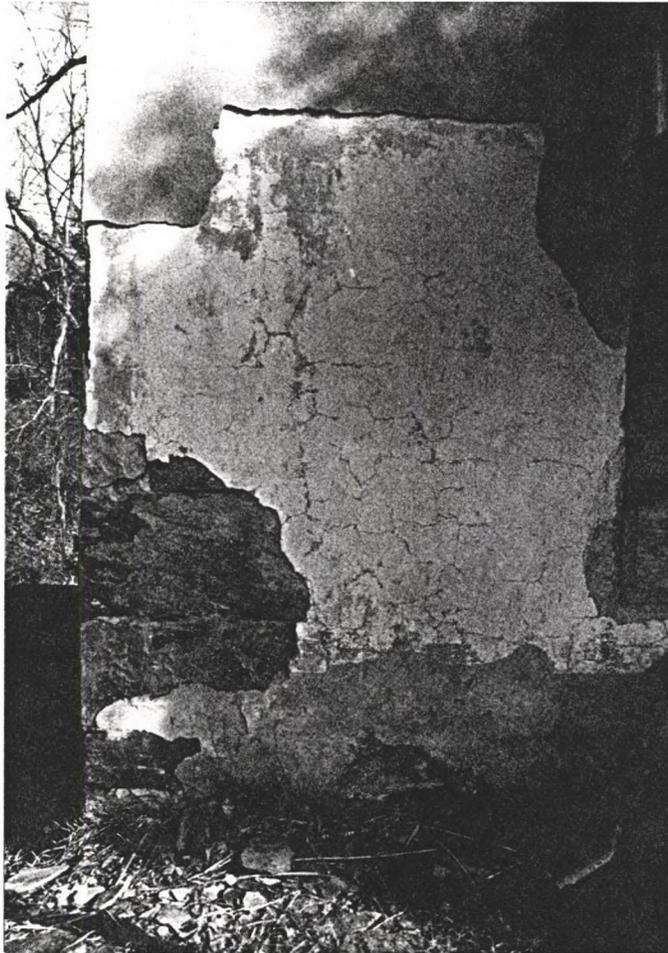
Used throughout is a dense, whitish mortar, high in lime content, which is finished in a fish-tail point. Due to its strength, the mortar is in good repair throughout most of the building, although spot-repointing with Portland cement has occurred. Covering the facade is a layer of light-colored, lime stucco, as thick as 2" in places, which is topped with numerous coats of whitewash. The aggregate in this stucco contains a distinctive mixture of stones, many of a rosey-purple hue, which matches that of the mortar. Over the early stucco is a layer of hard, brown, Portland cement which was applied in the middle of this century by Harry Utter. These finishes have spalled in areas where the walls are unprotected by the porch and hair-line cracks occur throughout the intact material (*Photo 7*).

*Photo 7.
Stonework of front
elevation, original
white-washed stucco
and 20th Century
Portland Cement
stucco.*

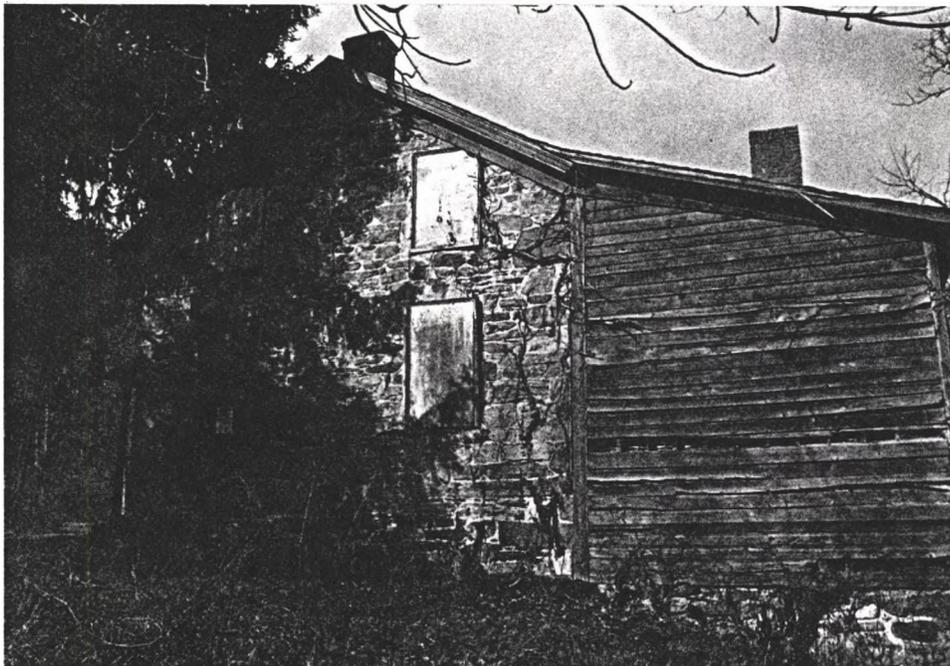
The walls of the rear extension are finished with beveled siding, with exposures varying from $4\frac{3}{4}$ " to $6\frac{1}{2}$ ". The uppermost, reciprocally-sawn boards are secured with cut nails; those closer to the ground are secured with wire nails, indicating that earlier material has been replaced. At the west end of the rear addition, enclosing the north side of the small porch, are vertical boards, extending from the top of the stone foundation to the eaves. Much of the siding at the rear of the house has rotted or is missing entirely, leaving the interior lath exposed. On the east elevation vines have grown around the boards into the interior of the house (*Photo 8*). The material on the west side of the house is in slightly better condition, as the siding is protected by the broad overhang of the porch.

*Photo 8.
East elevation showing
damaged siding of
frame addition.*

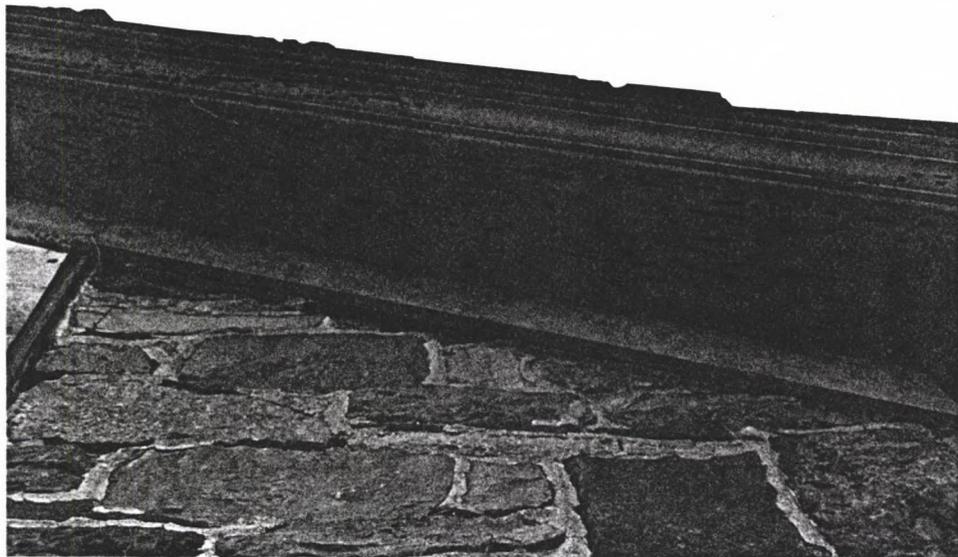
This original section of the roof has a simple, well-proportioned crown moulding at the eaves line and along the rake. The wide raking cornice has suffered severe damage by carpenter bees (*Photo 10*). A complete inspection of this area should be conducted in order to evaluate the full extent of the damage, and to determine the appropriate method of repair. The fascia board at the front elevation appears to remain in good condition.

Photo 10. Insect damage in raking cornice on west elevation.

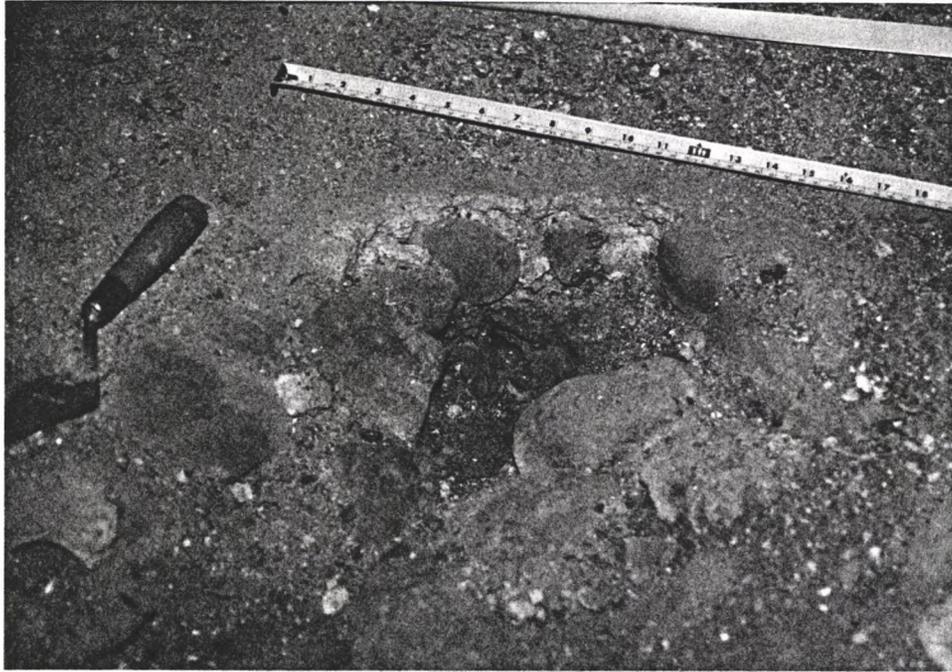
Wood planking originally existed in Room B-1, although this material has since been removed, leaving only the exposed earth. Rounded, fist-sized stones, embedded in a clay base, constitute a portion of the floor in Room B-2 at the eastern side of the basement (*Photo 12*). (Refer to Appendix H for archaeological report of this floor.) Their purpose is unknown, although in other areas this technique has been used for flooring in root cellars, which may also have been the case at the Rundle House. These cobblestones are unusual and must remain intact.

Photo 12. Cobblestone flooring in east side of basement.

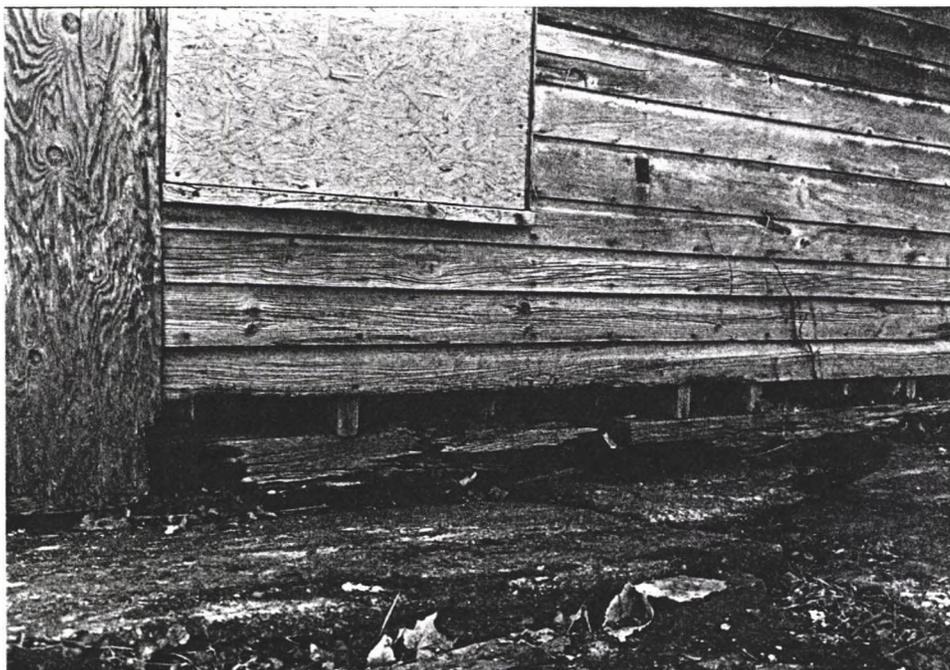
Photo 24. Rotted framing members at north elevation.

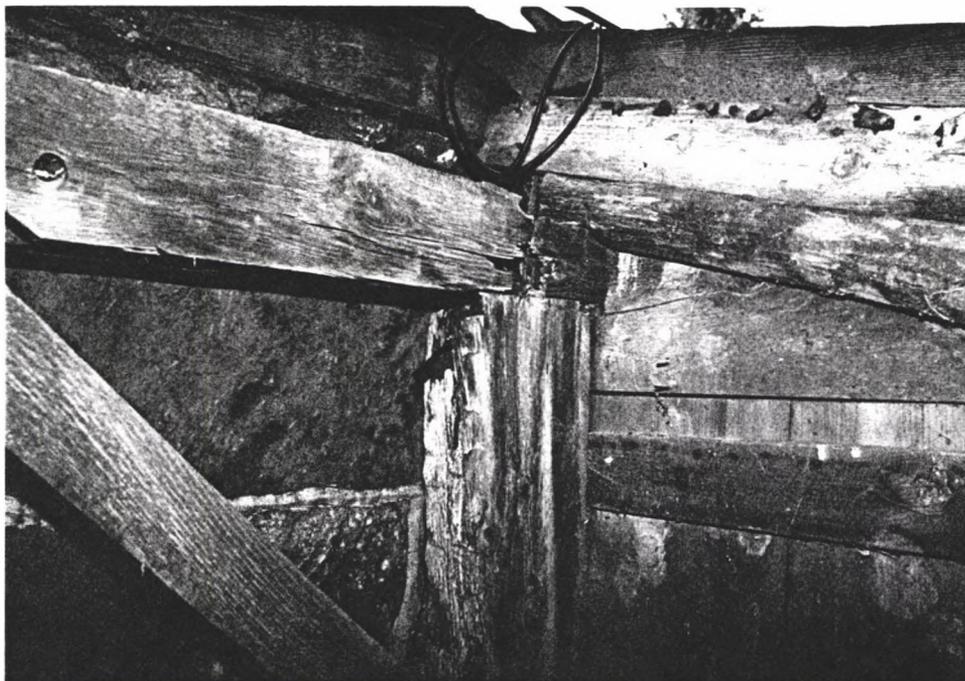
During a recent reroofing of this area, it was found that the initial rafters, two of which remain, were also unmilled saplings which had been located under the eaves of the original structure. However, during the late 1960's, most of these members were replaced with new, 2" x 6" rafters, located under the first layer of slates. As the roll roofing was not continued under the third course of slates, substantial water infiltration occurred over the years, which accounts in part for the extreme damage now in evidence (*Photo 25*).

Photo 25. Roof rafters in frame addition. National Park Service photo taken during recent re-roofing.

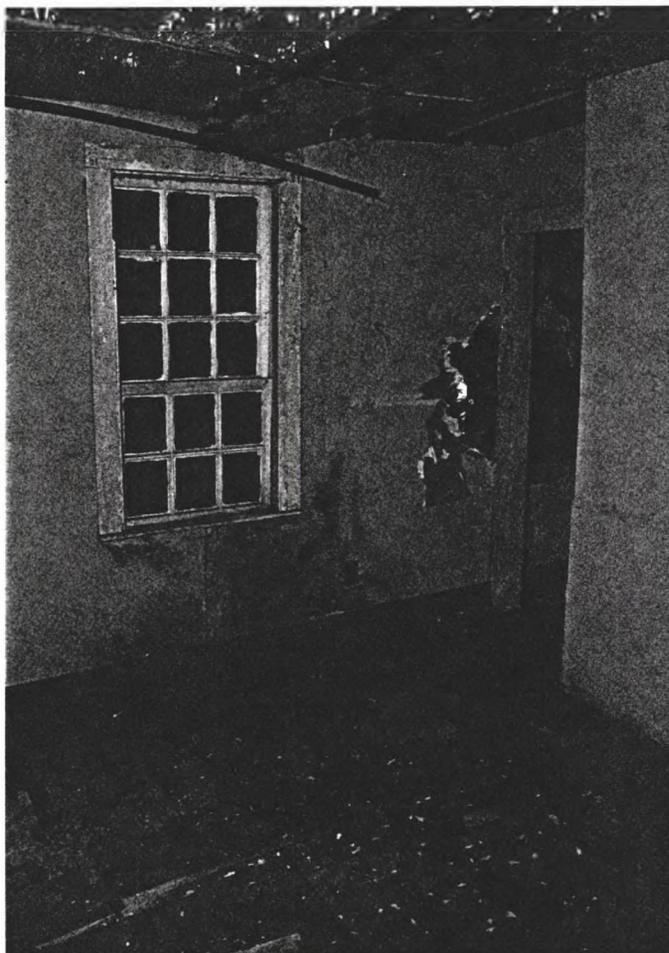
Due in part to a leaking roof, and in part to poor grading and the broken concrete slab which channels water toward the building, the frame addition at the rear of the Rundle House has become extremely dilapidated. It is safe to say that the addition must be rebuilt in its entirety, or, possibly demolished; the posts, sills, studs, floor joists and door and window frames, particularly those at ground level, are all severely damaged. Although a small percentage of the original material may be salvageable, the structural members have been subjected to prolonged water infiltration, and most are spongy and rotted beyond repair. As it currently stands, the addition is a serious hazard, and must either be removed or reconstructed (*Photos 26 and 27*).

Photo 26. Rotting floors and damaged surface materials in Room 1-5 of frame addition.

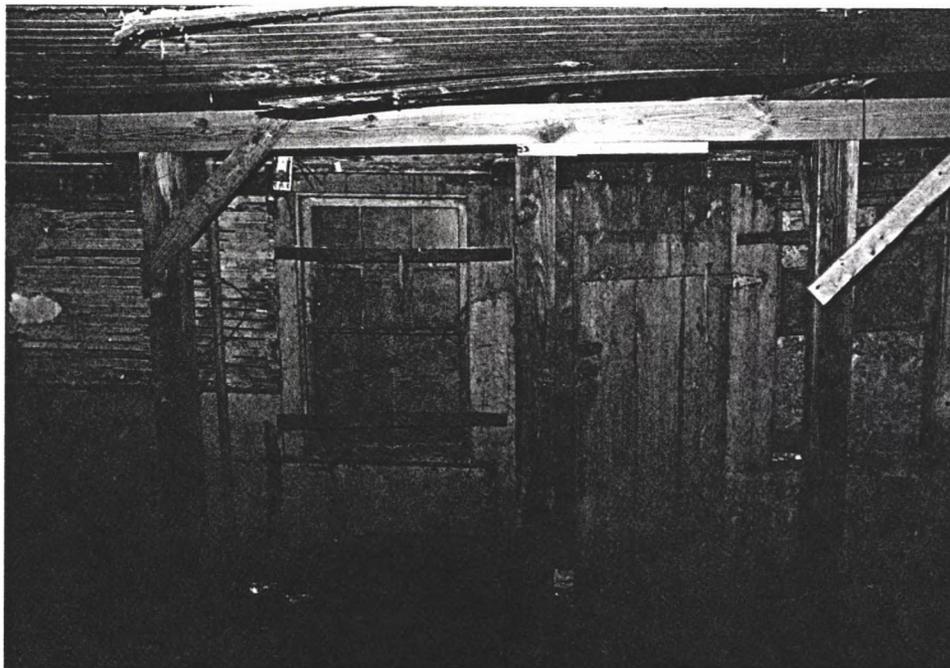
Photo 27. Deteriorated conditions at ground level of frame addition.
