Conserving Fort Jefferson's Harbor Light

Garden Key Lighthouse History

Preservation Issues

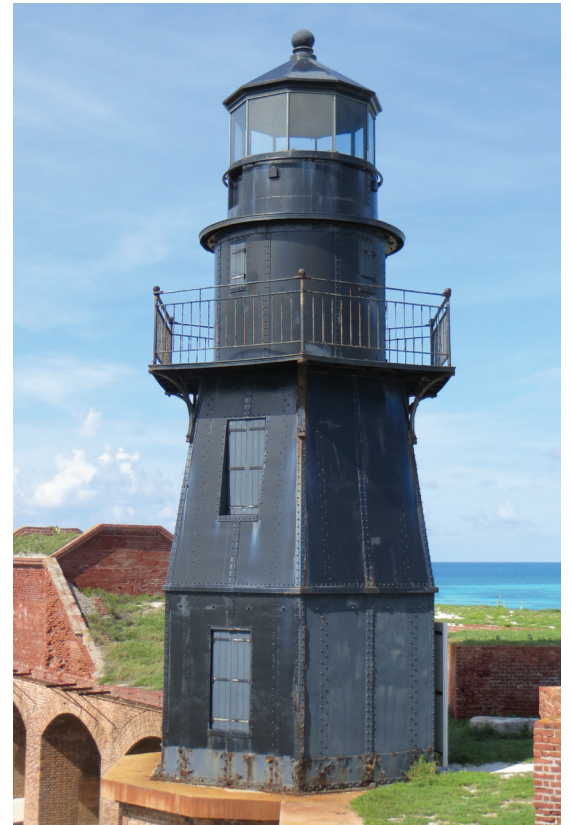
The cast iron structure of the Tortugas Harbor Light, is in varying condition, between good and poor, depending upon exact location

Significant structural work needs to be performed at the base of the structure where it is attached to the granite. Loose material, primarily corrosion products at the roof eaves, catwalk railings, and the curved brackets that support them, need to be addressed. Additionally, there is significant corrosion at the joint between the Service Room and the Watch Room.

1876 Lighthouse with Corrosion

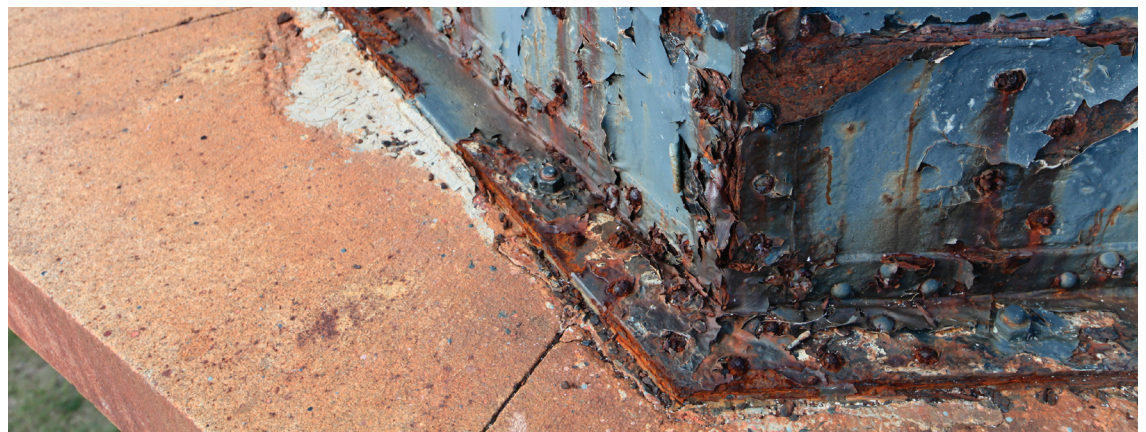
within the structure. The base is in poor condition, despite that it has been repaired and augmented several times during the last 50 years.

Corrosion at Base of Lighthouse

Contractors are scaffolding the Harbor Light in order to provide additional access for the structural engineers and to provide some stability to the tower. In addition to the structural and architectural elements being restored and stabilized an entirely new hi-performance marine grade coating system will be applied to all iron components.
