HISTORIC STRUCTURES REPORT - PART II (PORTION)

THE DEN CEILING, EDISON HOME, BUILDING NO. 10

Subject: Historic Structures Report - Part II (Portion)
The Den Ceiling, Edison Home, Building No. 110,
Administrative and Historical Data

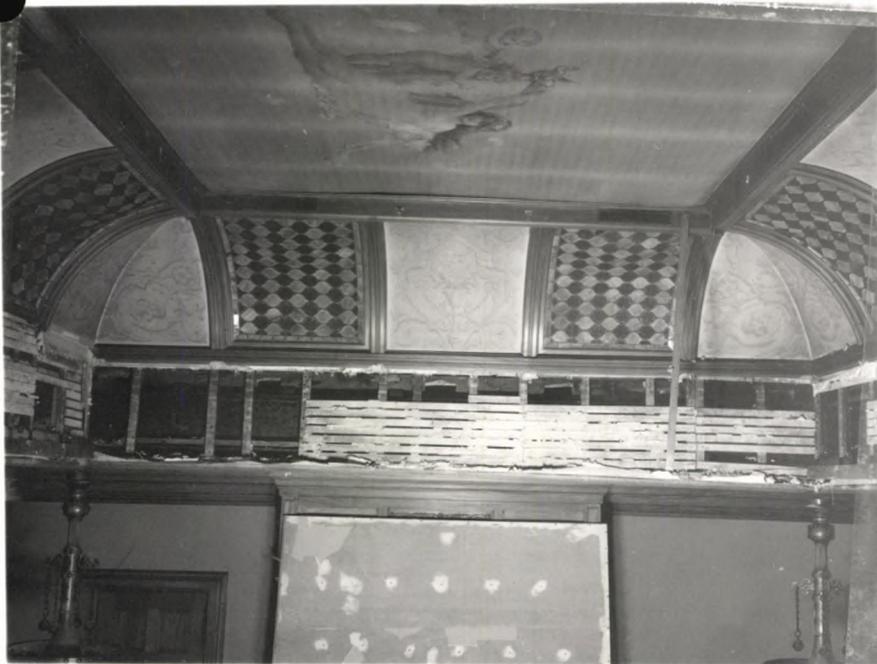
PHOTOGRAPH NO. O-1569

About five or six years ago, it was noticed that some of the wood trim of the ceiling, especially in the northeast corner, appeared to be breaking away, and that the old chandelier in that corner had also dropped somewhat. The condition was inspected periodically, and as time passed it seemed to grow worse, extending gradually to other parts of the entire ceiling. Finally, on January 17, 1966, one week after the annual meeting of the Proprietors of Llewellyn Park held in the Den and adjacent Dining Room, Room No. 115, it was decided that the time had come, both for the good of the building and in the interest of safety for persons and historic furnishings, to initiate a careful study of what was causing these failures.

General view of the clerestory section of the ceiling in the Den at Glenmont, looking toward the north or fireplace end of the room. Note dropping of trim at right corner of painting and at right-hand chandelier below. The open section, with lath showing, was formerly covered by decorative, painted panels like those between the windows. Whittington photo, 1/27/66.

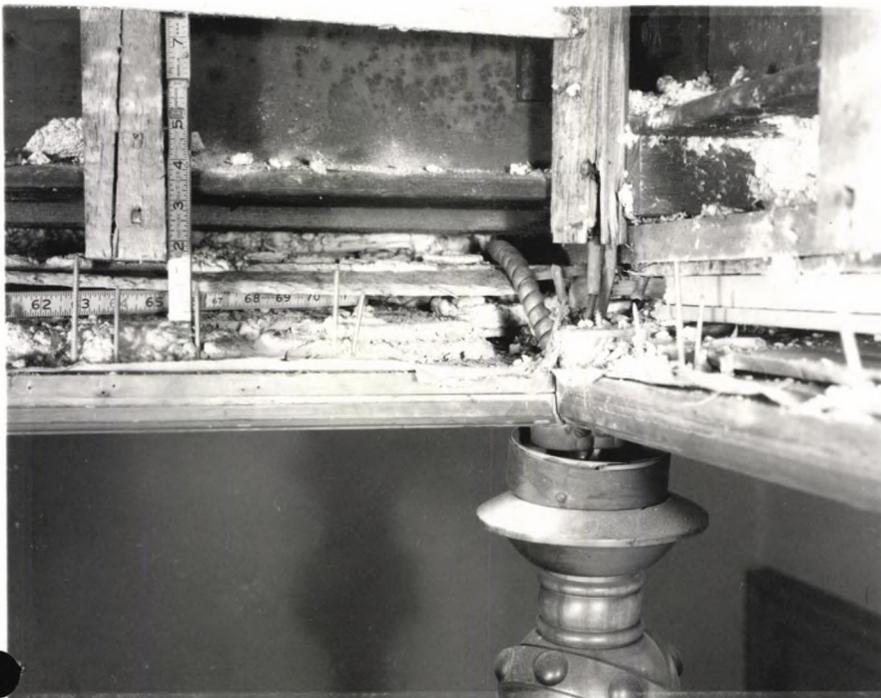
PHOTOGRAPH NO. O-1567

the latter still in surprisingly good condition, as shown in Photograph No. O-1565 attached to this report. The condition of the flat portion of the main ceiling, however, surrounding the domed opening, was discovered to be much worse than expected. Typical findings are illustrated in the attached Photographs Nos. O-1569, O-1567, and O-1566. Breaking away of wood trim in the domed or clerestory section is pictured in Photograph No. O-1568.

Northeast lower corner of clerestory opening, Den ceiling, Glenmont, showing plaster away from the lath to extent that a rule can be placed between. Note that the screws did not hold anything. Whittington photo, 1/27/66.

7. The border ceiling (actual width about 4'-4") should be finished as follows: (1) application of rock lath over the existing or replaced wood lath, (2) application of metal lath over the rock lath, and (3) application of vermiculite plaster over the metal lath.

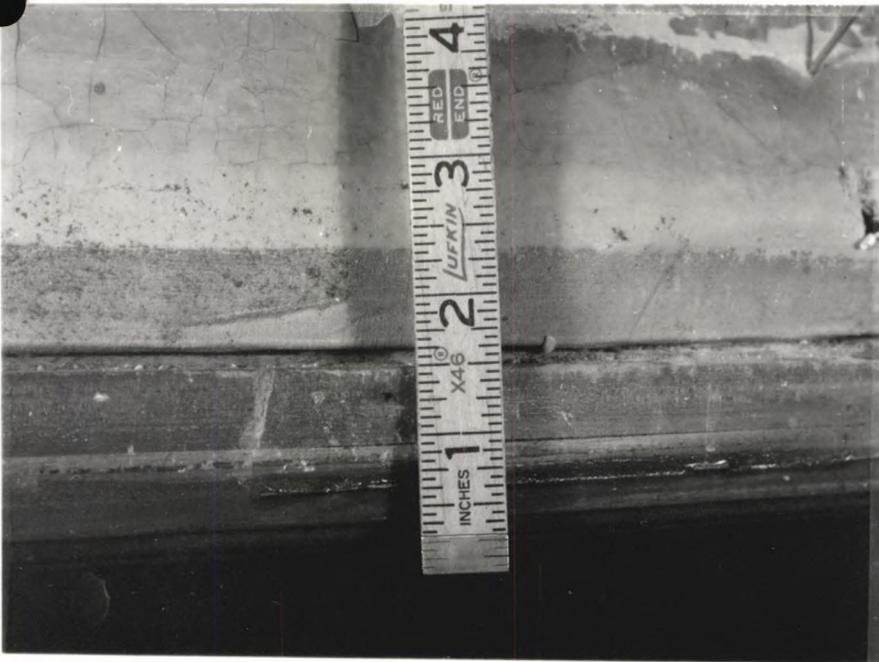
PHOTOGRAPH NO. O-1566

Canvas strip left at the lower edge of the clerestory opening of the Den ceiling at Glenmont, with paint markings showing width of trim removed when this opening was closed up. The piece of canvas shown in this picture was part of an original decorative panel below the clerestory windows, and this sample has been saved. Whittington photo, 1/27/66.

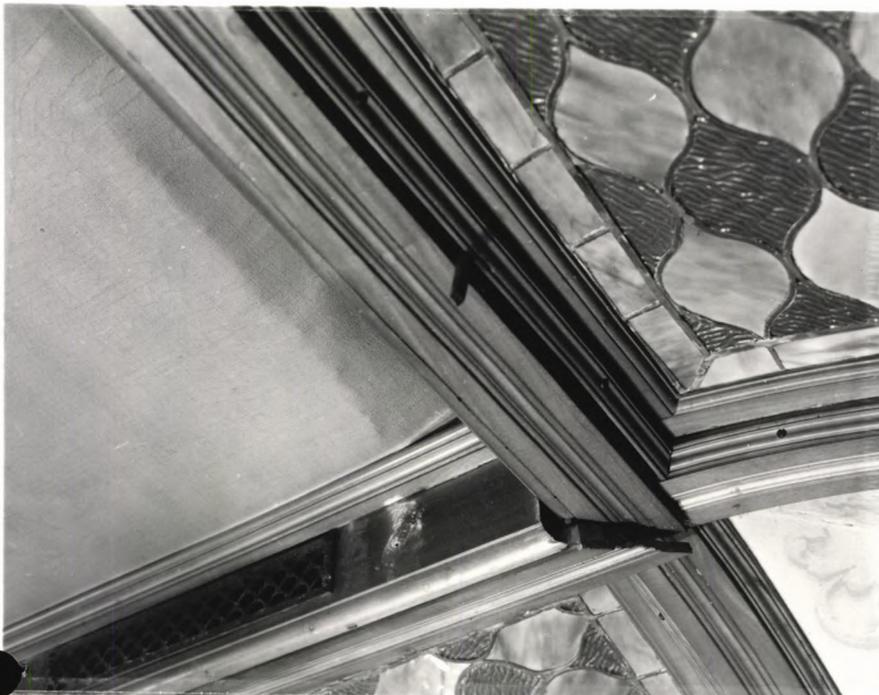
PHOTOGRAPH NO. O-1568

Detail of trim falling away from painting of muses and cherubs in northeast corner of the clerestory opening of the Den ceiling at Glenmont. Whittington photo, 1/27/66.

8. Wood trim should be replaced and adequate grounds provided for replastering, missing component parts to be restored and finished as necessary.

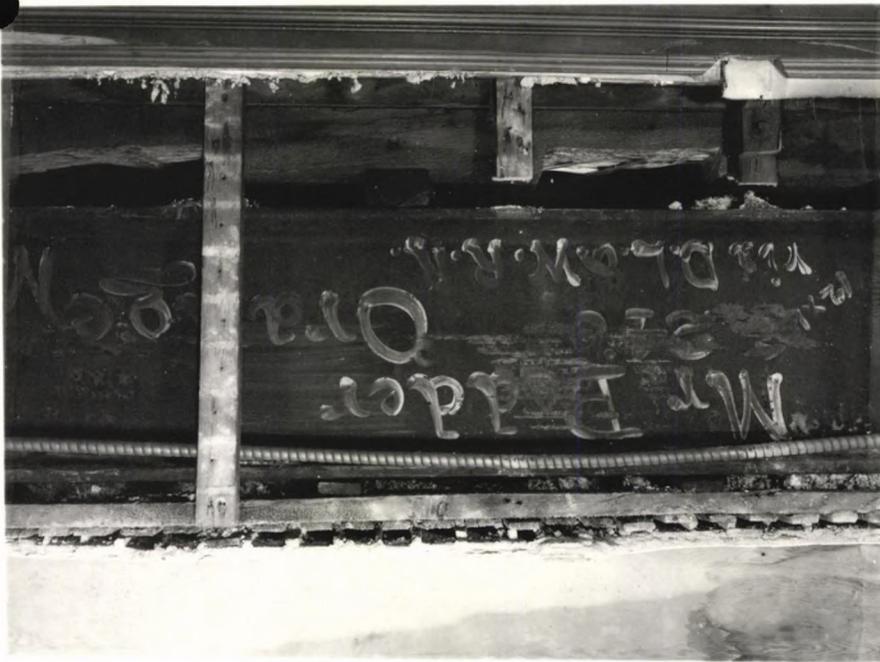
PHOTOGRAPH NO. O-1570

Meanwhile, Architect Souder began preparation of the "Architectural Data" section of this report, and following further discussions of the Site office with both EODC and the Northeast Regional Office funds in amount of \$2,305 were provided under Work Order 403-211729 (dated February 2) to remove the deteriorated ceiling and make further investigation of related structural conditions. Carrying this work forward led to further interesting discoveries. Among these was the fact that construction of the Den addition to Glenmont was initiated by Mr. Henry C. Pedder, for whom the house was built in 1880, his name being found painted on several of the steel beams running from brick wall to brick wall as basic support for the ceiling and roof structure (see Photograph No. O-1570 attached). On February 2 Mr. Whittington also found this pencilled note on a

Lettering detail steel beam framing, Den ceiling at Glenmont, proving that construction of the Den addition was begun by Mr. Henry C. Pedder, the pre-Edison owner. This photograph is right side up. Note how plaster has dropped away from the lath. Whittington photo, 1/27/66.

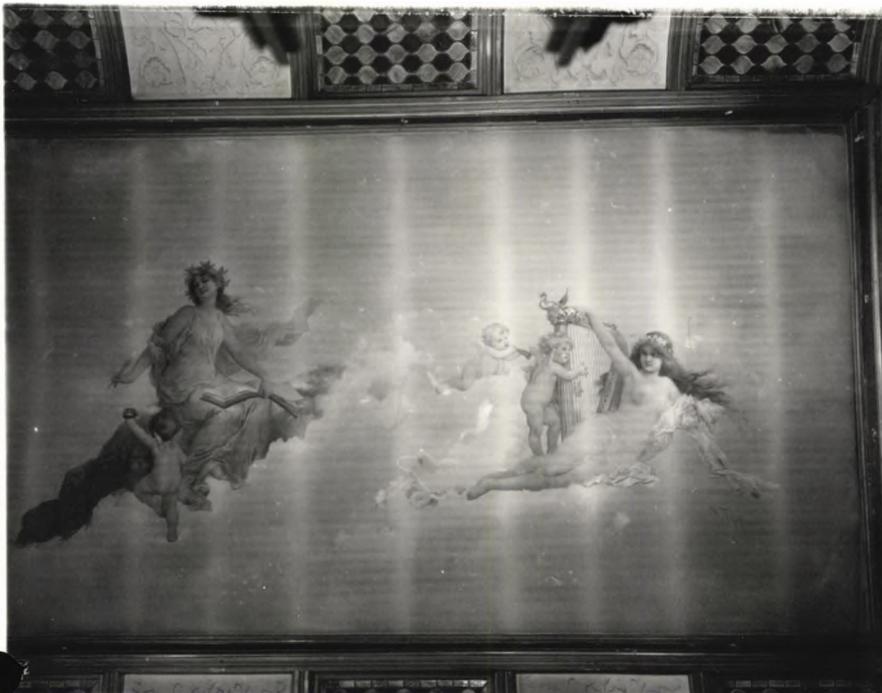
PHOTOGRAPH NO. O-1565

Painting of muses and cherubs in flat vault of the clerestory section of the Den ceiling at Glenmont, as it appeared when the lower or false ceiling installed about 1935 was removed. The Edison children always liked this painting and are delighted at the prospect of its being once more revealed. Note signature in lower right corner: "V. Tojetti 90". Whittington photo, 1/27/66.

3. Immediate steps should be taken to arrange for professional inspection and preparation of a report on necessary work and estimated cost of cleaning and restoring the Tojetti painting of muses and cherubs, as well as the decorative panels both between and below the clerestory windows. It is suggested that Mr. Walter Nitkiewicz, Division of Interpretation and Visitor Services,

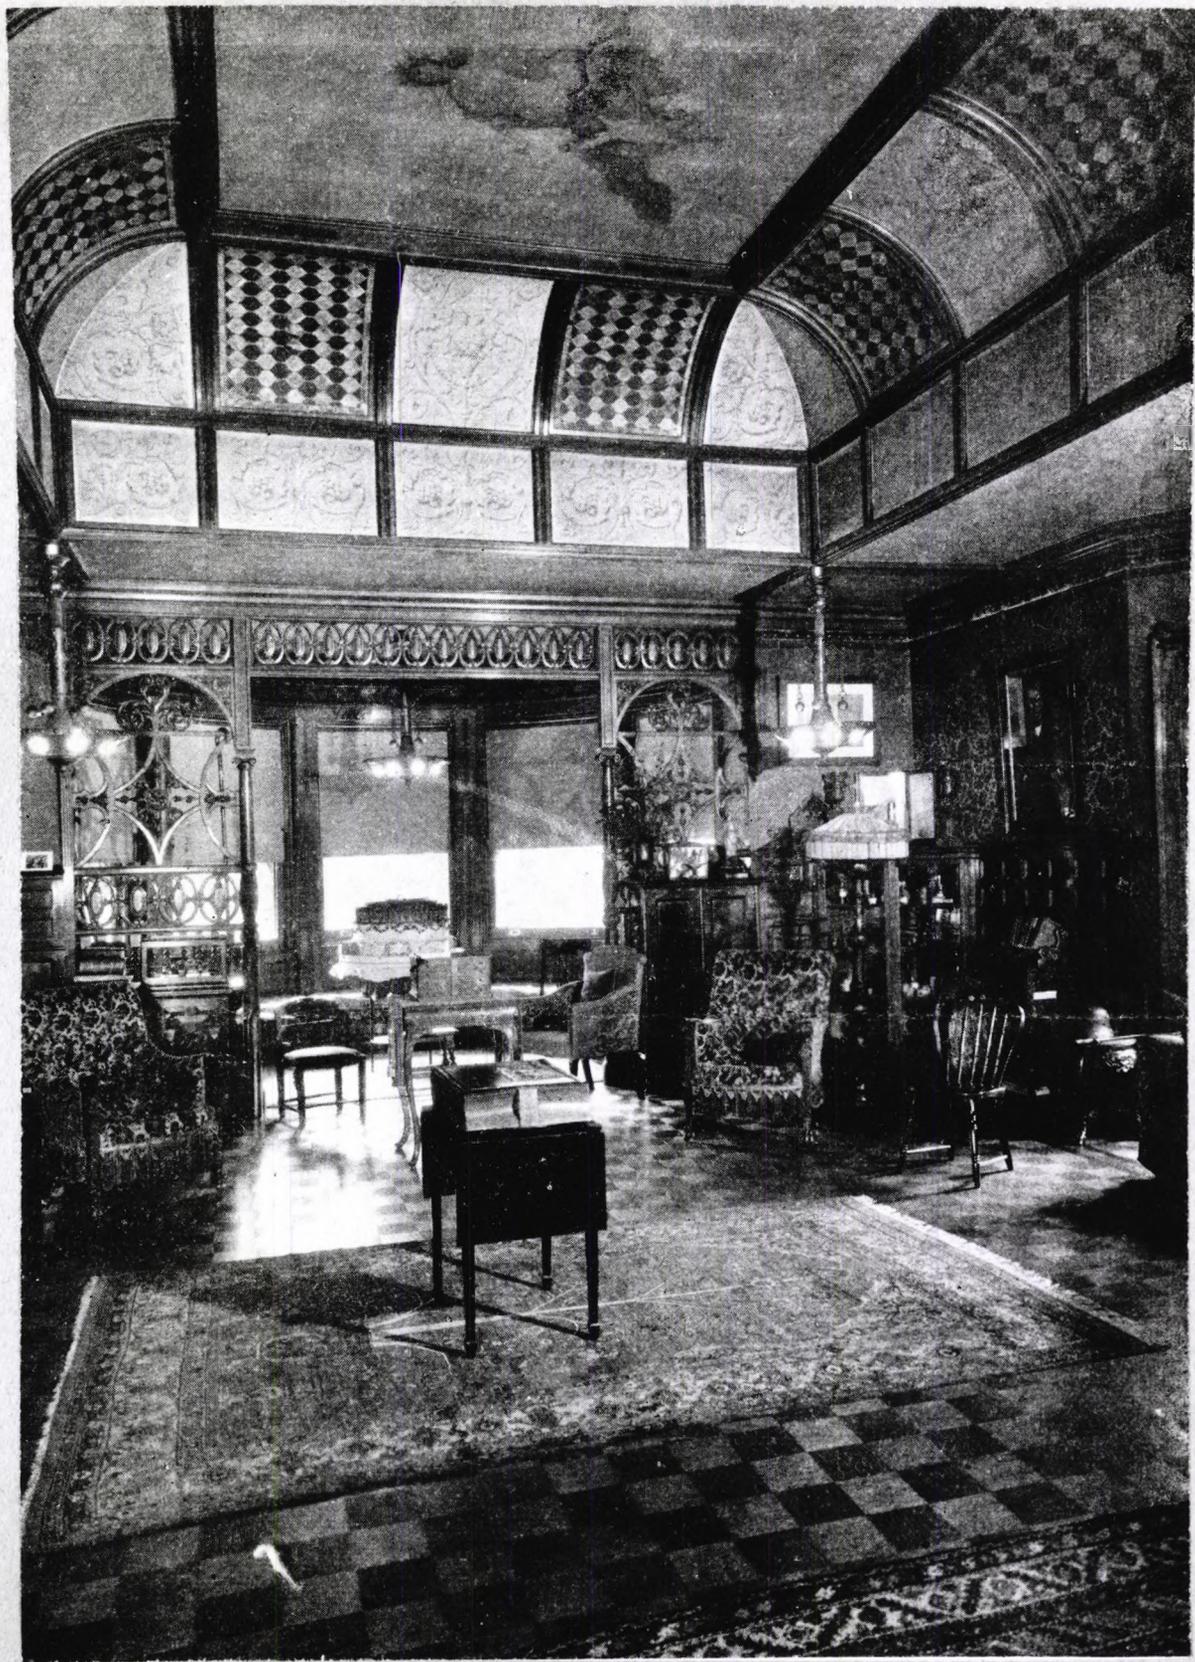
PHOTOGRAPH NO. 6940

General view of southwest end of the Den, Room No. 114, Glenmont, as it appeared in a copy of a half-tone photograph now in one of the Glenmont photo albums owned by Governor Charles Edison and Mrs. John Eyre Sloane. There was no date for this picture in the album. Note scroll work between the main room and the bay window section, as mentioned in this report. This photograph is a new negative copy of the album photograph made with permission of Governor Edison and Mrs. Sloane

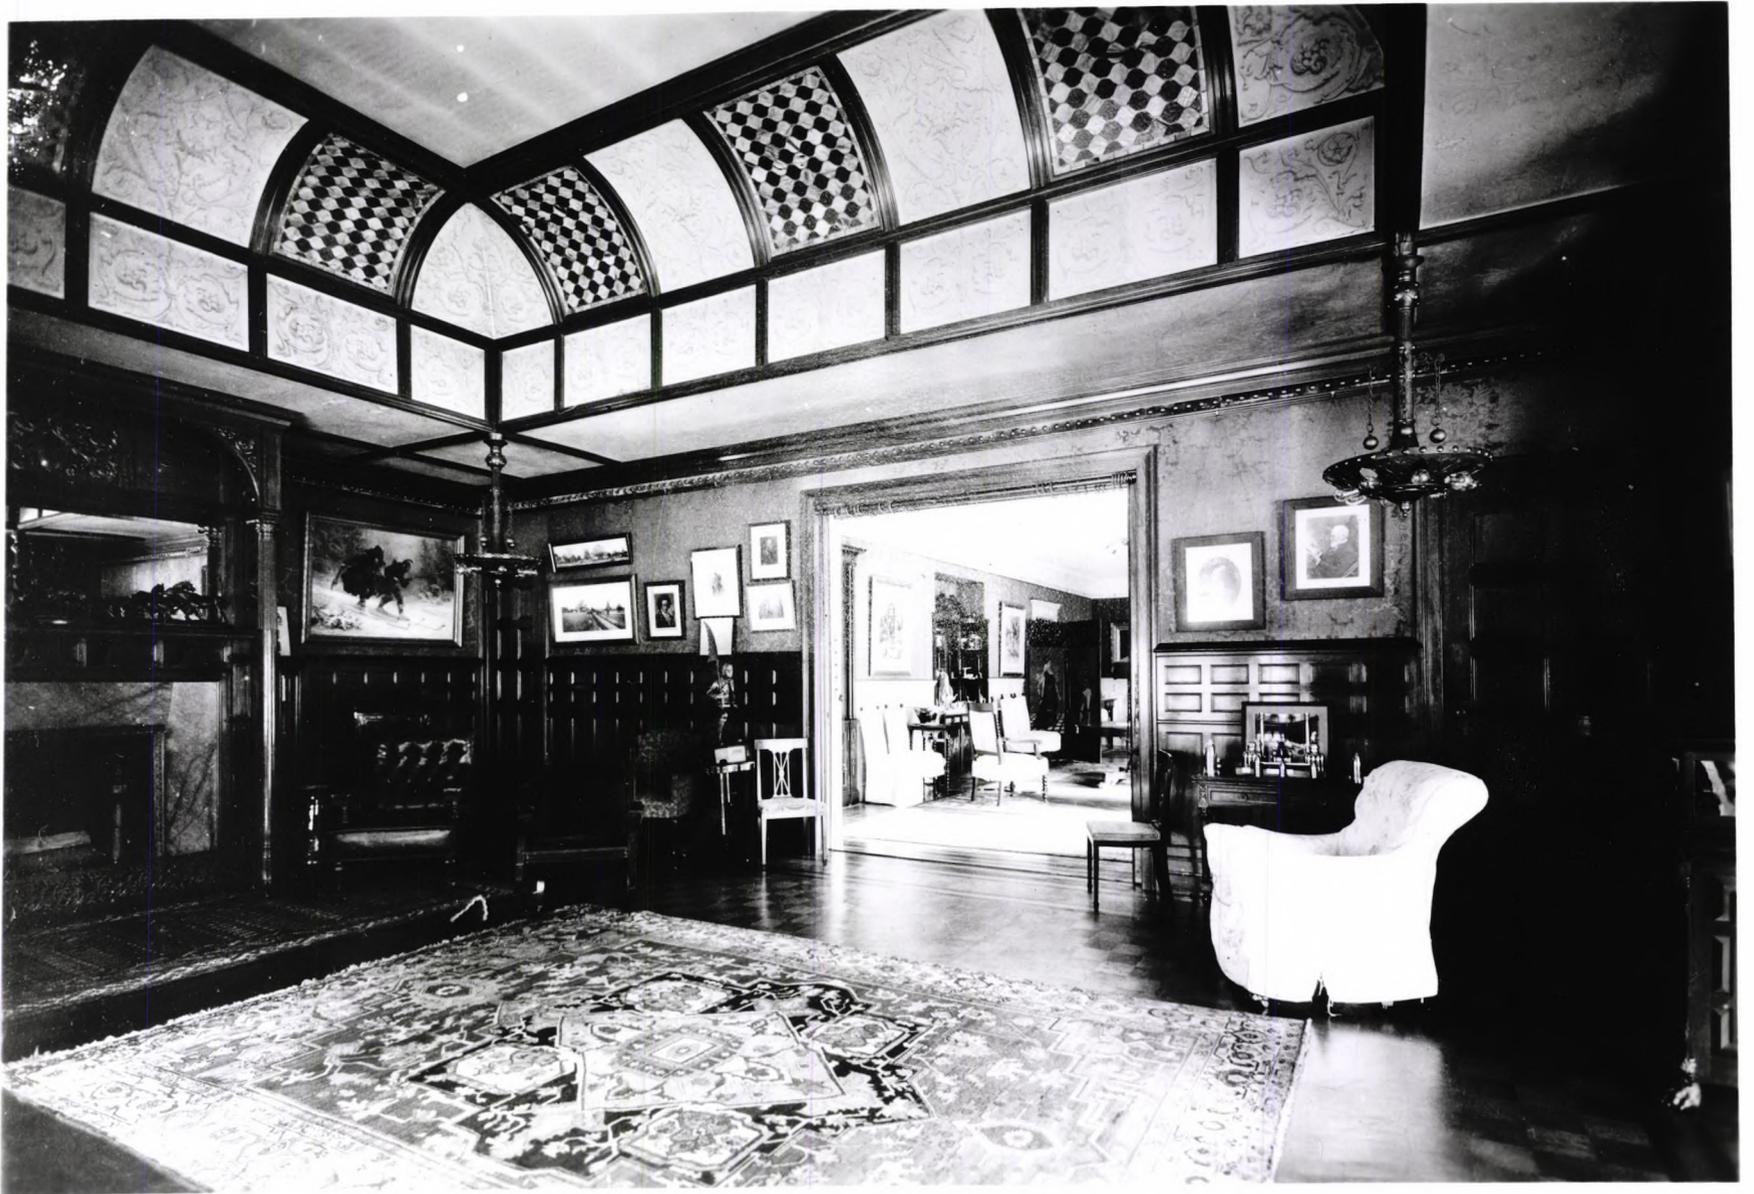
PHOTOGRAPH NO. 6938

General view of the Den, Room No. 114, Glenmont, looking toward the northeast corner, as it appeared in a photograph now in one of the Glenmont photo albums owned by Governor Charles Edison and Mrs. John Eyre Sloane. There was no date for this picture in the album. This photograph is a new negative copy of the album photograph made with permission of Governor Edison and Mrs. Sloane.

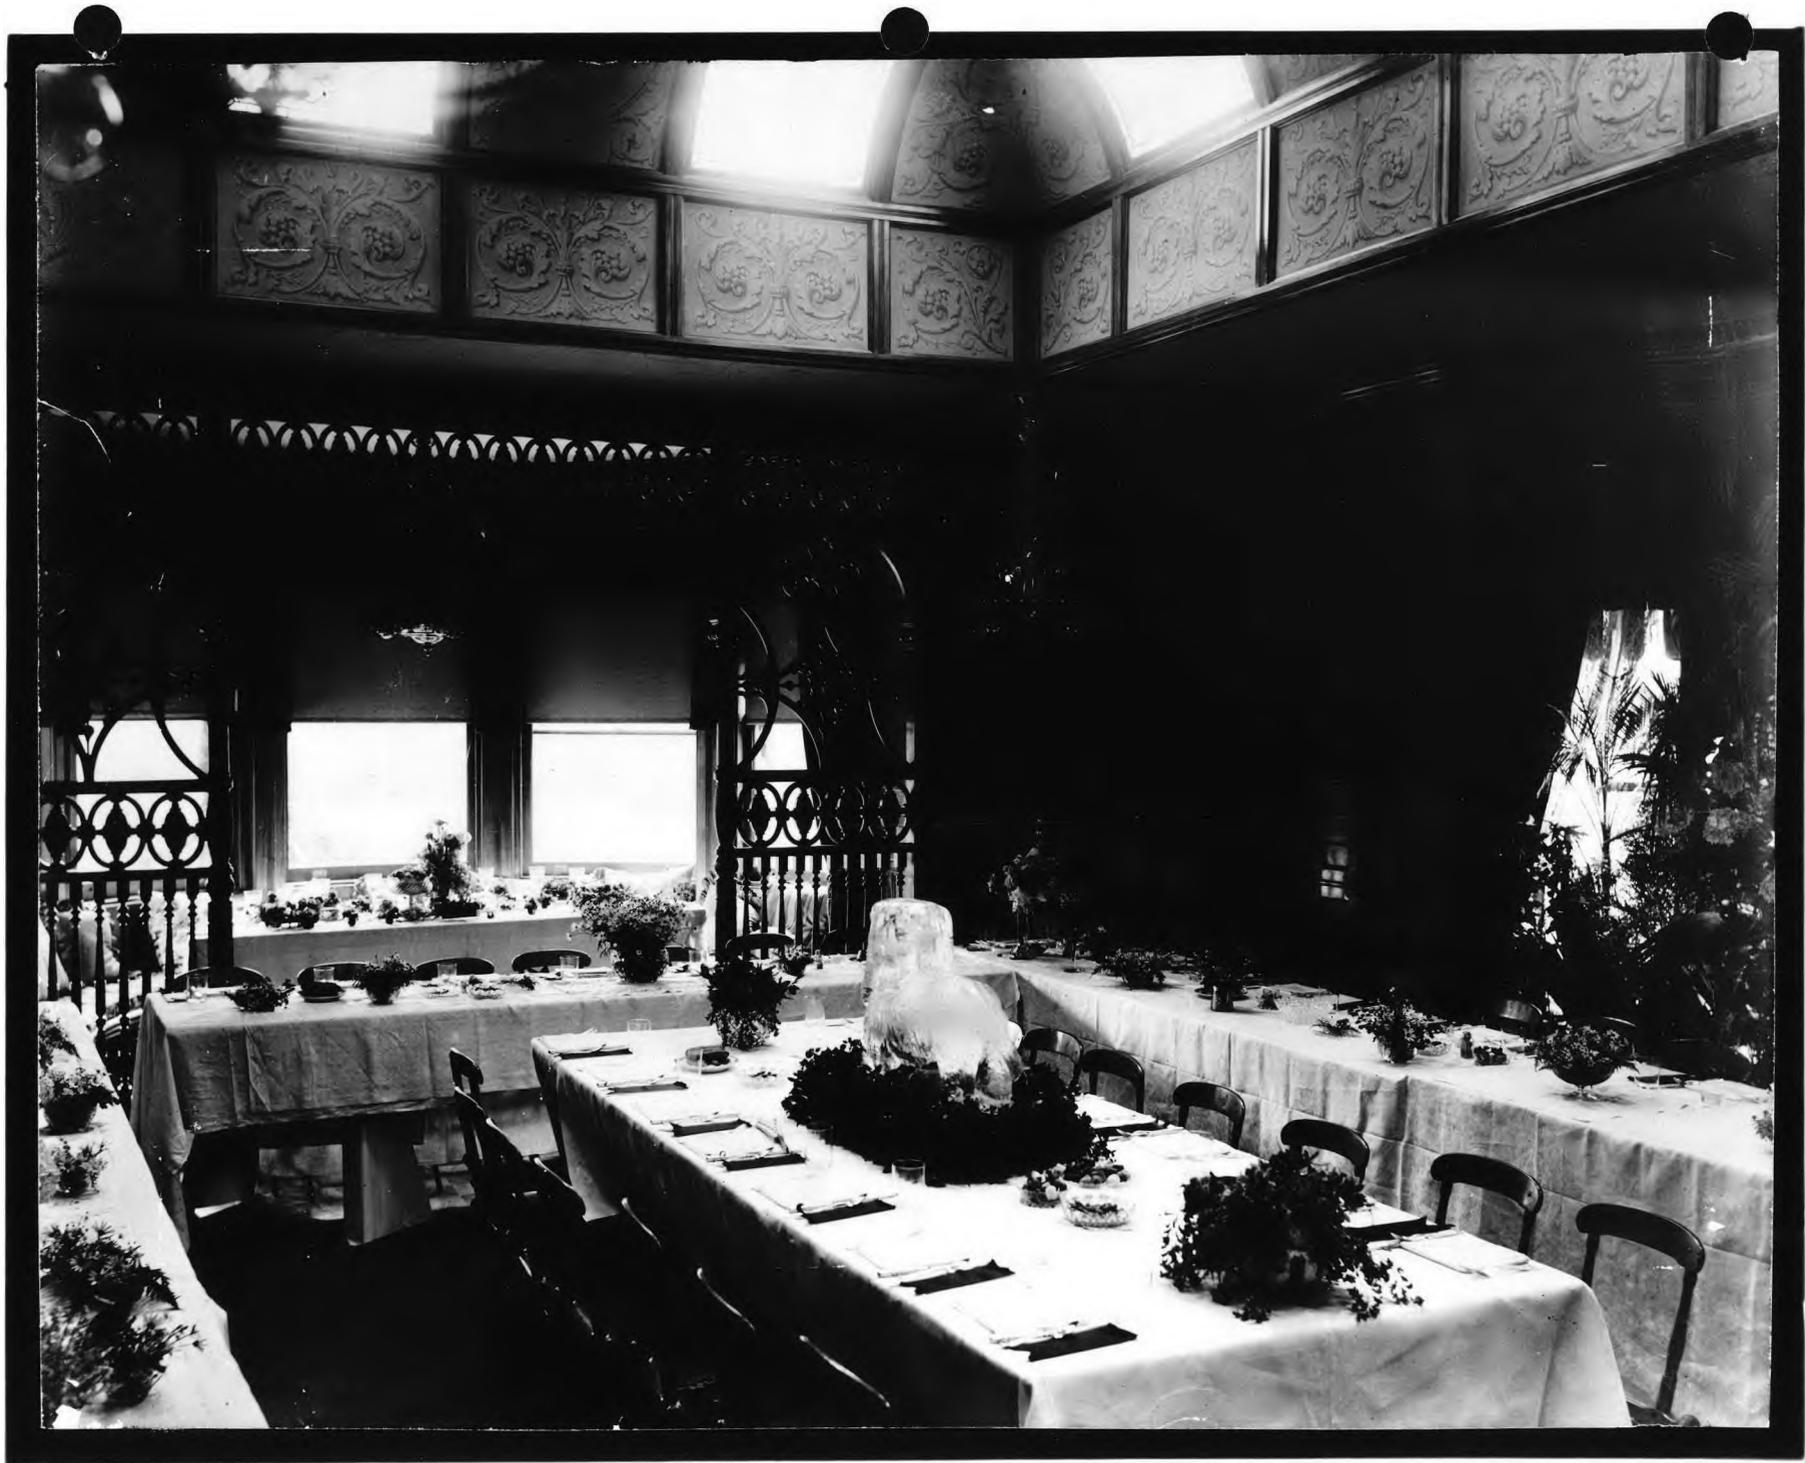
PHOTOGRAPH NO. 6939

days, before the central section was closed up. They should thus have much restoration value. No. 6939 is best of the three on the decorative panels below the clerestory windows, which panels were unfortunately removed when the opening was closed, and which in the projected restoration will have to be reproduced 100%.

General view of the Den, Room No. 114, Glenmont, looking toward the southwest corner, as it appeared in a photograph now in one of the Glenmont photo albums owned by Governor Charles Edison and Mrs. John Eyre Sloane. Note detail of painted decoration in panels below the clerestory windows, all of which is now gone and will need to be replaced in restoration. There was no date for this picture in the album. This photograph is a new negative copy of the album photograph made with permission of Governor Edison and Mrs. Sloane.
