DAM REMOVAL AND CHANNEL RESTORATION AT FOSSIL BUTTE NATIONAL MONUMENT

Clayton R. Kyte,¹ Vincent L. Santucci,² and Richard R. Inglis, Jr.³

KEY TERMS: dam removal; erosion control; gully restoration.

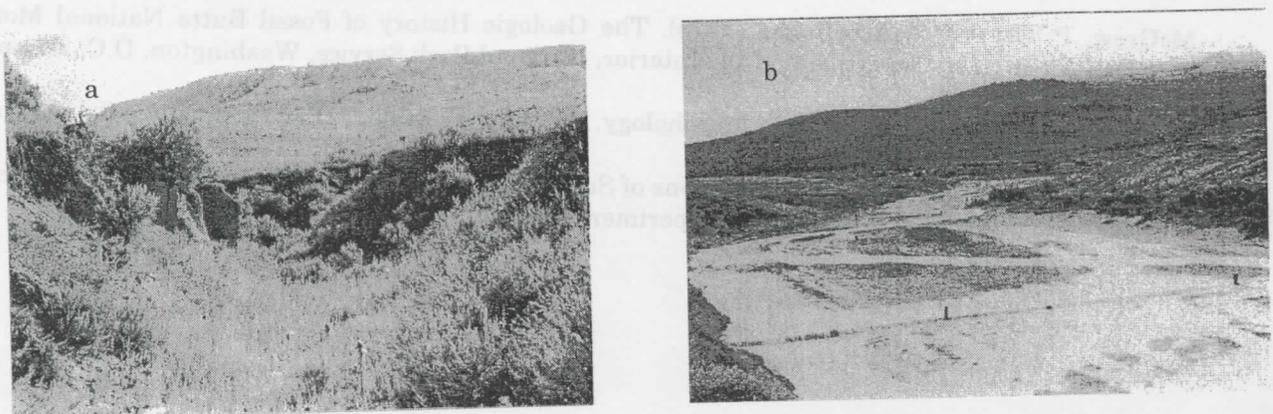
The channel of the East Fork, immediately downstream of the spillway mouth, was severely gullied for nearly 600 feet. The gully was approximately 8 feet deep immediately downstream of the headcut; its bottom width varied from less than ten feet near the headcut, to nearly fifty feet at the downstream end.

The installation of innovative wooden grade controls helped maintain the configuration of the new floodplain after the East Fork gully was filled and reshaped (Figure 2). The controls were designed to 1) prevent channel incision until sufficient vegetation could be established to control erosion, 2) minimize the stream gradient by maintaining the meandering pattern of the smaller channel incised within the broader floodplain, and 3) spread the flow of larger runoff events across the broader floodplain, thereby minimizing streamflow velocities and erosional forces.

Figure 2. East Fork gully prior to restoration (a) and during a runoff event following restoration (b).

Grade controls, made from 8-foot panels of 3/4-inch exterior plywood 16 inches wide, were installed across the new floodplain in order to control the depth and course of streamflow. Wherever a grade control crossed the inner floodplain channel, the 8-foot long panel intersecting the smaller channel was lowered by approximately 3.5 inches. These controls were intended to spread flows exceeding 3 - 4 inches in depth across the new floodplain. The panels were fastened together and reinforced by 8-foot lengths of 2x4 inch lumber. The panels were set into trenches which had been excavated across the width of the new floodplain. The wooden controls were set into 18-inch deep trenches which had been dug across the width of the floodplain. Earth was compacted around the plywood using a gasoline-powered tamper. The top of each wooden dam protruded above the ground 4 - 6 inches when the installation was complete. The wooden controls varied in length from 32 feet to 56 feet and were installed at approximately 50-foot intervals along the entire 560-foot long, reclaimed section of the East Fork.

On June 17, 1998, an extraordinary flood event occurred which tested the reclamation design of the restored East Fork channel segment. The reclaimed streambed withstood the runoff event with minimal damage, indicating that the reclamation design was adequately controlling erosion. By the fall of 1998, the reclaimed flood plain supported an excellent growth of vegetation consisting of rhizomatous wheatgrasses and Silver Sagebrush seedlings. As it matures, the vegetation should increase the channel roughness, which should, in turn, help decrease future stream velocities and the potential of channel erosion. There were few undesirable plants at the east dam site, and weed growth at the west dam site was within acceptable limits. Some small areas of saline soils at the West Dam where vegetative growth was poor are expected to improve with time. Several native species of plants, not contained in the seed mixes, were also observed at the reclaimed sites. This occurred when topsoil, containing native seeds and/or rhizomes, was salvaged from the sites beforehand and redistributed over the surface afterwards.
