Fort Donelson Cemetery Carriage House/Stable
& Pump House
Fort Donelson National Battlefield
Historic Structure Report

Historic Structure Report

Fort Donelson Cemetery Carriage House/ Stable
LCS#: 007170

Fort Donelson Cemetery Pump House
LCS#: 000066

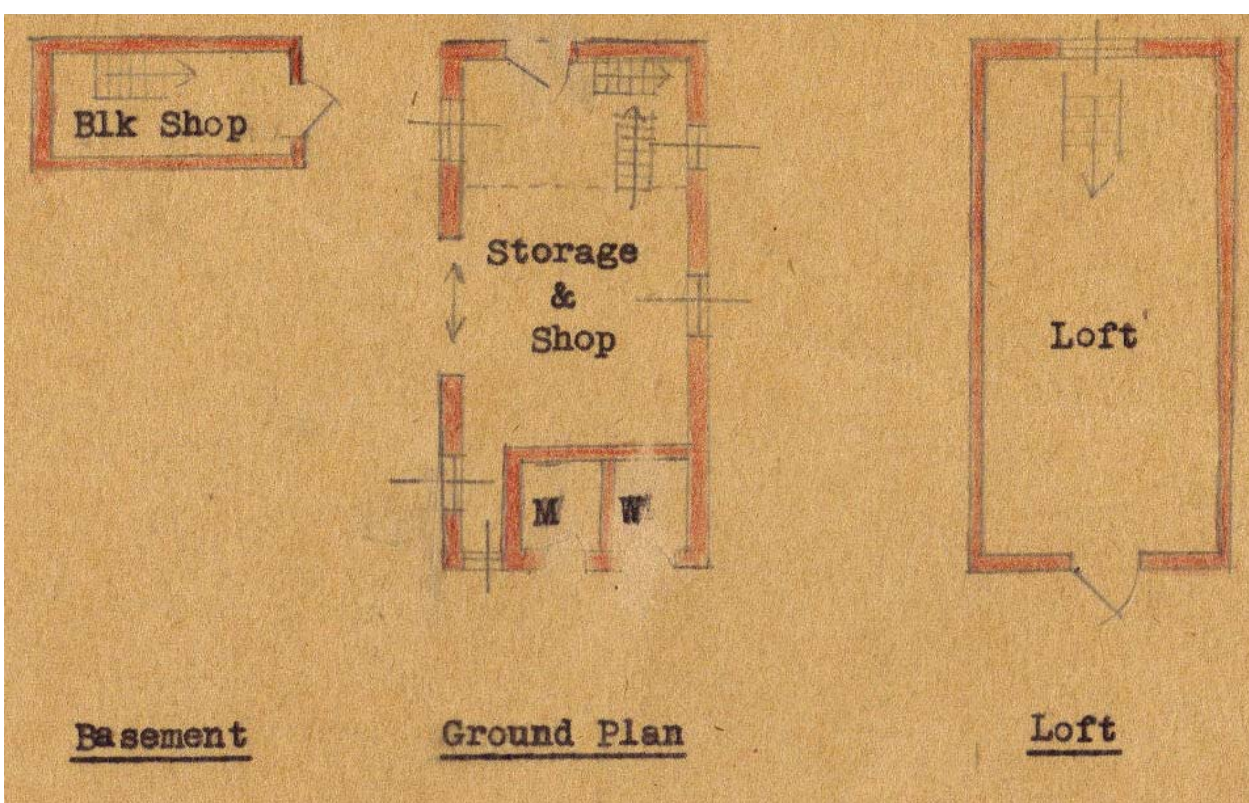
Figure 24. 1949 Data Sheet, zoomed in, showing floor plans with stairs. Loft door and window are reversed.

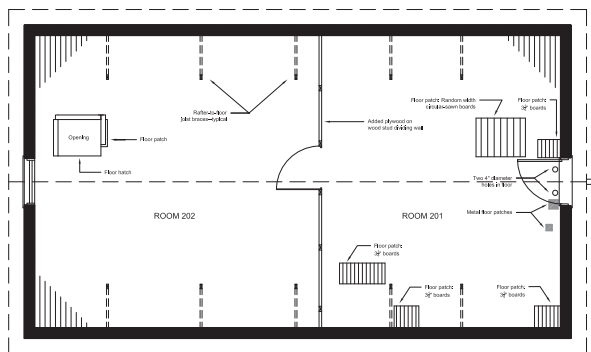
Figure 25. Plan of loft showing possible stair opening and hay drops, all now patched. Existing open hatch is near northwest corner.

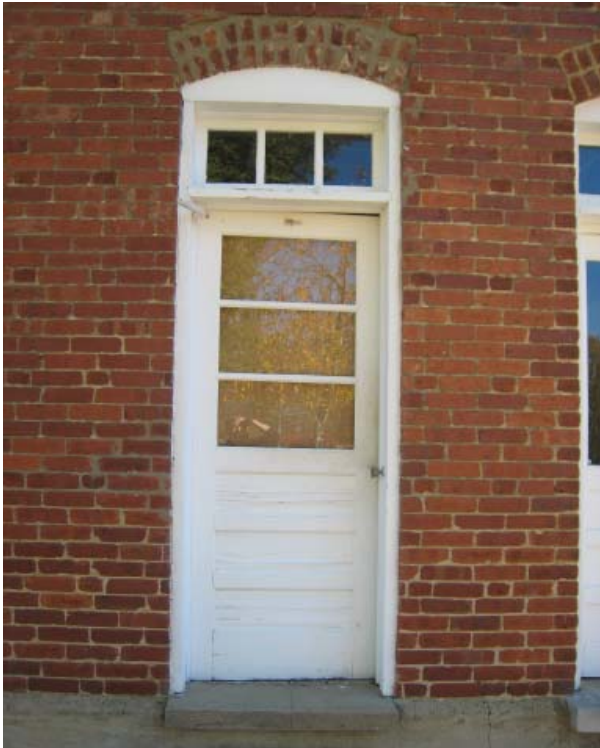
occurred is not certain, but possibly in 1931 when other major building modifications occurred. The frostproof toilets that were installed and the clamshell door hinges still on this door frame were popular in the 1920s-30s. The three-light transom apparently dates to that modification. The sash door now in place with three horizontal lights atop three horizontal wood panels may date to that era also but stylistically appears to be later. This door measures 2'-10" wide by 6'-8" tall by 1 3/8" thick. The door is missing its lock but it does have two 1920s-30s-era clamshell hinges.

Figure 67. Added central doorway of west elevation.

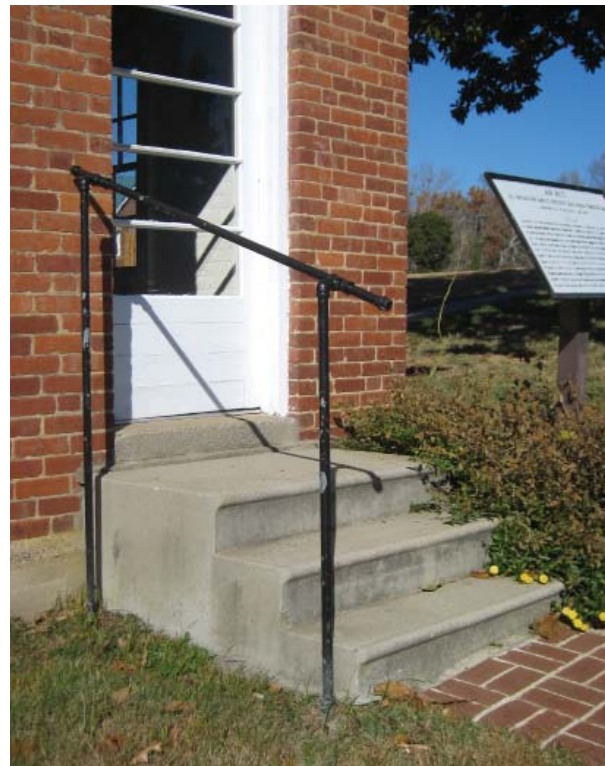
The steps leading to the east elevation doorway are made of pre-cast cement. The exact date of installation of these particular steps is unknown but the need for a taller set of steps was created in 1931 when the interior floor level was raised.

Figure 69. Pre-cast cement steps to east elevation doorway.

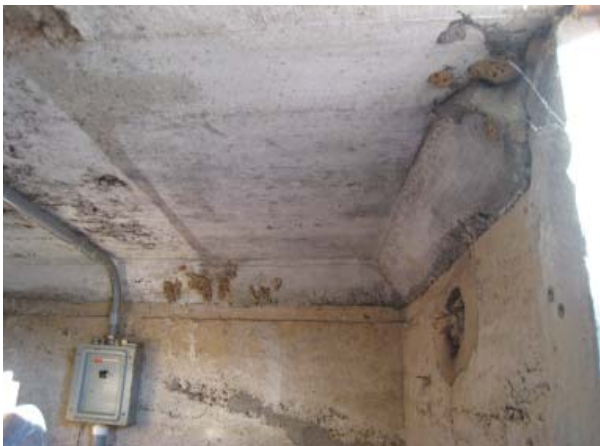
A cement “cornice” runs along the three original walls. Its purpose is not known but it does conceal the change in building material from concrete foundation to brick wall.

Figure 74. Added cement “cornice” visible on east and south walls.

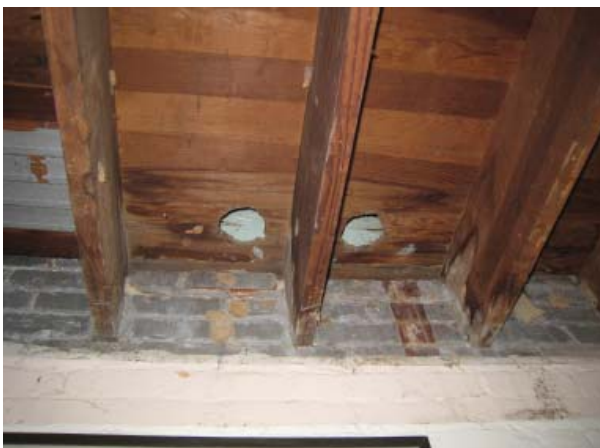
Two sections of four-inch-diameter copper downspouts are set in the concrete floor slab along the east wall. Holes of the same size are directly above in the loft flooring. Their purpose is not known. One possibility is that the two were used as feed chutes to deliver stored grain from the loft to animals in the basement room. Another possibility is that they were associated with a cistern.

Figure 82. Two 4" diameter holes in loft flooring. Note water stains on flooring which may have come from a cistern or leaks from the adjacent loft doorway.

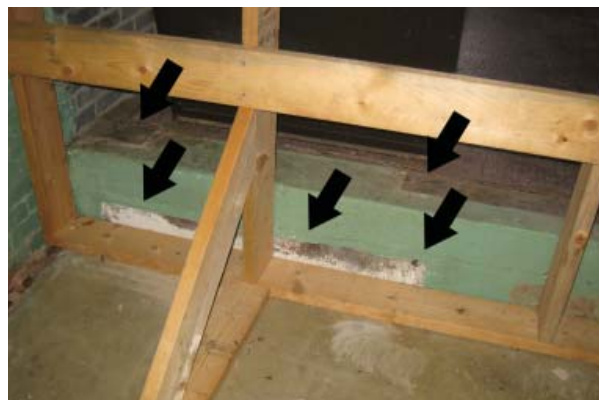
Figure 90. Ghostmarks for previous step to doorway atop raised concrete floor of Section 101.

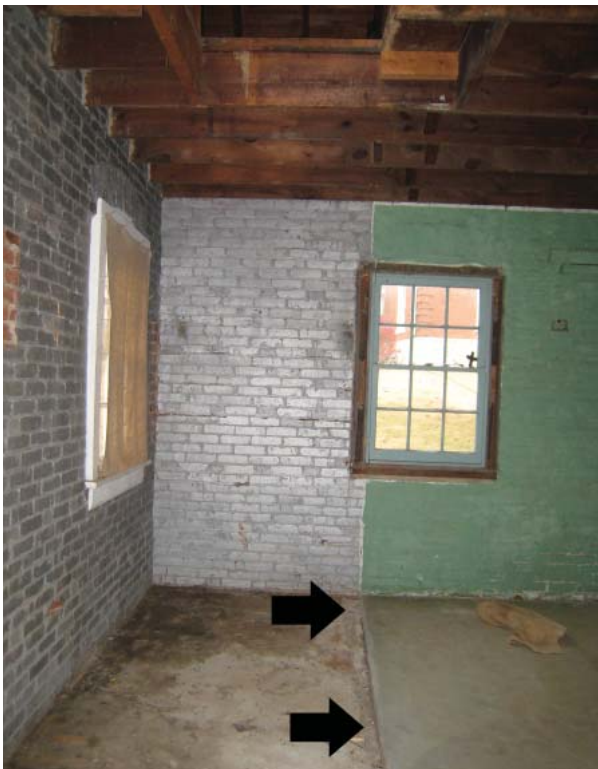
Figure 91. North wall of west section. Note imprint of wall enclosing ladder stair and hatch above.

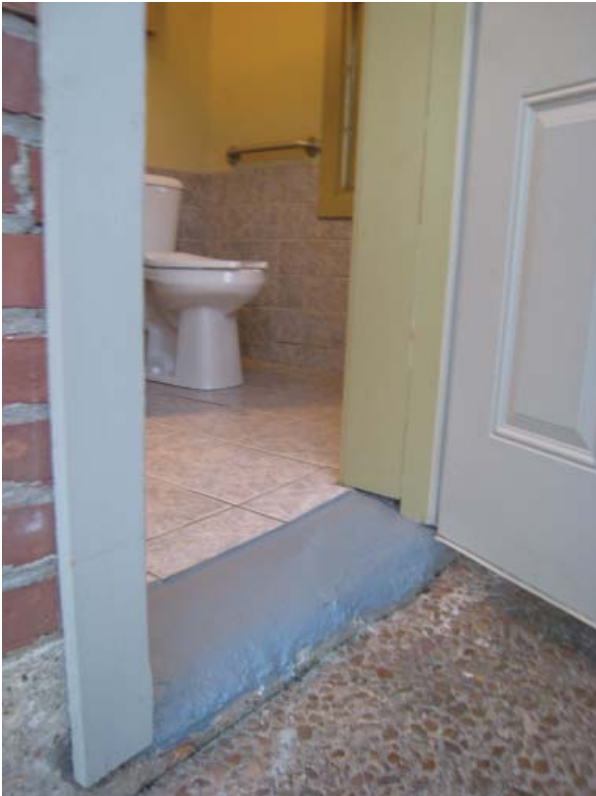
Figure 134. Entrance platform is 4" lower than restroom floor level.
