Inventory of Coastal Engineering Projects in Fort Matanzas National Monument

Natural Resource Technical Report NPS/NRSS/GRD/NRTR—2013/703

March 2013

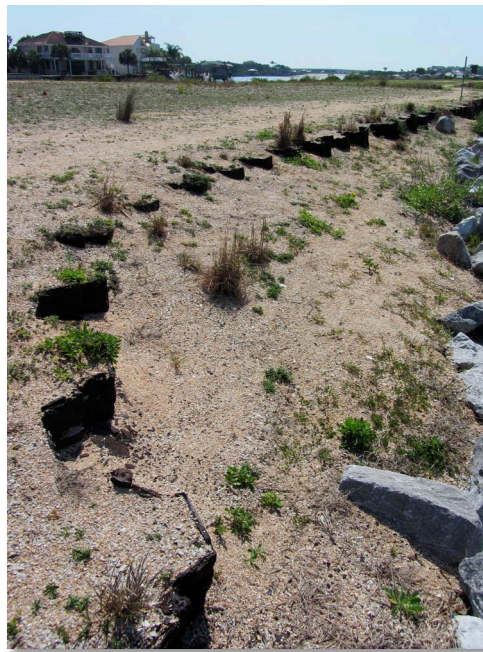
Figure 4. The top of the 1936 steel sheet pile dike buried in fill along the southwest shore of Rattlesnake Island (#17 Figure 5). View is to the southeast (image by Kate Dallas).

The dike was built to 3 m (10 ft) above mean low water and included placement of 147,890 m³ (193,428 yd³) of fill along the dike dredged from the ICW at a cost of \$24,544,86 (Mehta and Jones 1977). In addition, 8,200 m³ (10,729 yd³) of revetment was also installed along both sides of the dike (USACE 1976). This revetment has been buried over time and is not currently visible. Minor flanking around the north end of the dike in subsequent years was repaired through placement of sand during ICW maintenance dredging (USACE 1976).

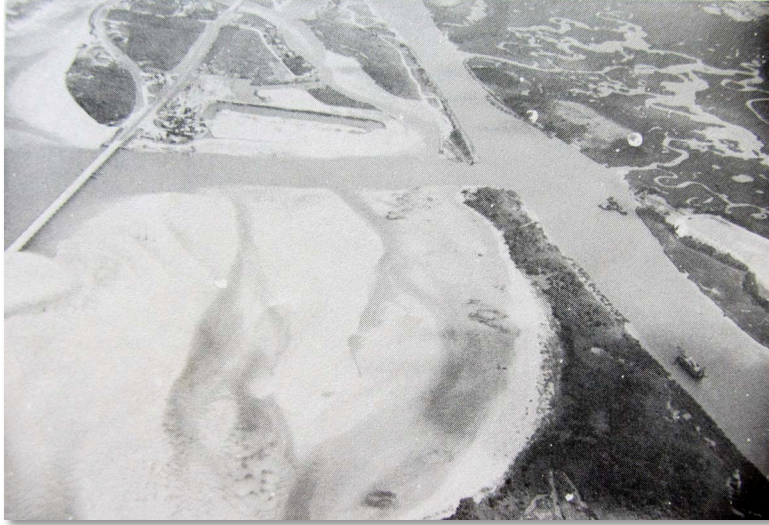
In 1964 Hurricane Dora breached the northern end of the dike, causing a decline in the percentage of tidal flow moving through the north arm of the river (Figure 6) (Mehta and Jones 1977). The USACE closed the breach in 1977, which had widened to 97 m (319 ft), with construction of a steel sheet pile dike (#15 Figure 5) at a contract cost of \$873,419 and revetment on both sides of the breach (#14, 16 Figure 5 & Figure 7) (Mehta and Jones 1977). The project

Figure 6. View looking south in January 1974 towards the dike breach on southern Rattlesnake Island. The Matanzas River and Matanzas Inlet are to the left and the Intracoastal Waterway is to the right (from NPS 1980).

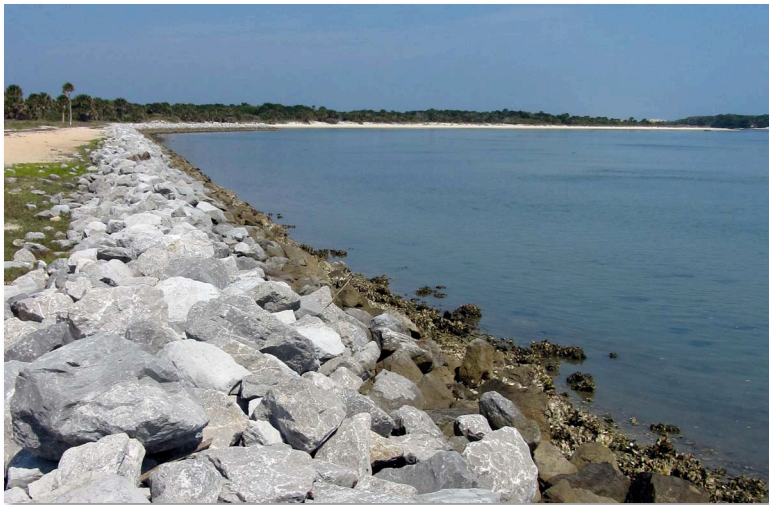
Figure 7. Revetment placed in 1977 to close the dike breach on Rattlesnake Island (#14 Figure 5). View is upriver (northwest) (image by Kate Dallas).

also included dredging of a relief channel in the north arm of the Matanzas River to increase flow. The dredged material was used to fill the breach and as beach nourishment on 975 m (3,200 ft) of ocean beach south of Matanzas Inlet (USACE 1976). The cost of the entire project in 1976 was approximately \$1,980,000 (USACE 1976).

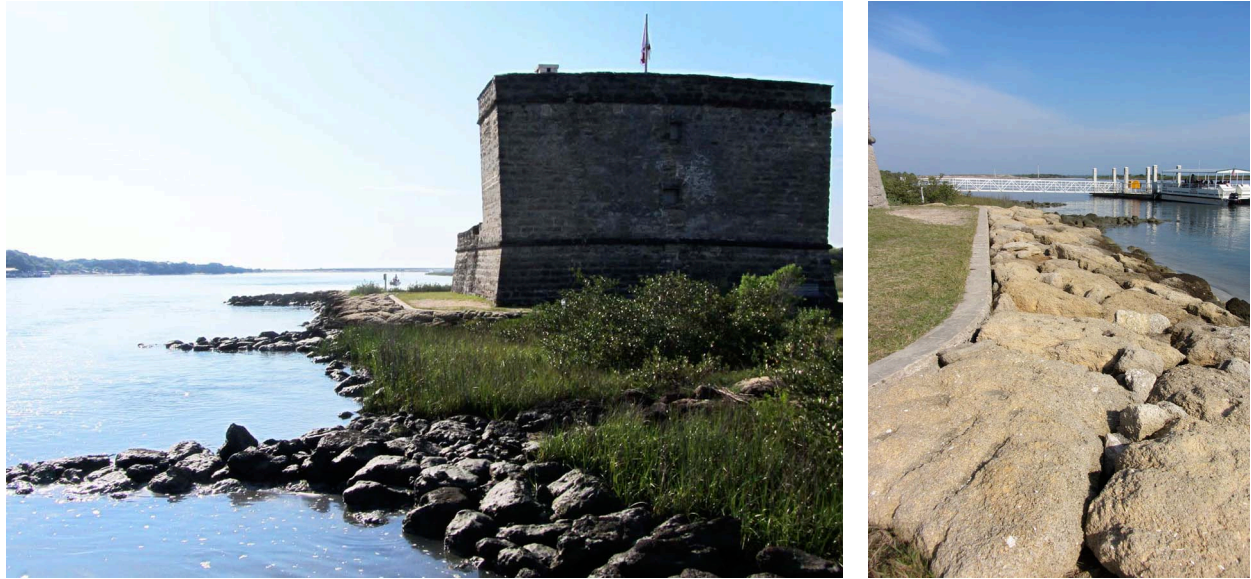
impacts of the Matanzas River (Figure 8 & #5 Figure 9) (NPS 1980, USACE 1987). The area behind the bulkhead was backfilled and revetment was placed in front (NPS 1980). In 1948–1949 parts of the bulkhead were cleaned and treated and the void between the bulkhead and fort was filled following storms in 1944 and 1947 (NPS 1980). Additional steel sheet pilings were placed approximately 0.3 m (1 ft) in front of the bulkhead by the NPS in 2007 (NPS 2006b).

Figure 8. Groins, revetment, bulkhead, and ferry dock at Fort Matanzas in 2011 (#1–7 Figure 9). Left image looks downriver (southeast), while right image looks upriver (northwest) (images by Kate Dallas).

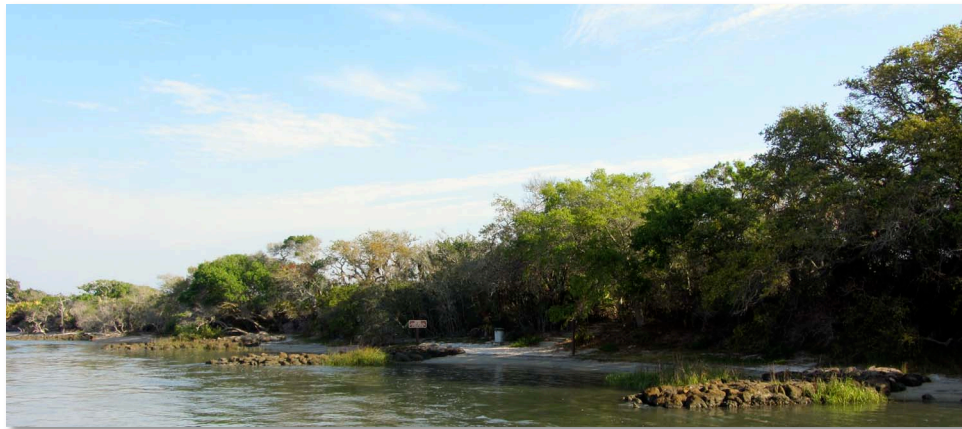
In 1934–1935 eleven rock groins were constructed near the present day Visitor Center to stabilize the shoreline (Mehta and Jones 1977). The Youth Conservation Corps repaired the groins in 1976 (NPS 1980). Only five groins were visible during our site visit in 2012 (#8–11, 13 Figure 9 and Figure 10), all of which were repaired by the NPS in 2007 (NPS 2006b). The ferry dock on Anastasia Island was originally built in 1935 (Kurt Foote, Natural Resource Management Specialist FOMA, email, 27 August 2012) and replaced in 2000 by the NPS with a floating concrete dock (#12 Figure 9) (NPS 2006b).

Figure 10. Rock groins along Anastasia Island's Matanzas River shoreline (#9–11 Figure 9). View is upriver (northwest) (image by Kate Dallas).

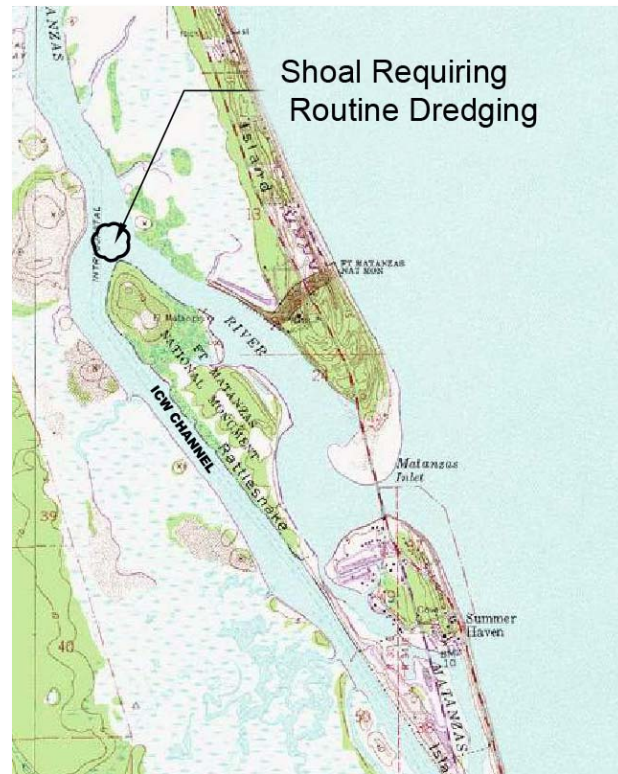
from this location every 2.7 years to maintain ICW navigational depths (Figure 12) (Kabling and Odronec 2010). The dredging and filling activities associated with the ICW have also altered water depths and fetch distances, which have impacted waves and currents and indirectly contributed to local erosion (Price 2005).

Figure 12. Map of shoal located north of Rattlesnake Island (image from Topoquest 2009).
