HISTORIC STRUCTURES REPORT

ARCHITECTURAL DATA SECTION

RESTORATION OF BASEMENT KITCHEN

ENLISTED MENS' BARRACKS "E"

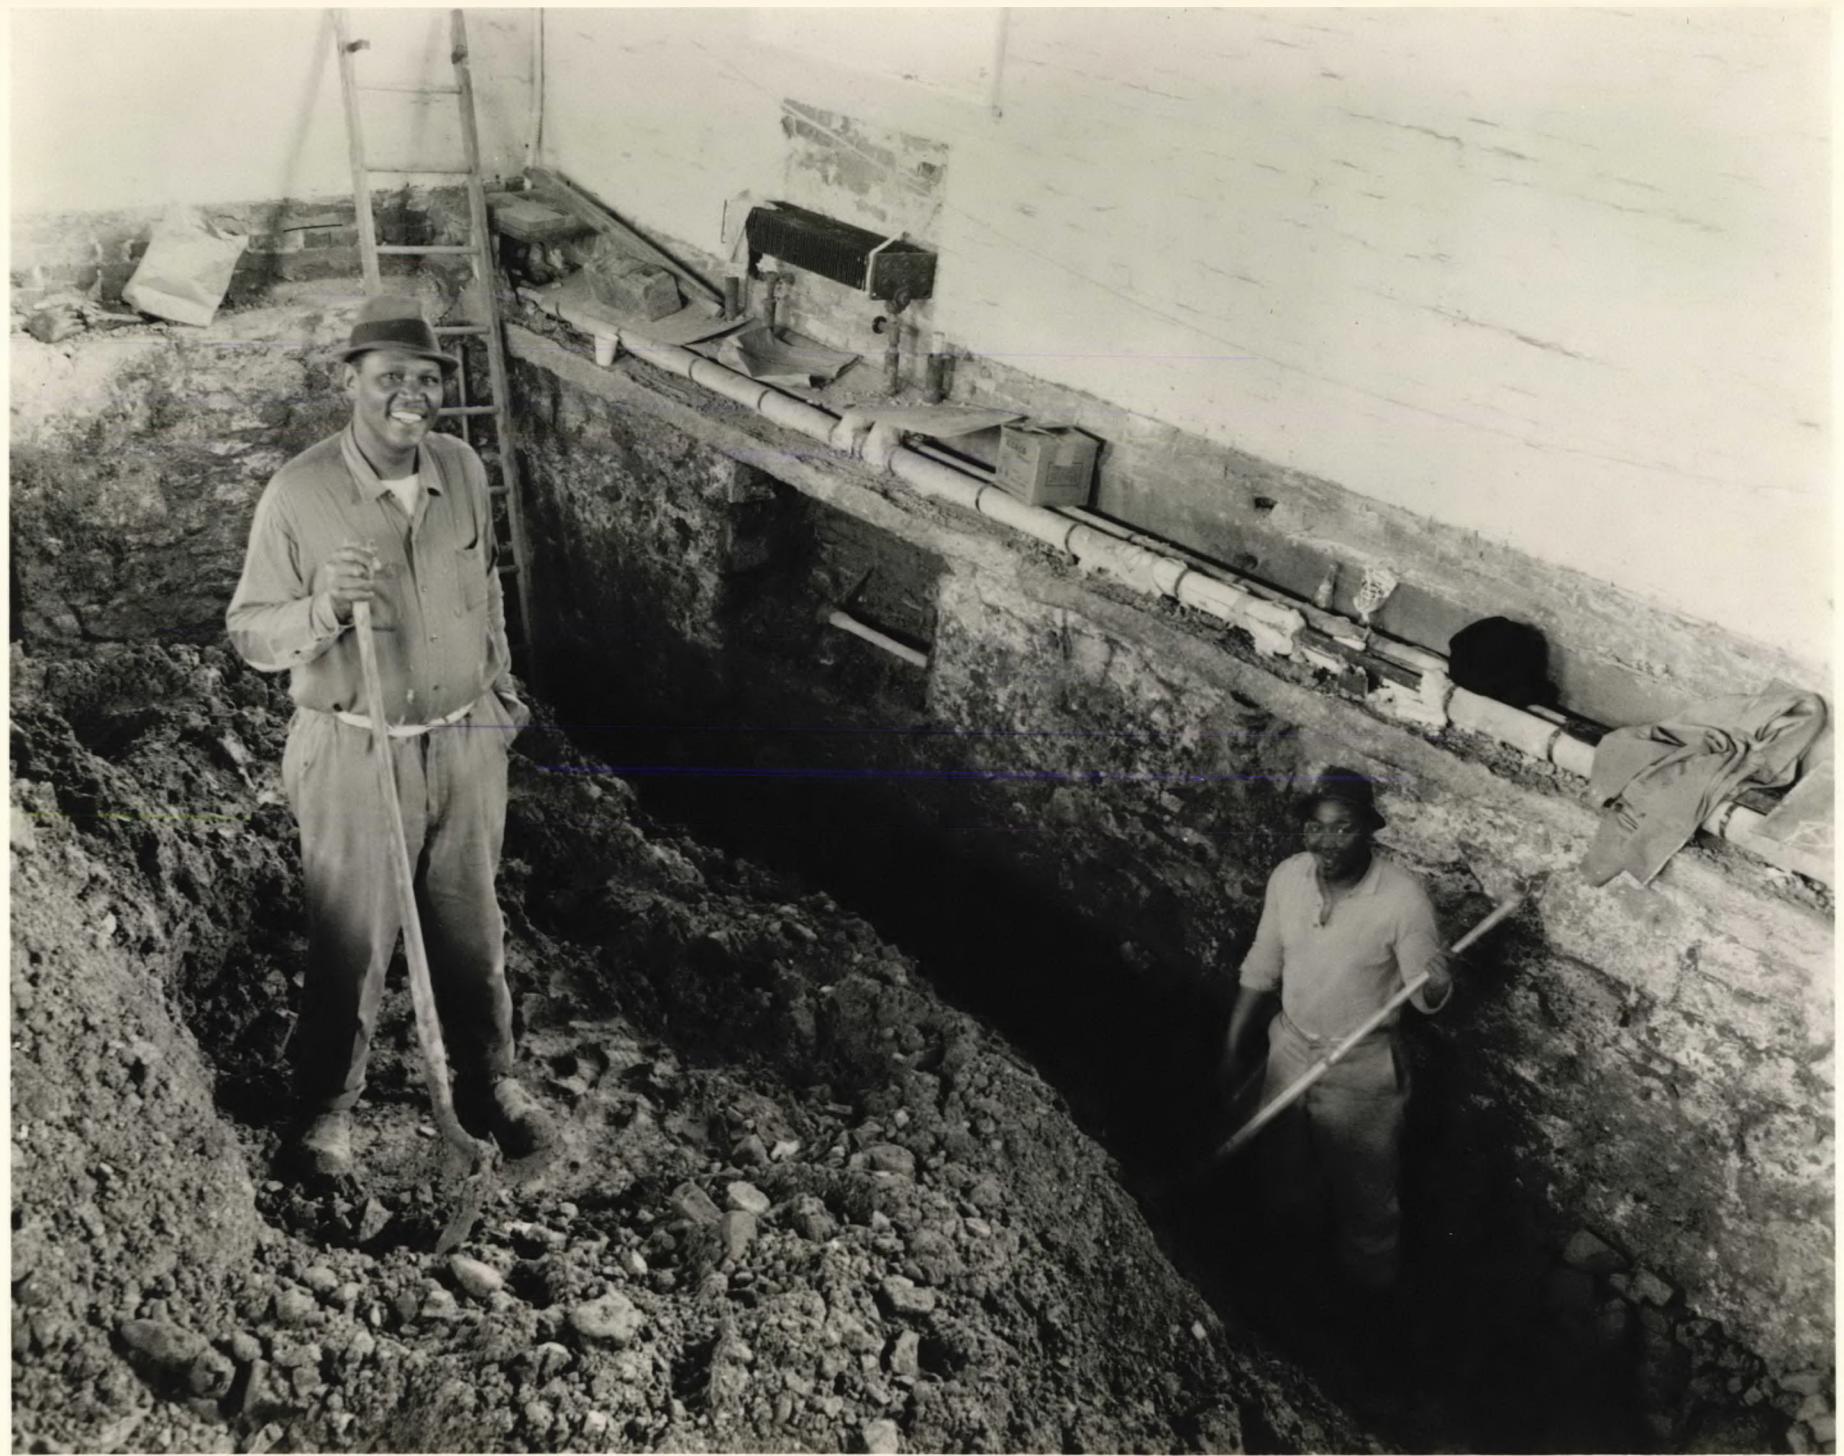
ILLUSTRATION NO. 1

This photograph was taken during the excavation of the Basement Kitchen. The recess in the southeast wall is one of the windows which was bricked-in when the basement was originally filled, circa 1837. The concrete ledge on top of the stone foundation wall was a channel for the supply and return pipes to the convector. The clearly defined line above the ledge is the former first floor line.

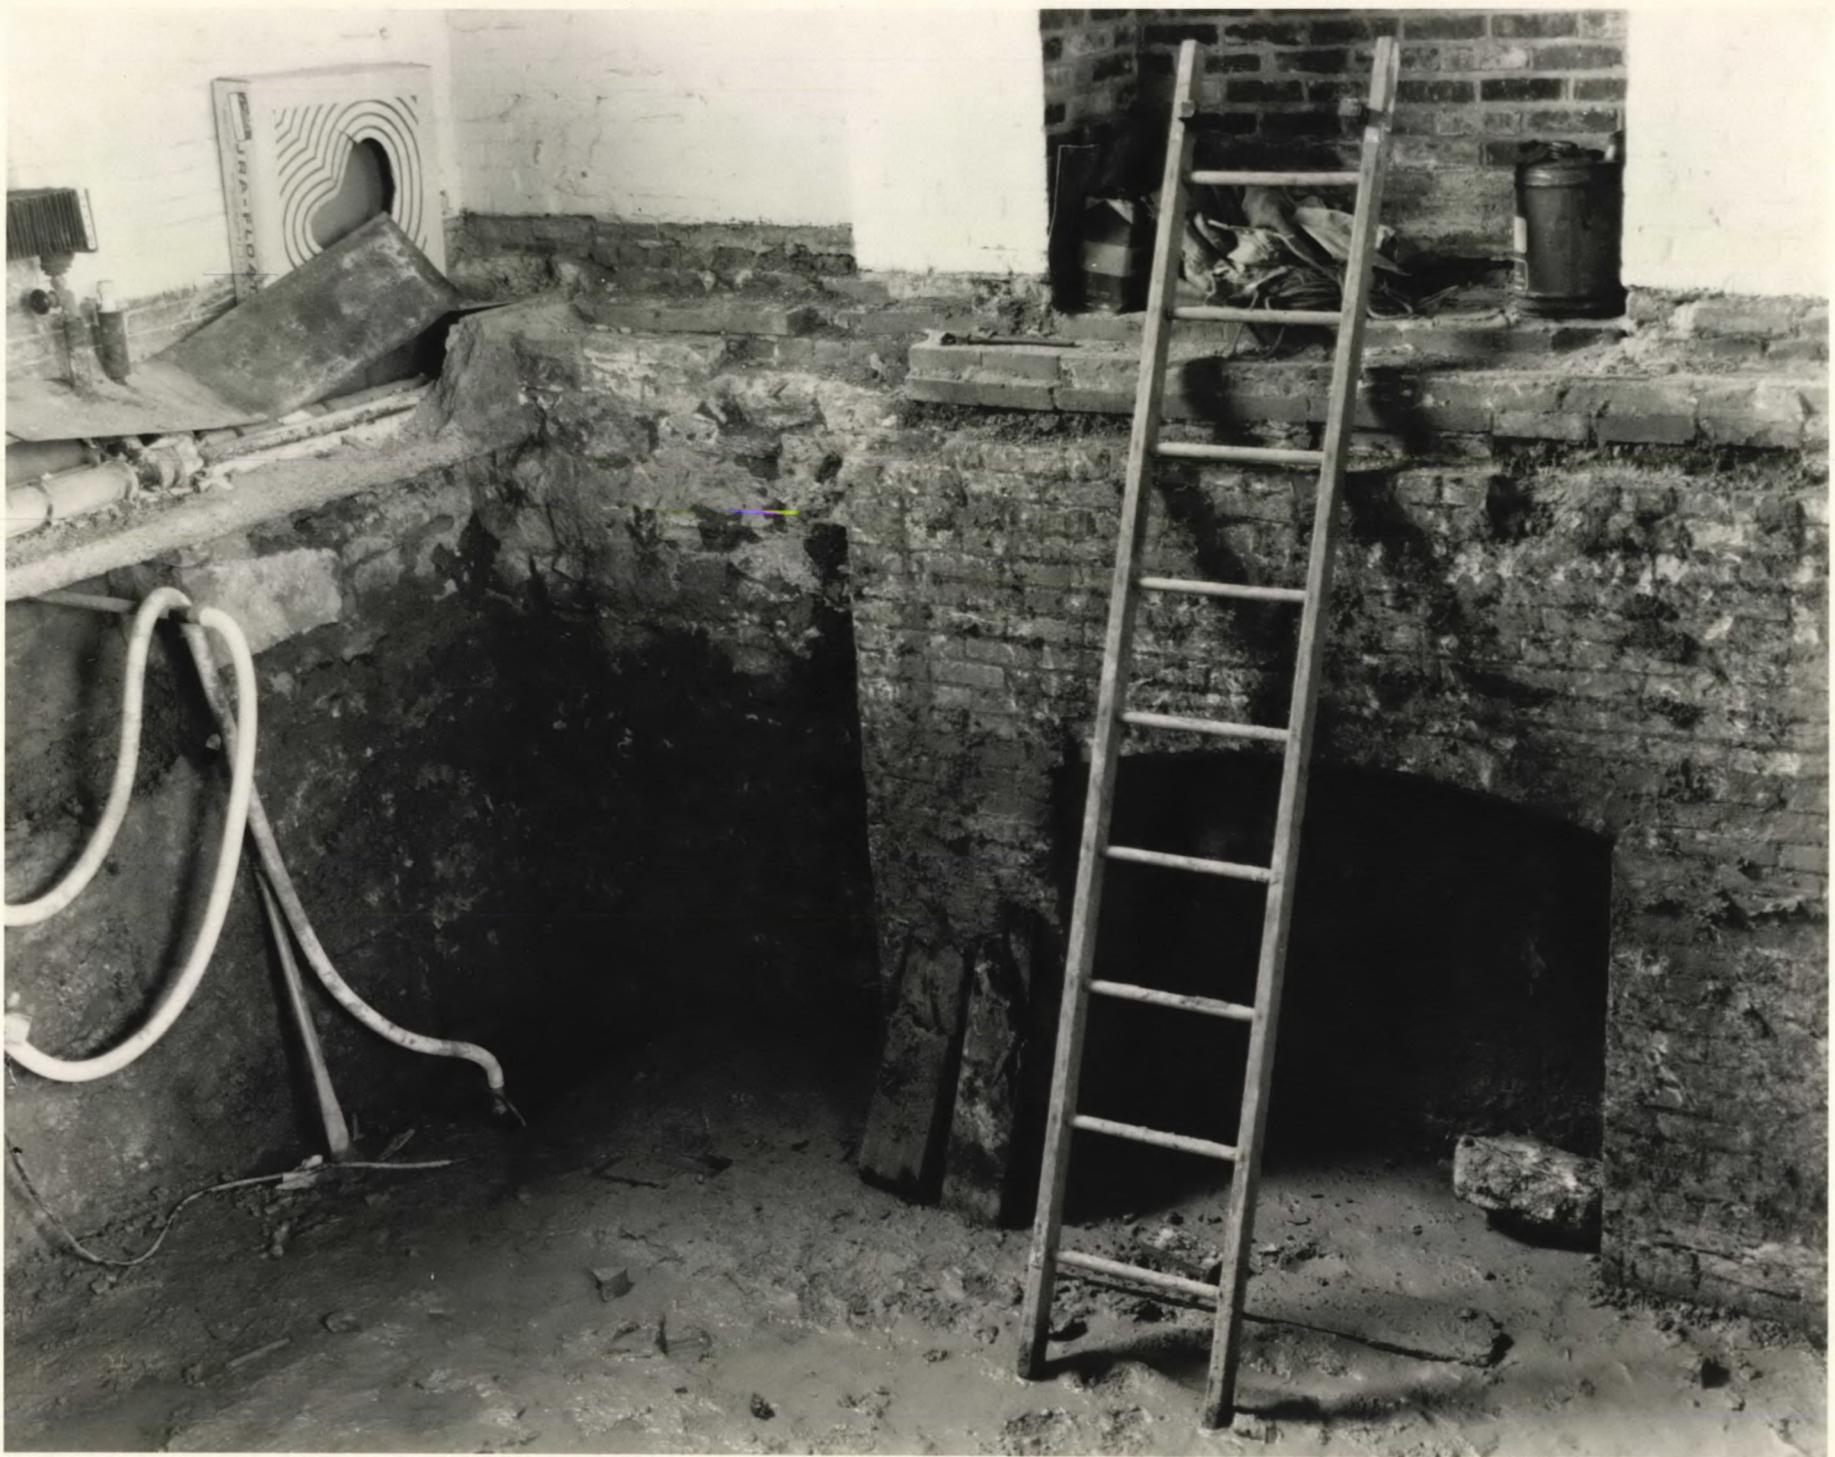
ILLUSTRATION NO. 2

The southwest end of the Kitchen after excavation revealing the fireplace. Note the muddy condition of the floor area. The brick fireplace walls and the stone walls of the basement were covered with three layers of whitewash which is not clearly visible in this photograph due to the mud clinging to the wall surfaces. A sump pit is located at the corner of the room (at the white hose) to keep the water level under control.

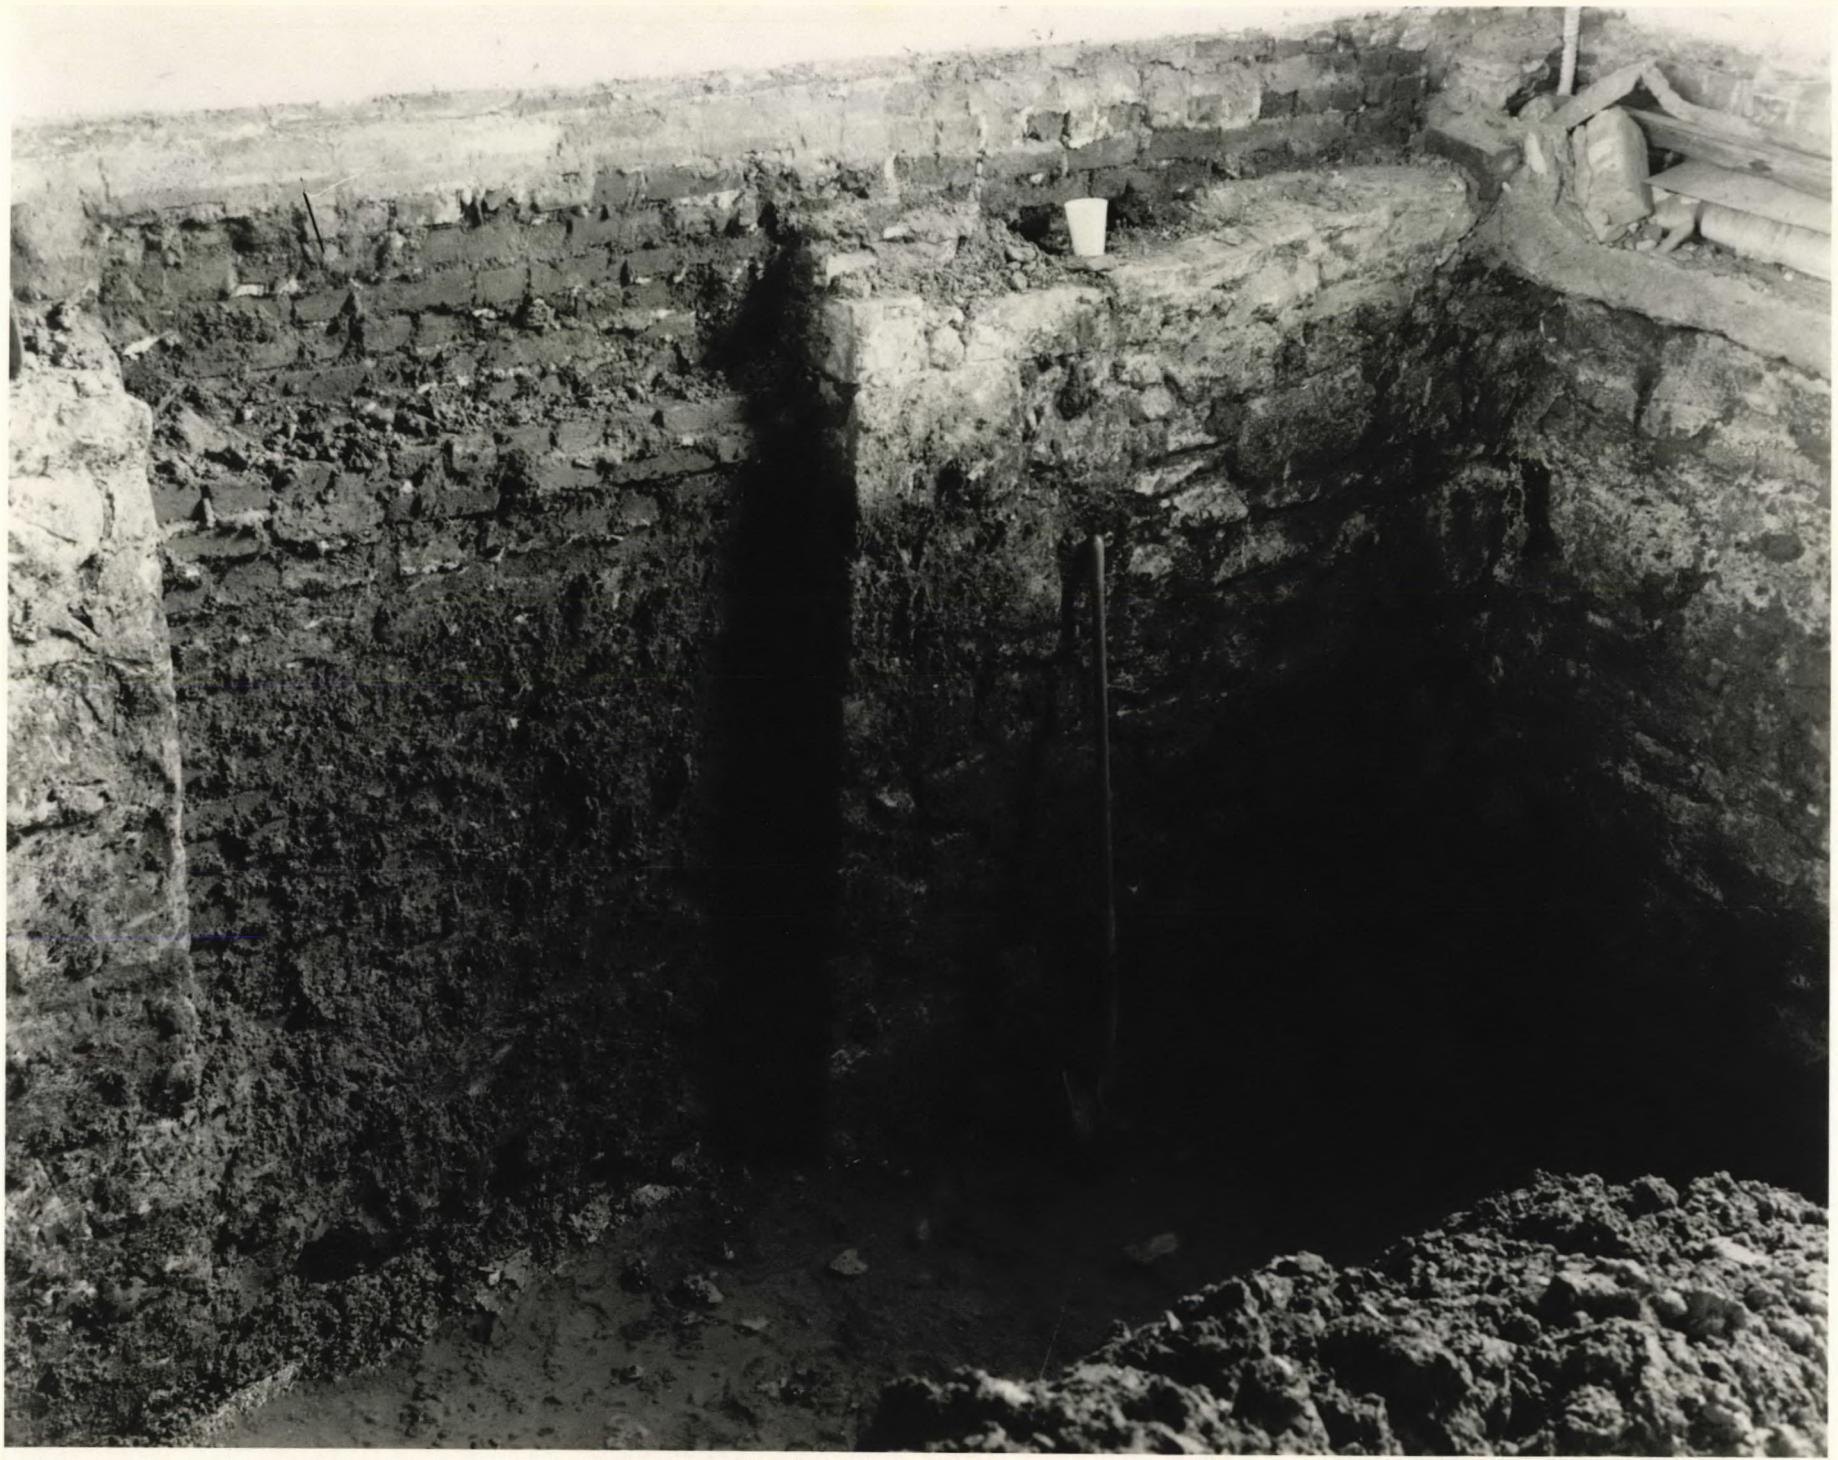
ILLUSTRATION NO. 3

This photograph shows the bricked-in doorway at the northeast end of the room. Note the standing water in front of the wall. The stairs on the exterior of the building which led from this level to the grade level have also been filled-in and covered by a brick walkway.
