Battery Horace Hambright

Fort Pulaski National Monument, Georgia

Historic Structure Report

February 2019

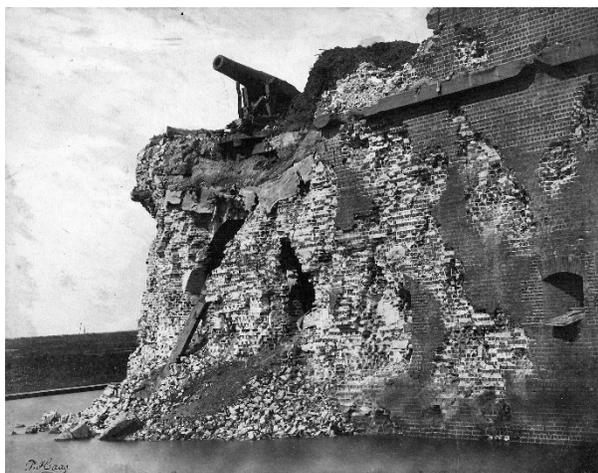
1 FIGURE 5. The southeast corner of Fort Pulaski
 2 following the attack, 1862. (Source: Fort Pulaski
 3 National Monument. Photograph by P. Haas)

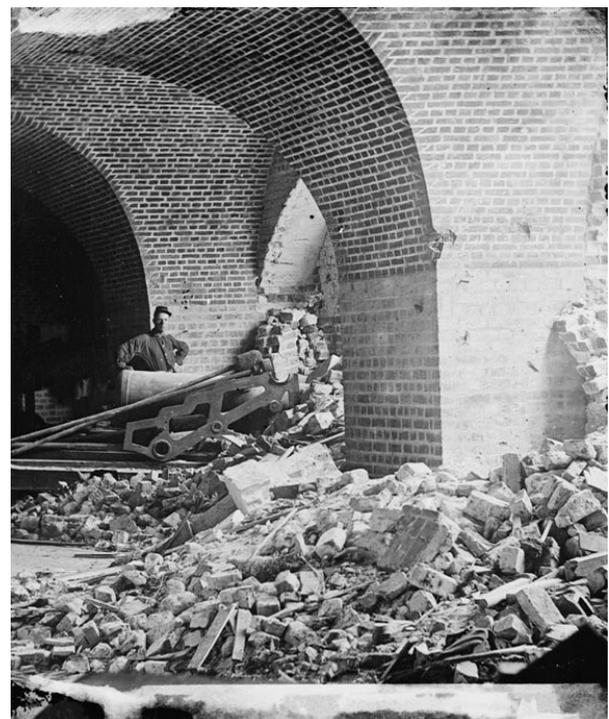
4 FIGURE 6. Fort Pulaski, 1862, showing damaged
 5 casemate masonry at the southeast corner. (Source:
 6 Fort Pulaski National Monument)

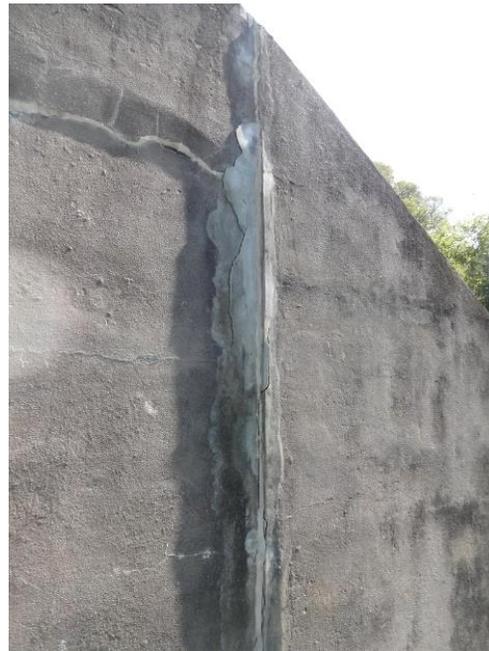
59 **FIGURE 55.** Movement and displacement
60 at a joint in the east retaining wall.

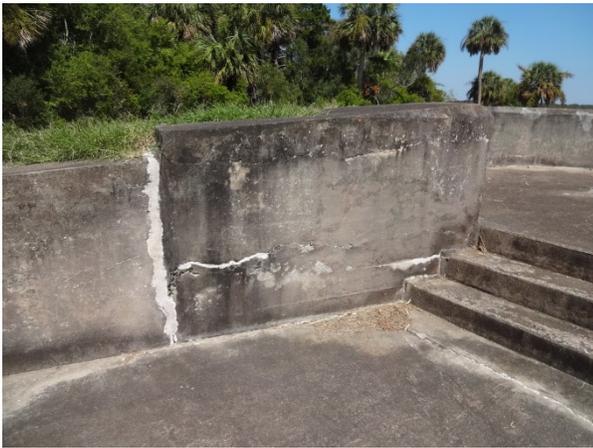
- 45 ■ There are cracks in the parge coating
46 throughout the structure (Figure 56). The
47 cracks are present in walls as well as the floors
48 of the upper level. The width of the cracks was
49 found to be as great as 1/4 inch, but most
50 cracks were narrower and many were hairline
51 in width (Figure 57).
- 52 ■ The parge coating is delaminated in many
53 areas, exposing the original concrete beyond
54 (Figure 58).
- 55 ■ Cracking of the concrete was observed
56 extending through the parge coat and into the
57 structural concrete beyond, particularly at the
58 south walls (Figure 59 and Figure 60).

1 **FIGURE 56.** Cracks were observed in the parge
2 coating throughout the structure.

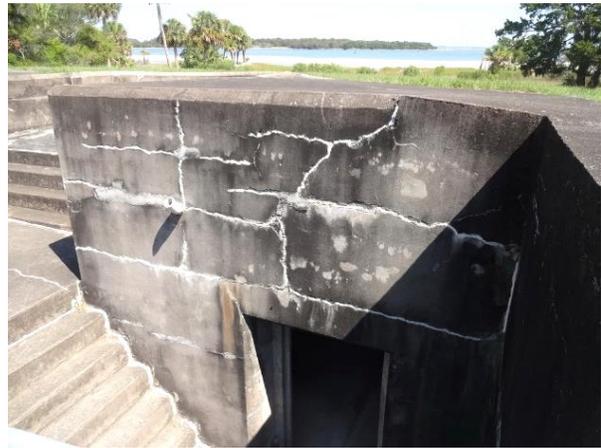
7 **FIGURE 59.** Cracking extended through the parge
8 coating and the concrete structure.

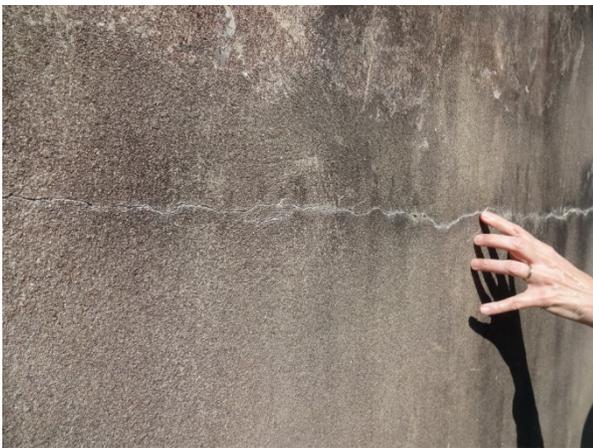
3 **FIGURE 57.** The majority of the cracks observed in the
4 parge coat were narrow.

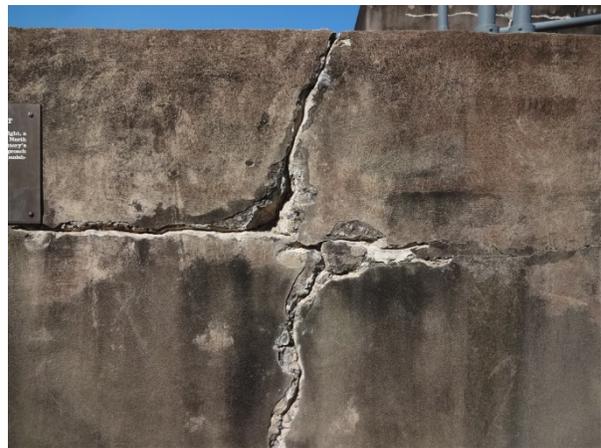
9 **FIGURE 60.** Cracking in the concrete structure
10 extended beyond the parge coating. This crack,
11 along the south wall, appears to have been routed,
12 but not repaired.

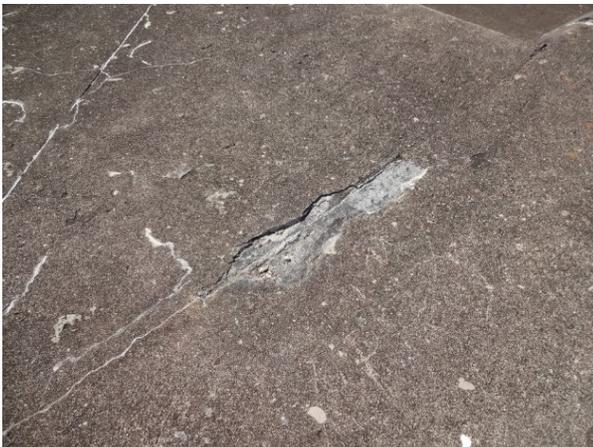
5 **FIGURE 58.** Delaminated parge coating was observed
6 in several locations.

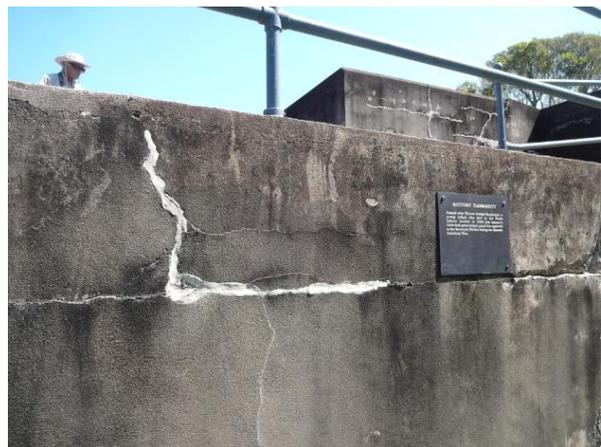
13 **FIGURE 61.** Sealant has been installed at routed-out
14 cracks throughout the structure.

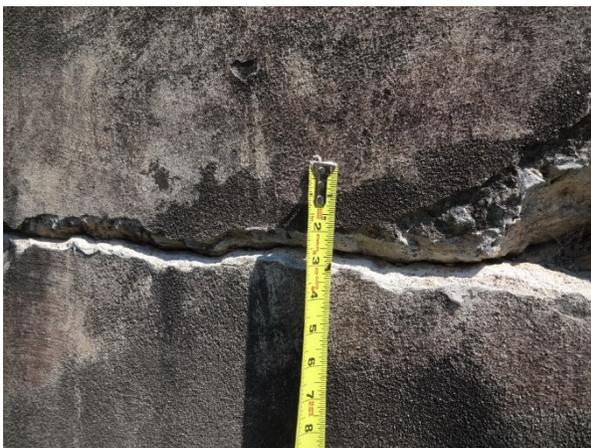
29 **FIGURE 62.** An open crack at the south wall that was
 30 routed out but not repaired.

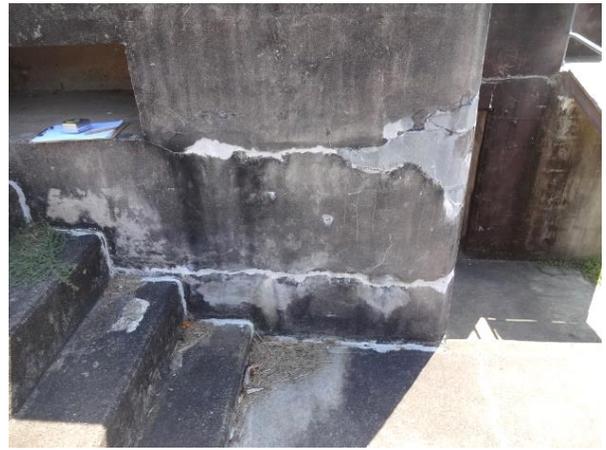
31 **FIGURE 63.** Previous crack repairs and patches are
 32 cracked and debonded.

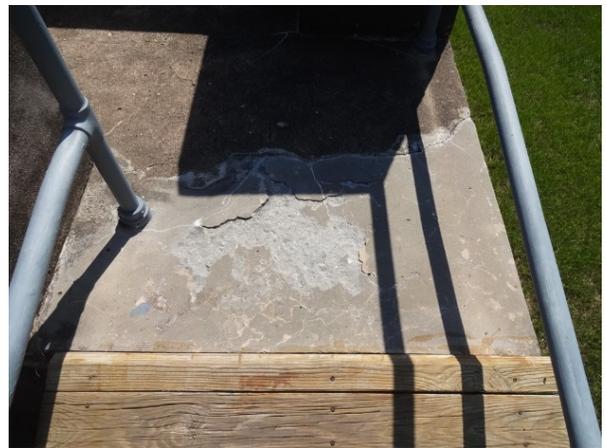
33 **FIGURE 64.** Delaminated patch repairs at the floor of
 34 the observation station.

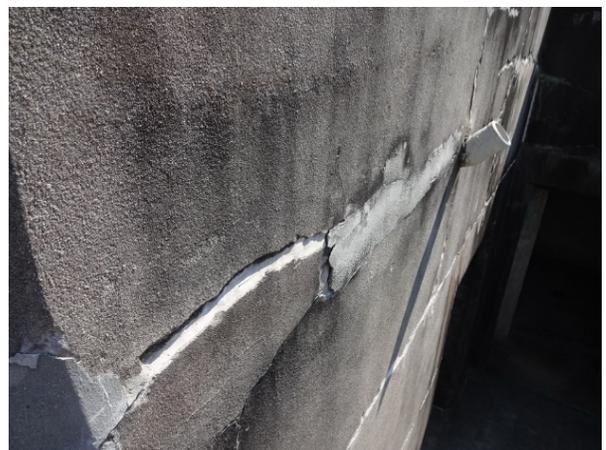
35 **FIGURE 65.** Previous patch repairs are cracked and
 36 delaminated.

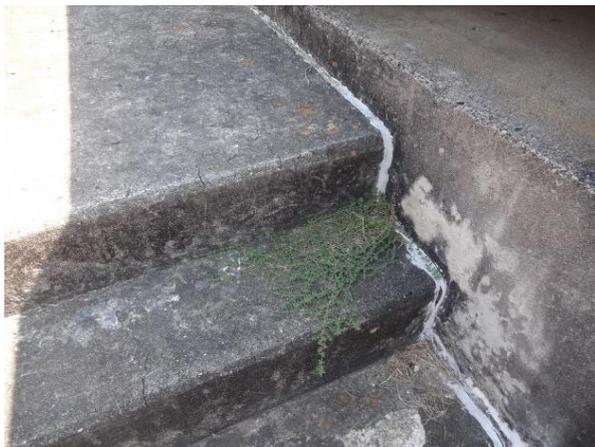
1 **FIGURE 66.** Biological growth was observed at a joint
2 between stairs and an adjacent wall.

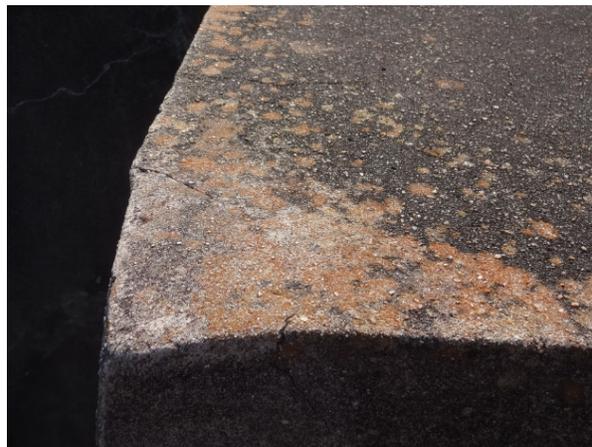
24 **FIGURE 67.** Biological growth observed at the top of
25 a concrete wall.

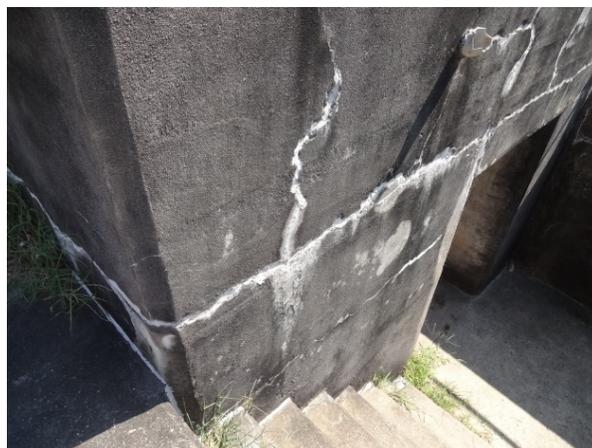
26 **FIGURE 68.** Leaching from the concrete was observed
27 in several locations, particularly near cracks.

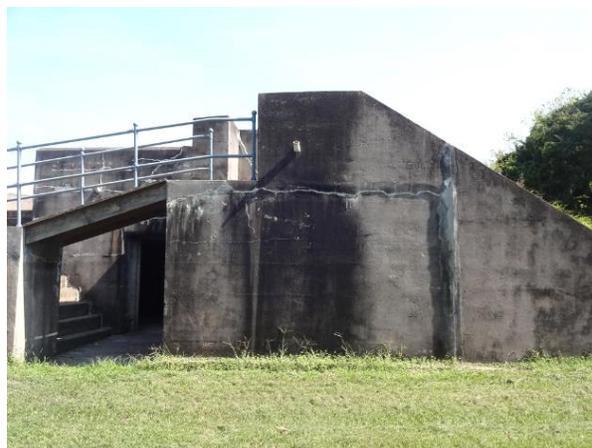
28 **FIGURE 69.** Staining from organic growth and soil
29 accumulation at the east retaining wall and
30 observation station.

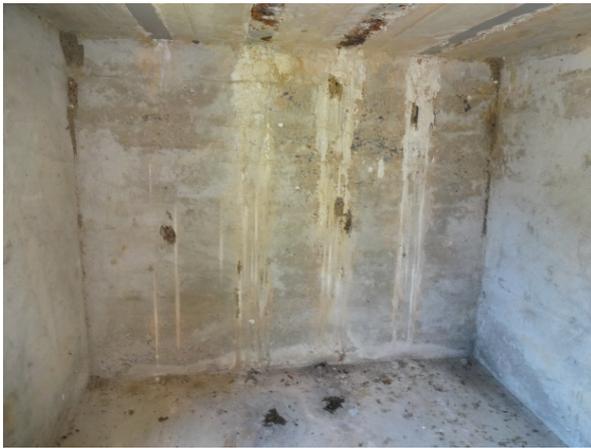
1 **FIGURE 70.** Surface corrosion of the embedded steel
 2 beams was observed in all interior spaces. Note the
 3 run-down staining associated with the steel beams at
 4 the back wall.

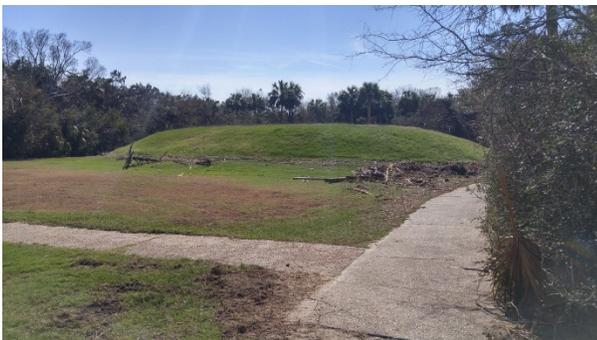
10 **FIGURE 76.** Rack line on Battery Hambright, several
11 days after Hurricane Matthew after floodwaters had
12 receded. (Source: Fort Pulaski National Monument)
