Visitor Center

Fort Pulaski National Monument, Georgia

Historic Structure Report

July 2019

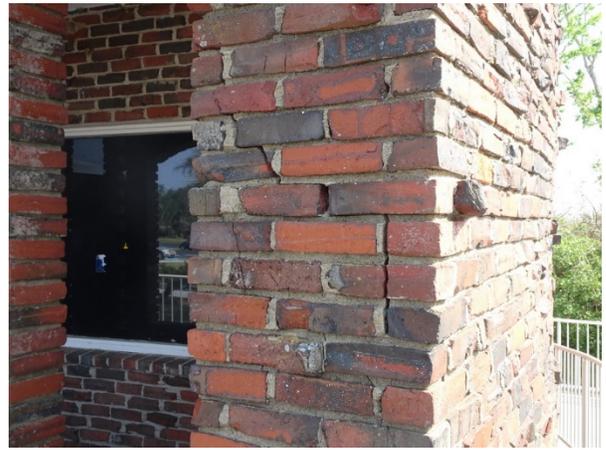
FIGURE 78. Step cracking in brick masonry return end wall at west entrance landing.

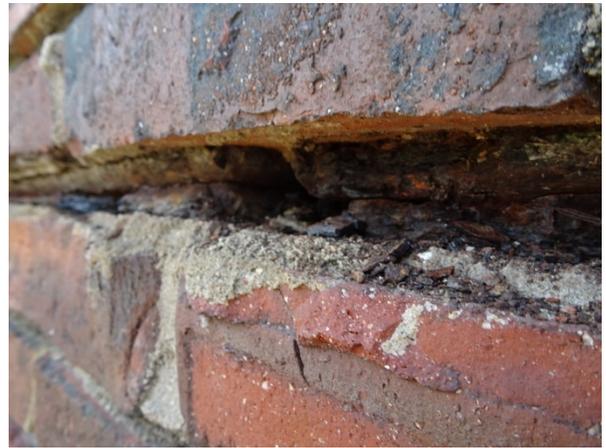
FIGURE 79. Corrosion at lower shelf angle.

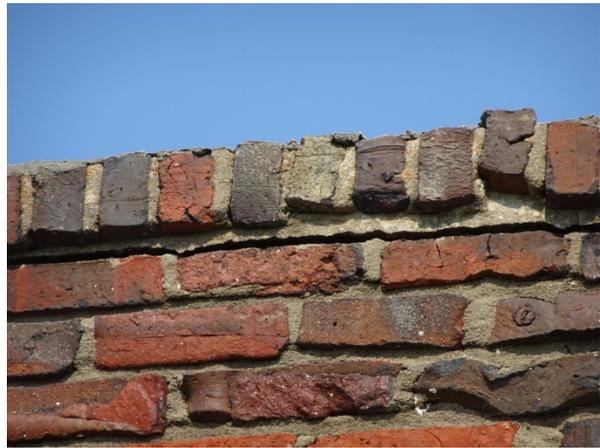
FIGURE 82. Cracked joints at brick coping units.

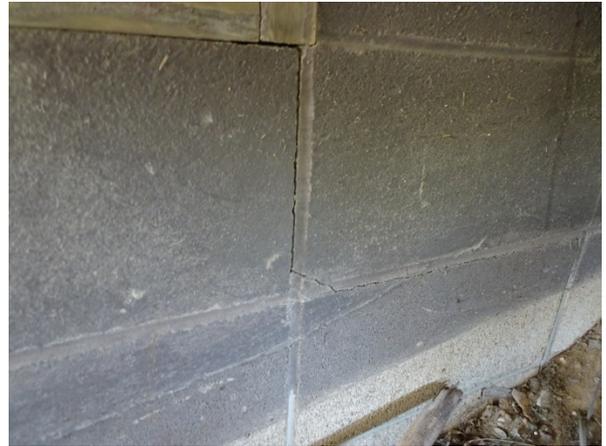
- At one location, cracked and open mortar joints were observed at the CMU foundation wall (Figure 88). The cracking extended from a vent opening.

FIGURE 88. Cracked and open mortar joints at CMU foundation wall.

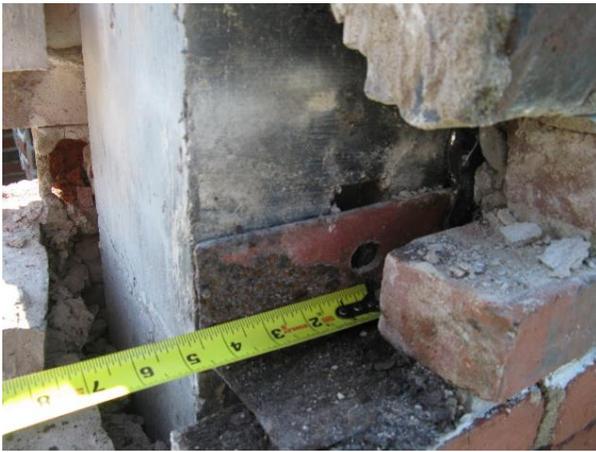
FIGURE 95. Missing bolt at end of angle at inspection opening no. 2.

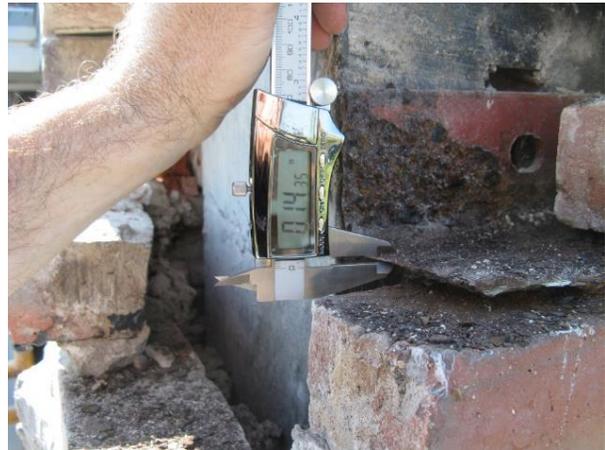
FIGURE 97. Severe corrosion at exposed end of shelf angle.

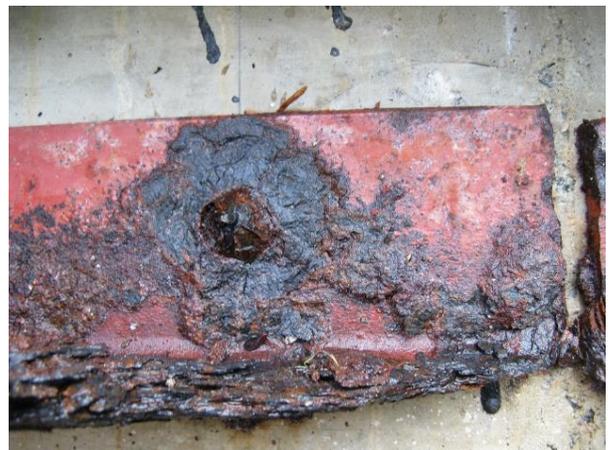
FIGURE 104. Severely corroded bolt at shelf angle segment at left end of inspection opening no. 4.

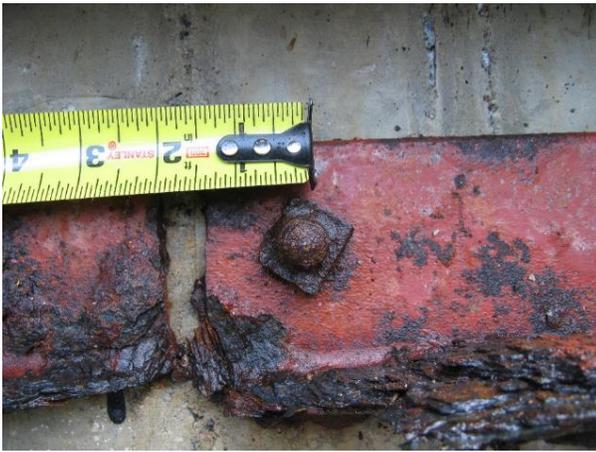
FIGURE 105. Bolt with corroded nut in shelf angle segment at right end of inspection opening no. 4.

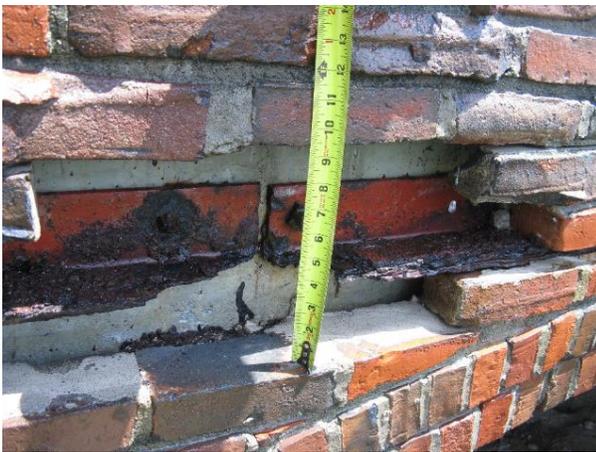
two courses of brick above the angle and one below (Figure 103). The angle dimensions matched those in inspection opening no. 3. The opening was made at the ends of adjacent shelf angle segments. The aluminum laminate flashing terminated approximately 9 inches above the angle and extended into the brick veneer. Bolts were observed near the end of each shelf angle segment. The bolt in the segment exposed at the left side of the opening was severely corroded (Figure 104). The bolt in the shelf angle segment exposed at the right side of the opening exhibited surface corrosion, but the nut had lost significant section (Figure 105). Both angles exhibited full section loss across the horizontal leg over a portion of the exposed area (Figure 106).

FIGURE 106. Complete section loss of horizontal leg of both shelf angles at inspection opening no. 4.

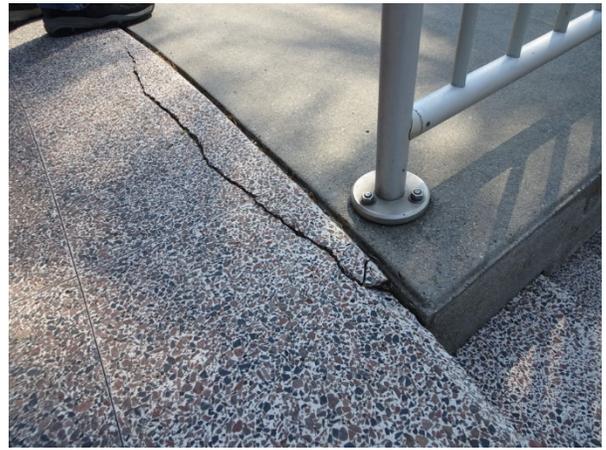
FIGURE 110. Cracking at landing slab/ramp abutment.

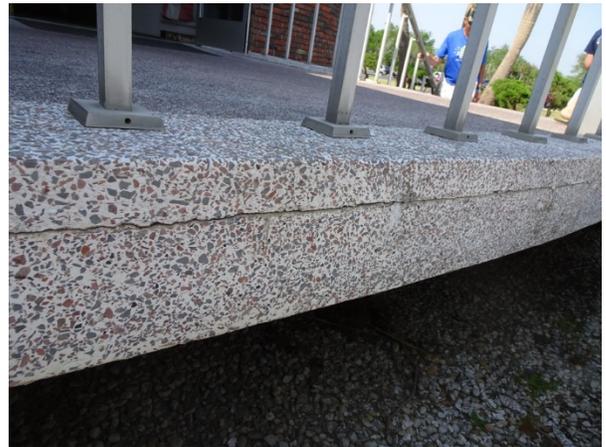
FIGURE 111. Horizontal cracking at curb.

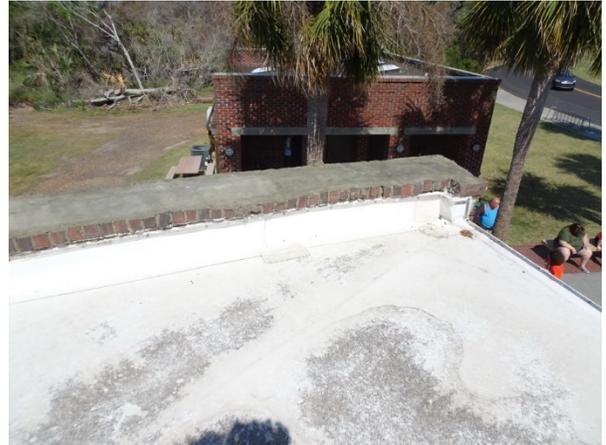
- Evidence of ponding water and biological growth was observed at the lower roof (Figure 119). While no actual ponding was observed, staining and discoloration on the roof indicate these conditions are likely present after heavy rainfall.

FIGURE 119. Ponding and biological growth at lower roof.

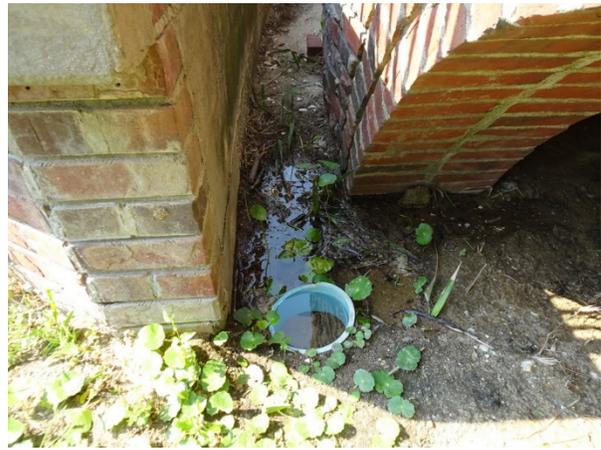
FIGURE 122. Ponding at storm drain.

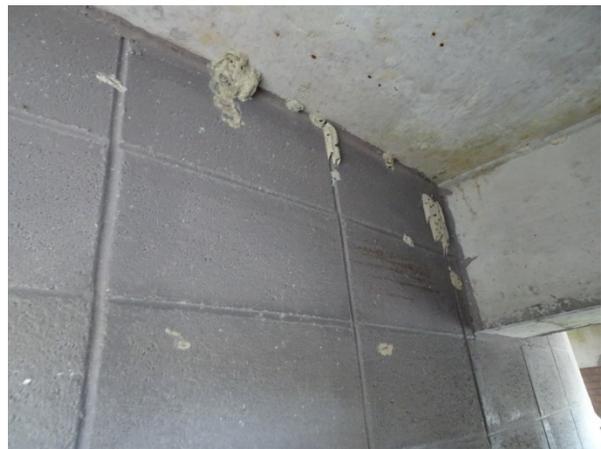
FIGURE 123. Mud dauber nests, observed at the perimeter crawl space.

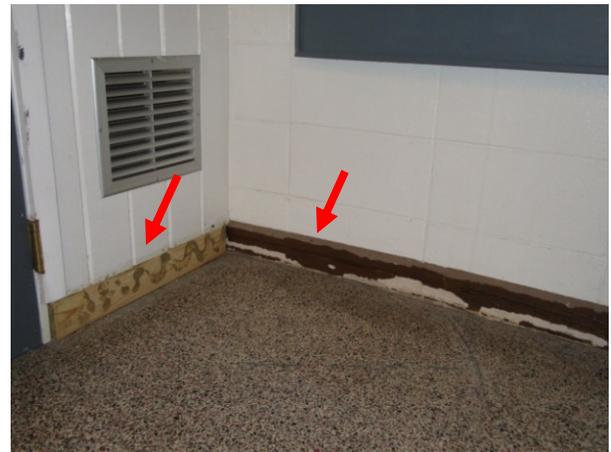
FIGURE 130. Missing vinyl cove base and remaining adhesive.

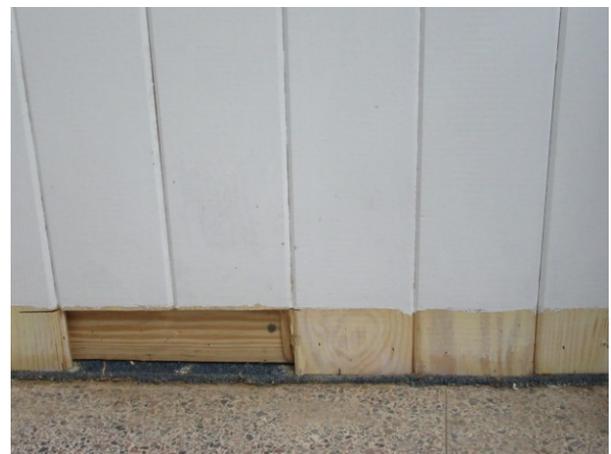
FIGURE 131. Missing wooden baseboard revealing unpainted wood paneling.

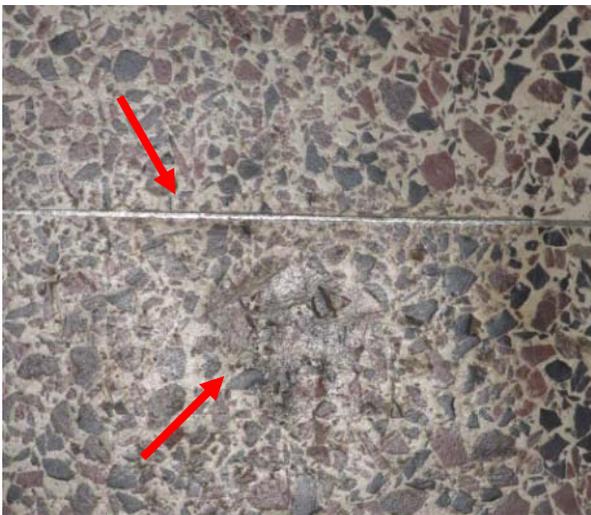
FIGURE 138. Metal divider strip and spalling of terrazzo.

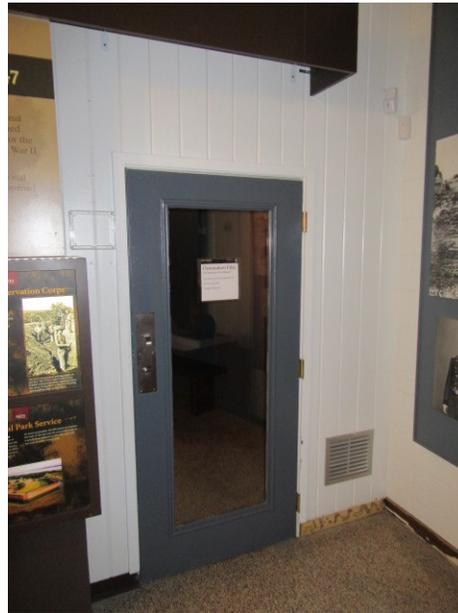
FIGURE 147. Painted stile-and-rail wood door at theater. Note missing vinyl cove base and exposed adhesive on the walls adjacent to the door.

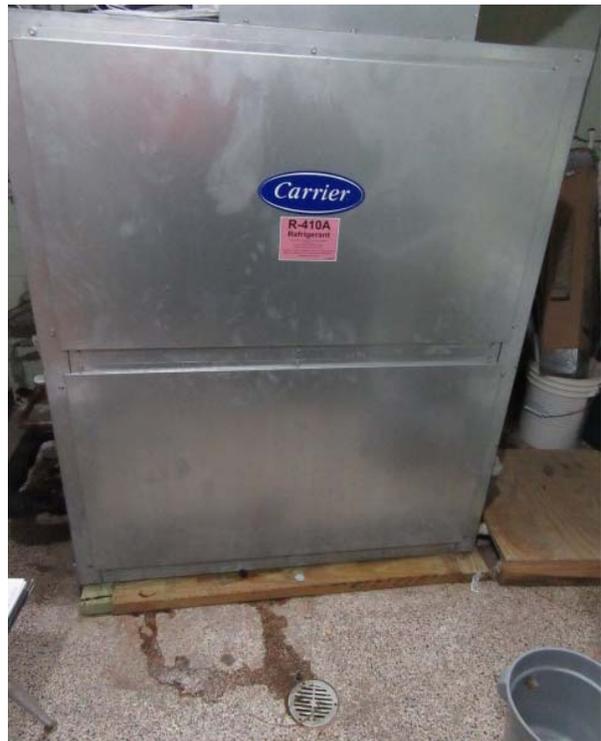
FIGURE 192. Condensate on the floor seeping from under the air handler.

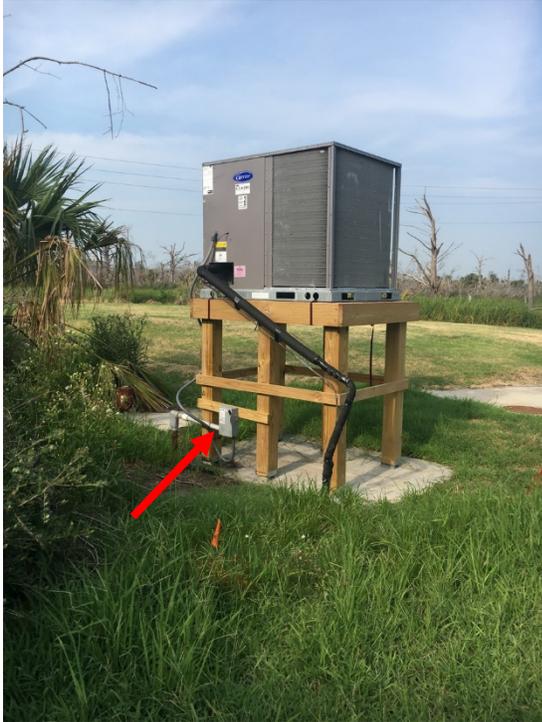
FIGURE 193. The new support for the ten-ton condensing unit is much higher than the previous structure, but the electrical disconnect for the unit remains close to the ground. (Source: Fort Pulaski National Monument)
