**Fort Pulaski National Monument
Quarantine Attendants' Quarters**

**Historic
Structure
Report**

March 2004

National Park Service

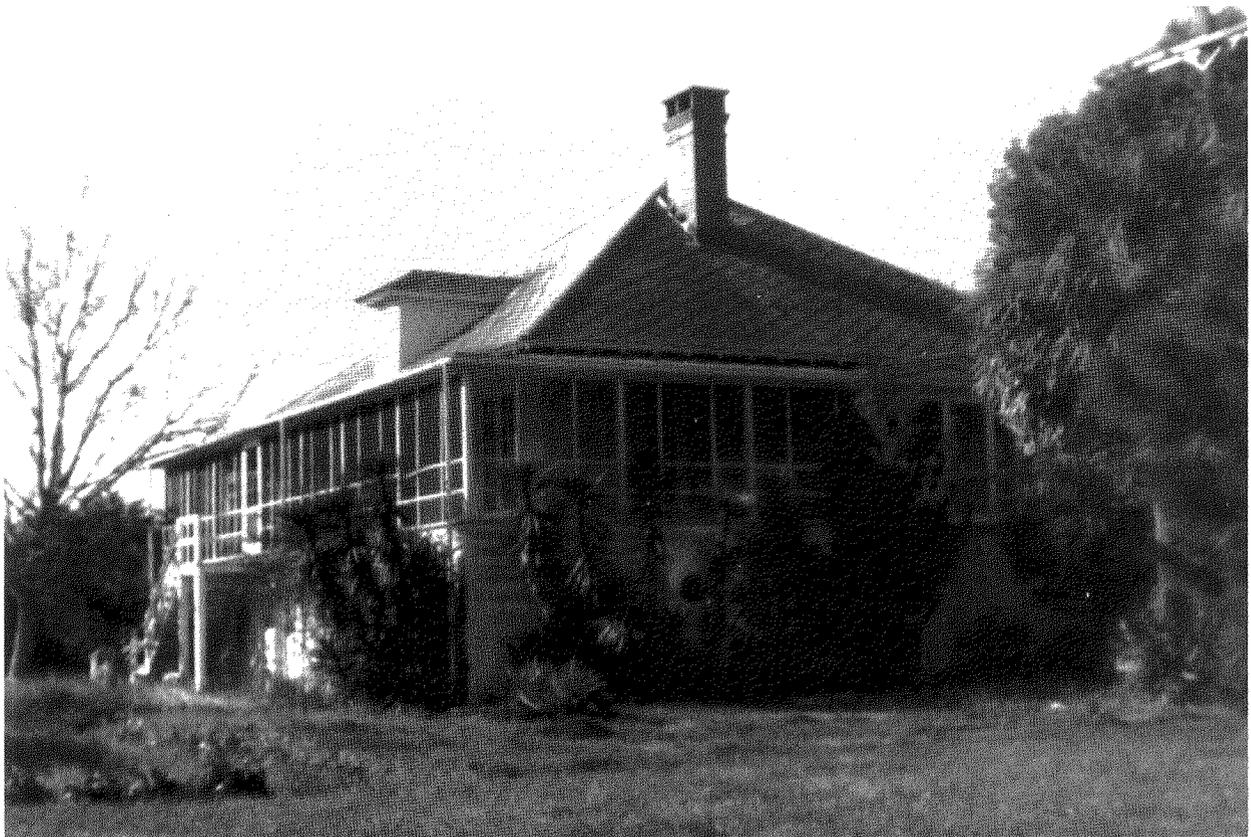
FIGURE 18. View of house from northeast, January 1960. Note unusual porthole windows and missing front stairs. (FOPU Coll.)

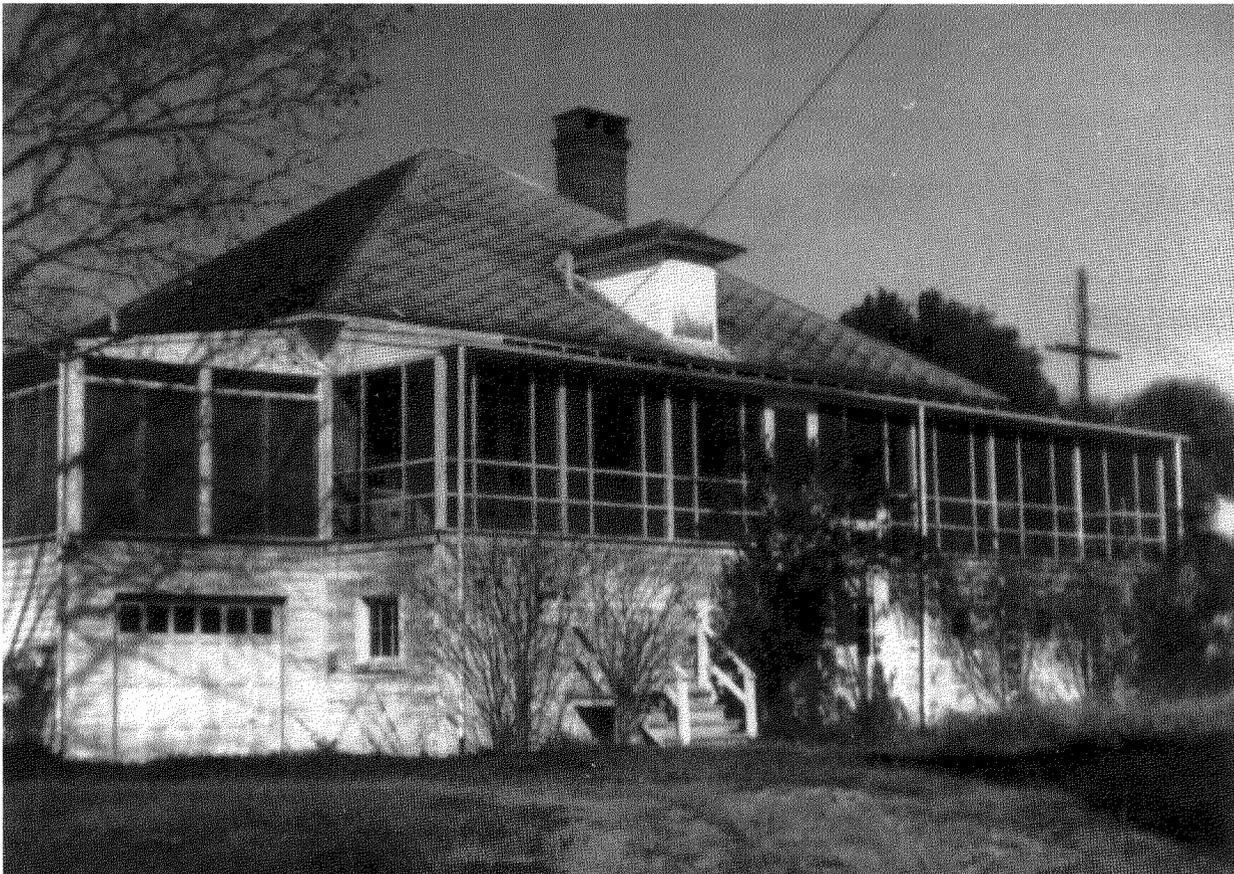
FIGURE 19. View of house from southeast, January 1960. Note jalousie windows installed in 1953 and the closed dormer window. (FOPU Coll.)

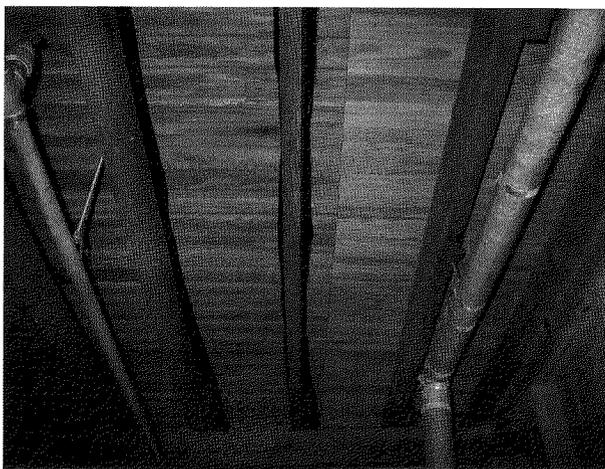
FIGURE 30. View of underside of east porch, with new flooring visible at right where older flooring has been removed. (NPS-SERO-CR, 2003)

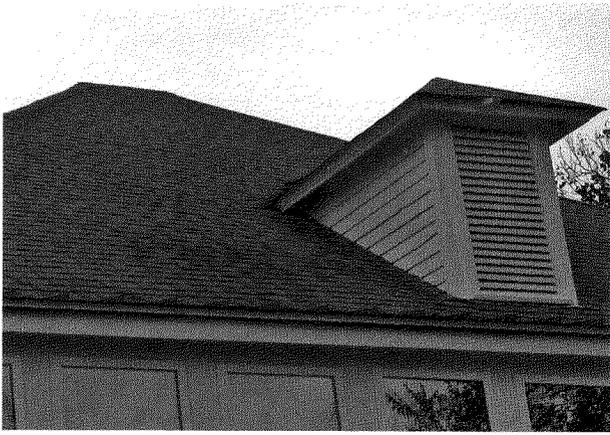
FIGURE 34. View east, showing original dormer. Note that modern fascia replaces original crown molding. (NPS-SERO-CR, 2003)

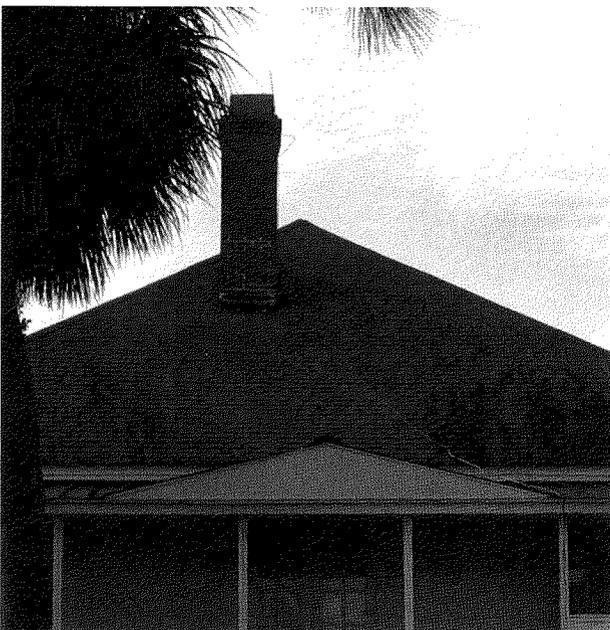
FIGURE 35. View south, showing modern gable over porch entrance. Note that modern fascia replaces original crown molding. (NPS-SERO-CR, 2003)

- Restore small gable over north entrance.
- Recreate openings at basement level and replace plastic lattice with lap siding.
- If necessary, preserve window wall that created Room 110; otherwise remove and restore west porch.

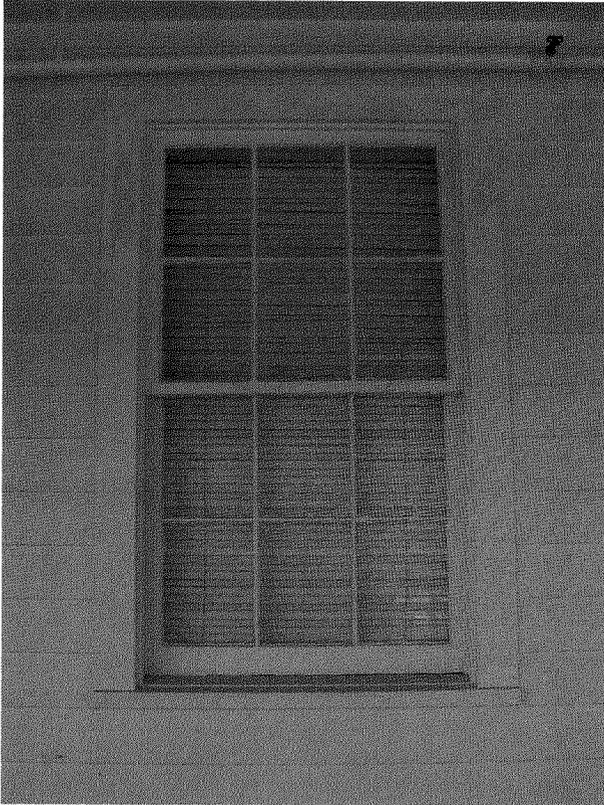
FIGURE 39. View of typical double-hung window from the historic period. (NPS-SERO-CR, 2003)

- Document the quarantine station as a whole through research in Navy and Public Health Service archives.
- Maintain and preserve all of the present wooden, six-over-six windows, repairing weather-stripping and adding storm windows if necessary for energy efficiency.

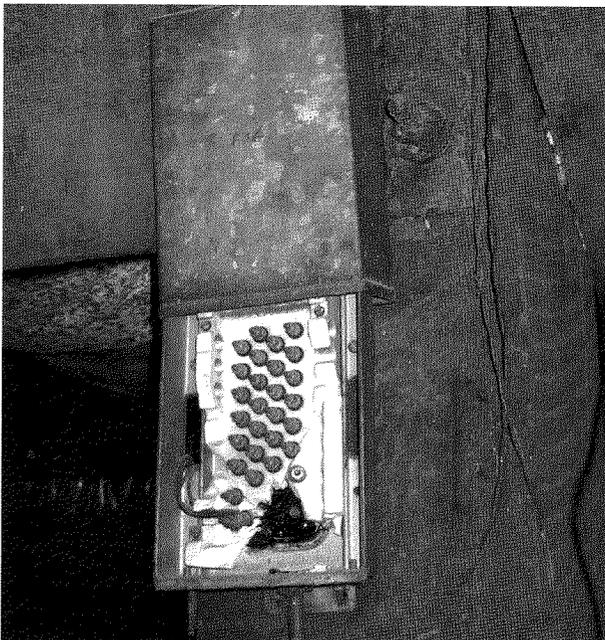
FIGURE 73. View of abandoned telephone junction box in basement. (NPS-SERO-CR, 2003)
