Fort Union National Monument

National Park Service
U.S. Department of the Interior

UNDERSTANDING THE DETERIORATION OF ADOBE WALLS

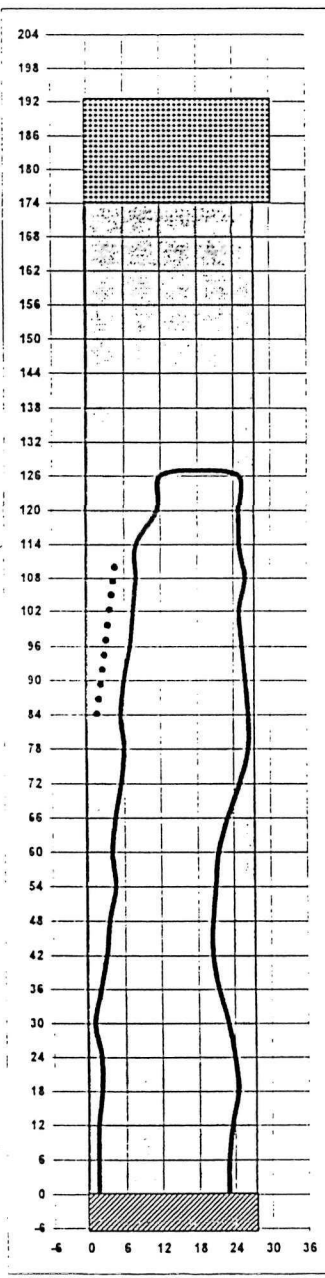
Fort Union National Monument — Adobe Wall Cross Section

The heavy black line on the illustration at left shows the present cross section of the eroded adobe wall of HS 36 at the location shown on the photograph, above, and plan, below. It is overlaid on a shaded field illustrating a cross section of the original adobe wall.
