Reconnaissance-level Survey *of* Fort Nisqually Living History Museum

DAHP Project: 2019-09-06886

October 4, 2019

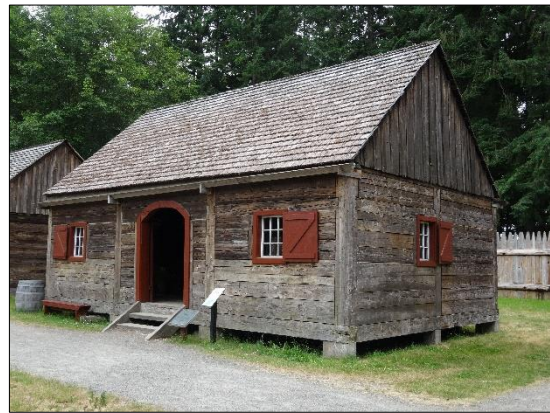
Current physical description: The Granary is one of two 19th-century fort buildings at the museum site. It is situated in the southwest quadrant of the fort and is oriented facing north. It is a one-story building constructed of hand-hewn, squared timbers with a rectangular footprint that measures approximately 20' by 31'. It has a medium-pitched, side-gable roof covered with cedar shingles and gable ends with board-and-batten cladding. V-shaped wood gutters rest on brackets along the building's north and south eaves. The building's horizontal timbers are set into notched vertical timbers. The building is elevated several inches and rests on newer concrete post bases. The Granary's type of construction, typical of Hudson's Bay Company (HBC) structures of the period, is often termed "*poteaux sur sole*, or post on sill.

Figure 4. Granary, June 2019. Photo by the author.

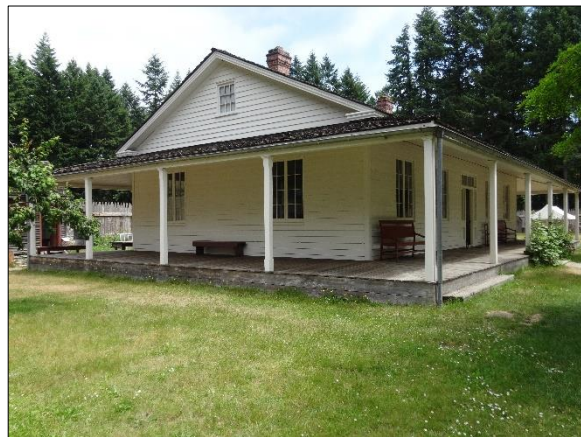
Figure 6. Factor's House, June 2019. View of southwest corner. Photo by the author.

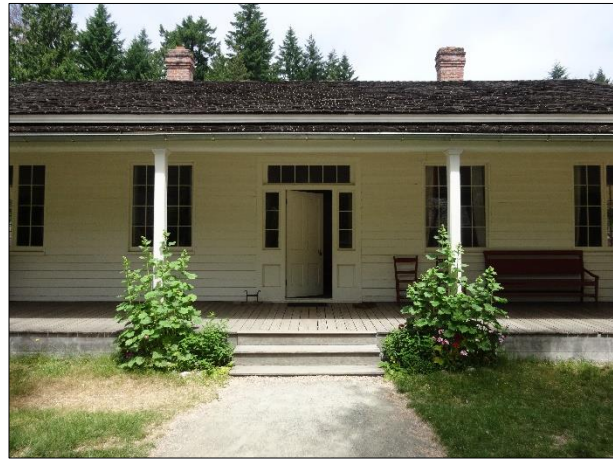
Figure 7. Factor's House, June 2019. Primary entrance.
Photo by the author.

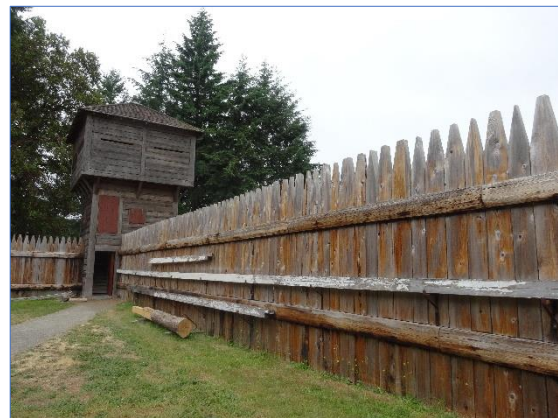
Figure 9. Palisade, June 2019. Photo by the author.

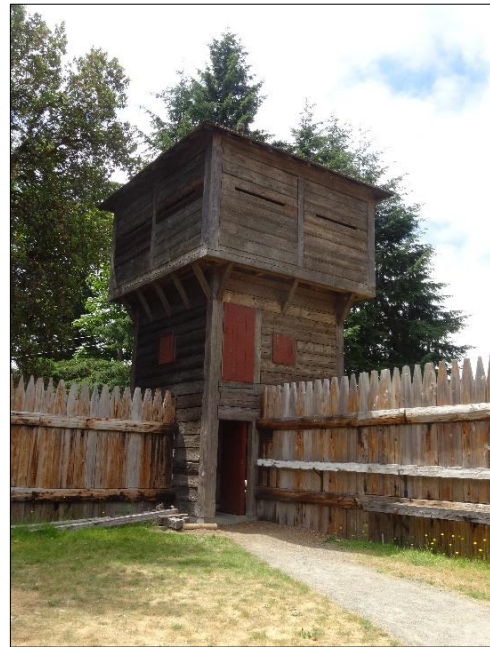
Figure 11. Southwest bastion, June 2019. Photo by the author.

While the Southwest Bastion currently reflects a more accurate representation of the historic fort's bastions, it retains little integrity from its New Deal-era construction. However, register eligibility assessments should take into consideration its potential significance as a reconstruction and its ability to convey its historical function.

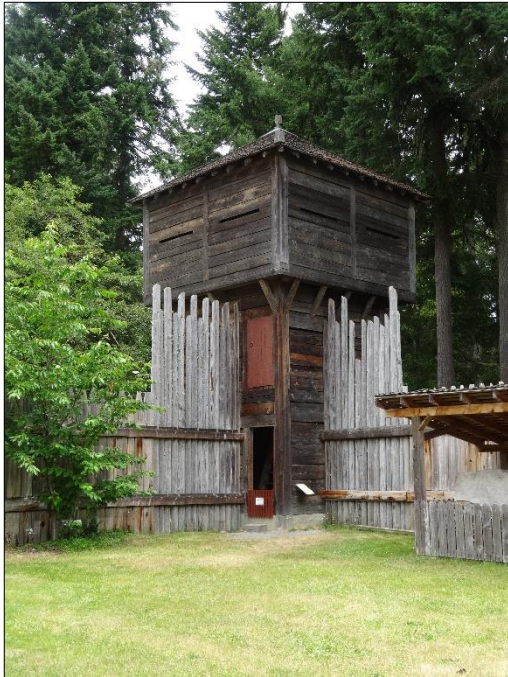
Figure 14. Northeast bastion, June 2019. Photo by the author.

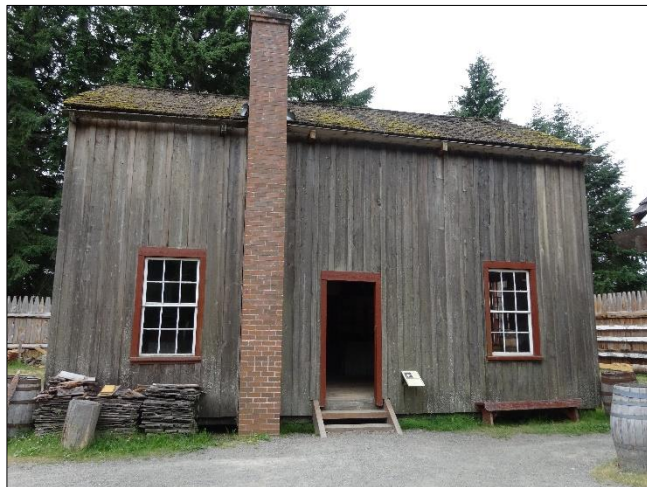
Figure 16. Trade Store, June 2019. Photo taken by the author.

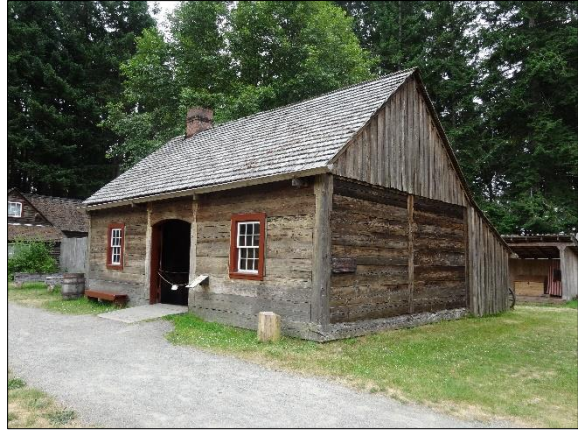
Figure 18. Blacksmith Shop, June 2019. Photo by the author.

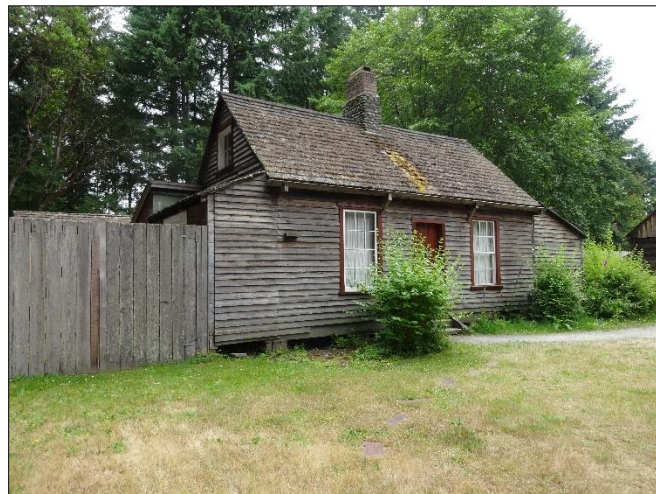
Figure 20. Caretaker's House, June 2019. Photo by the author.

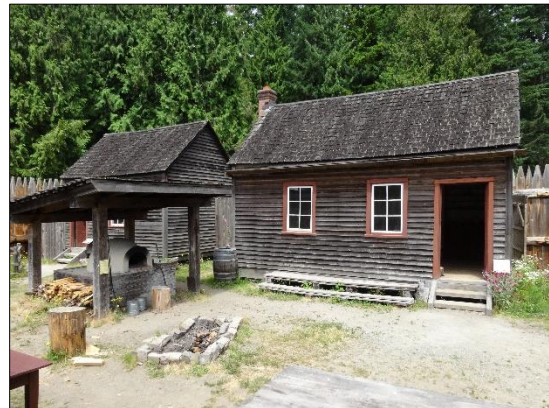
Figure 22. Cook House, June 2019. Photo by the author.

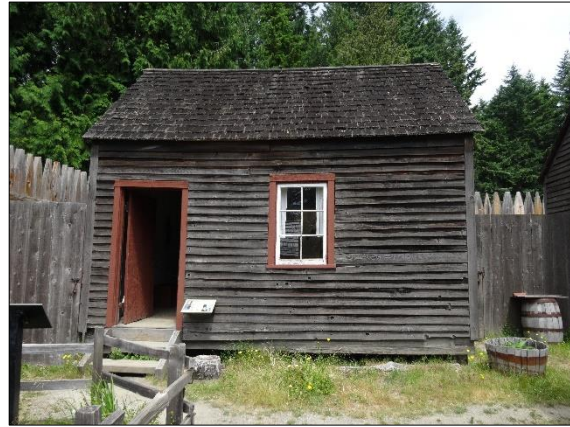
Figure 24. Wash House, June 2019. Photo by the author.

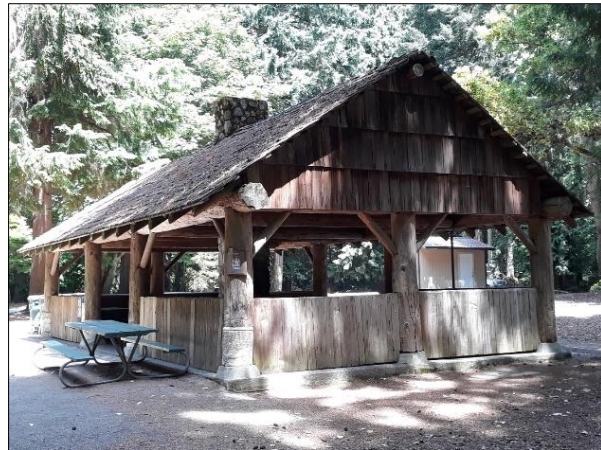
Figure 26. WPA Picnic Shelter, June 2019. Photo by the author.

Change over time: Repairs to the picnic shelter have included the installation of concrete bases to replace rotted post bases and the replacement of roofing where necessary. The structure retains a high degree of integrity and is able to convey its original function and historical significance.
