**Frederick Douglass
Home**

HISTORIC STRUCTURES REPORT

ARCHITECTURAL DATA

JUNE 1970

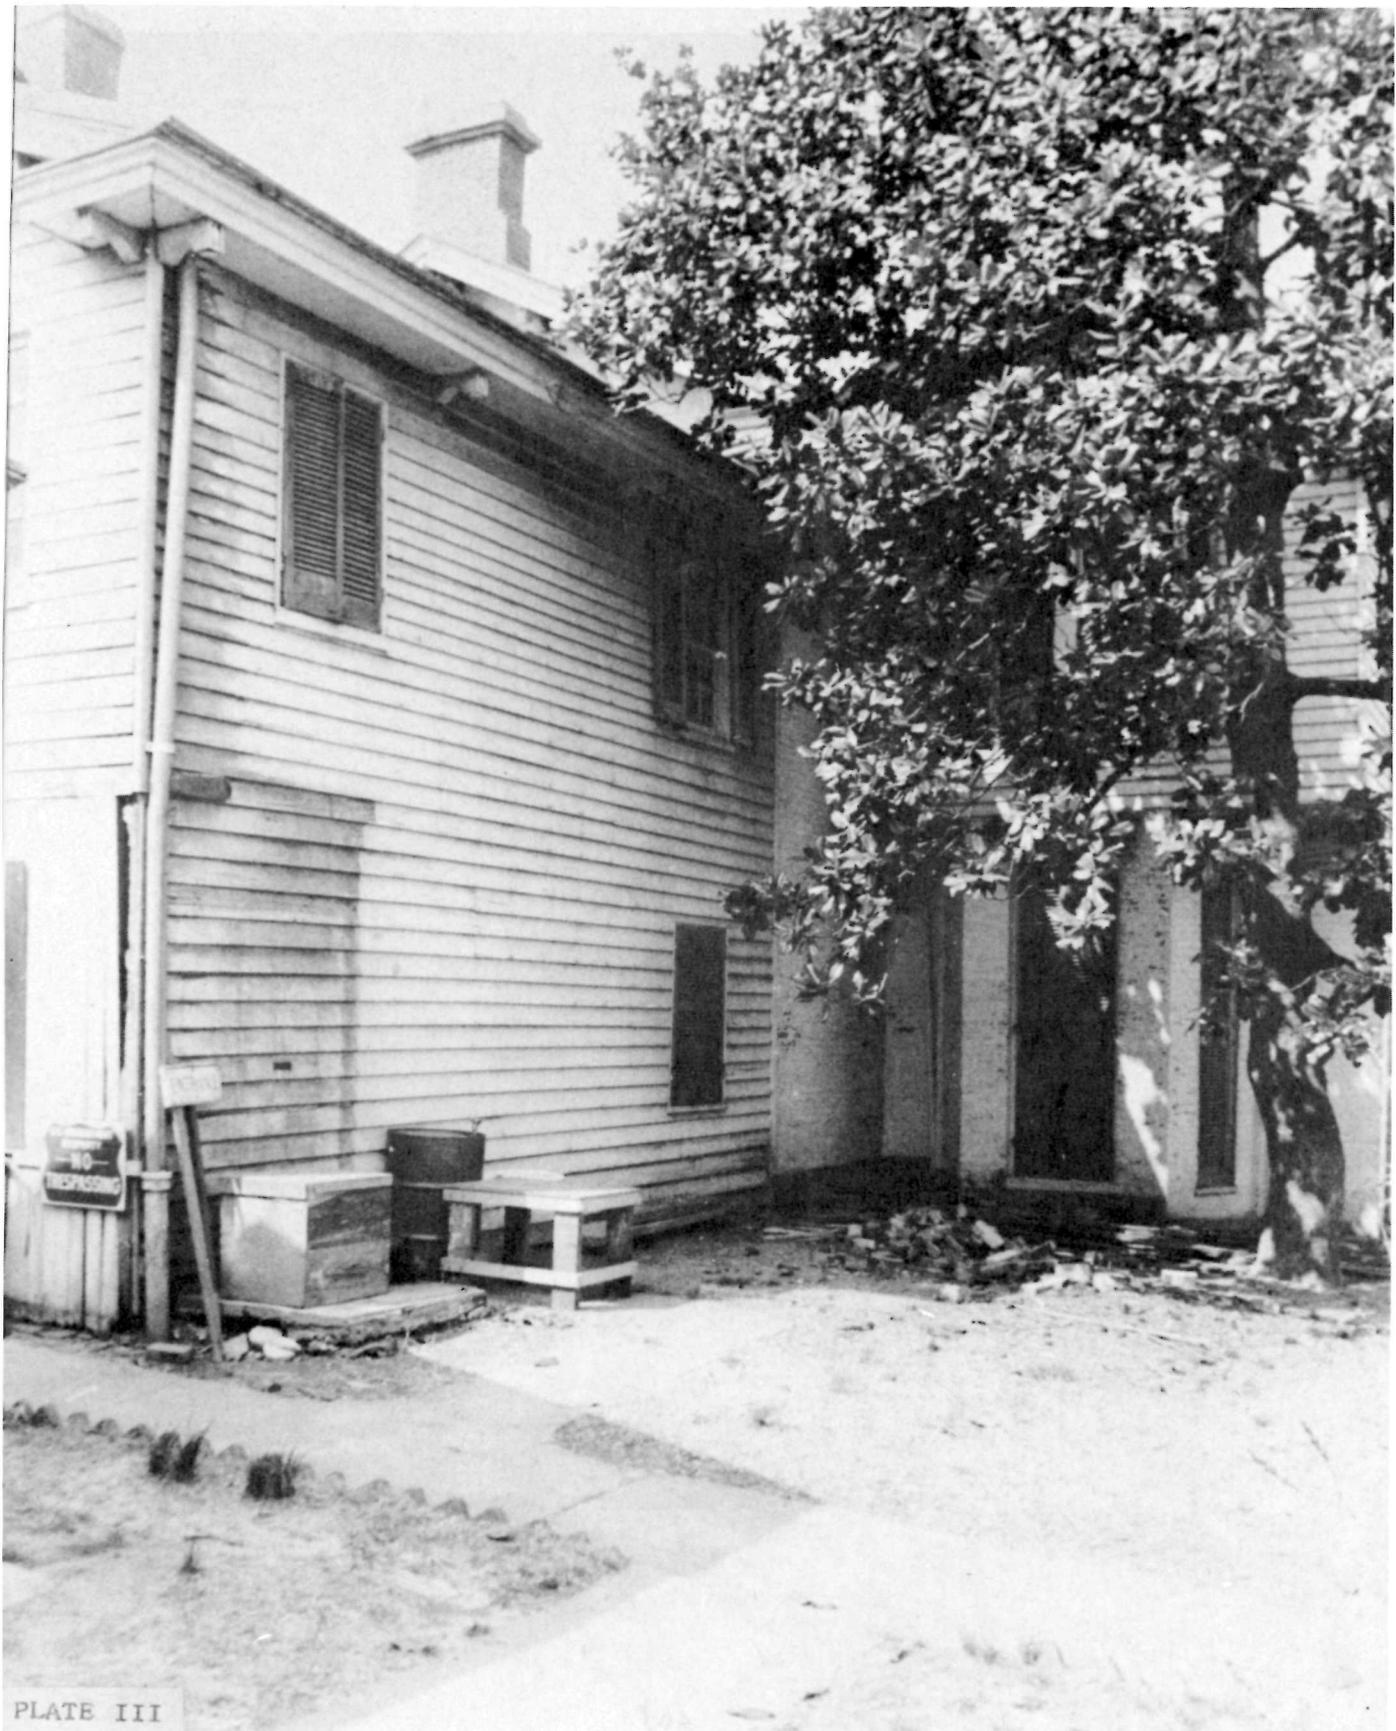
PLATE III

Frame south wing from the Southeast.
Note outline of post Douglass period
outside toilet compartment.

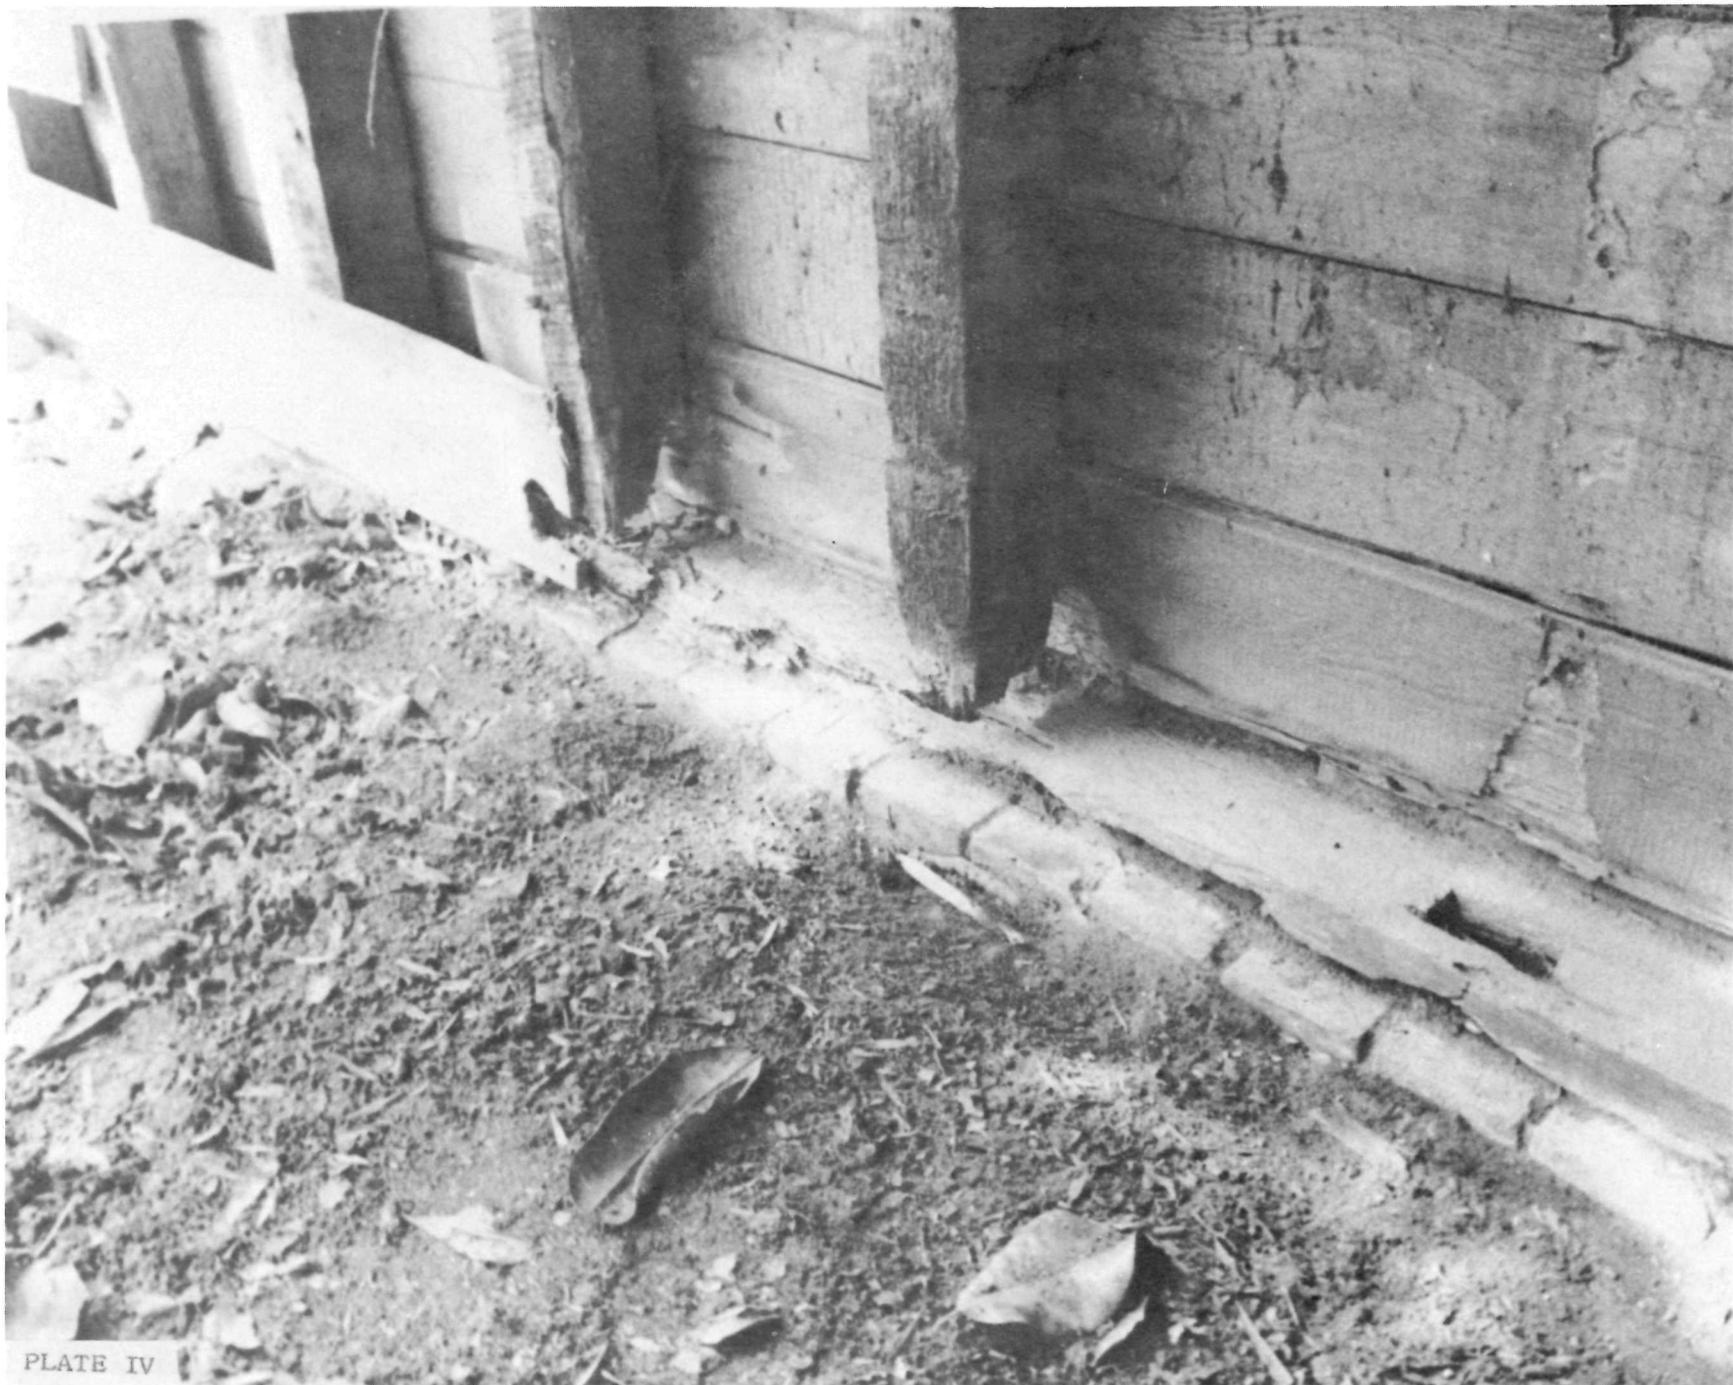
PLATE IV

Frame south wing sill (exterior siding removed) showing deterioration of sill, studs and interior wall boards.

This portion of the house will require new foundations and extensive replacement of the framing.

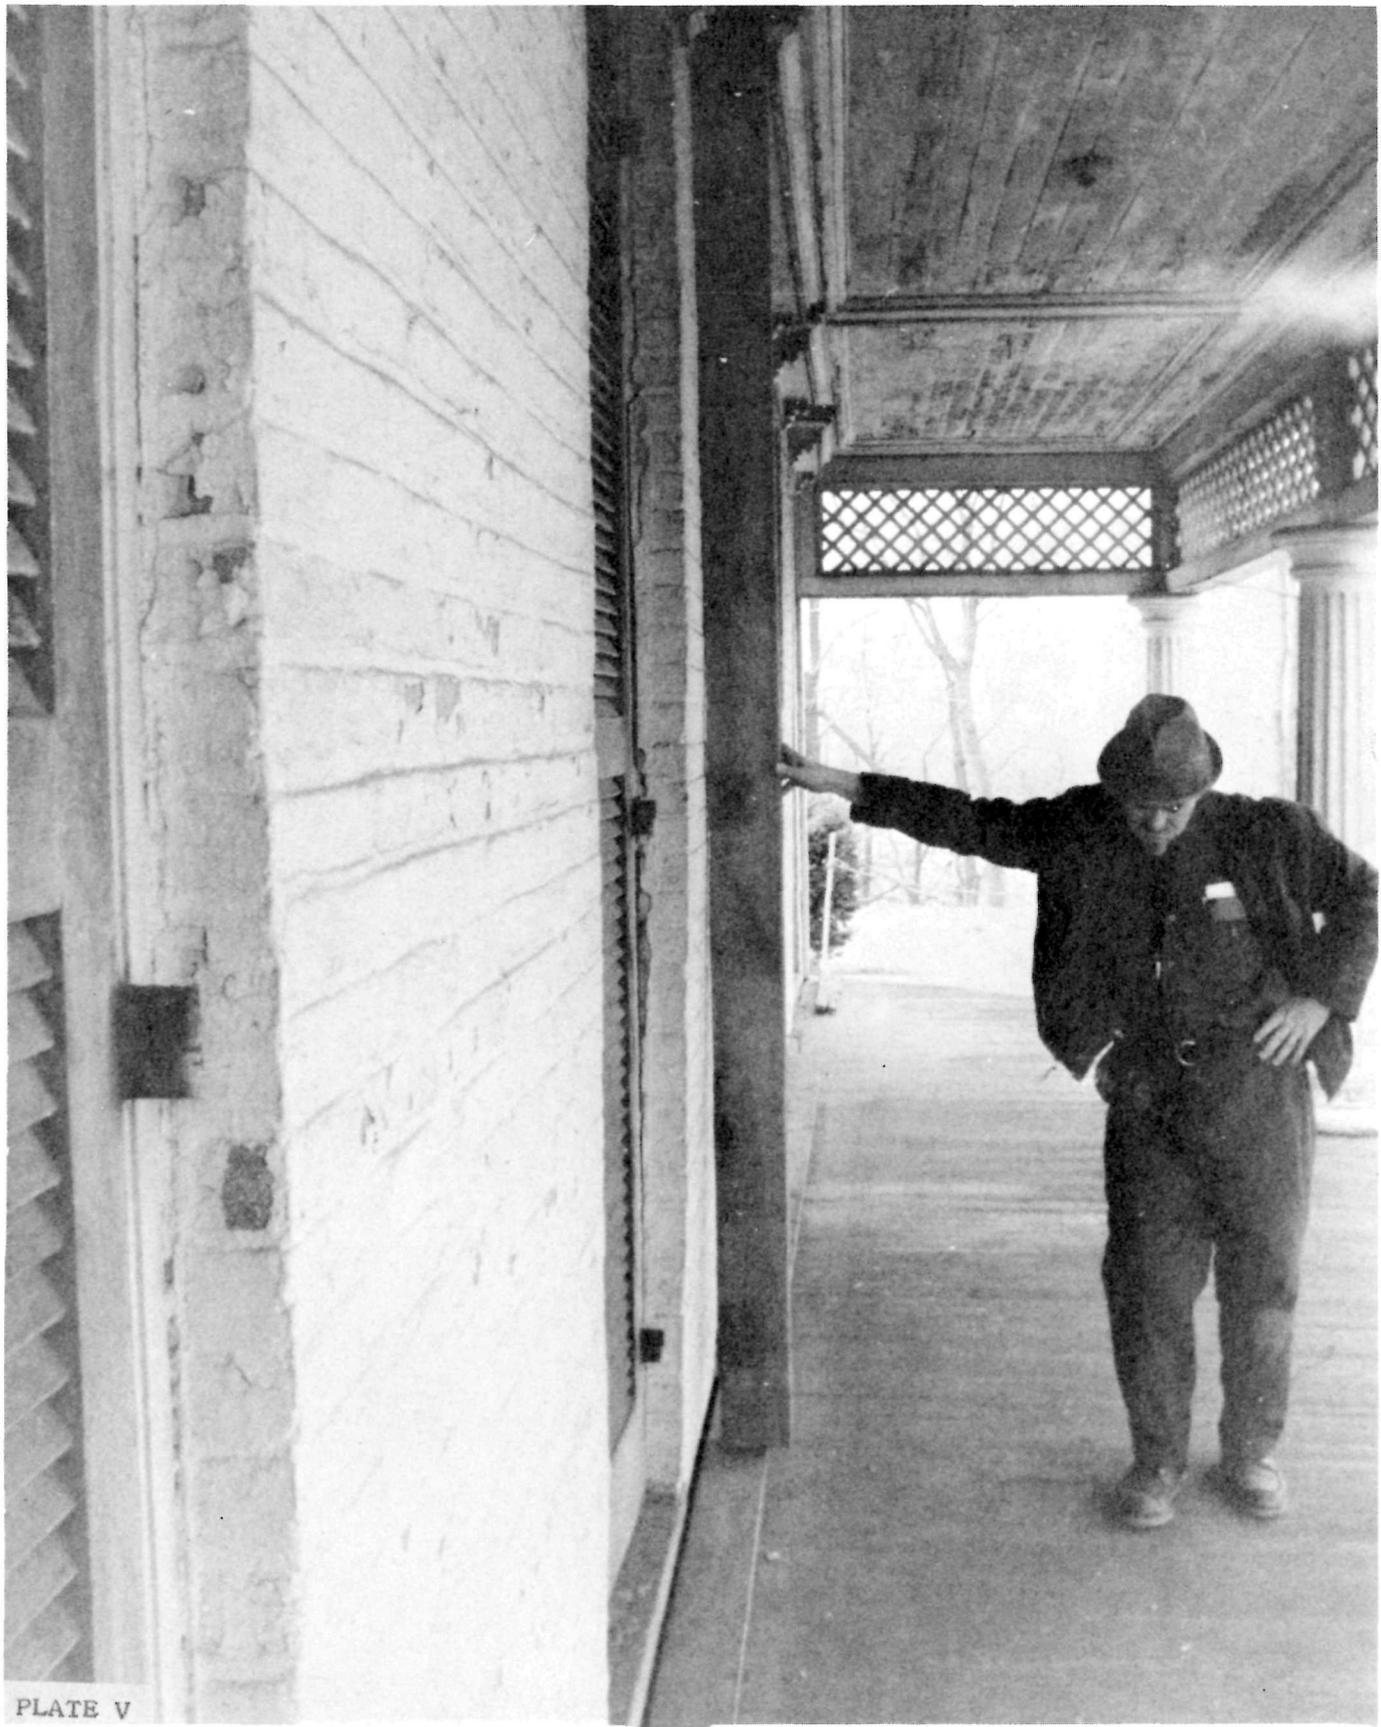
PLATE V

The front wall has been forced out of line by the collapse of the hall partition (See plate XXII). This condition can be corrected when the brick partition is replaced with stud construction.

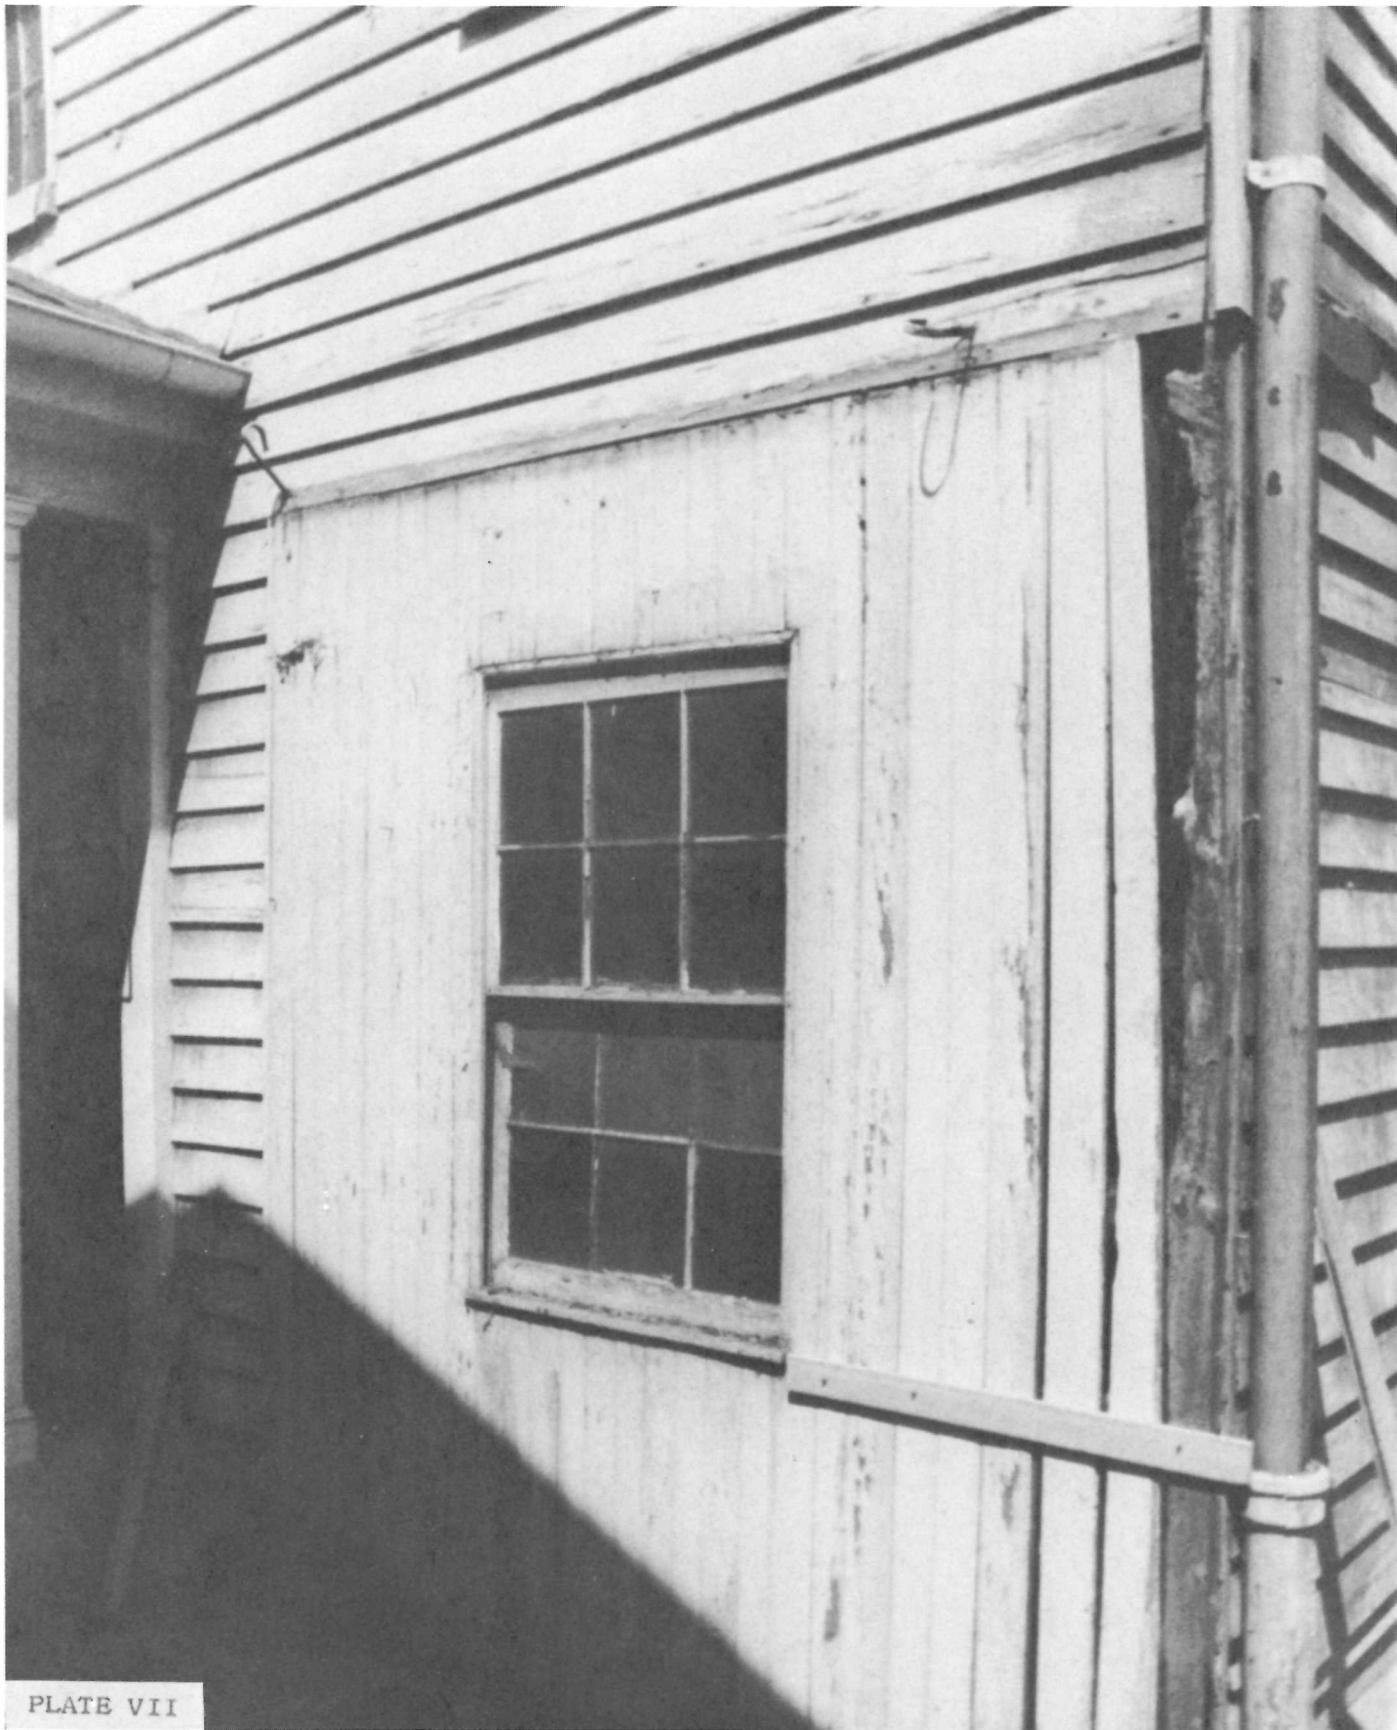
PLATE VII

South wall room #107 (storeroom)
must be rebuilt. Note deterioration
in corner post and missing vertical
siding.

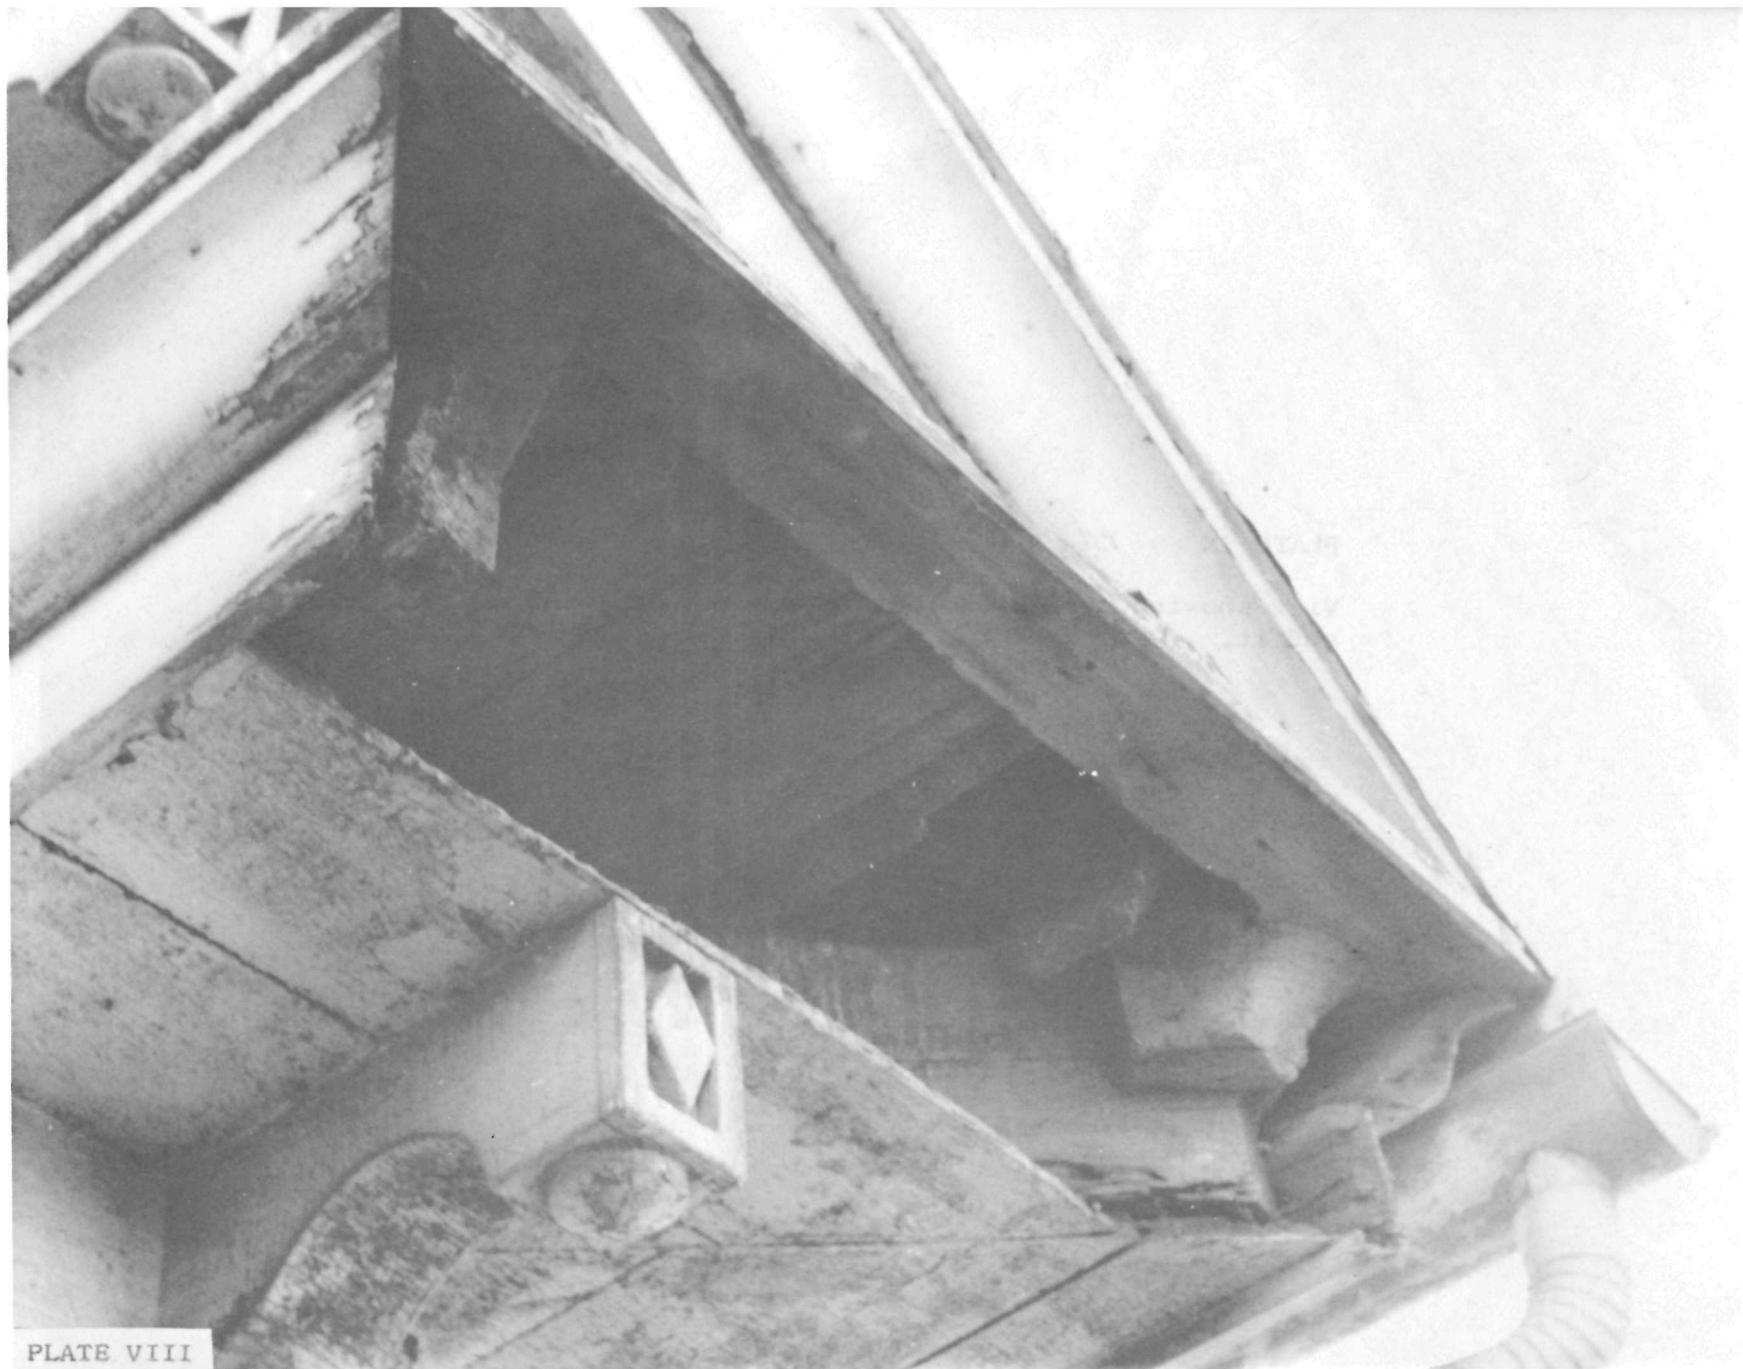
PLATE VIII

The cornice throughout the building will
require extensive repair and replacement.

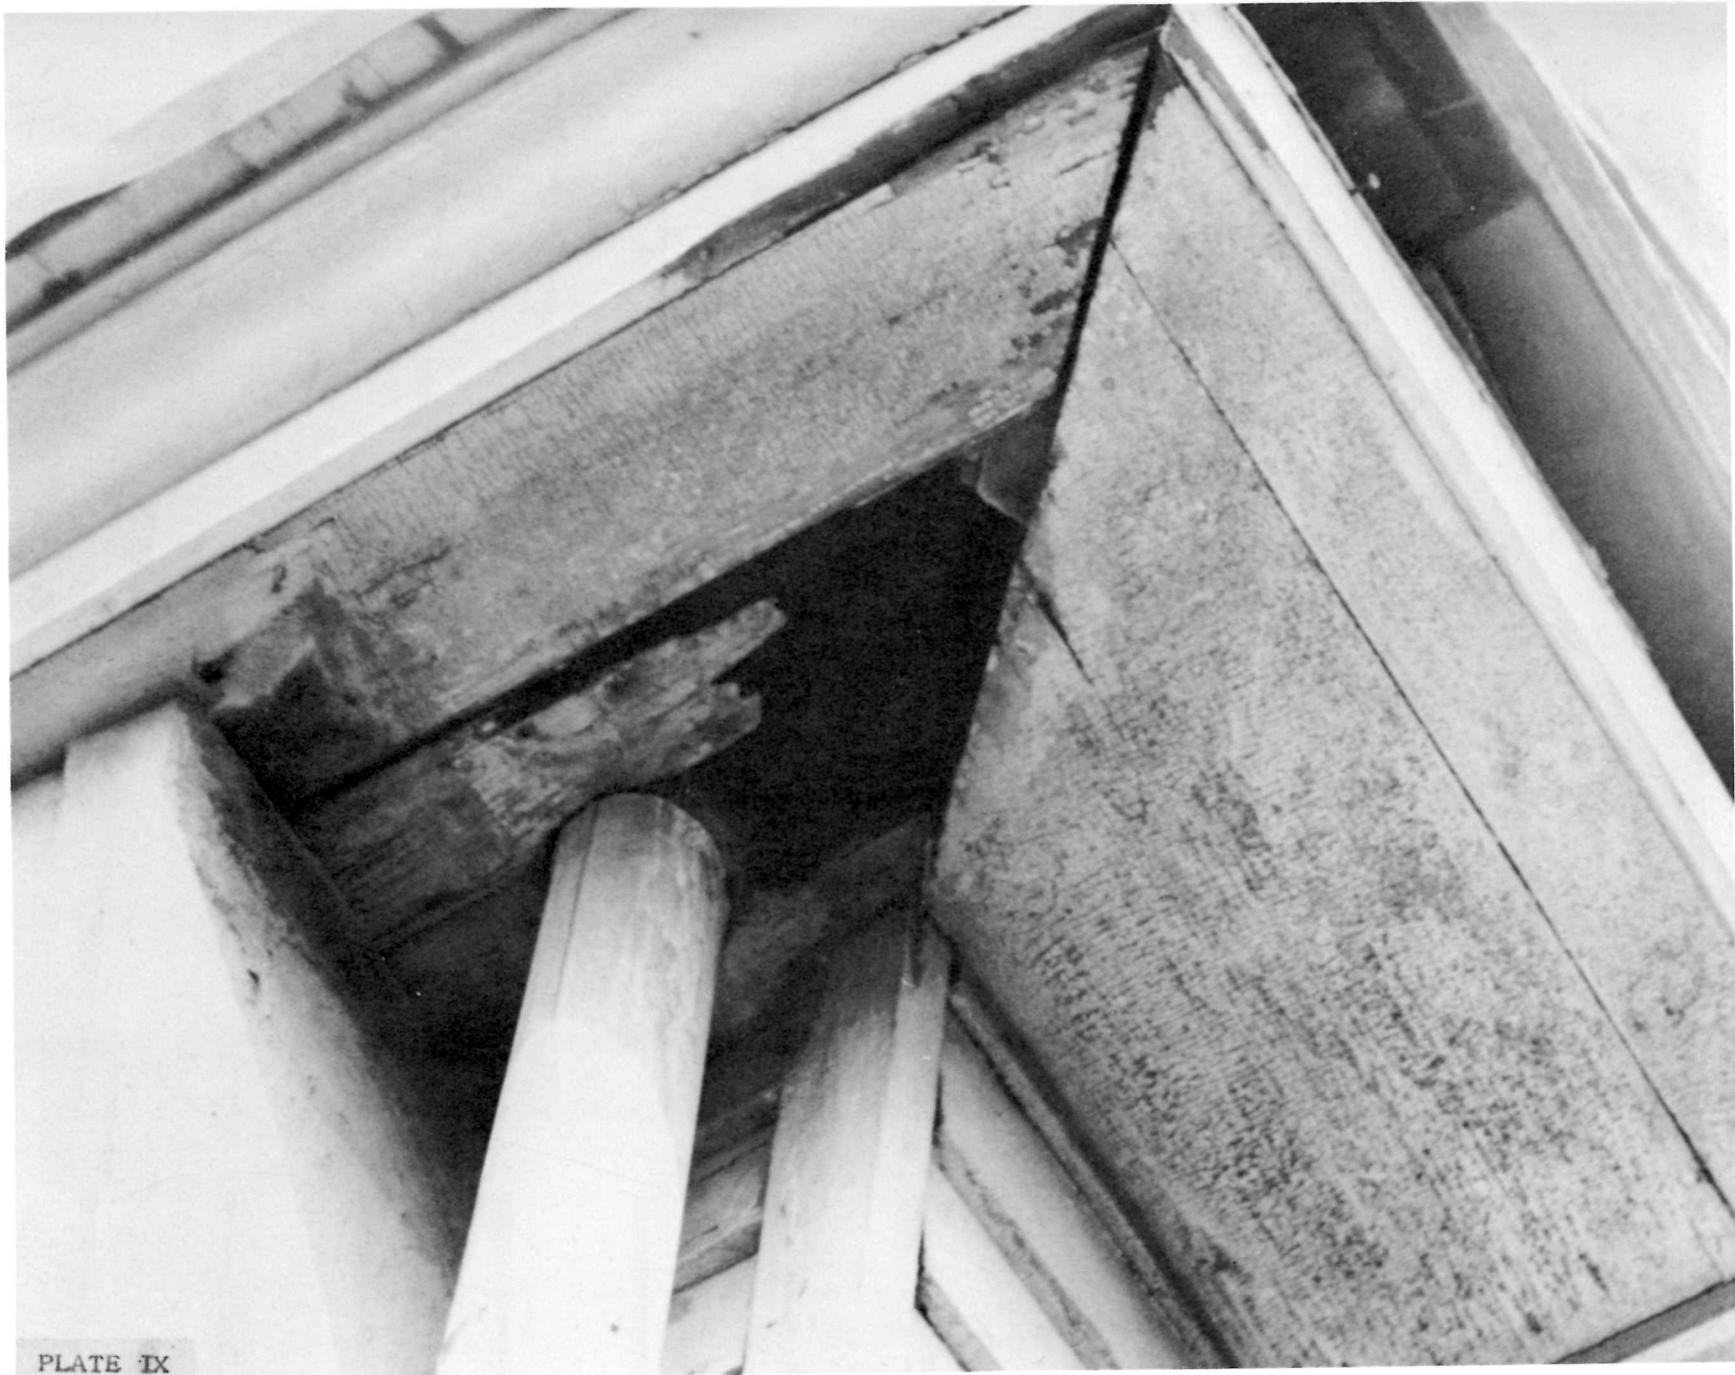
PLATE IX

View showing typical deterioration of the cornice
soffit.

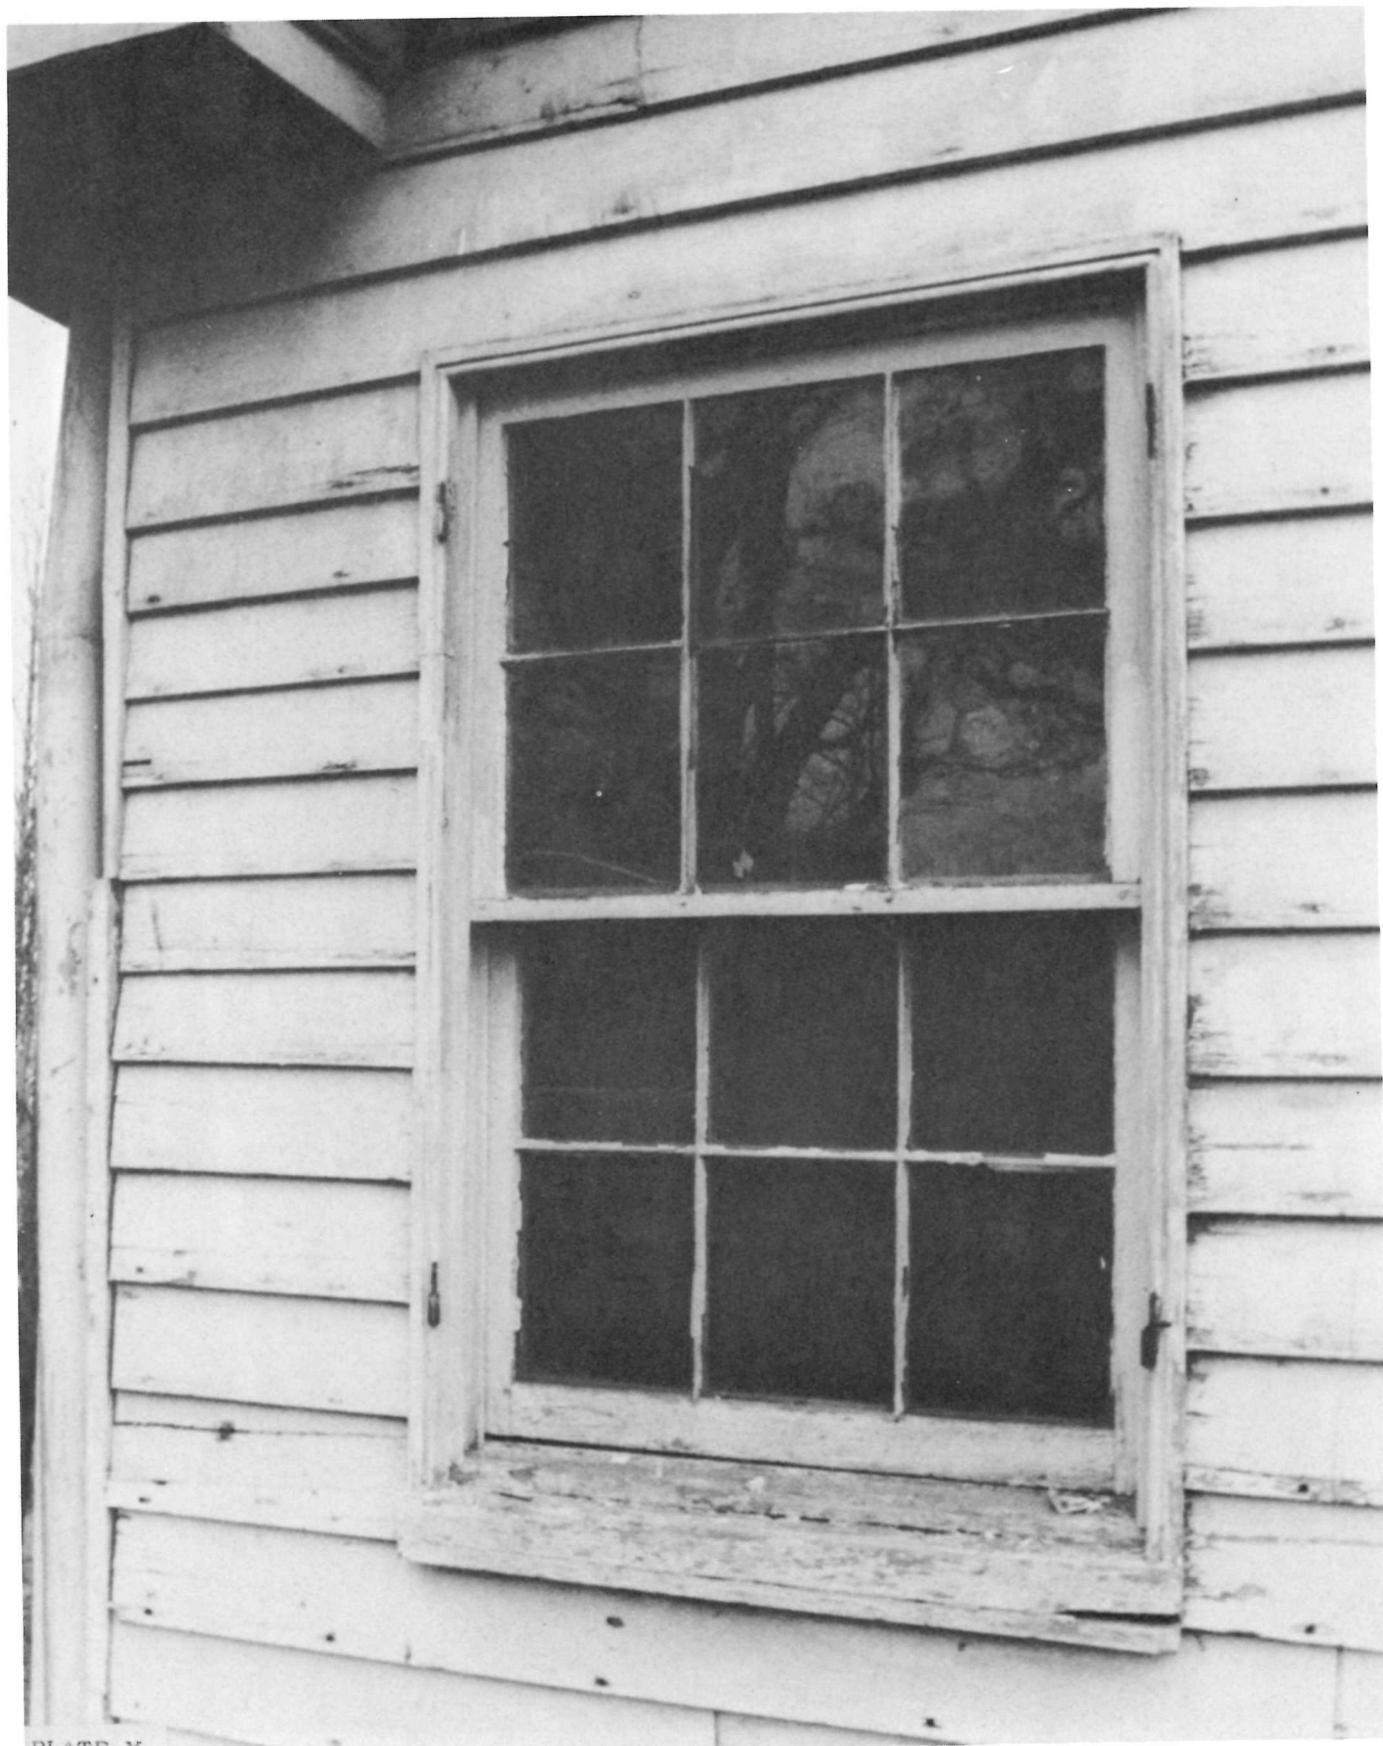
PLATE X

Frame south wing window shows general deterioration of frame, trim, sash, and glazing. Shutters and some hardware are missing.

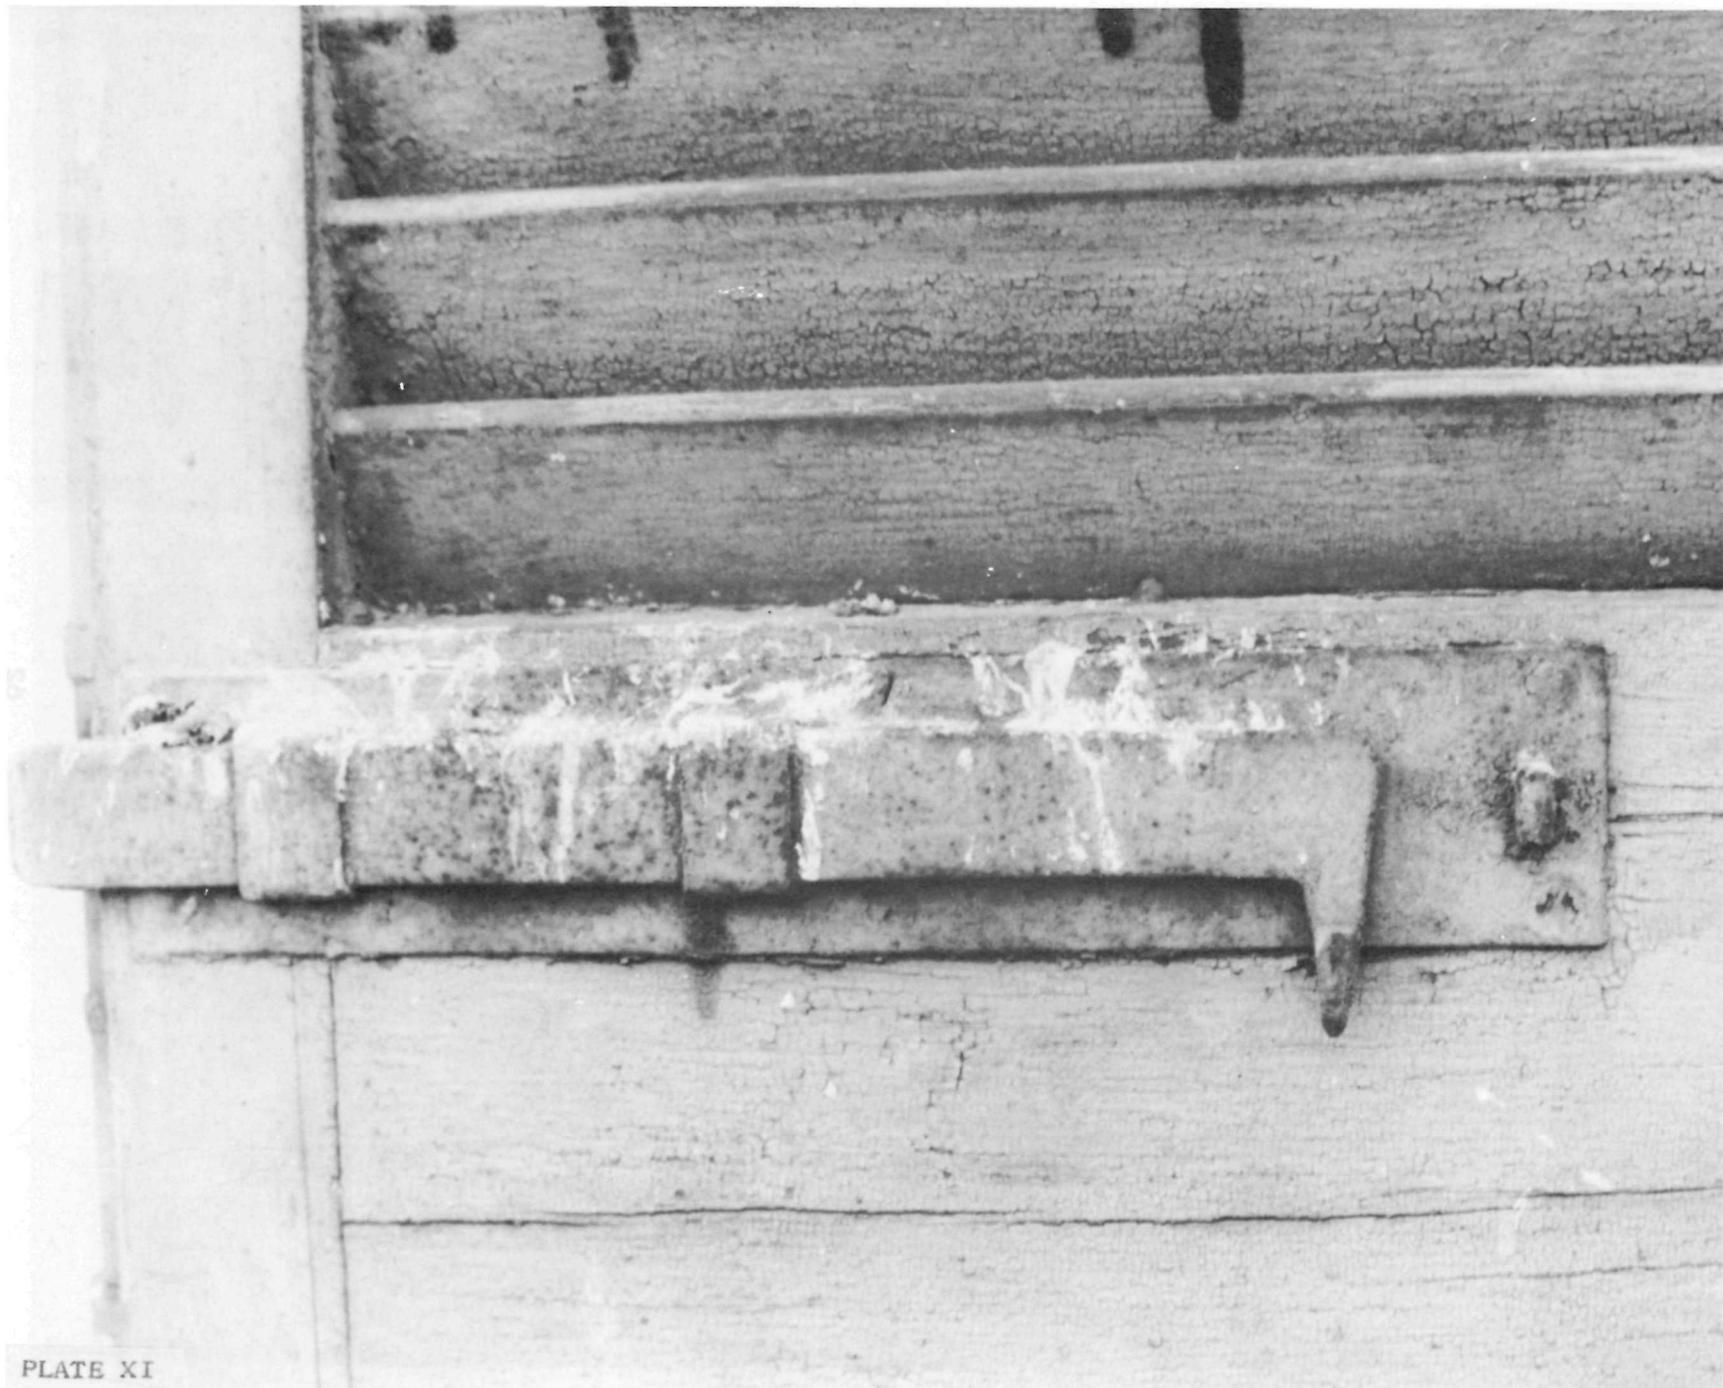
PLATE XI

Shutter bolt. Hardware will require repair and replacement.

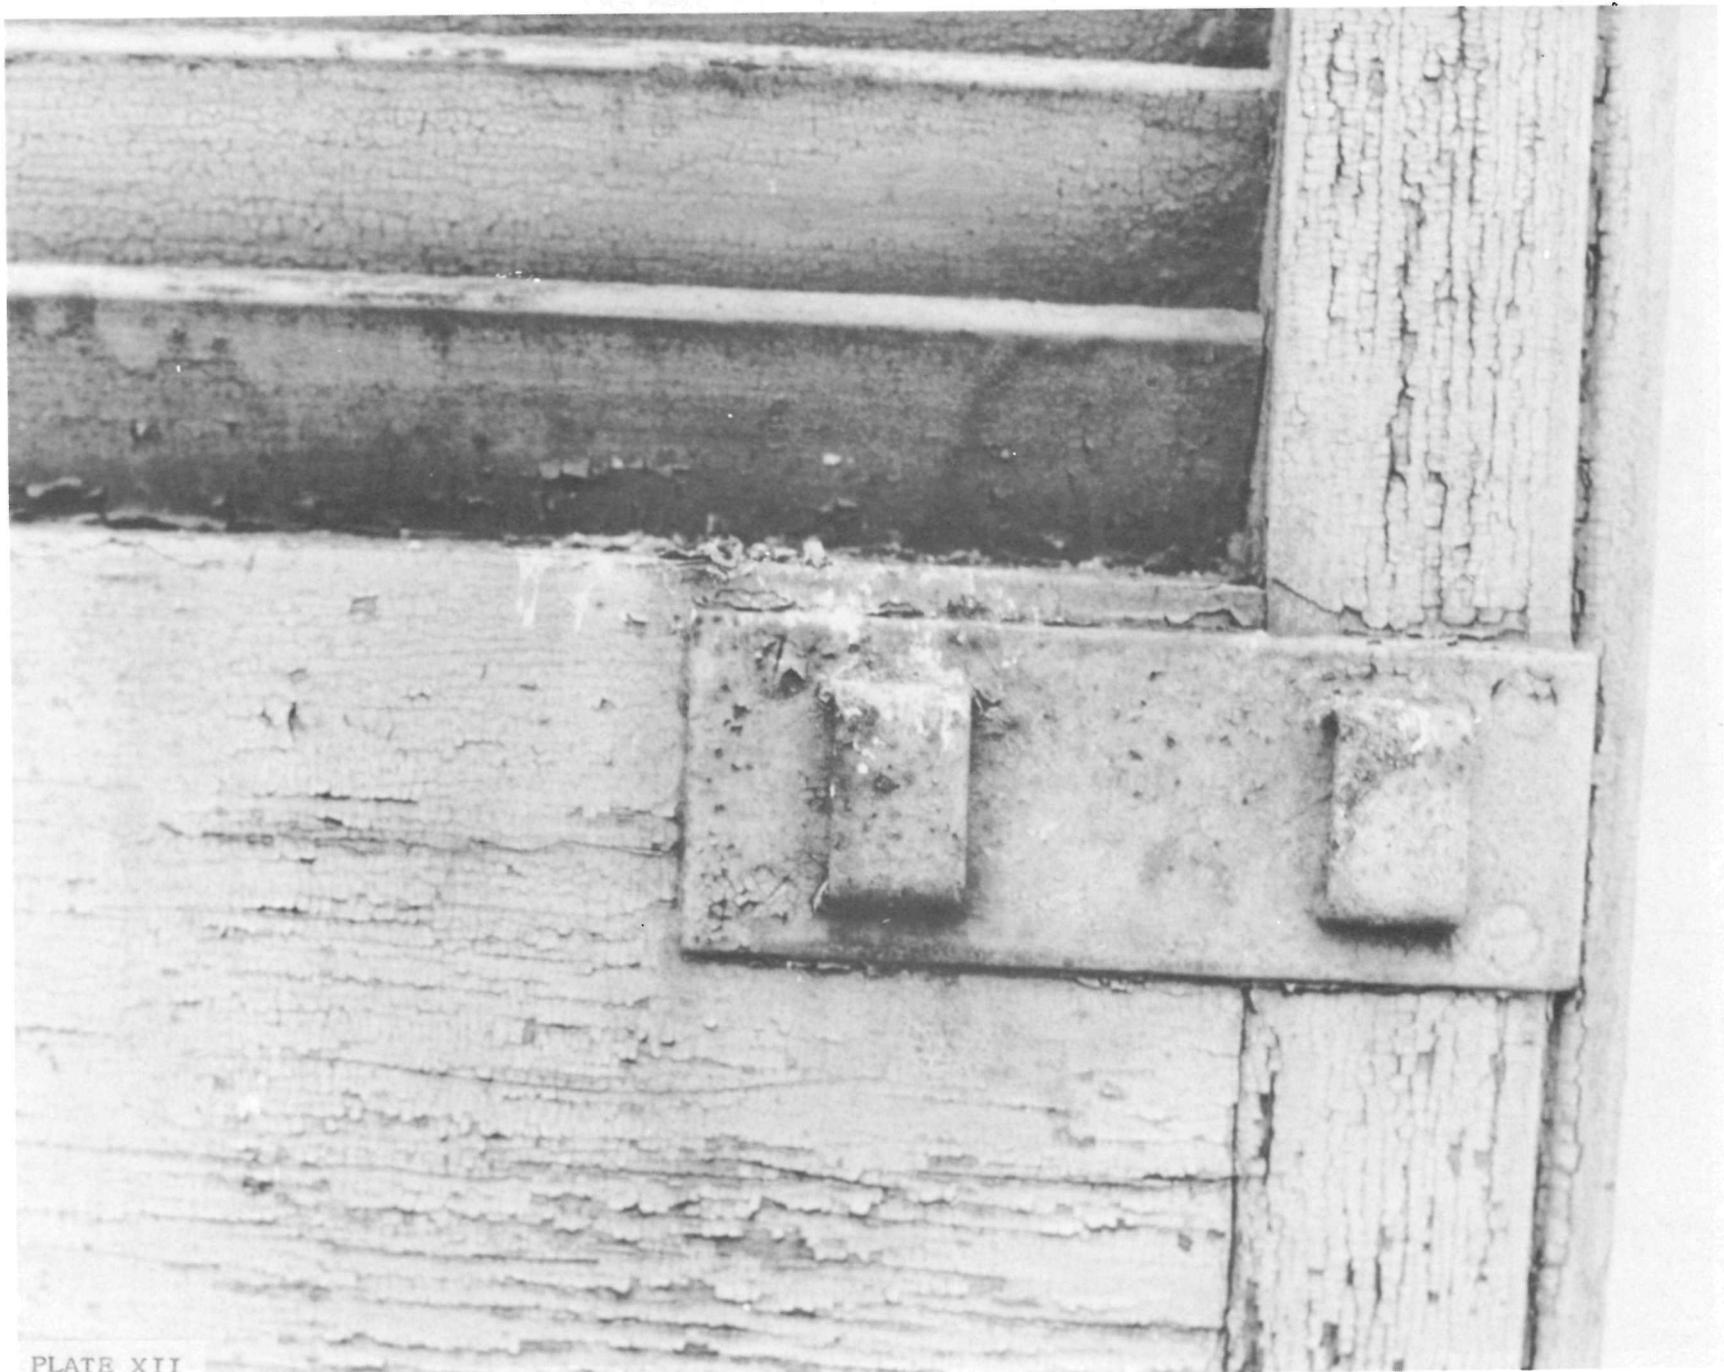
PLATE XII

Shutter keeper. Many coats of paint must be removed from the old hardware.
