**Frederick Douglass
Home**

HISTORIC STRUCTURES REPORT

ARCHITECTURAL DATA

JUNE 1970

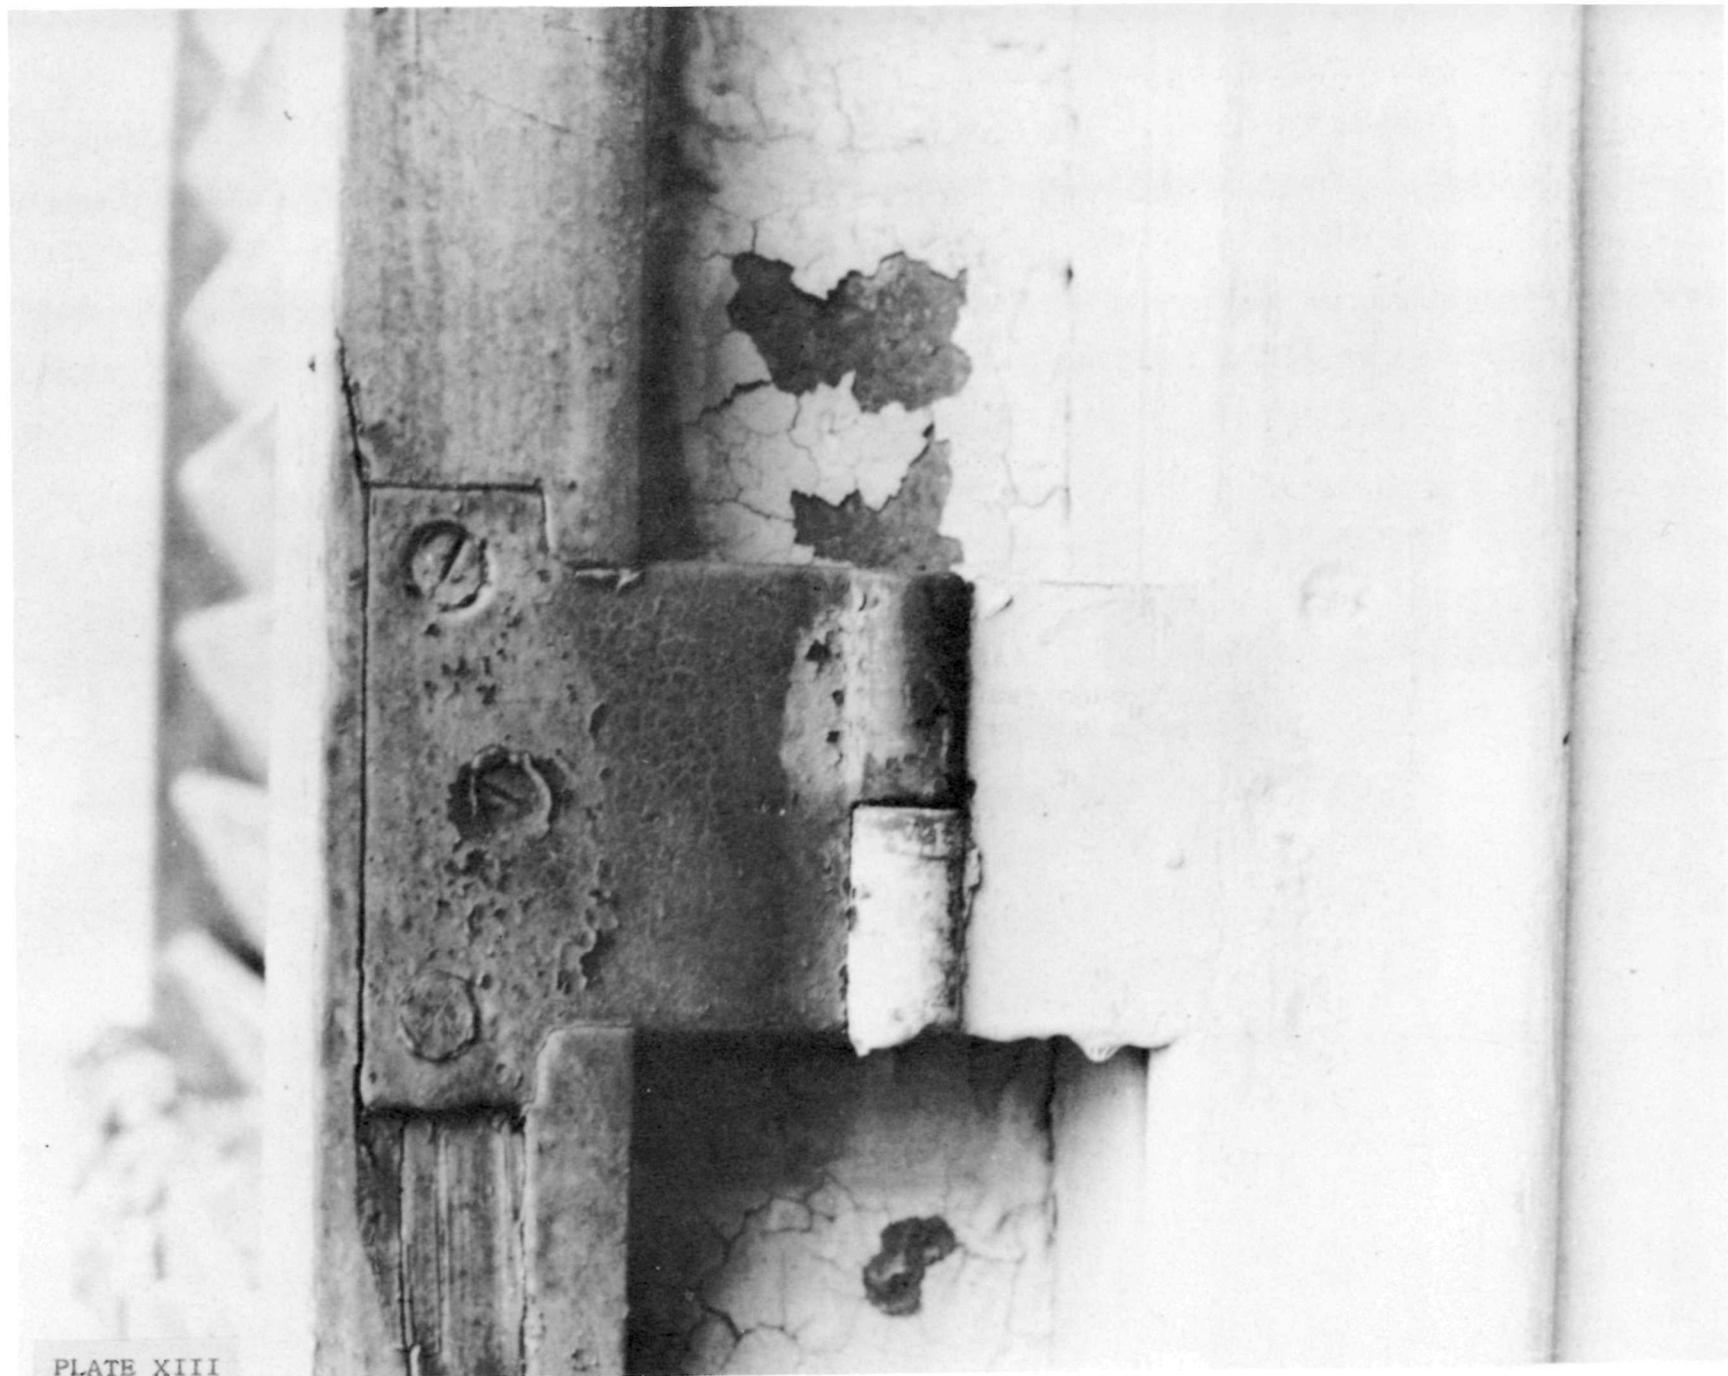
PLATE XIII

Existing shutter hinges are in good condition
but must be refastened.

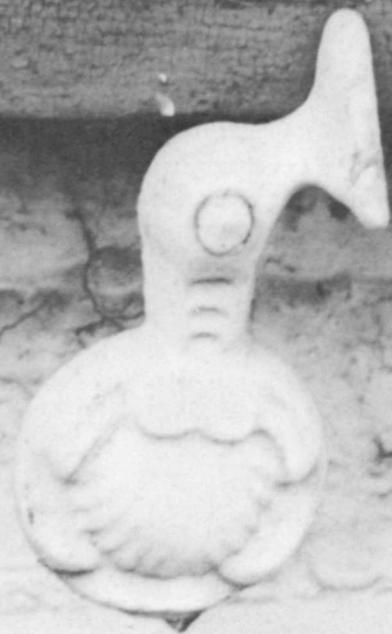
PLATE XIV

Many of the shutter hold-backs are missing and must be replaced. Note typical condition of shutter.

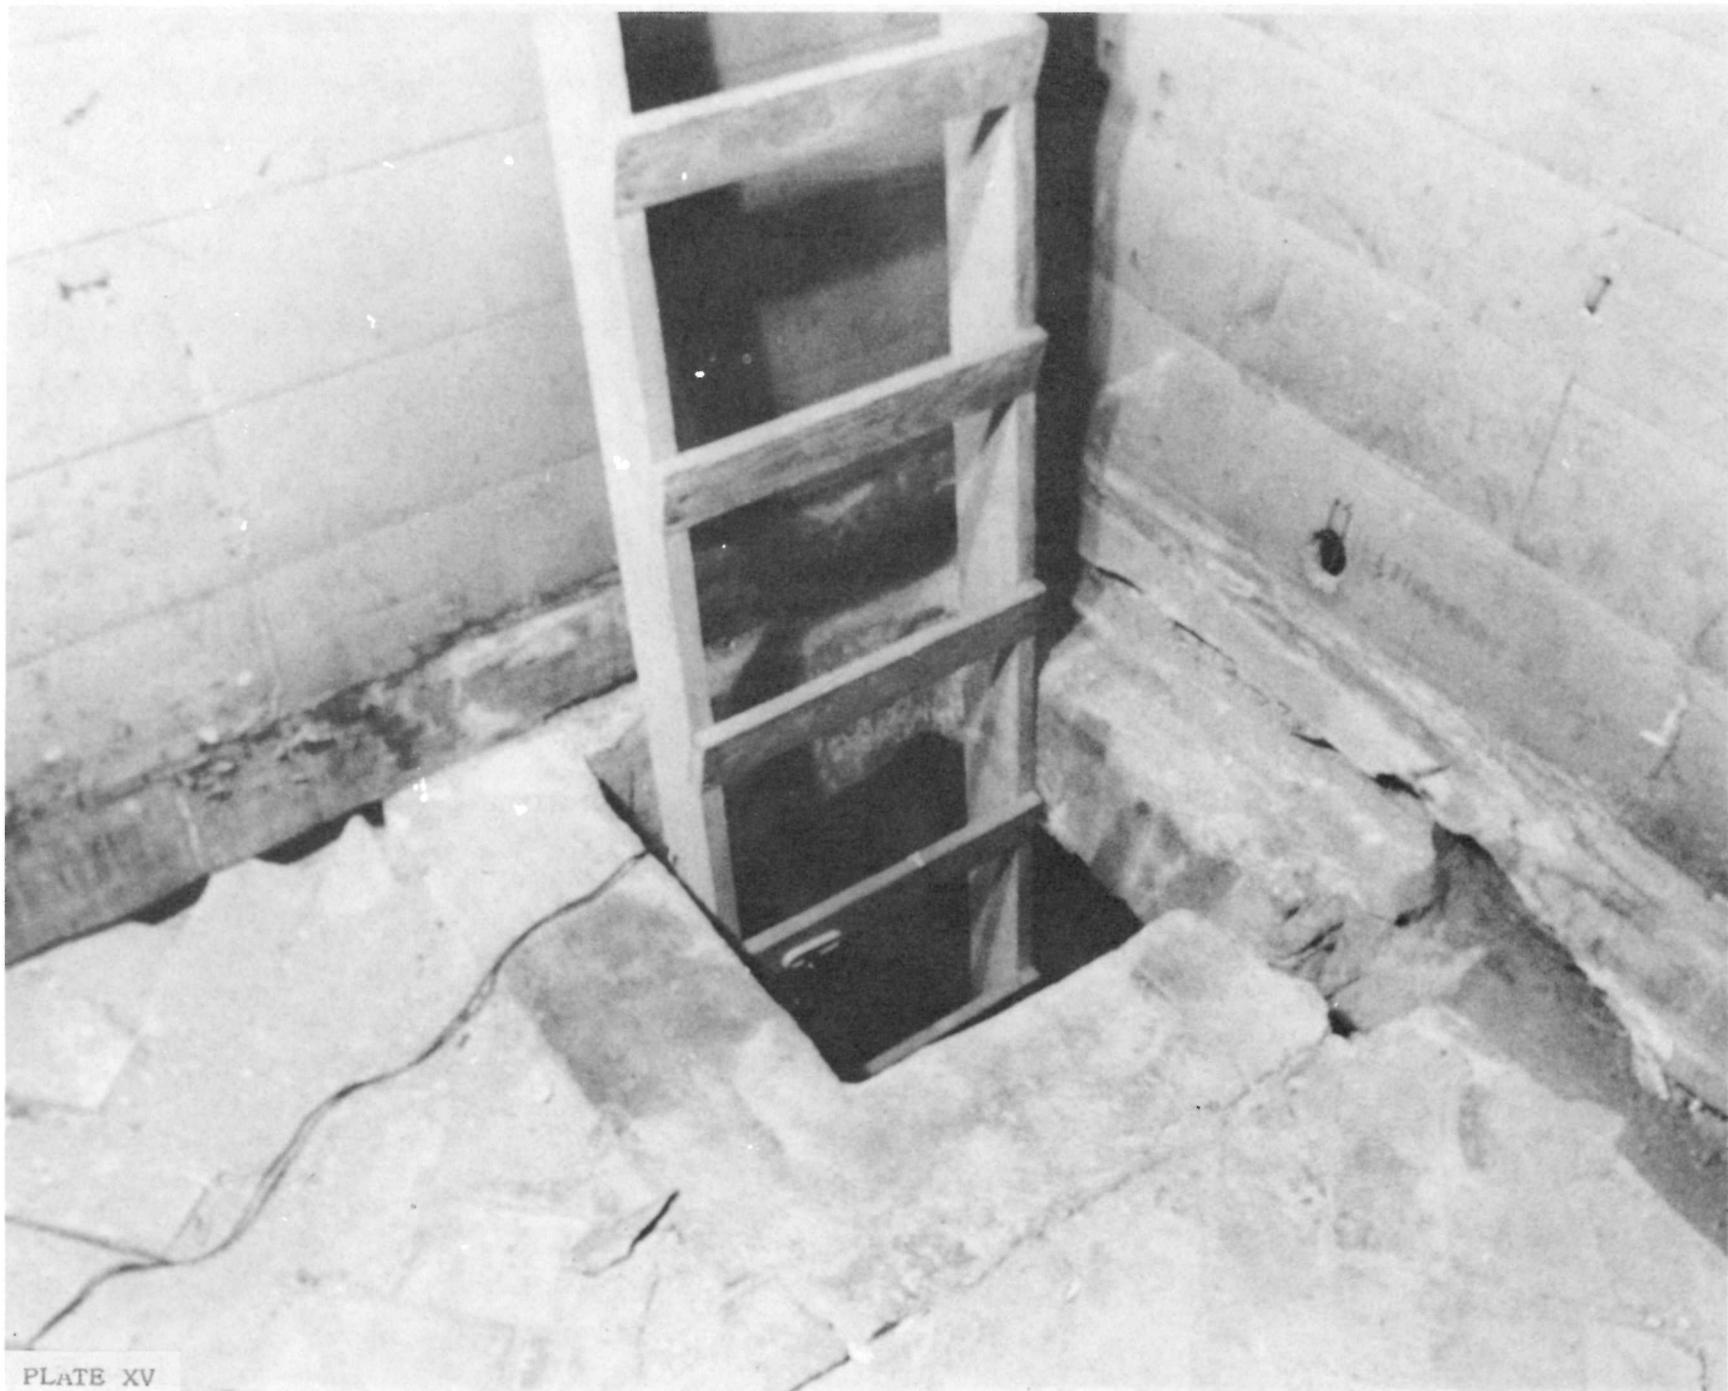
PLATE XV

Cistern manhole located in room #105. Cistern was discovered when deteriorated wood floor was removed for temporary repairs.

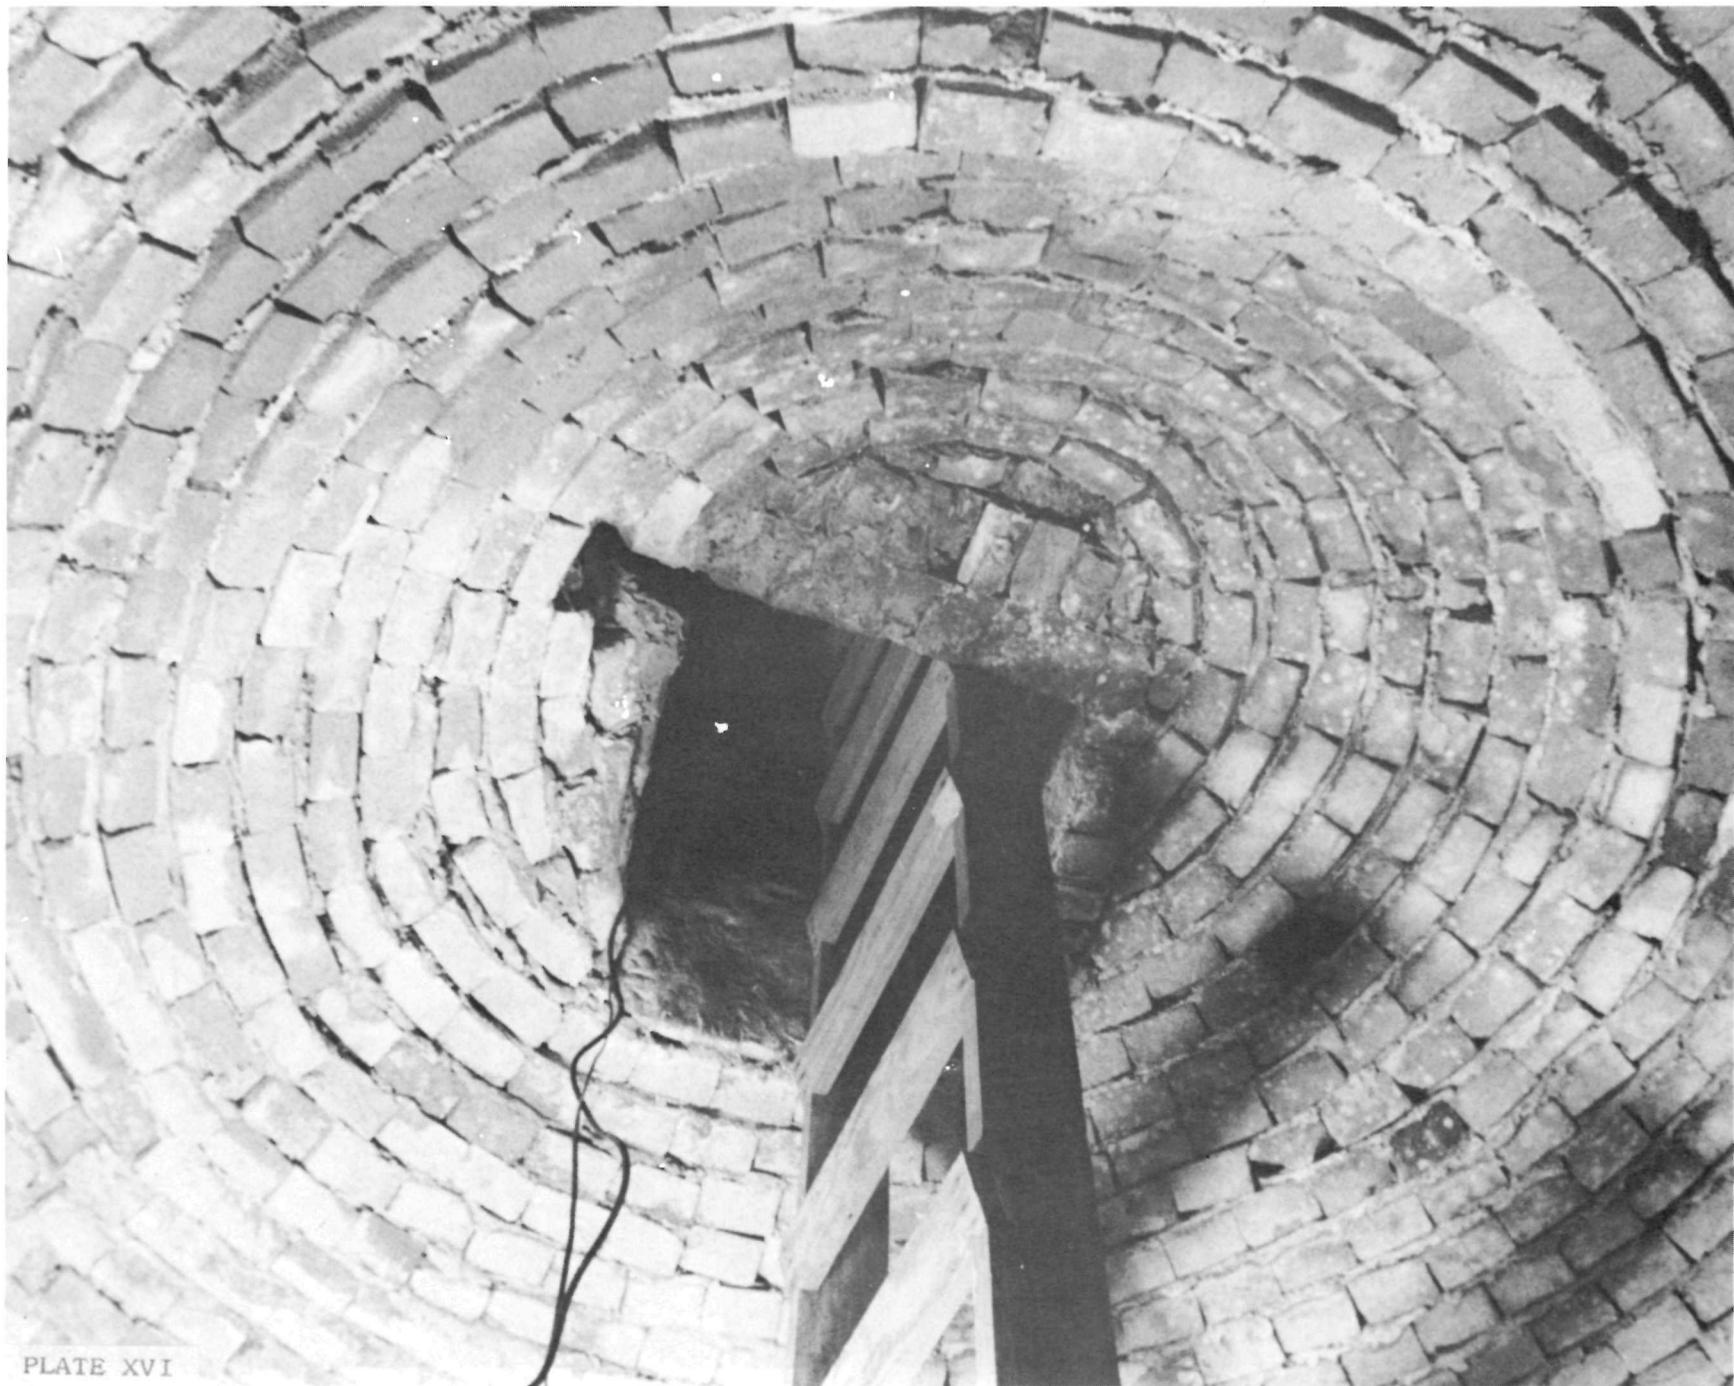
PLATE XVI

The dome of the cistern will require some
repair and repointing.

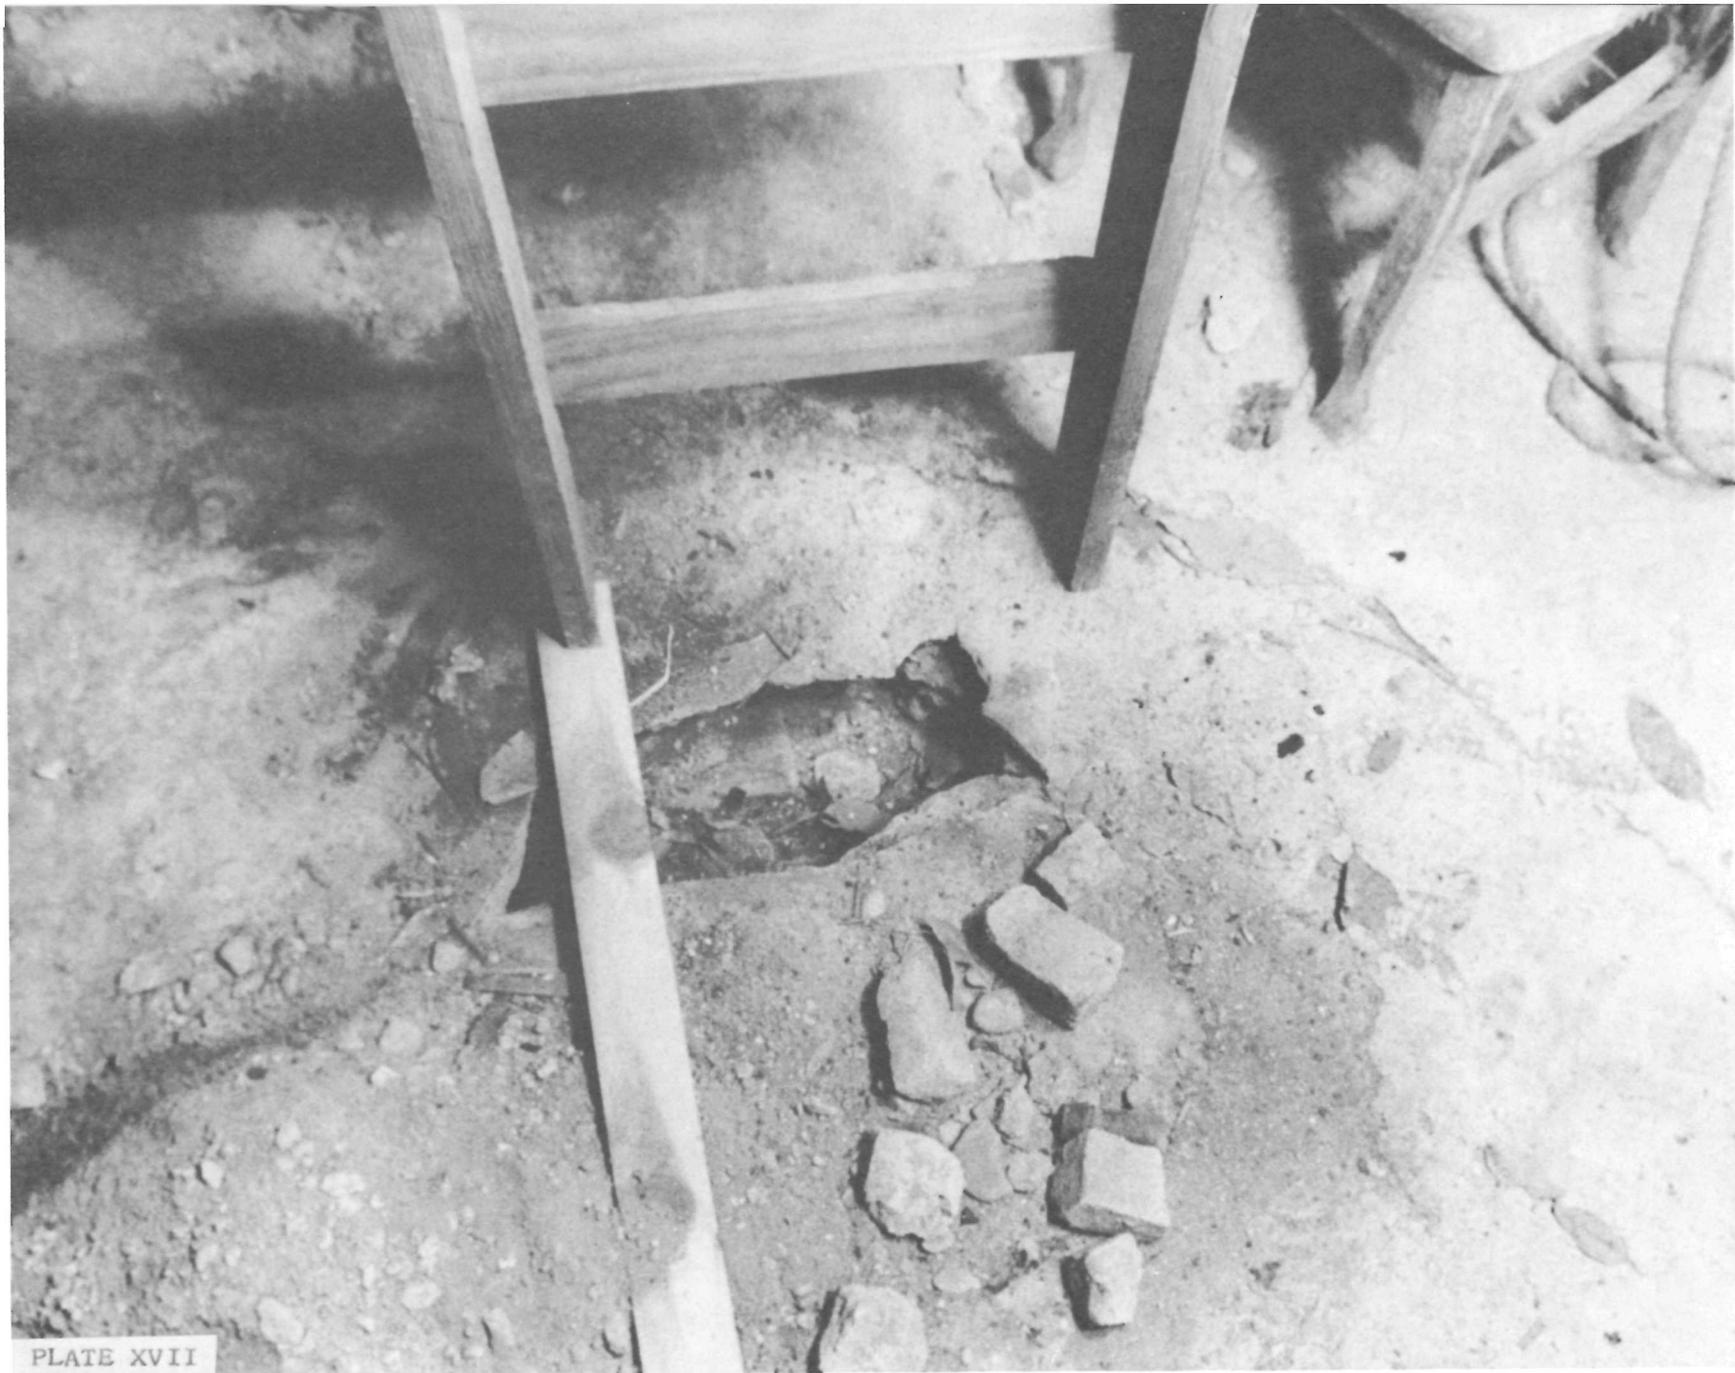
PLATE XVII

The paged brick bottom of the cistern has been broken in several places and will be patched.

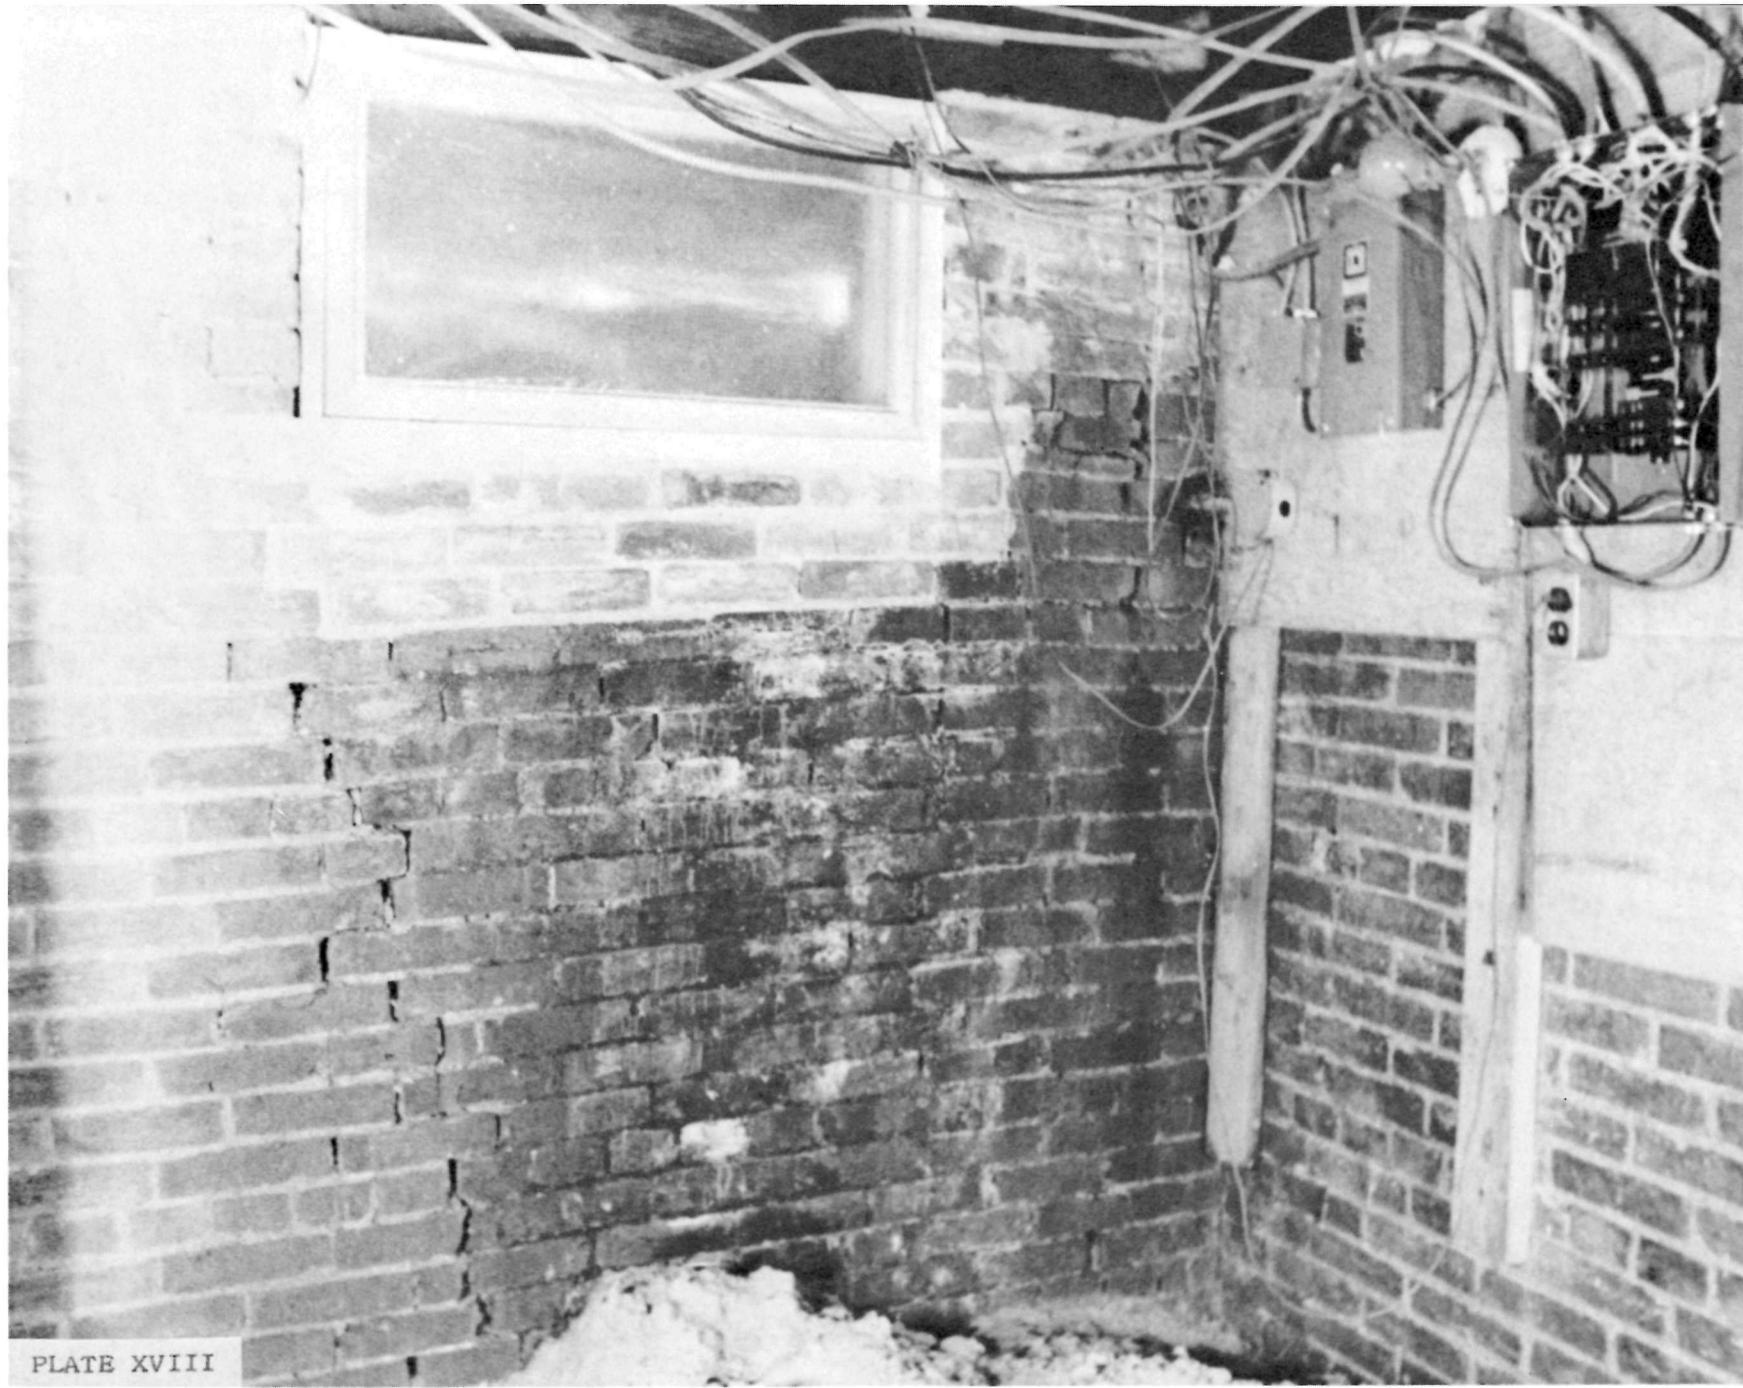
PLATE XVIII

Extensive cracks and erroded mortar joints of the west basement wall caused by surface water must be repaired and repointed.

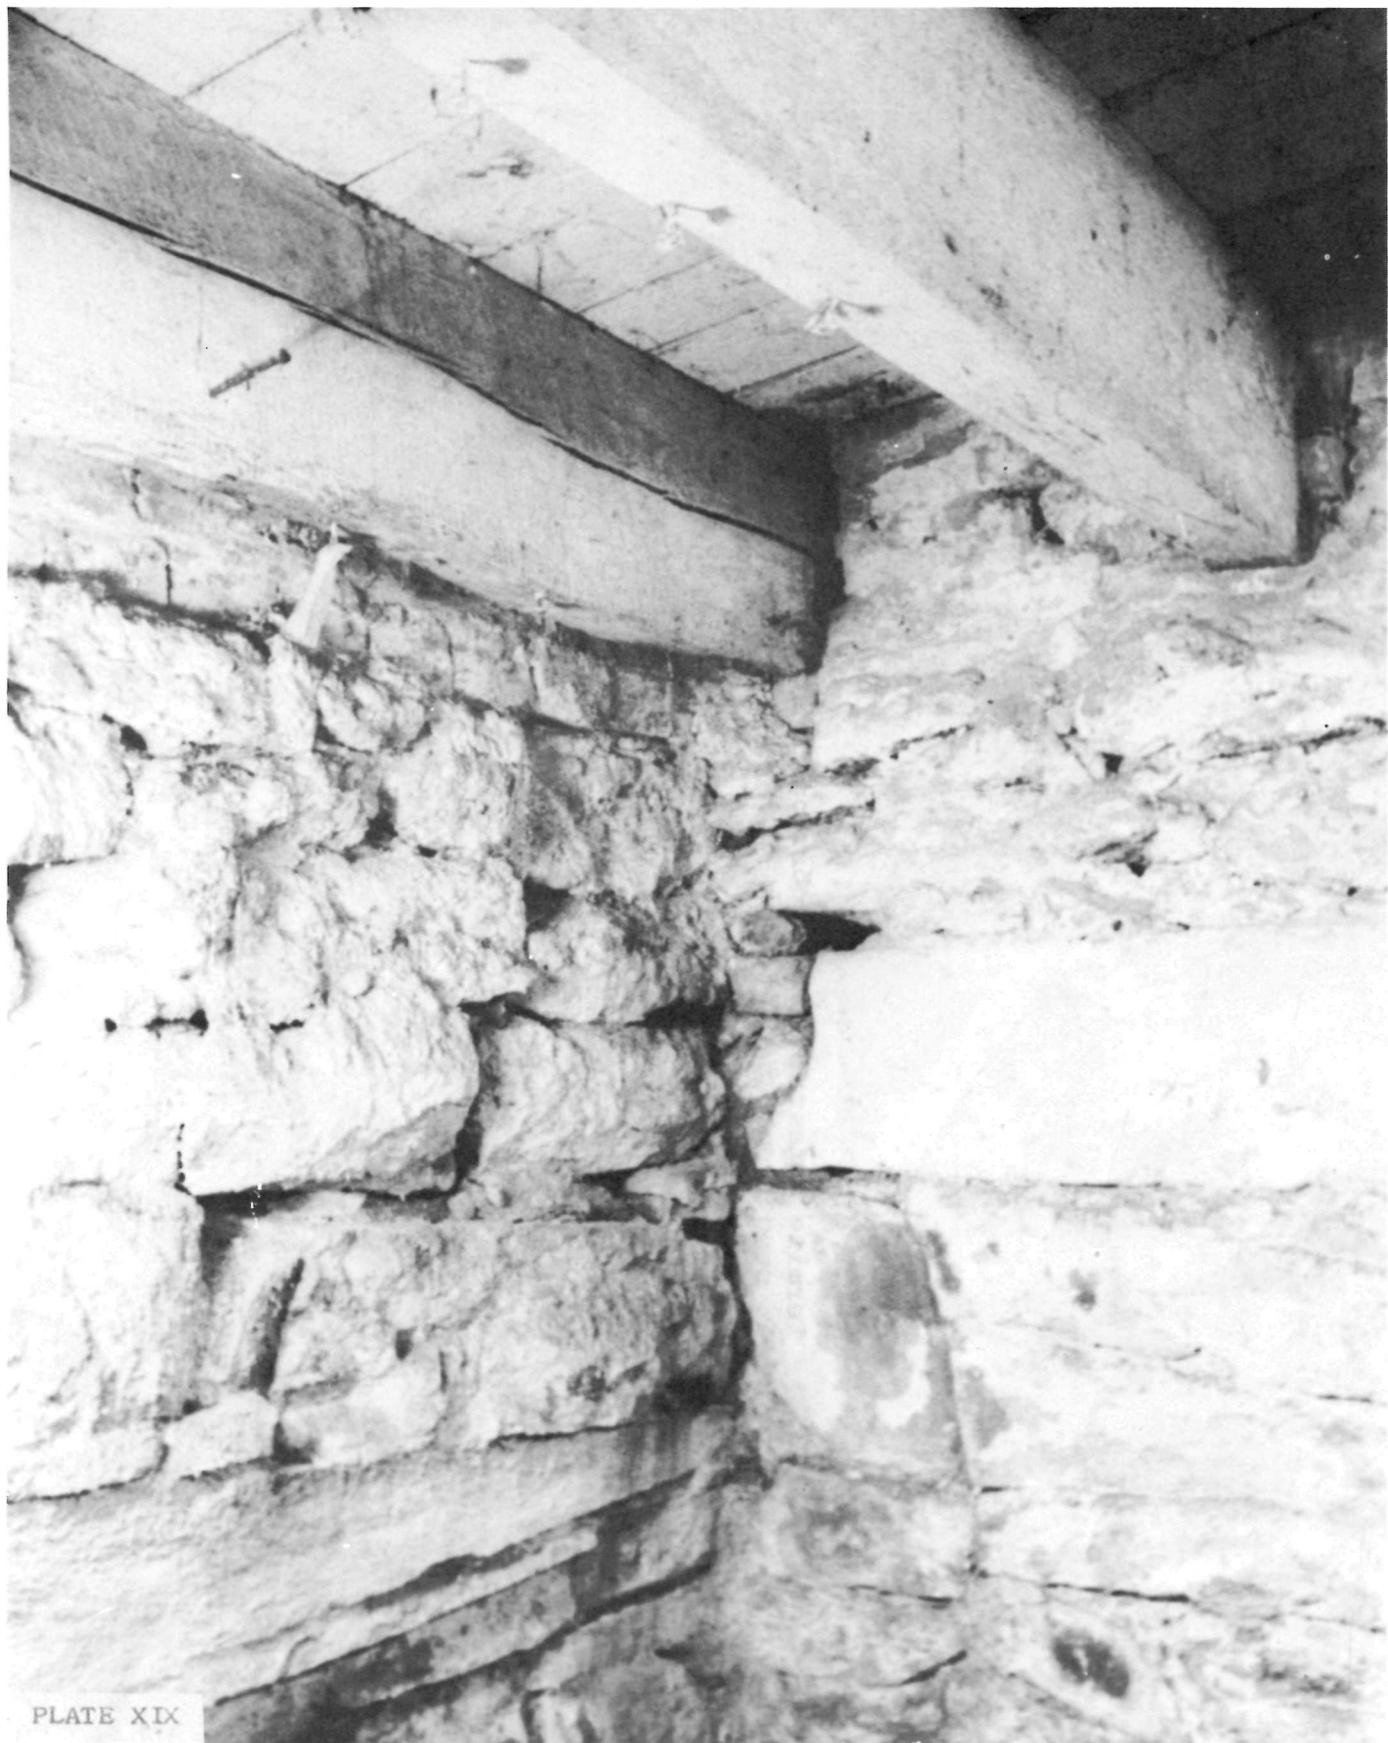
PLATE XIX

The stone walls of basement room #2 are structurally sound but should be repointed. Note the rotted joist end of the dining room (#103). First floor framing will be strengthened by setting new joist between the original members. New flooring will be laid.

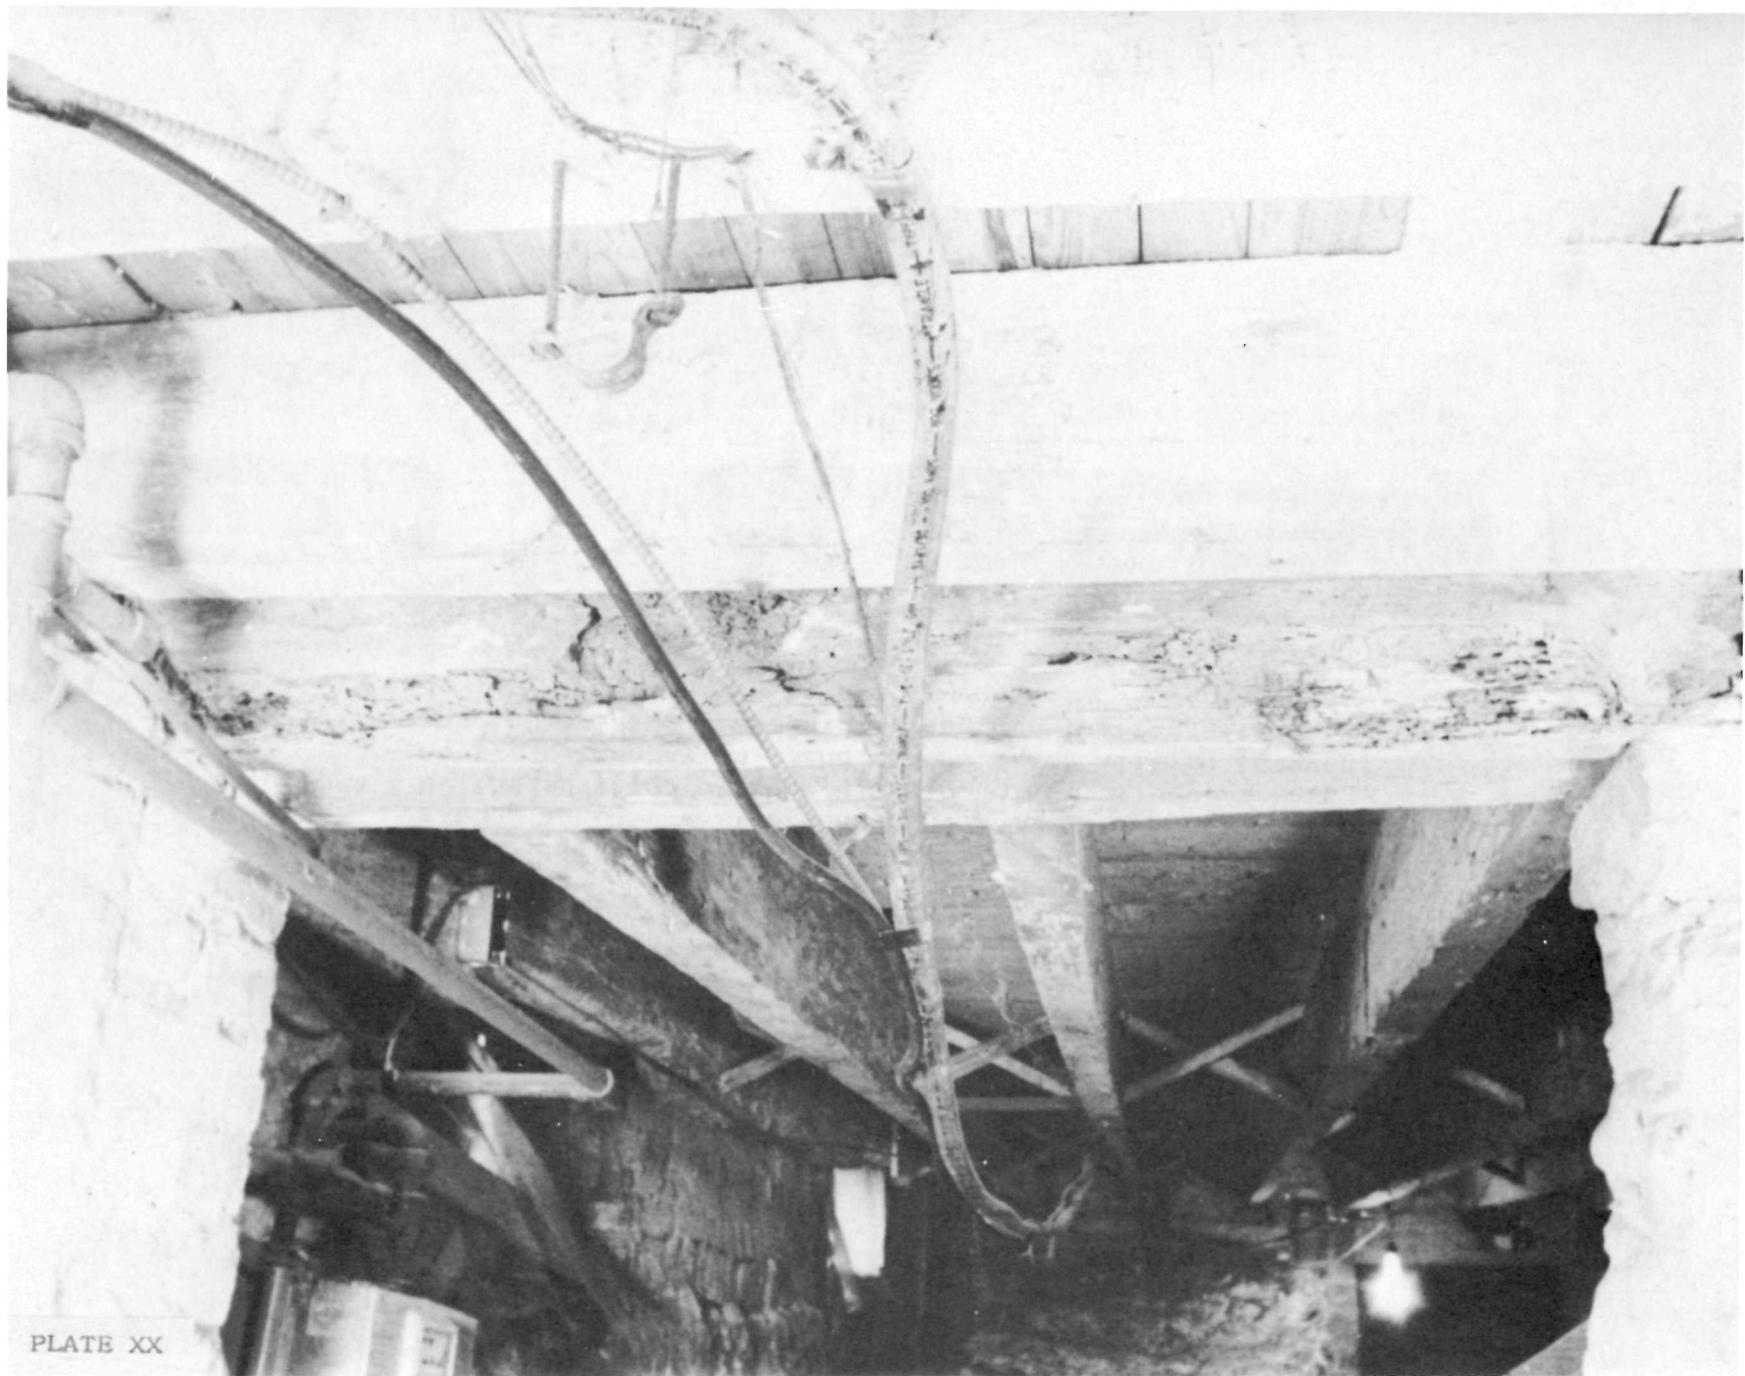
PLATE XX

Termite infested beam supporting first floor joist
as seen from basement room #2.

Note exposed power line from panel to caretaker's
quarters. This will be removed.

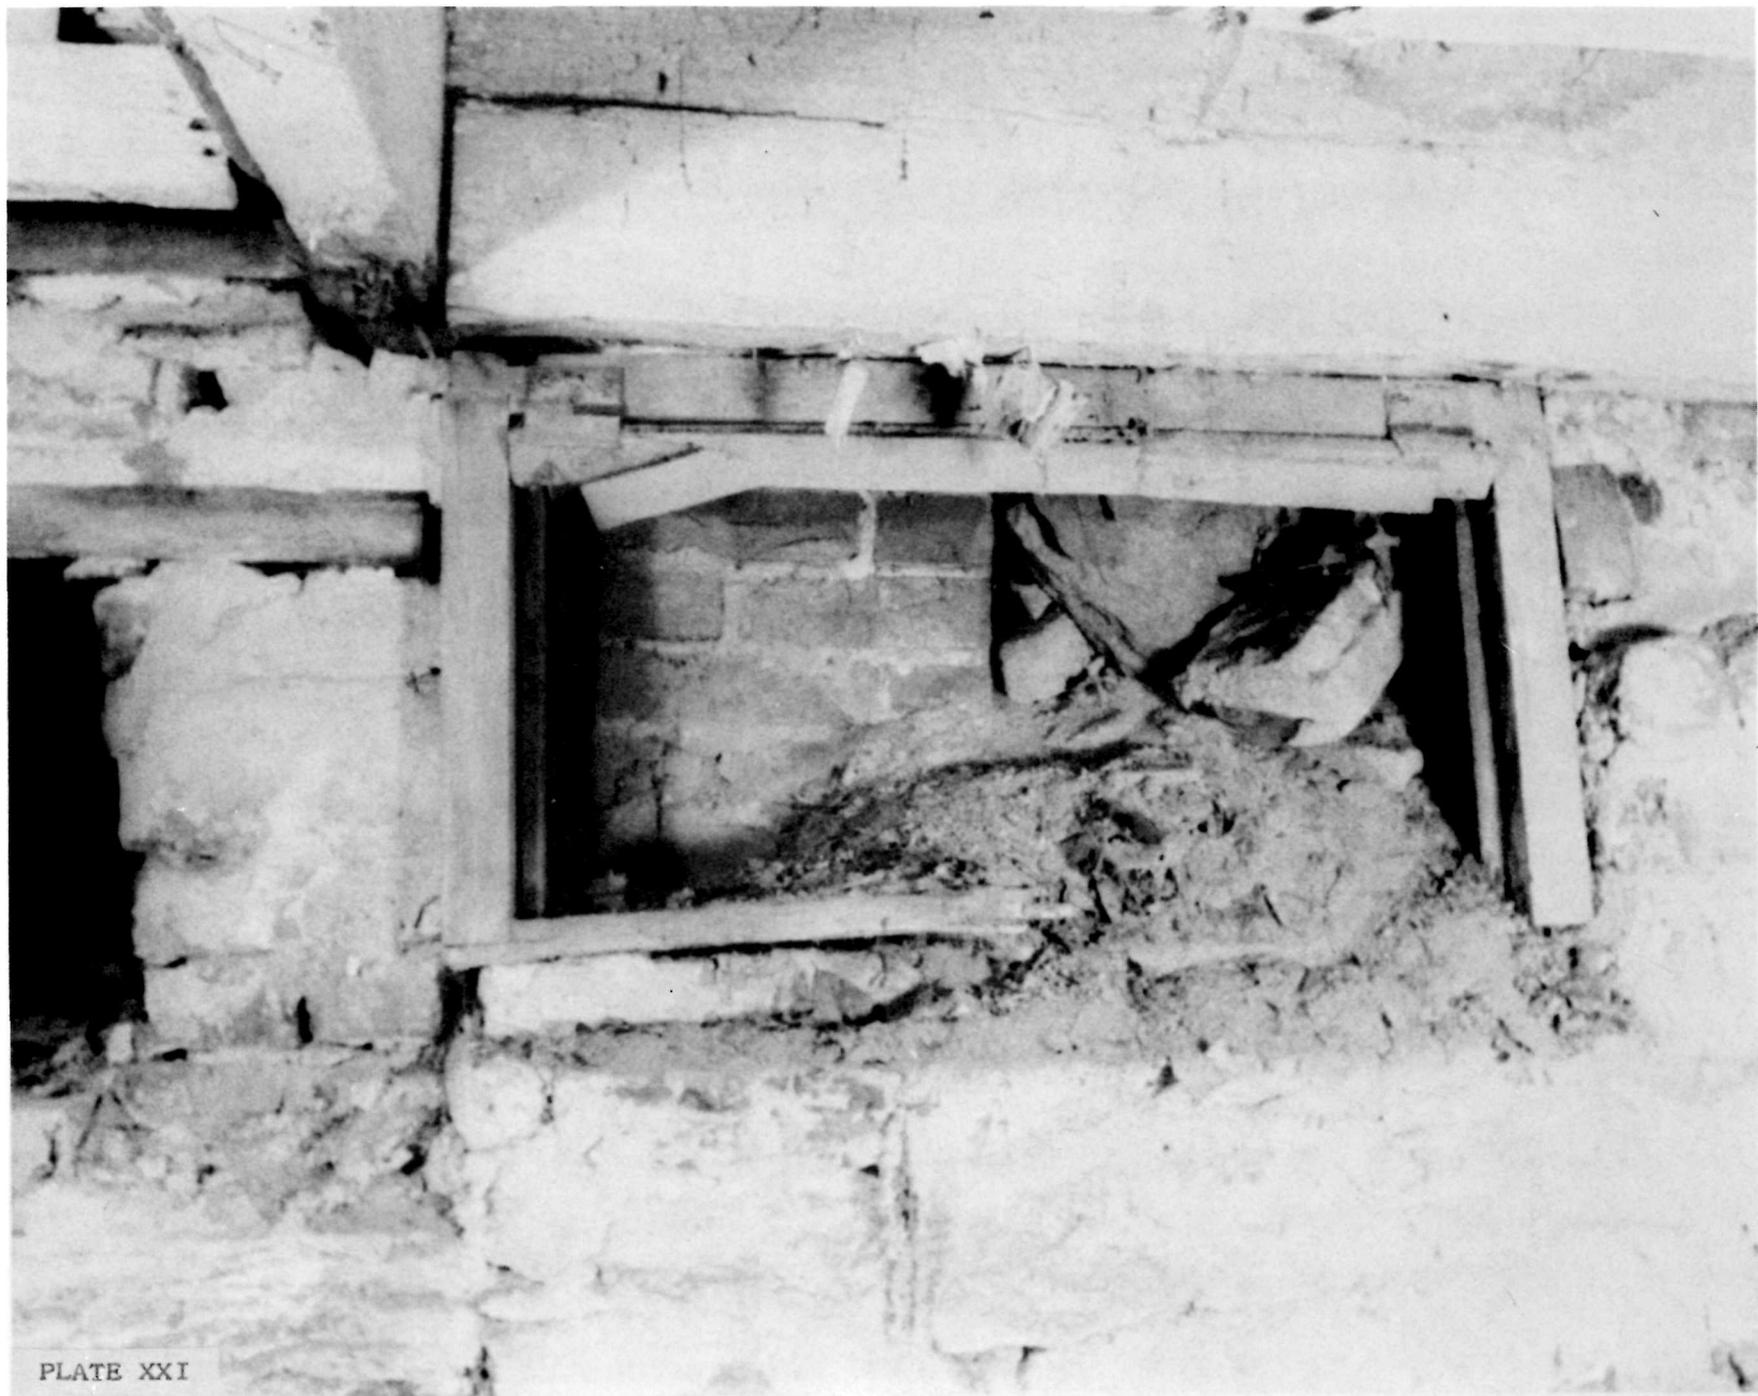
PLATE XXI

Window in east wall of basement room #2 was eliminated by the addition of room #109 (Douglass' study). Note abutting foundation. The window frame will be removed and the opening closed to strengthen the foundation.

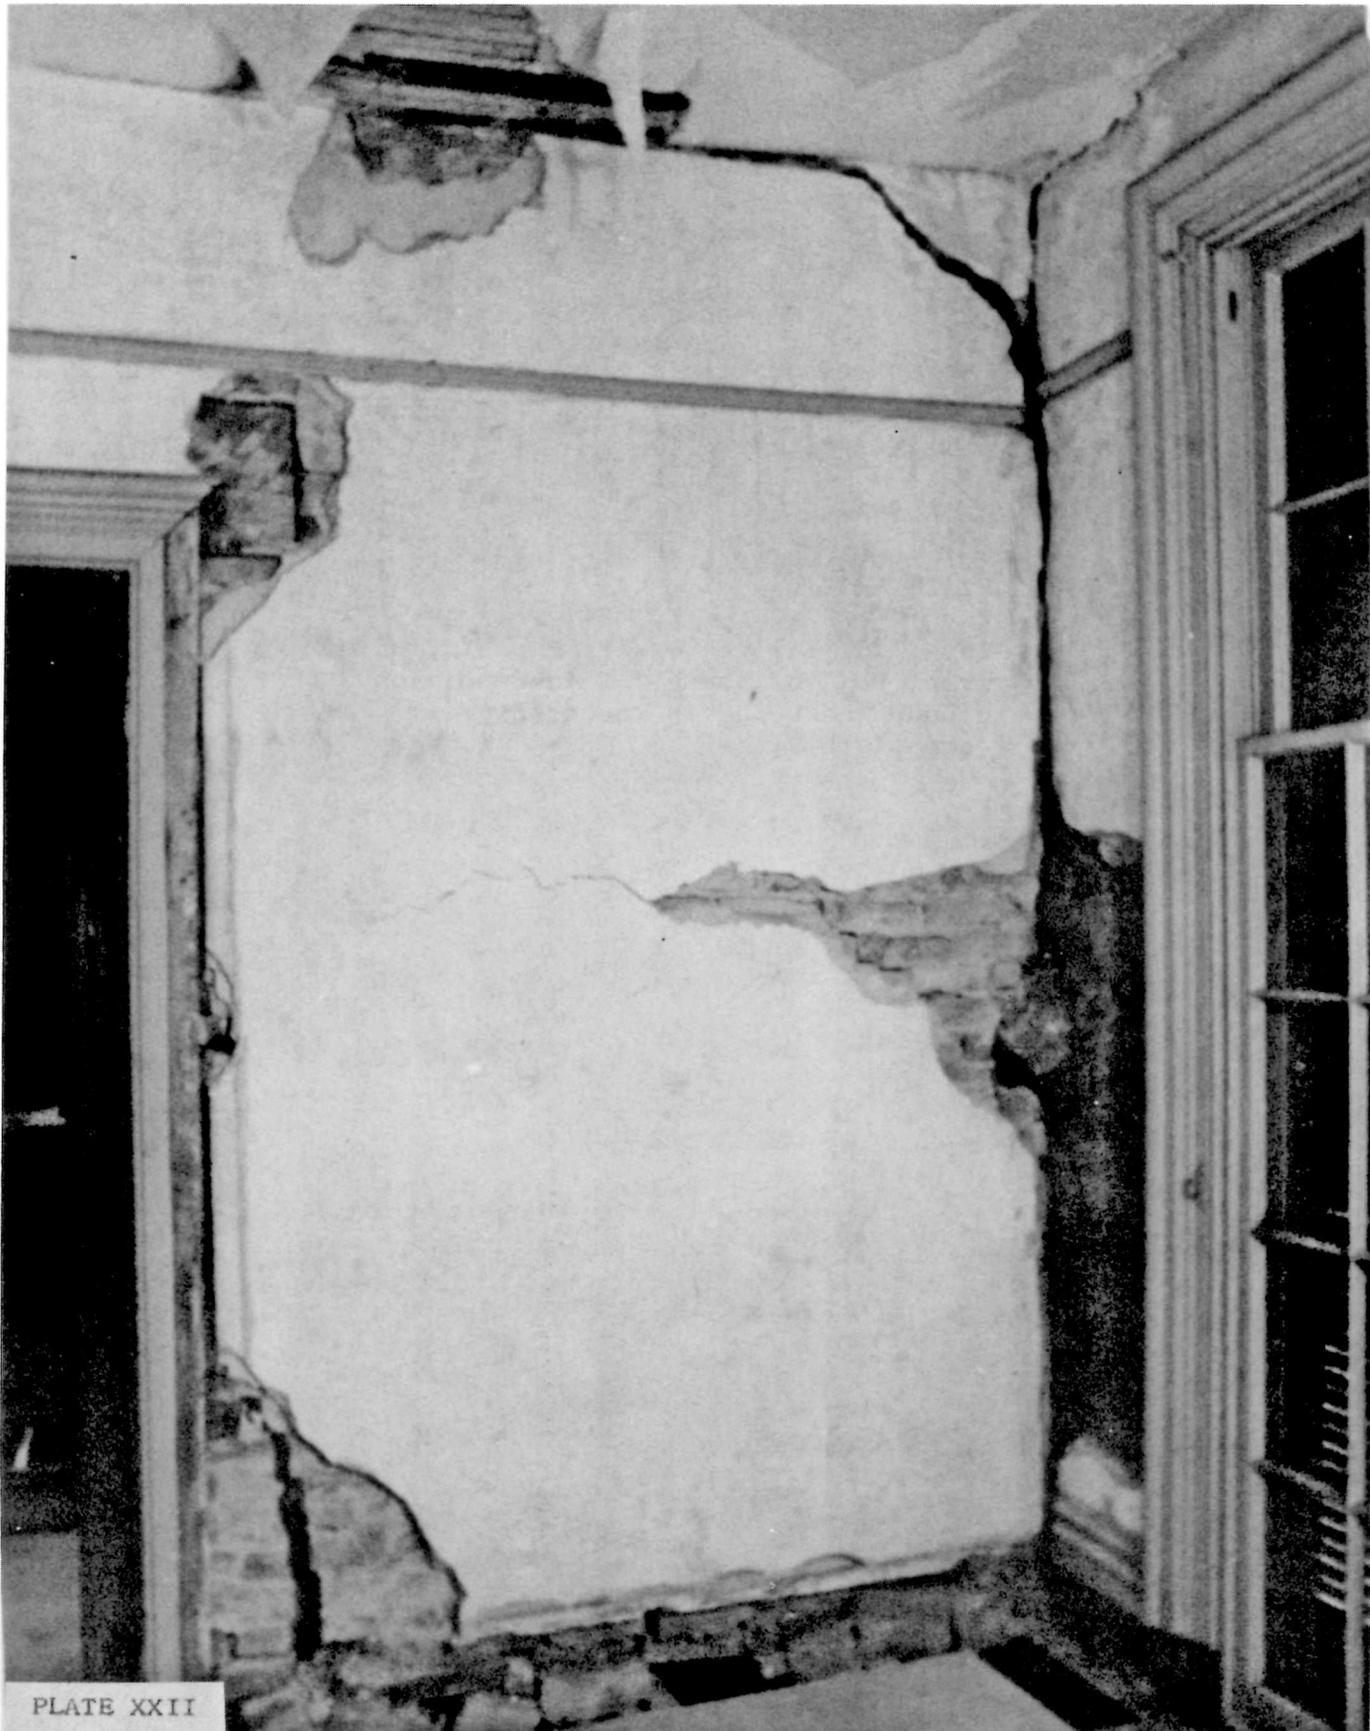
PLATE XXII

Interior brick partition between front Hall (#101) and east parlor (#108) as seen from room #108. Failure of the partition was due to the rotting of the supporting floor joists. Brick partition will be replaced by a double stud wall to reduce weight.
