**Frederick Douglass
Home**

HISTORIC STRUCTURES REPORT

ARCHITECTURAL DATA

JUNE 1970

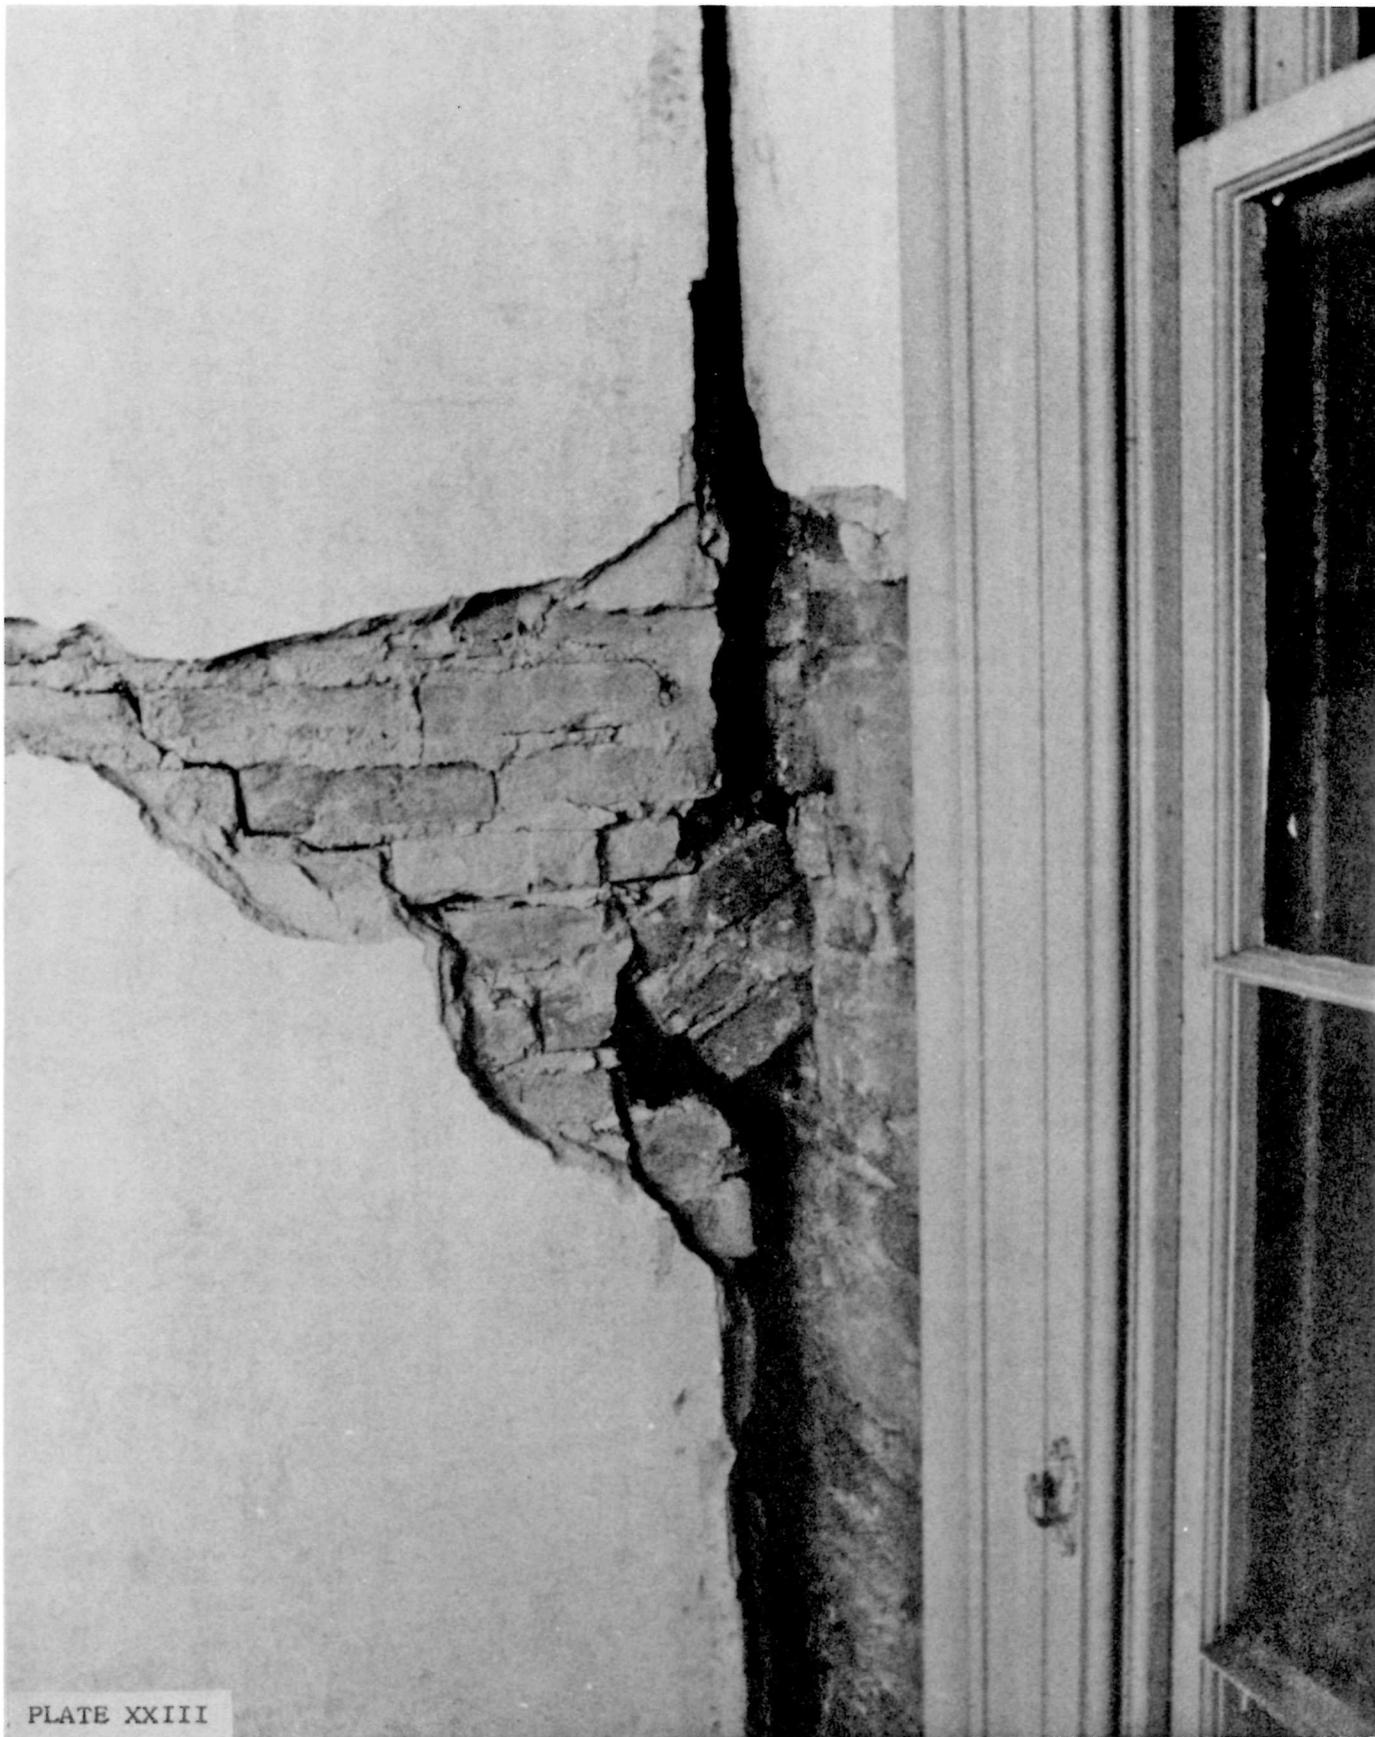
PLATE XXIII

Detail of failure of brick partition of front wall of house. This condition caused the bulge in the front wall (see plate V).

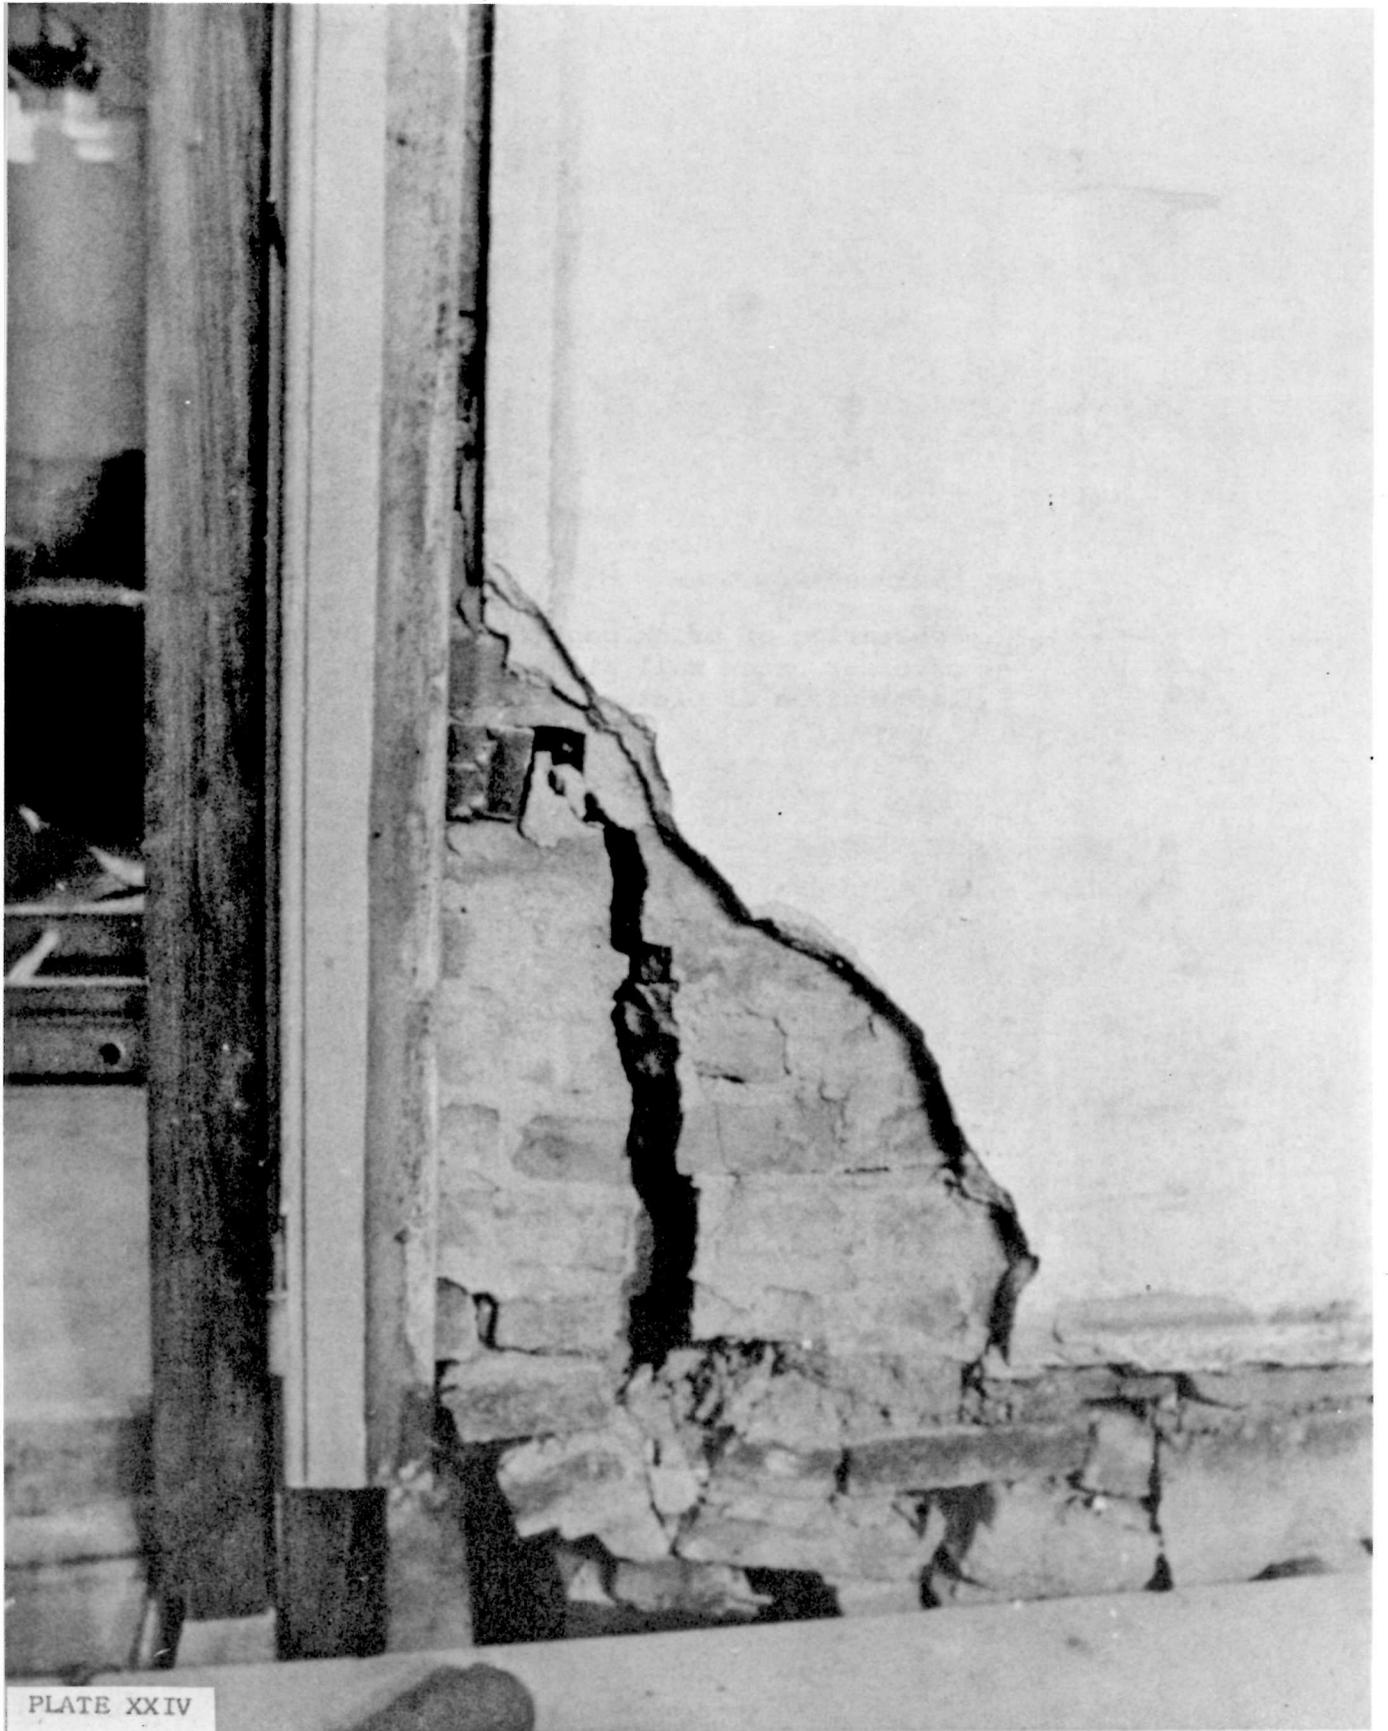
PLATE XXIV

**Detail showing failure of brick partition
at floor level.**

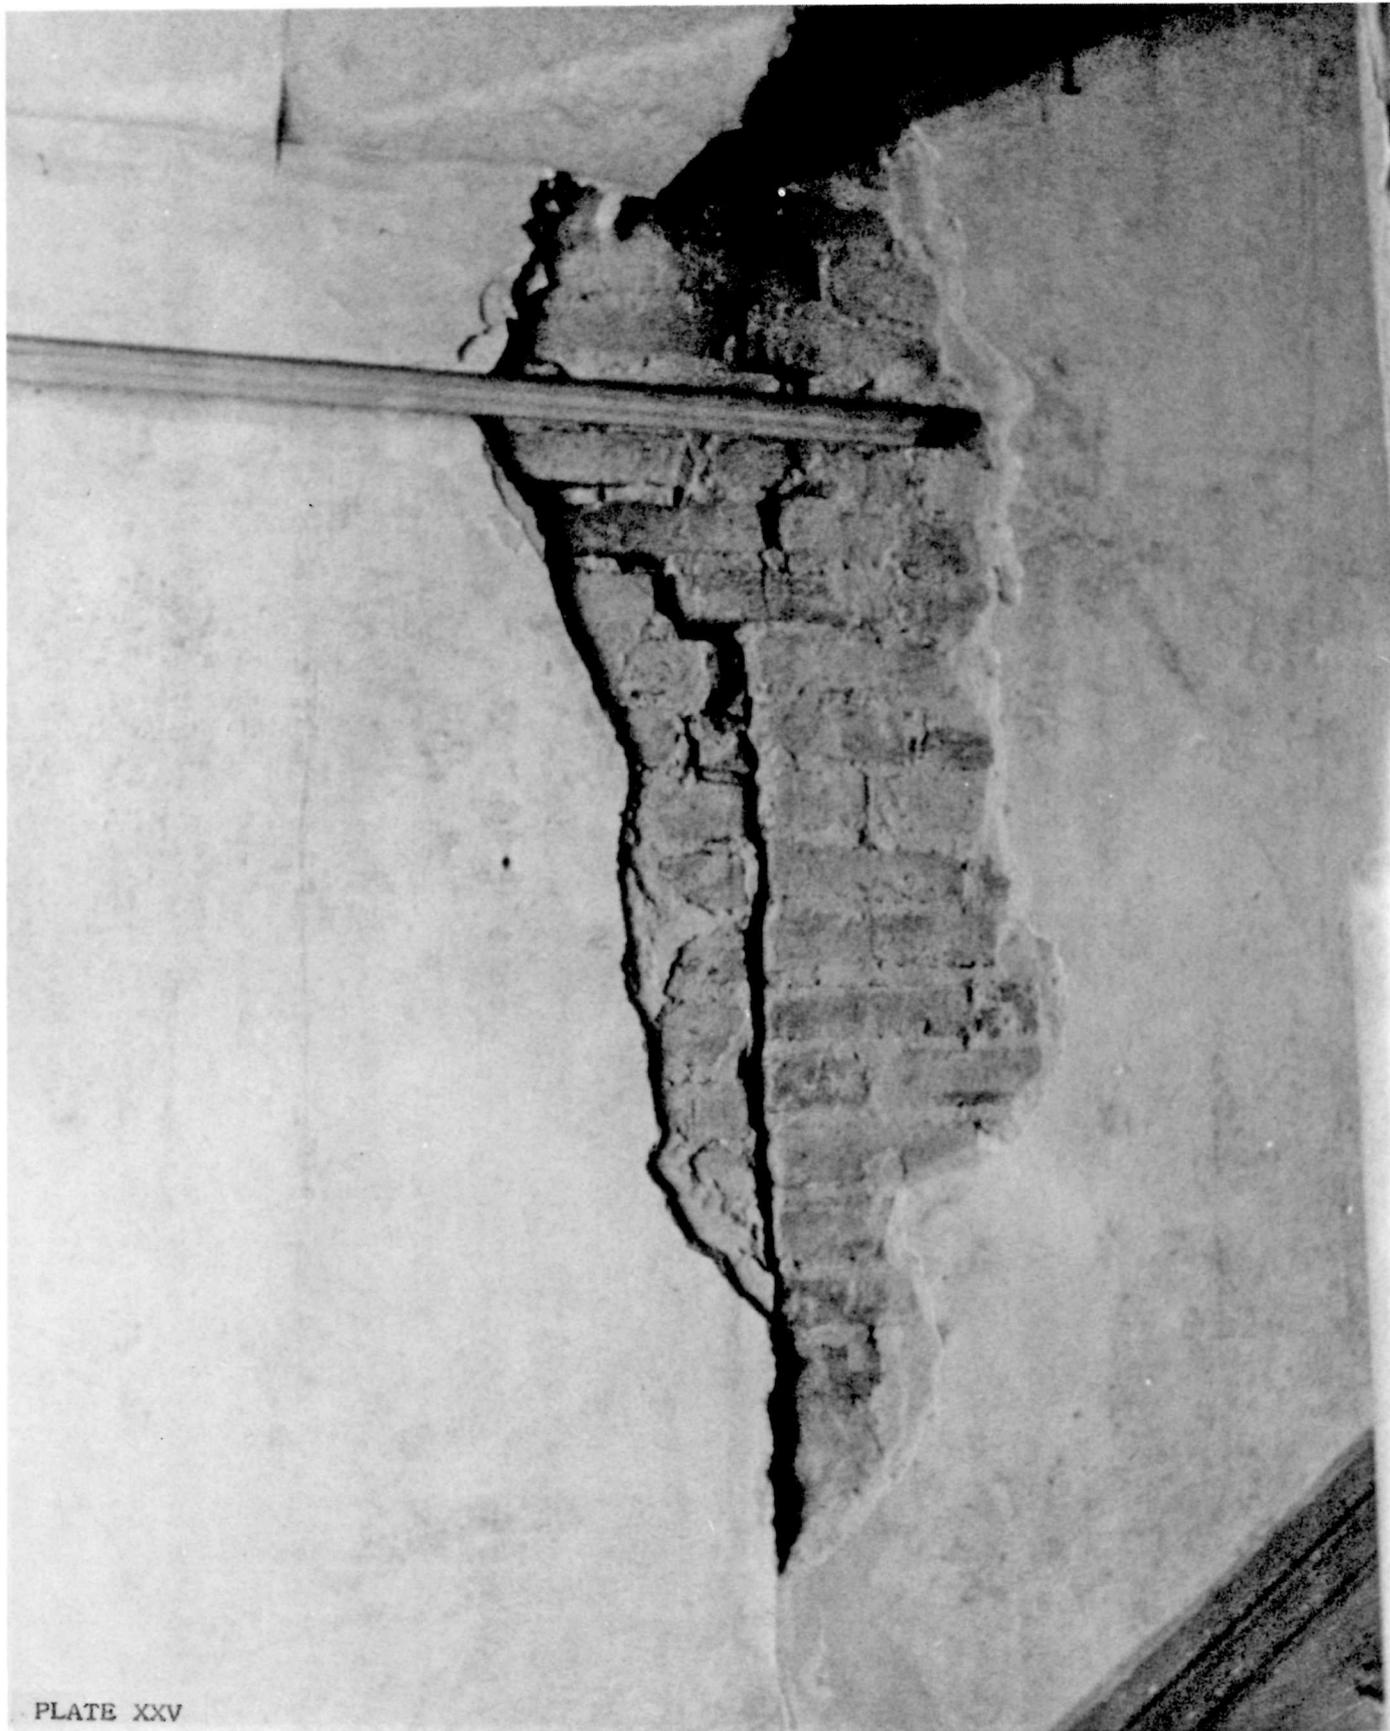
PLATE XXV

Separation of brick partition from original exterior brick wall at main stairway. Note termination of picture molding.

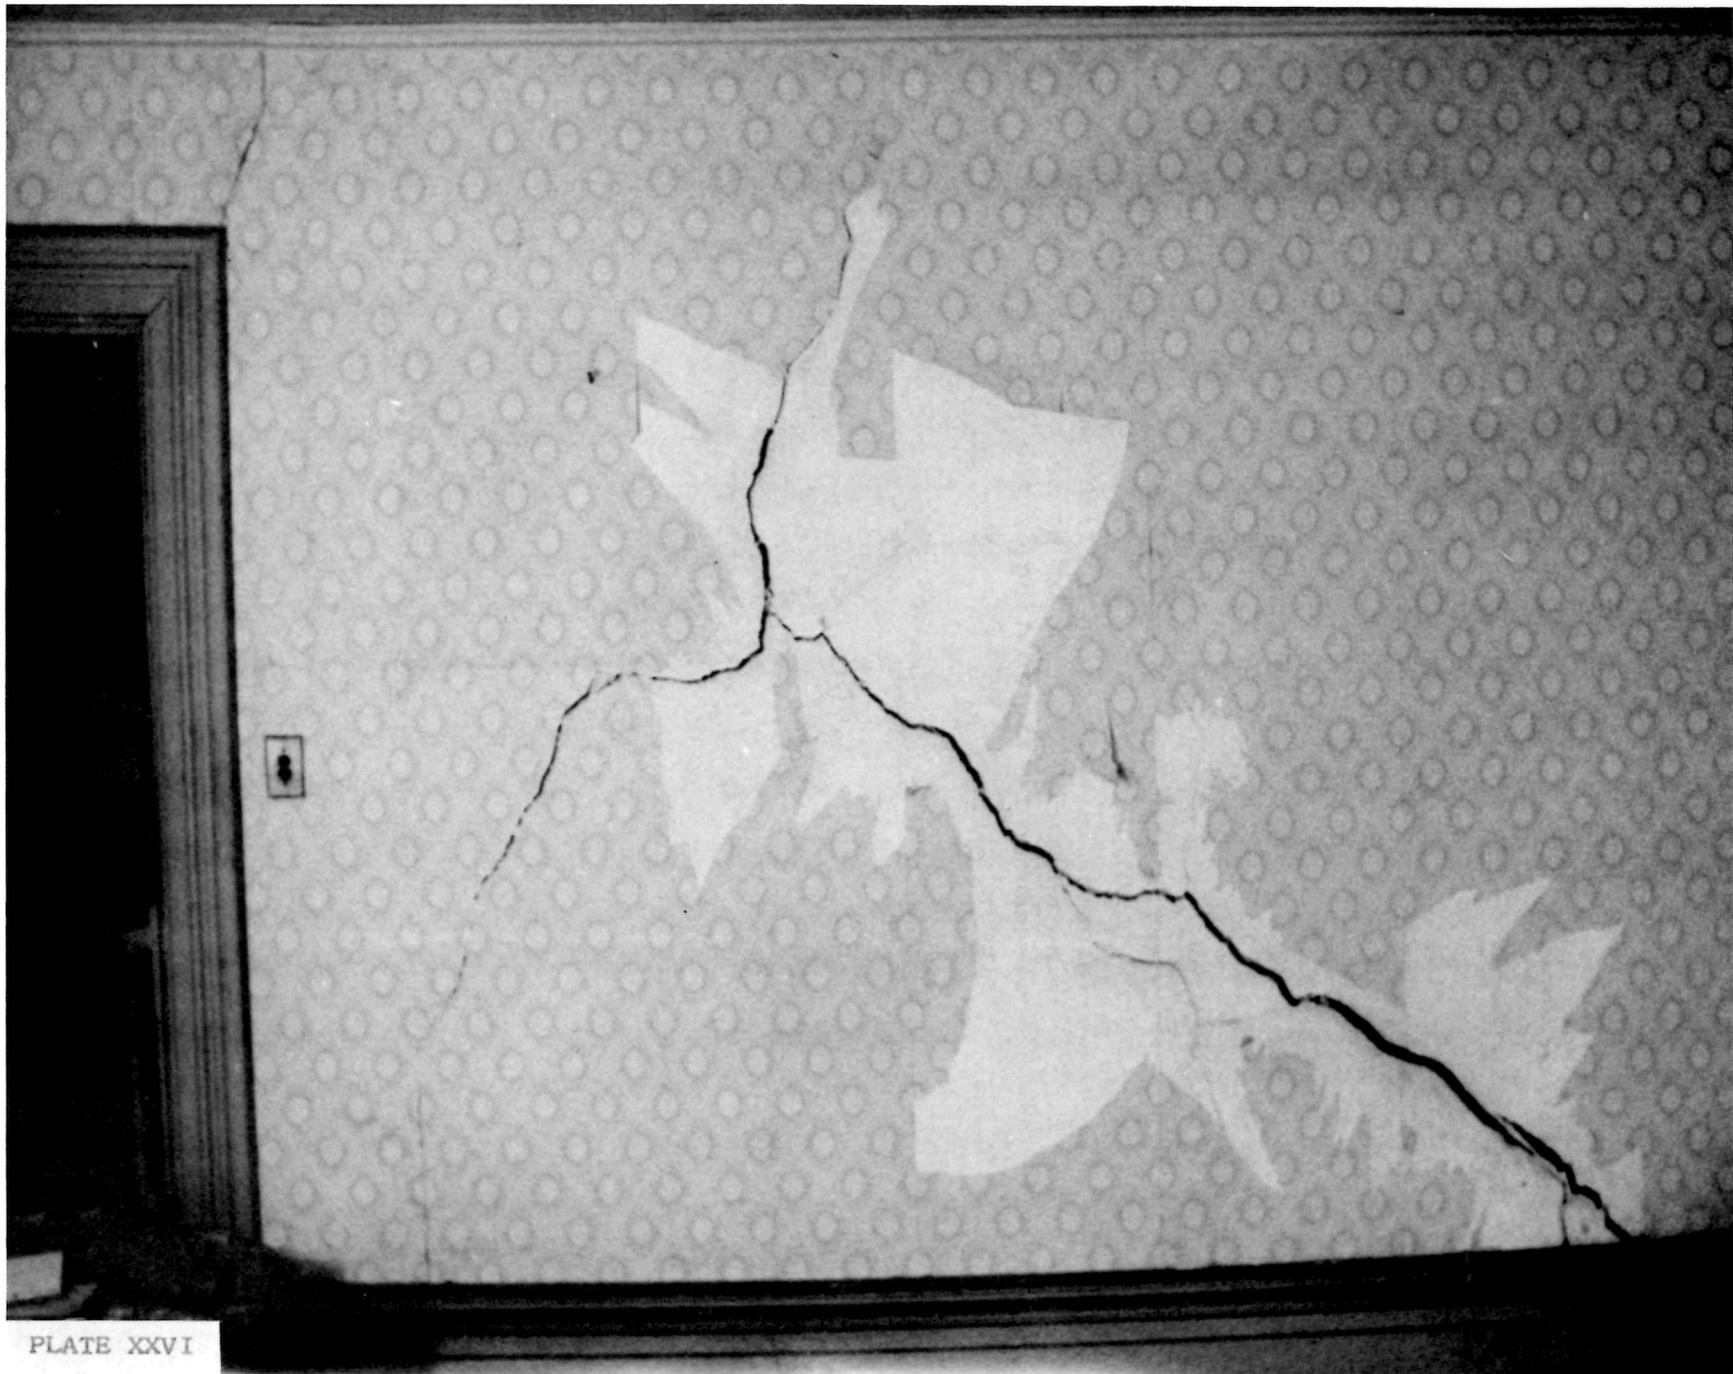
PLATE XXVI

Failure of second floor brick partition. This is a continuation of the first floor brick partition shown in plates XXII-XXIV.

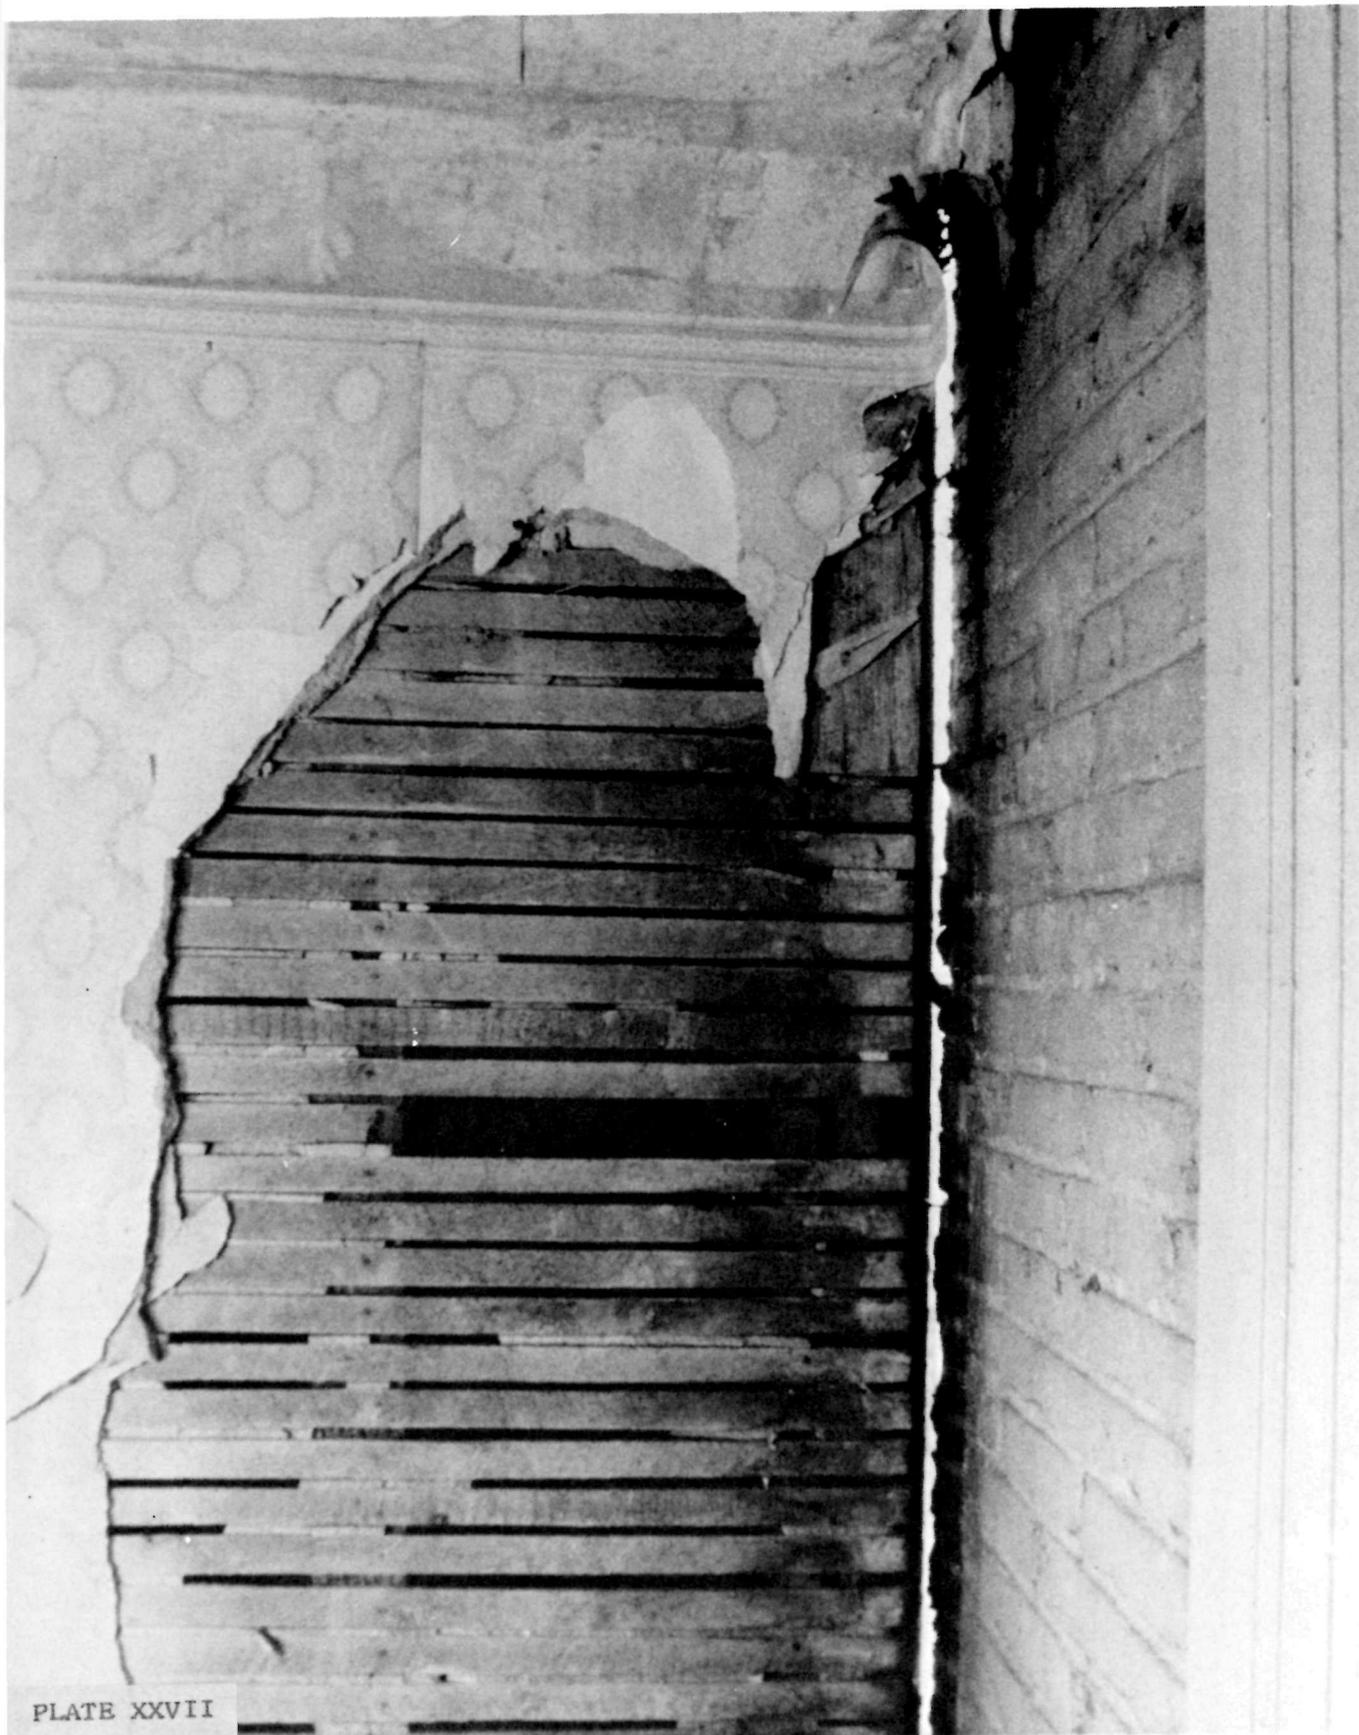
PLATE XXVII

Interior view junction of frame south wing and brick portion of house. Separation was caused by the rotting of the sills and studs.

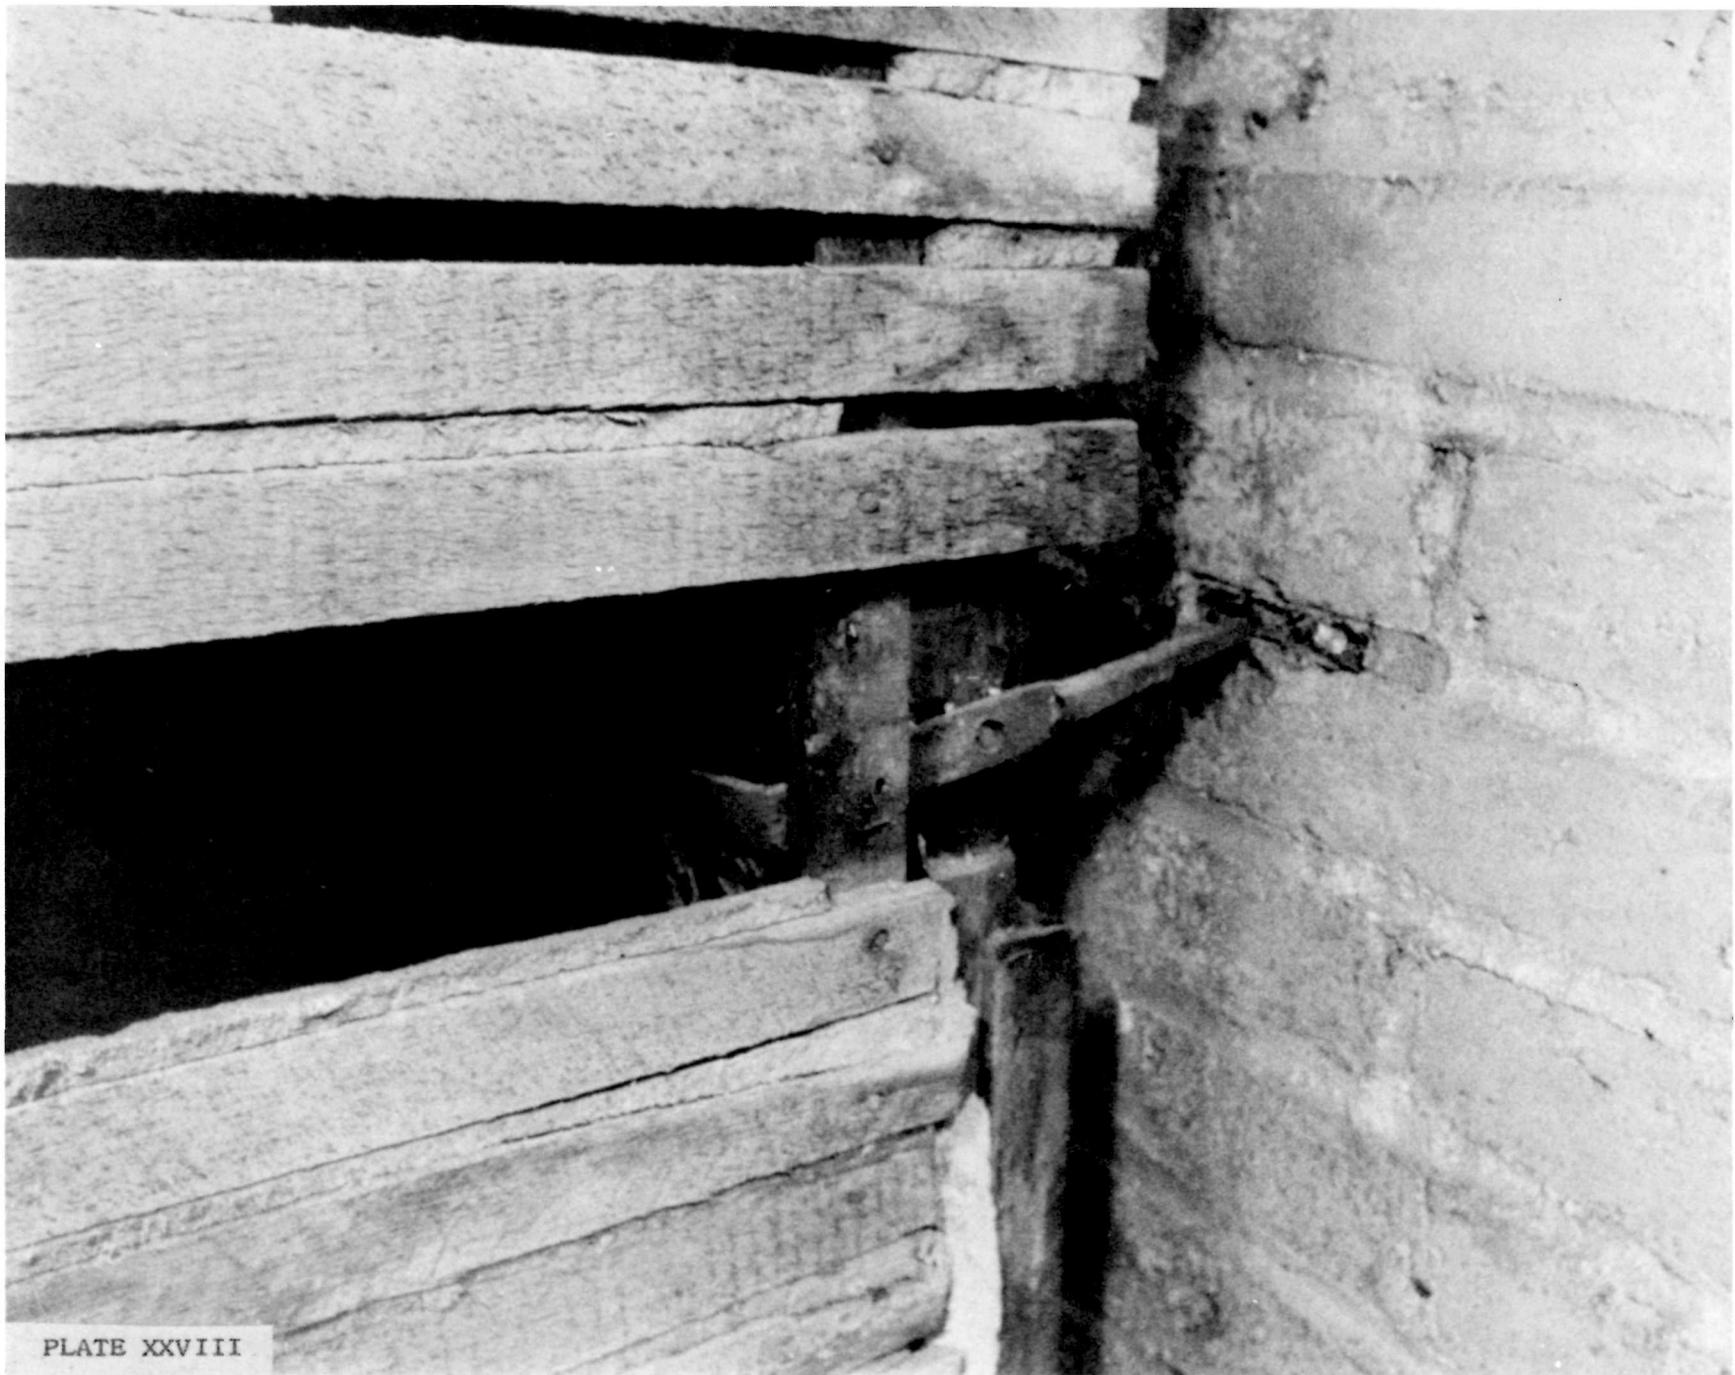
PLATE XXVIII

Detail showing withdrawel of anchor due to shifting
of frame south addition.

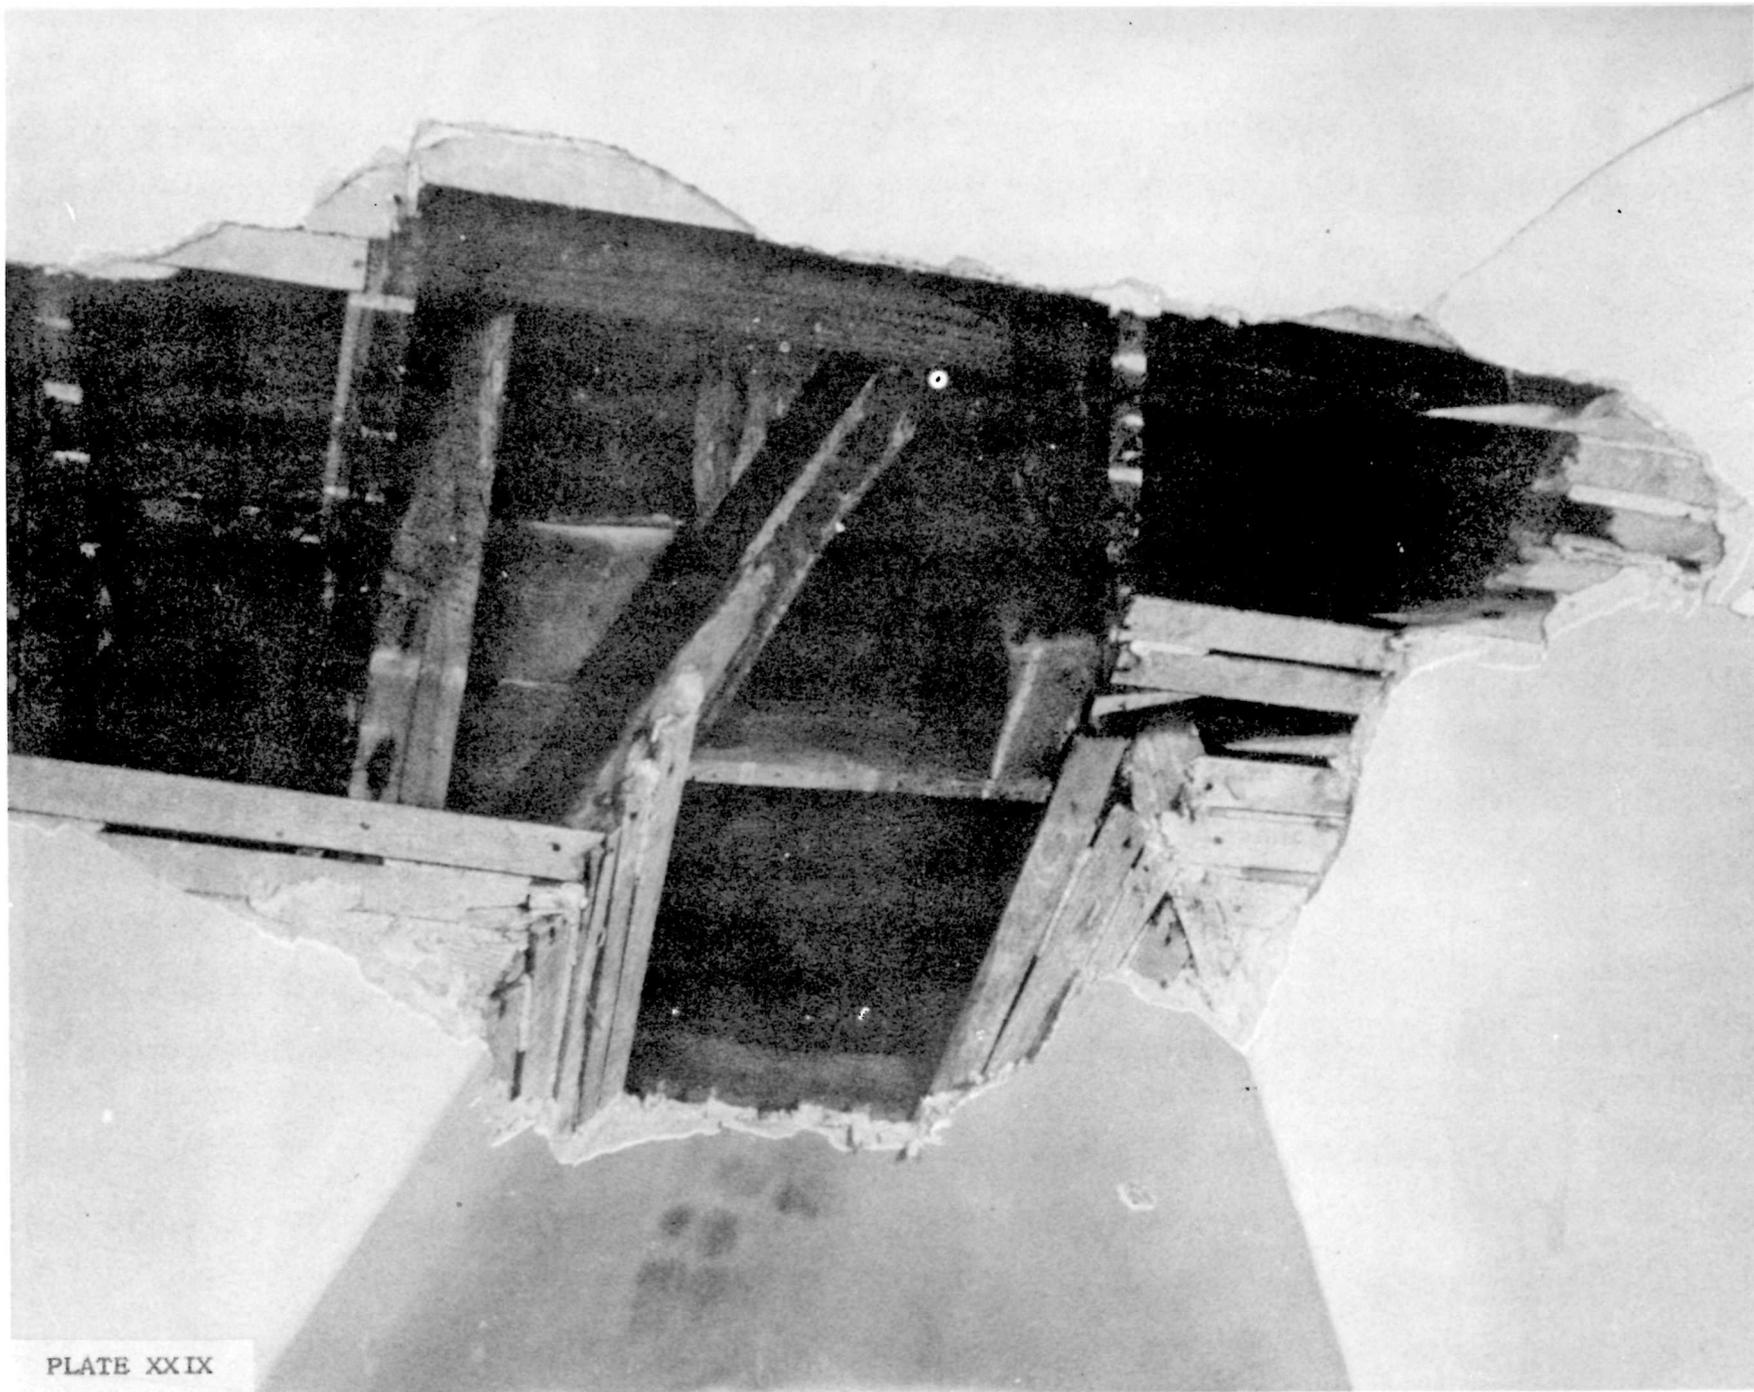
PLATE XXIX

Inspection opening third floor ceiling for spot investigation of the roof framing.

This is typical of inspection openings throughout the house which must be patched.

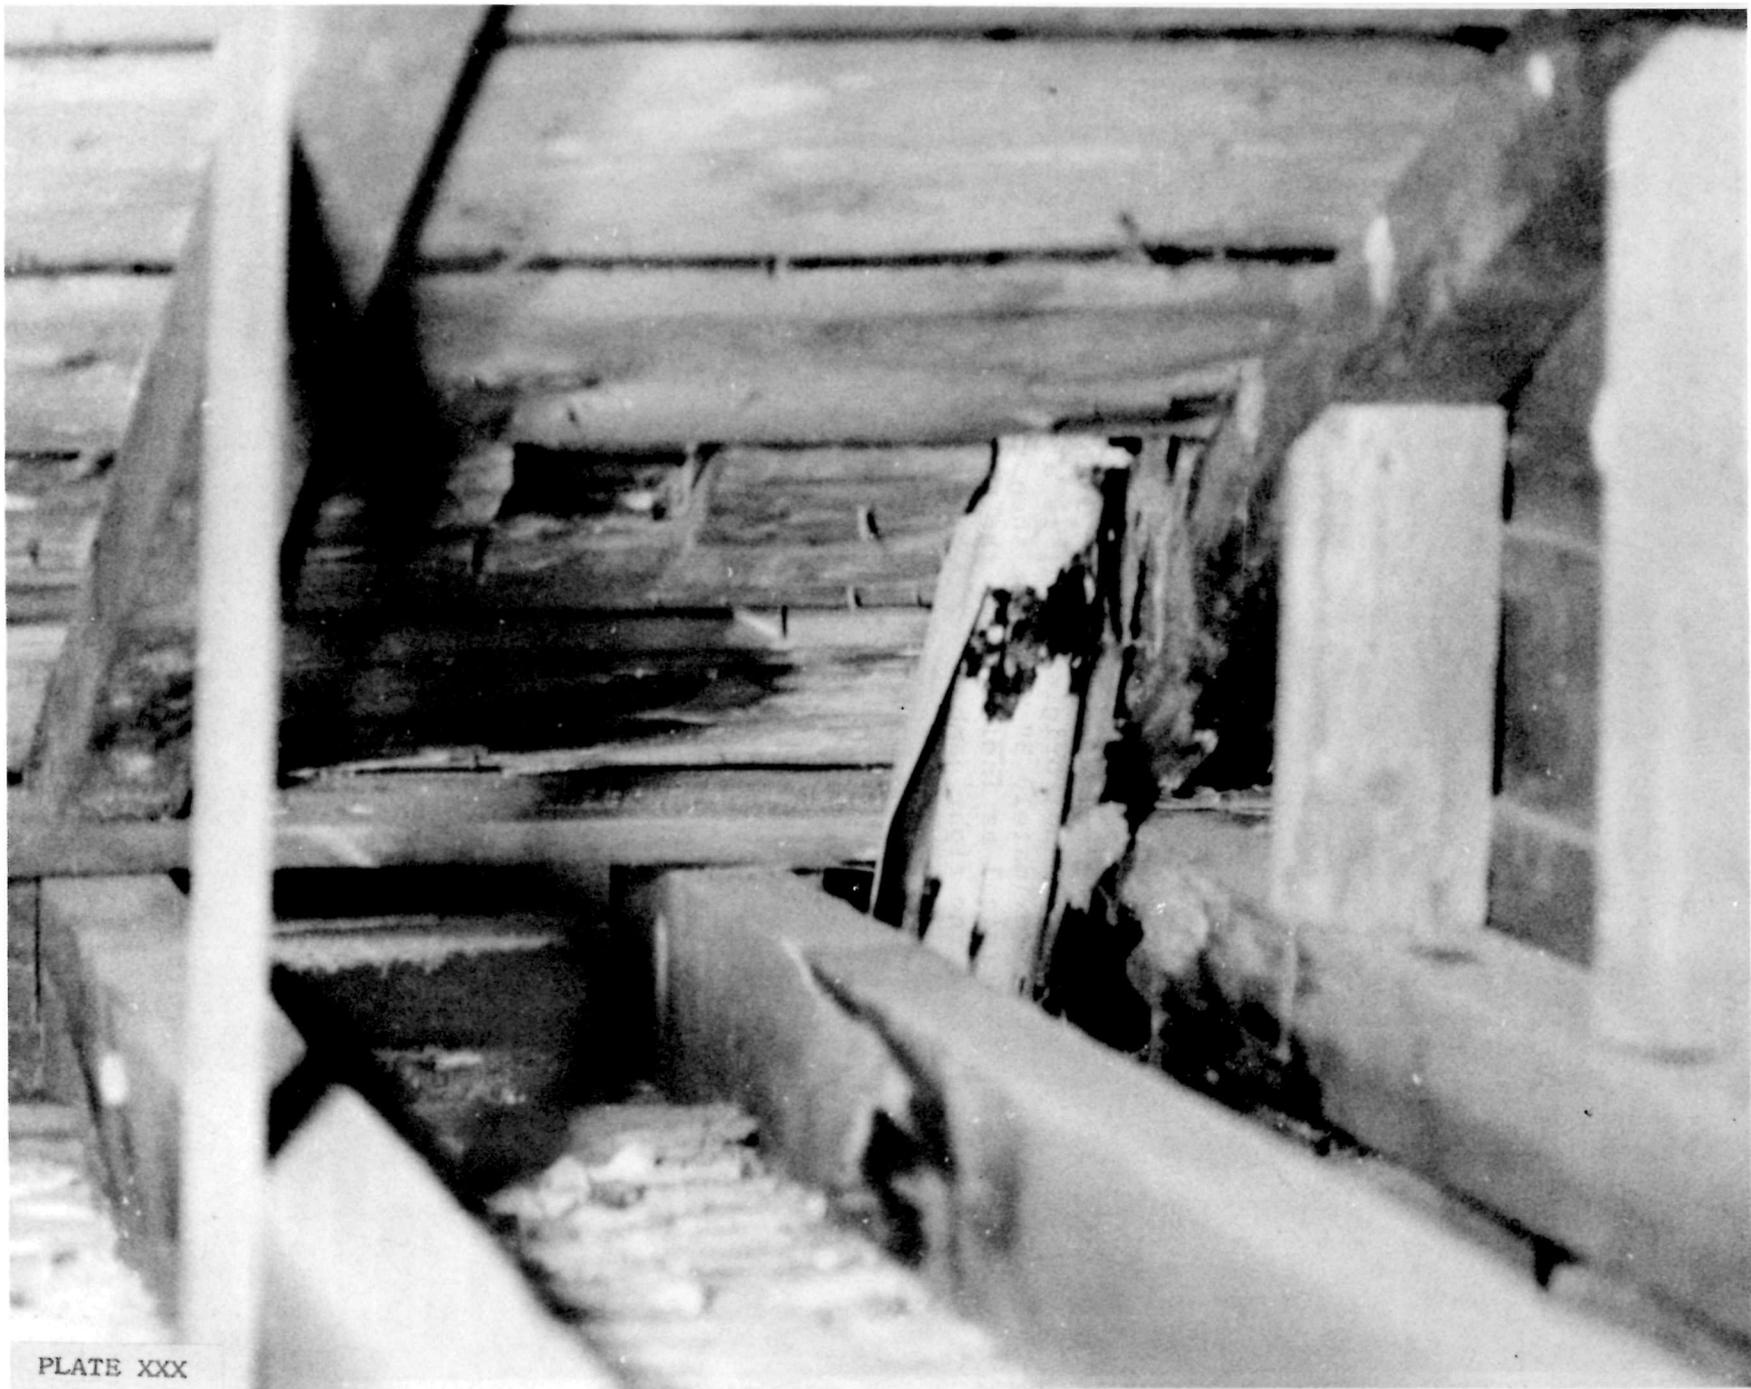
PLATE XXX

Rot in second floor ceiling joists, rafters and roof boards, southeast corner frame south wing as seen from the attic. Note protruding shingle nails. Earlier wood shingles were not removed when the present tin roof was installed.

Note also the downspout from the dutch gutter and hole for previous down spout.

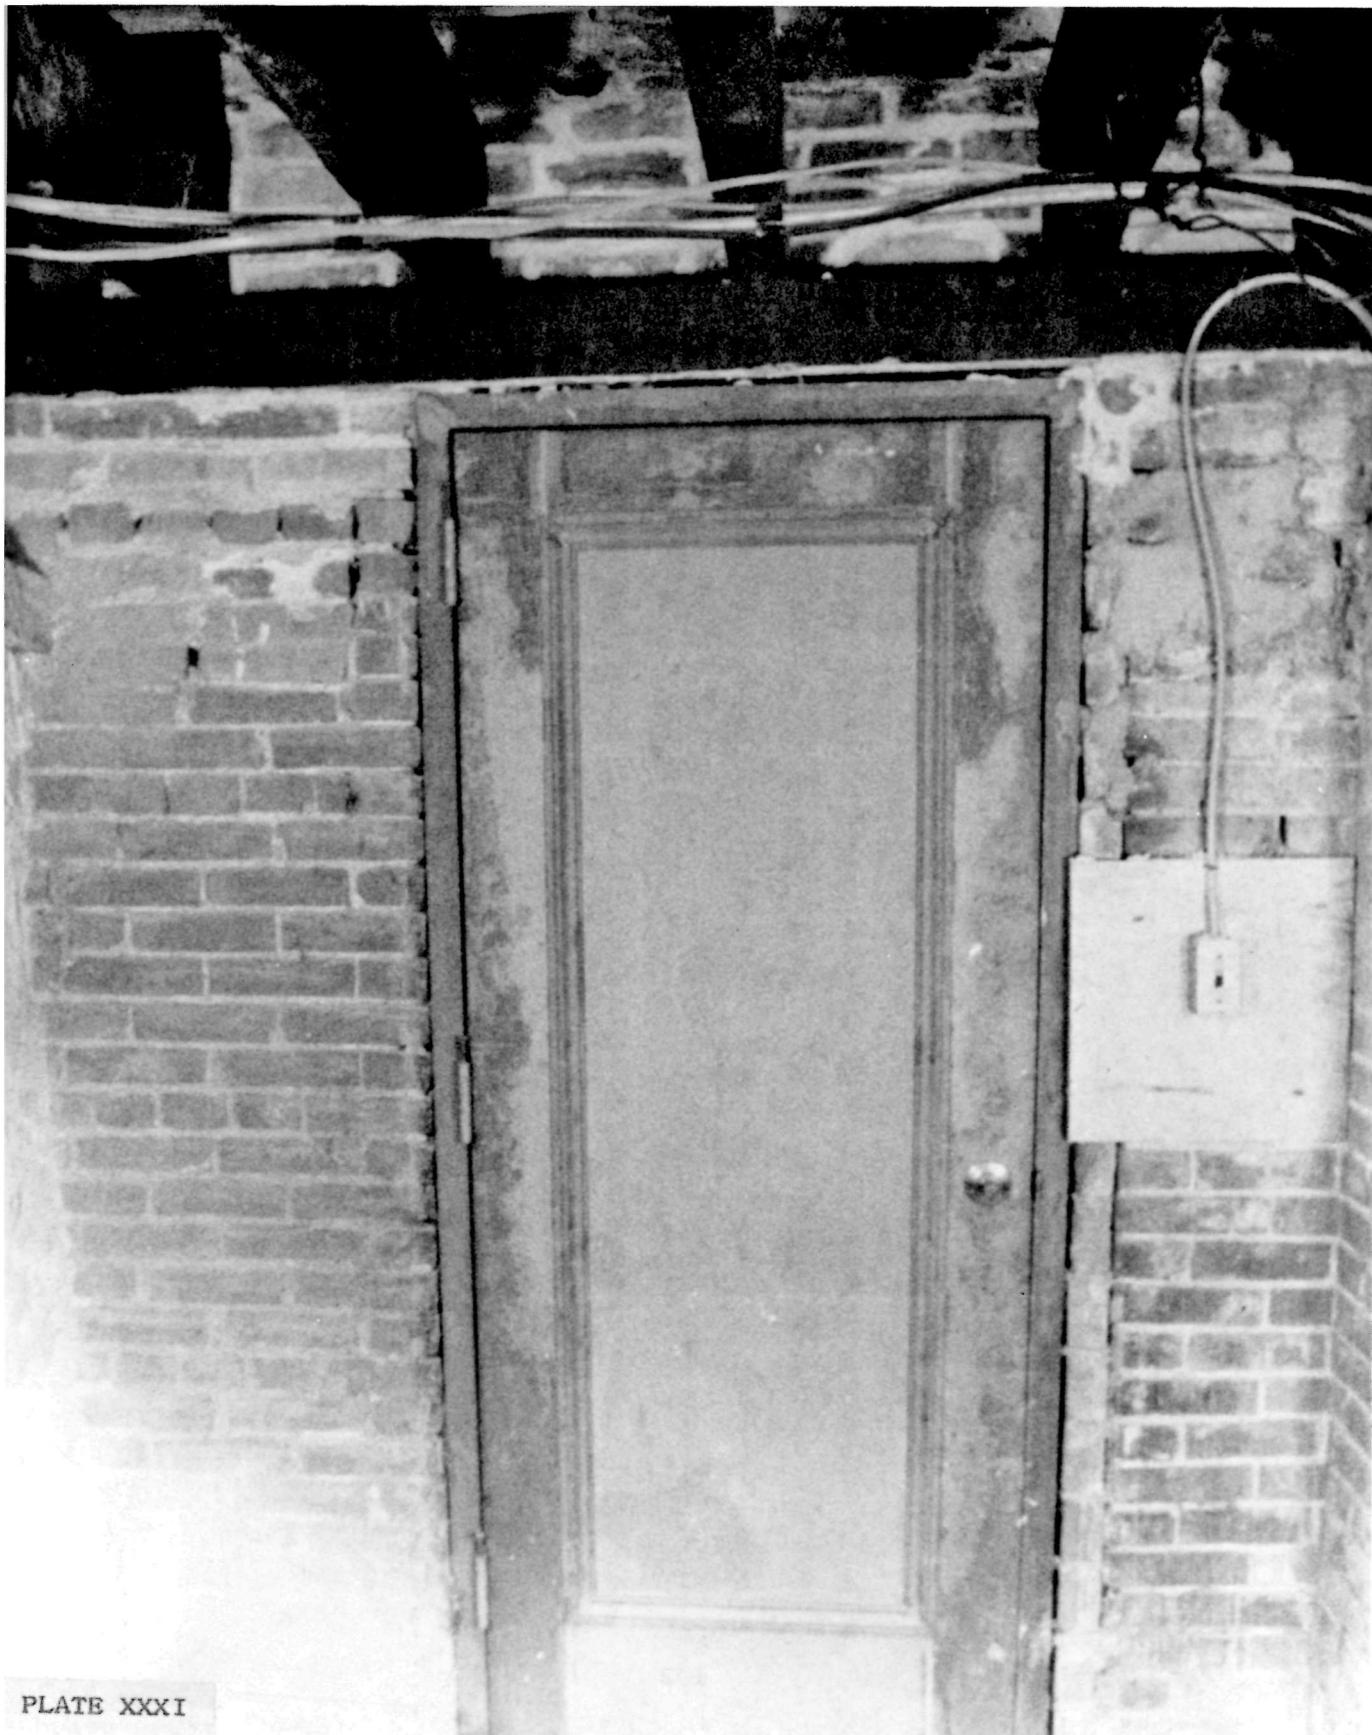
PLATE XXXI

The metal clad door and steel channel frame is not original. It is also approximately 3" narrower than the original as indicated by the brickwork at the right jamb.
