**Frederick Douglass
Home**

HISTORIC STRUCTURES REPORT

ARCHITECTURAL DATA

JUNE 1970

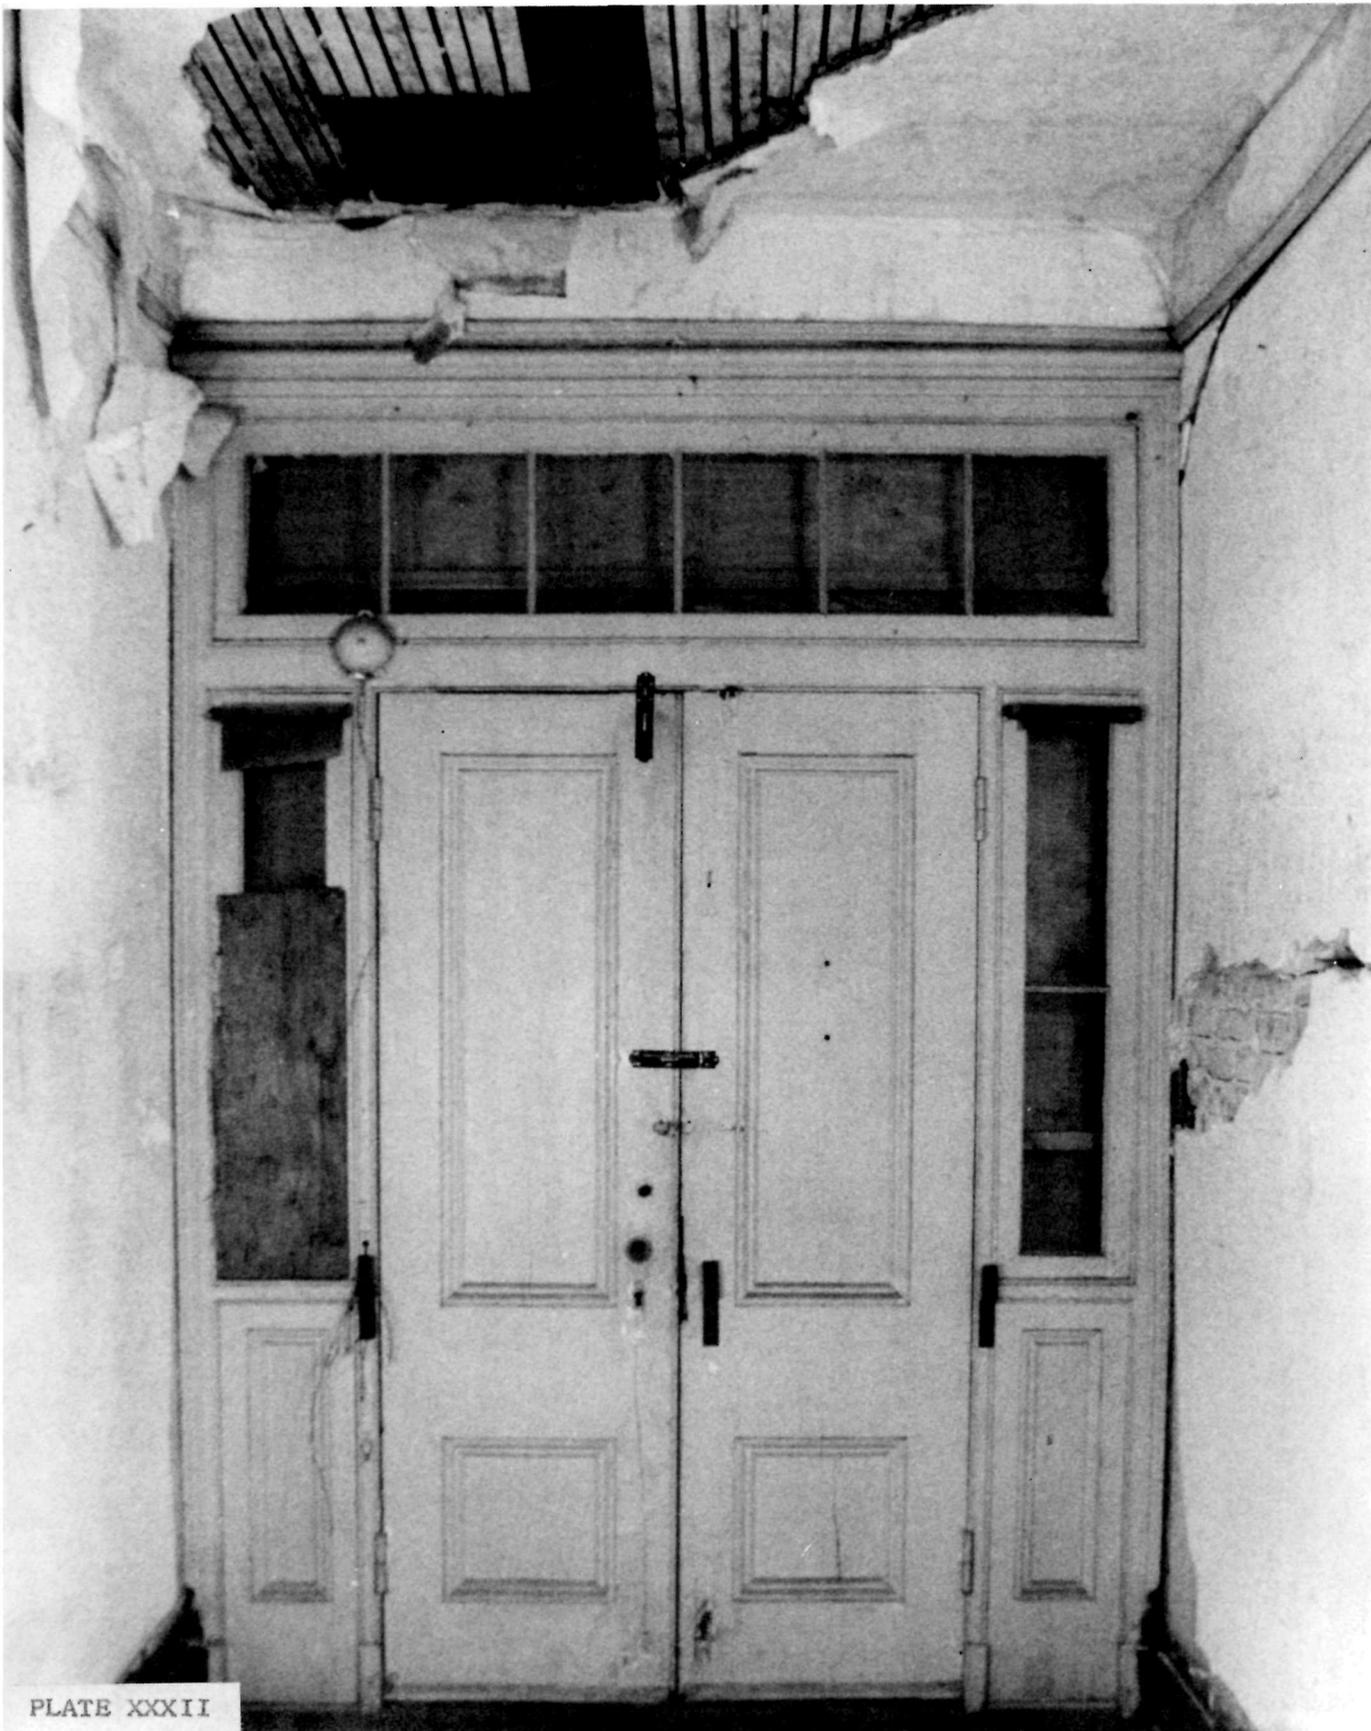
PLATE XXXII

Interior view of front door showing
general condition.

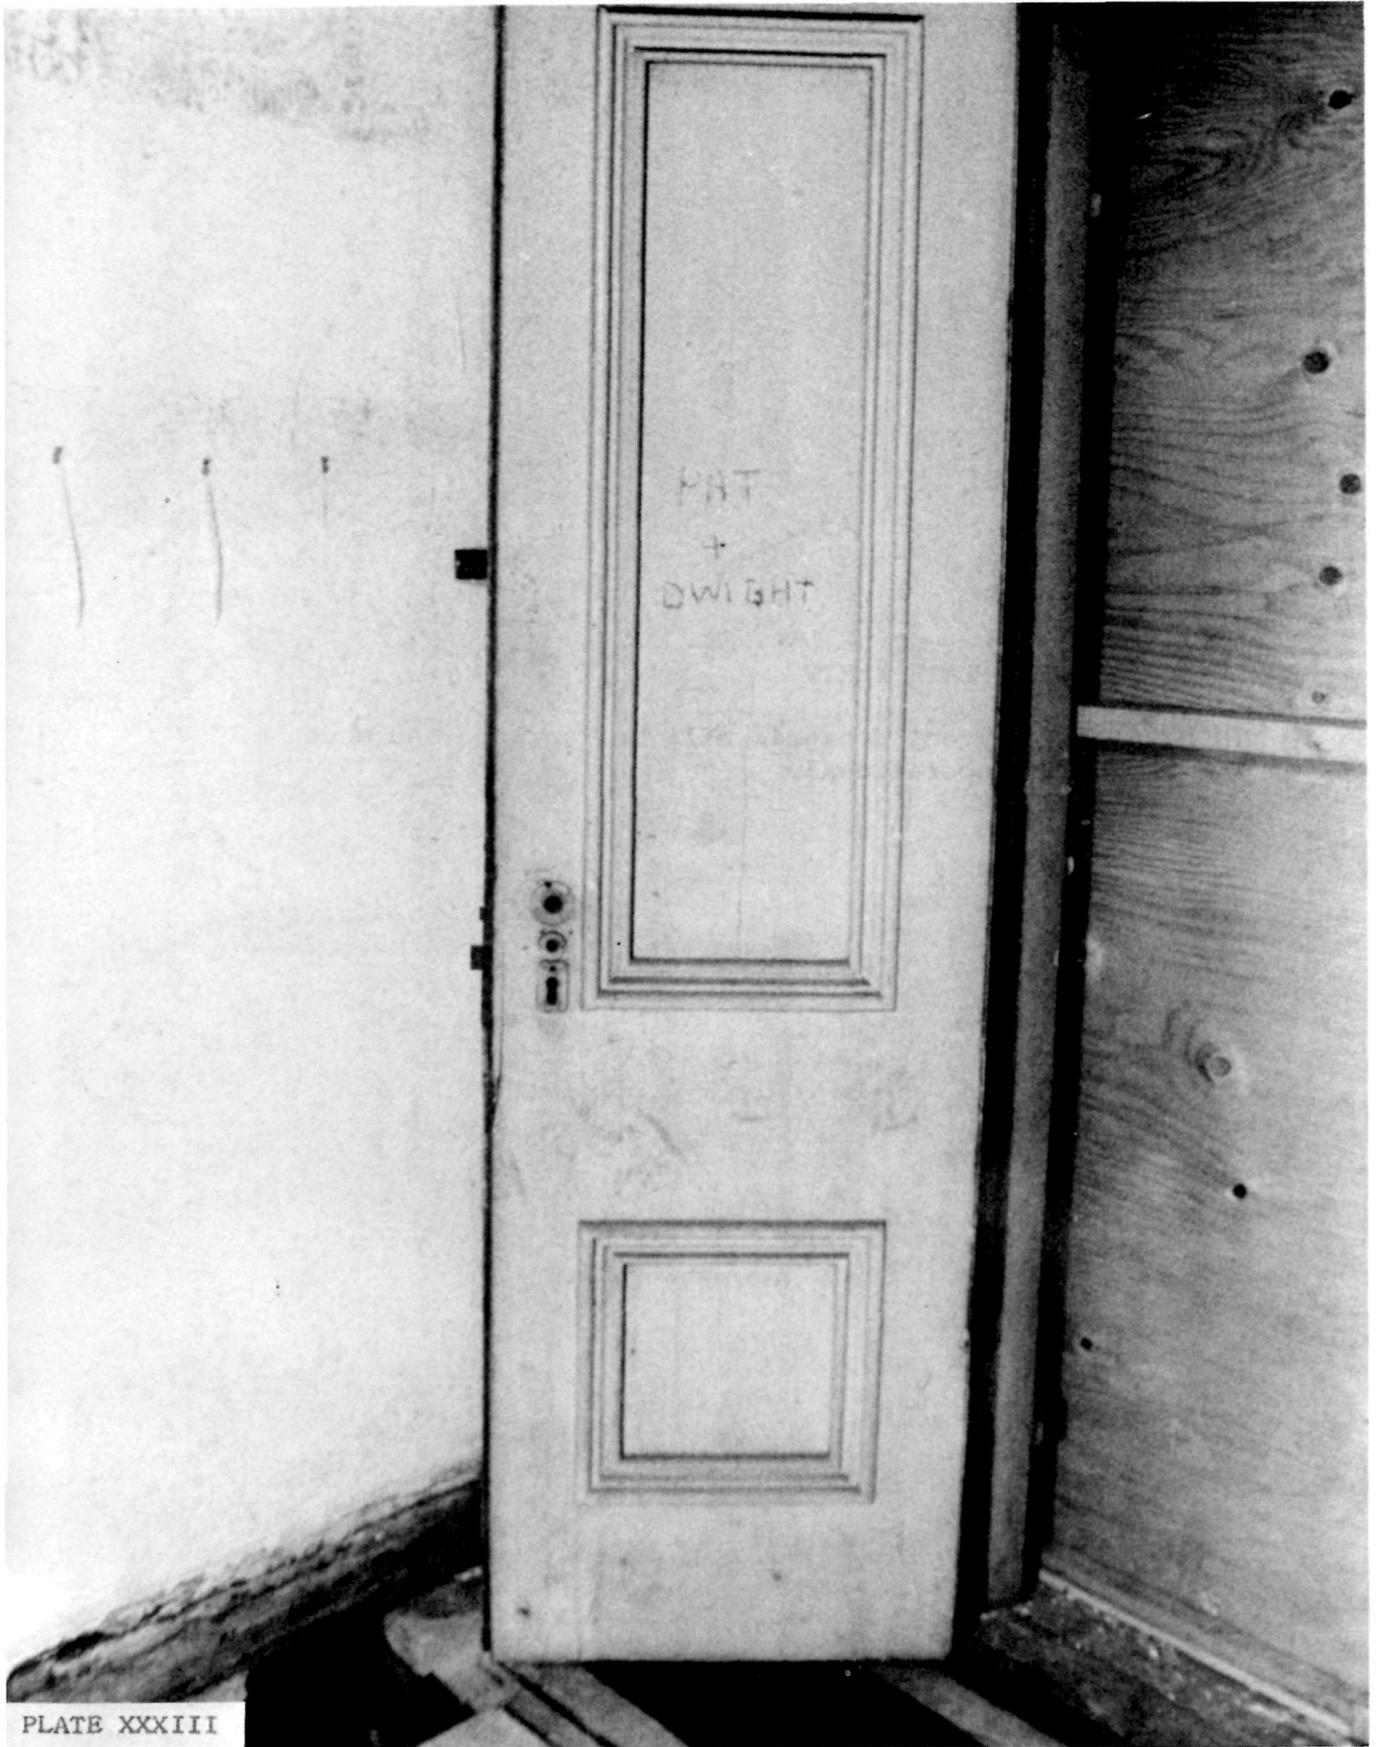
PLATE XXXIII

Detail of active leaf, front door. Note missing hardware and vandalism.

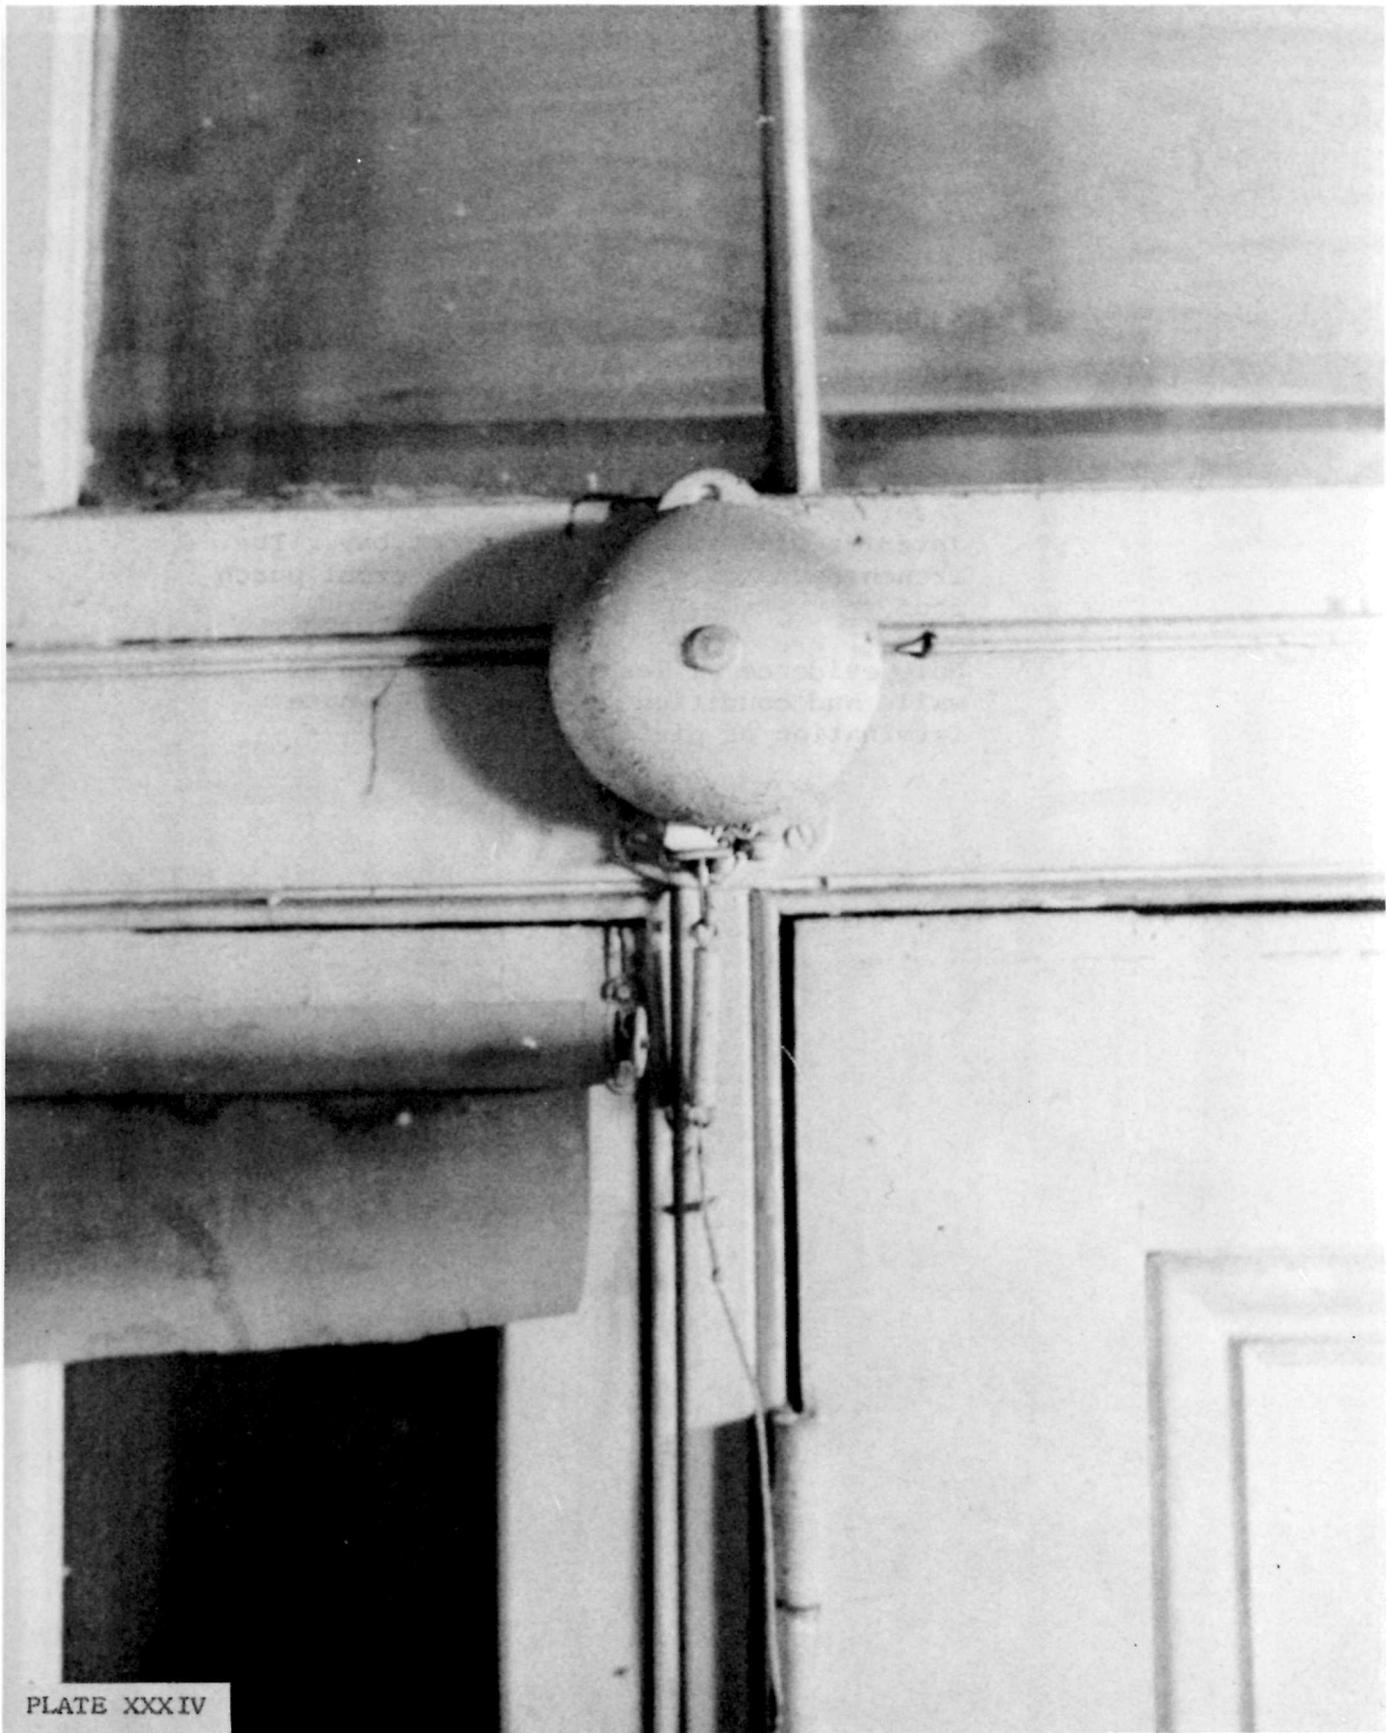
PLATE XXXIV

Front doorbell will be repaired and made operational.

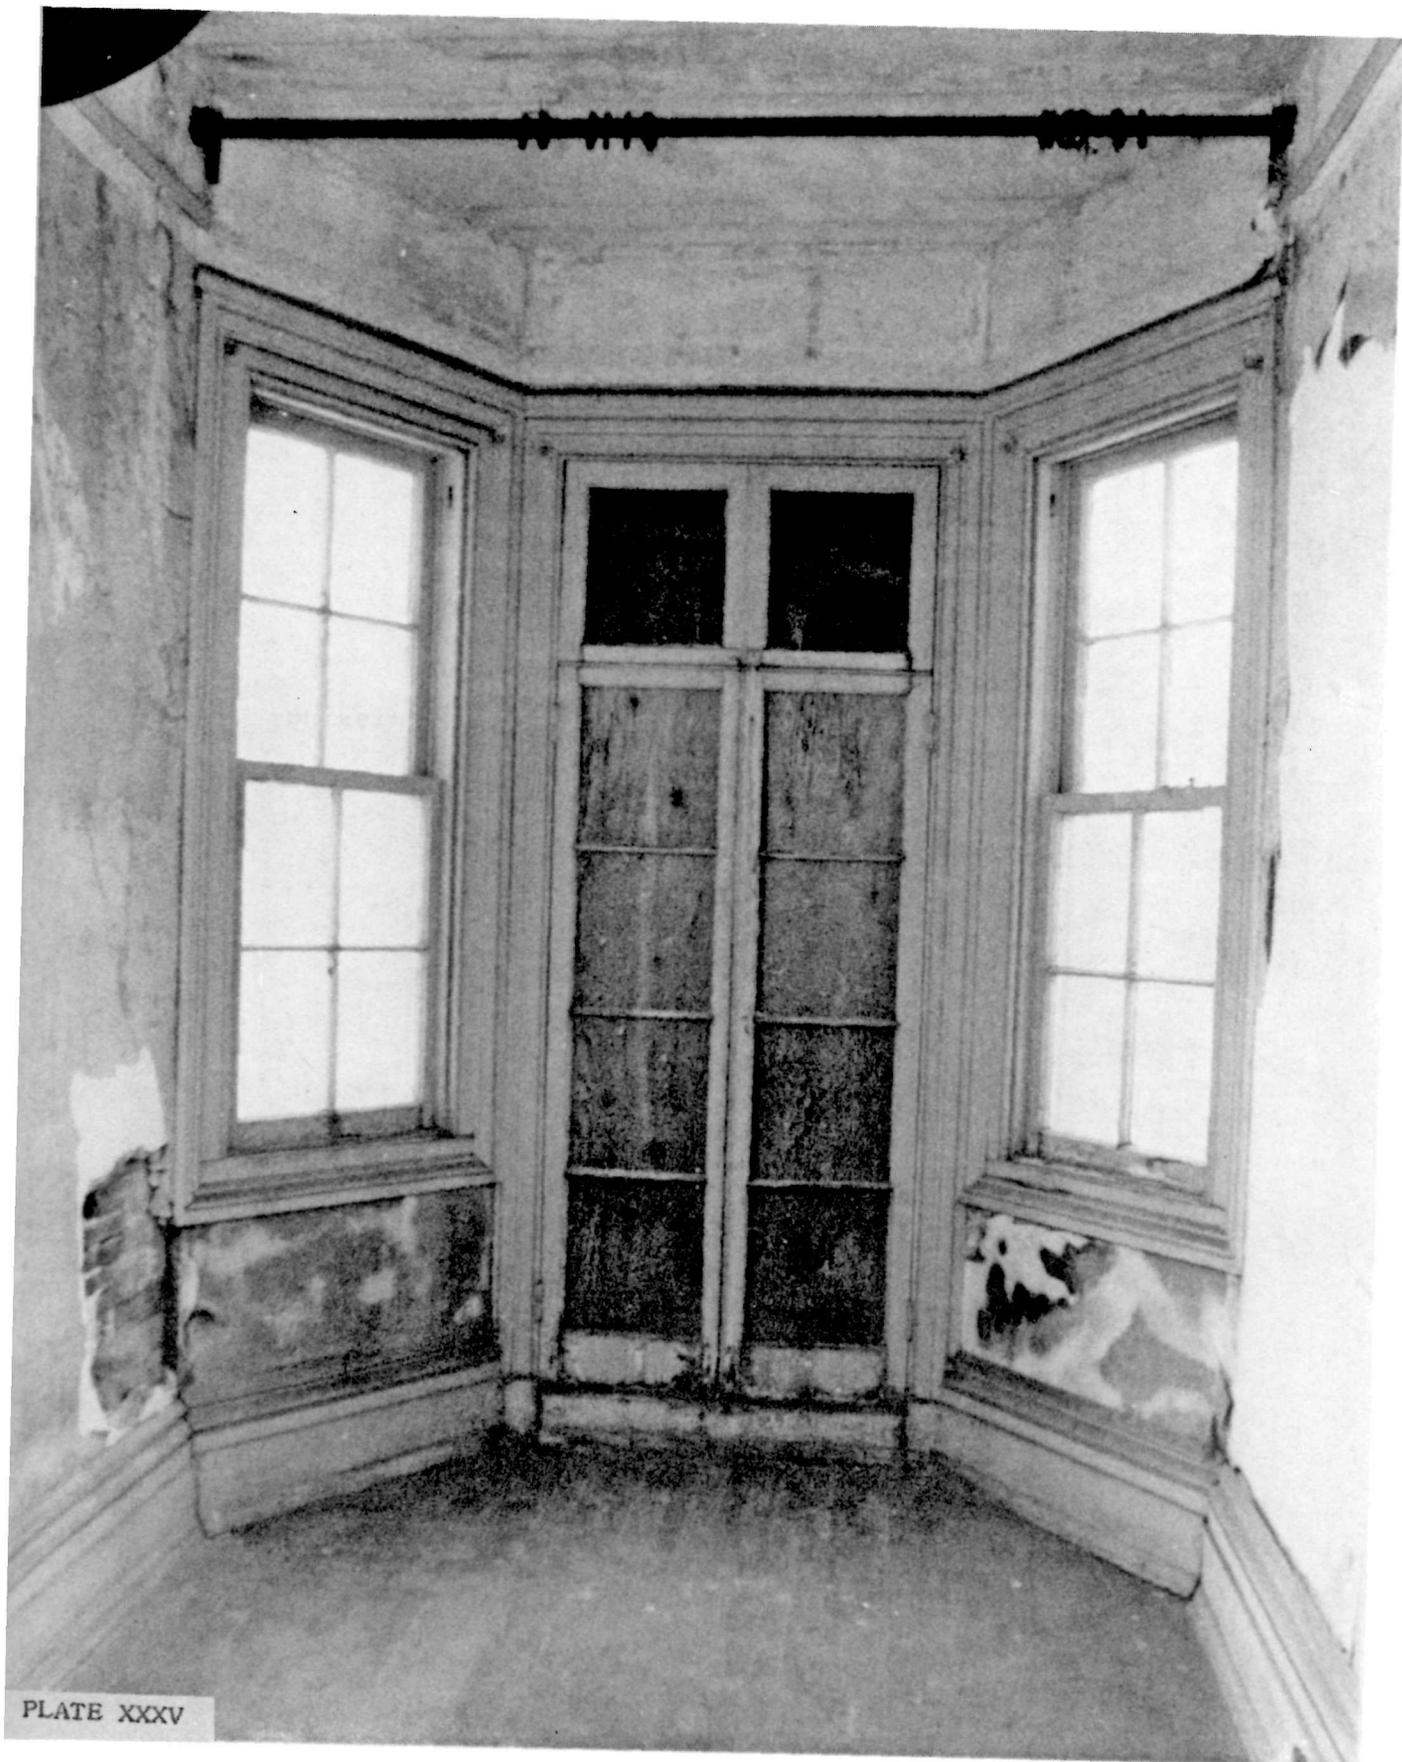
PLATE XXXV

Note evidence of leaking at junction of walls and condition of base. Also note termination of picture molding.

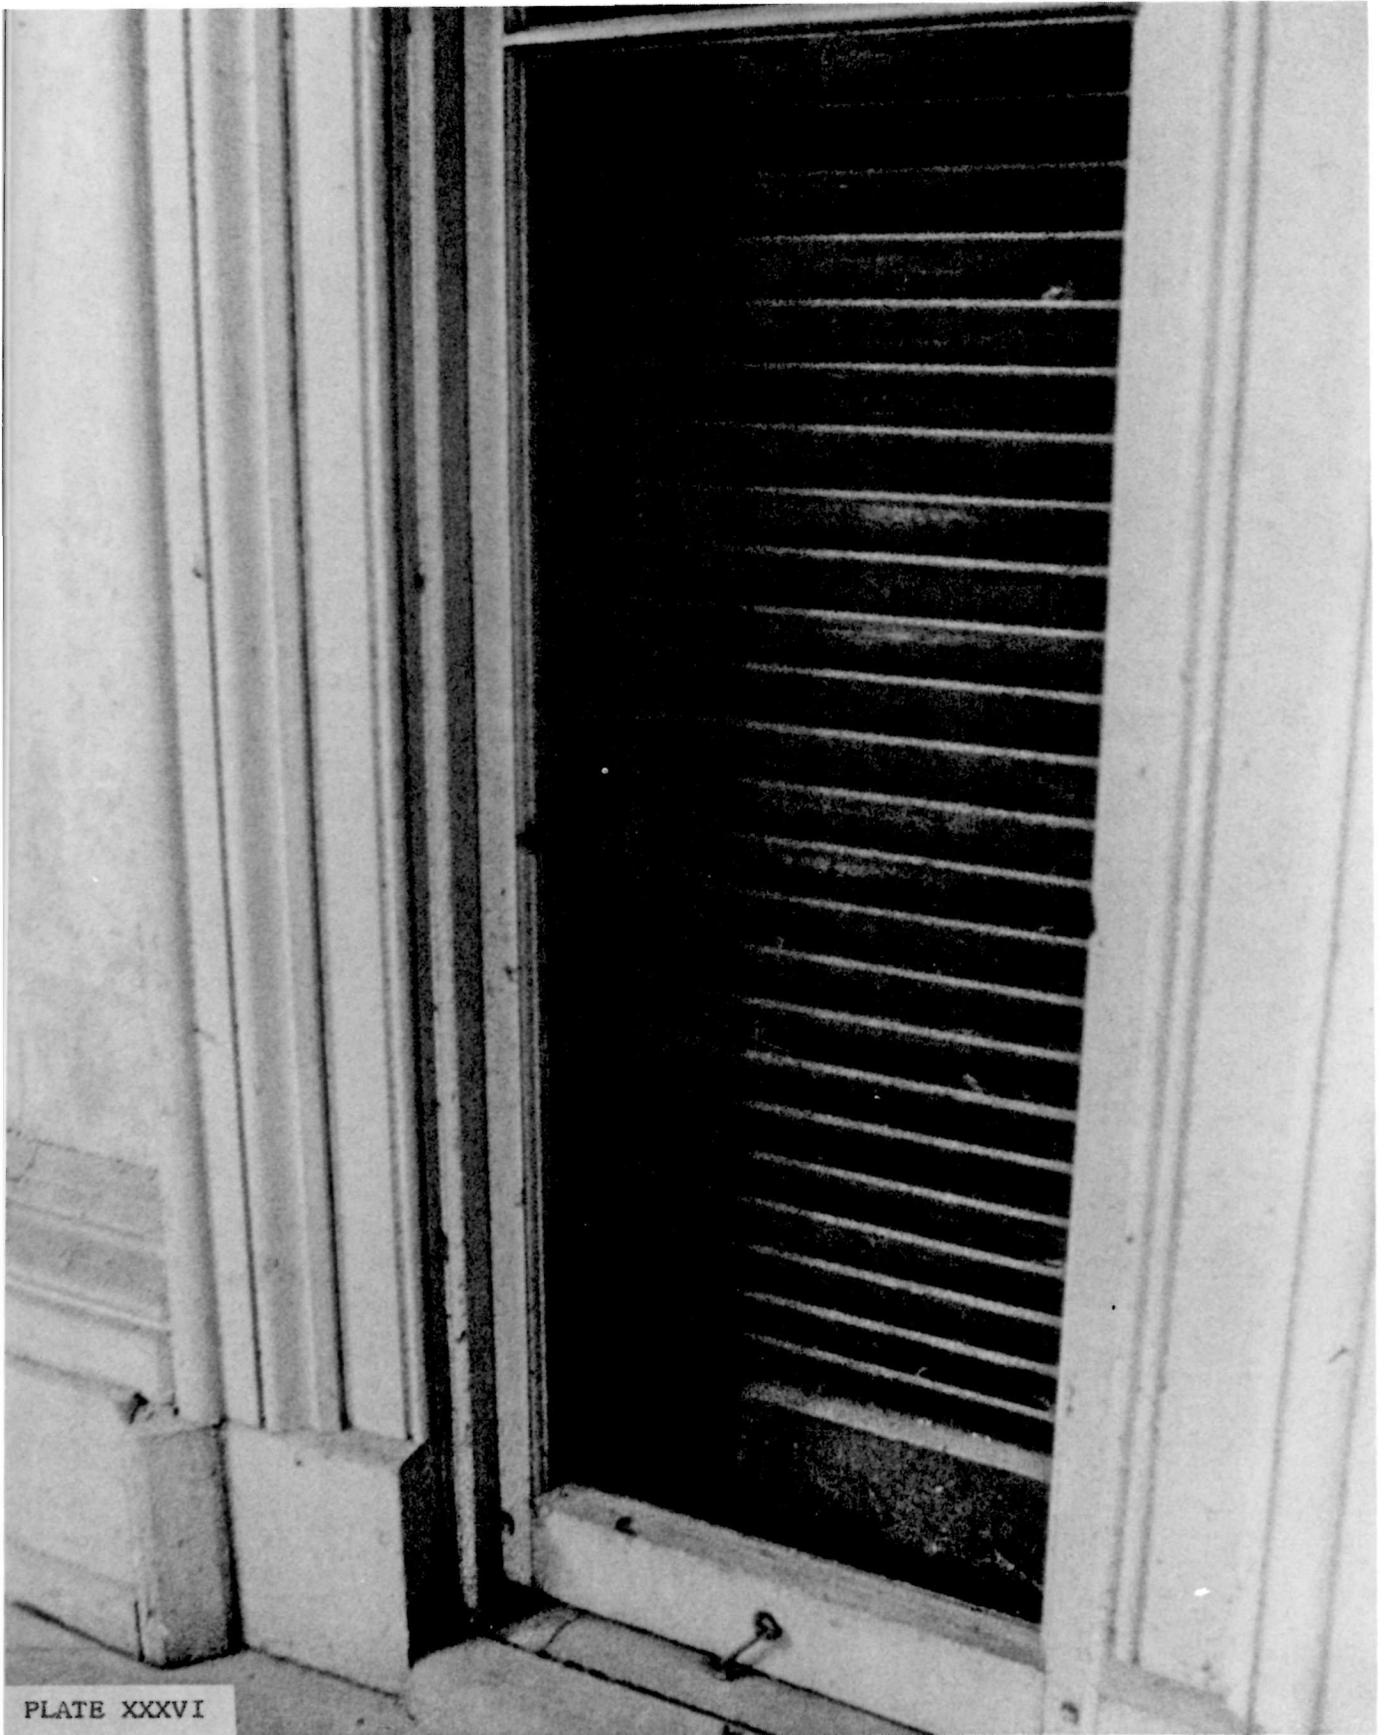
PLATE XXXVI

Detail showing muntins and glass missing
from sash.

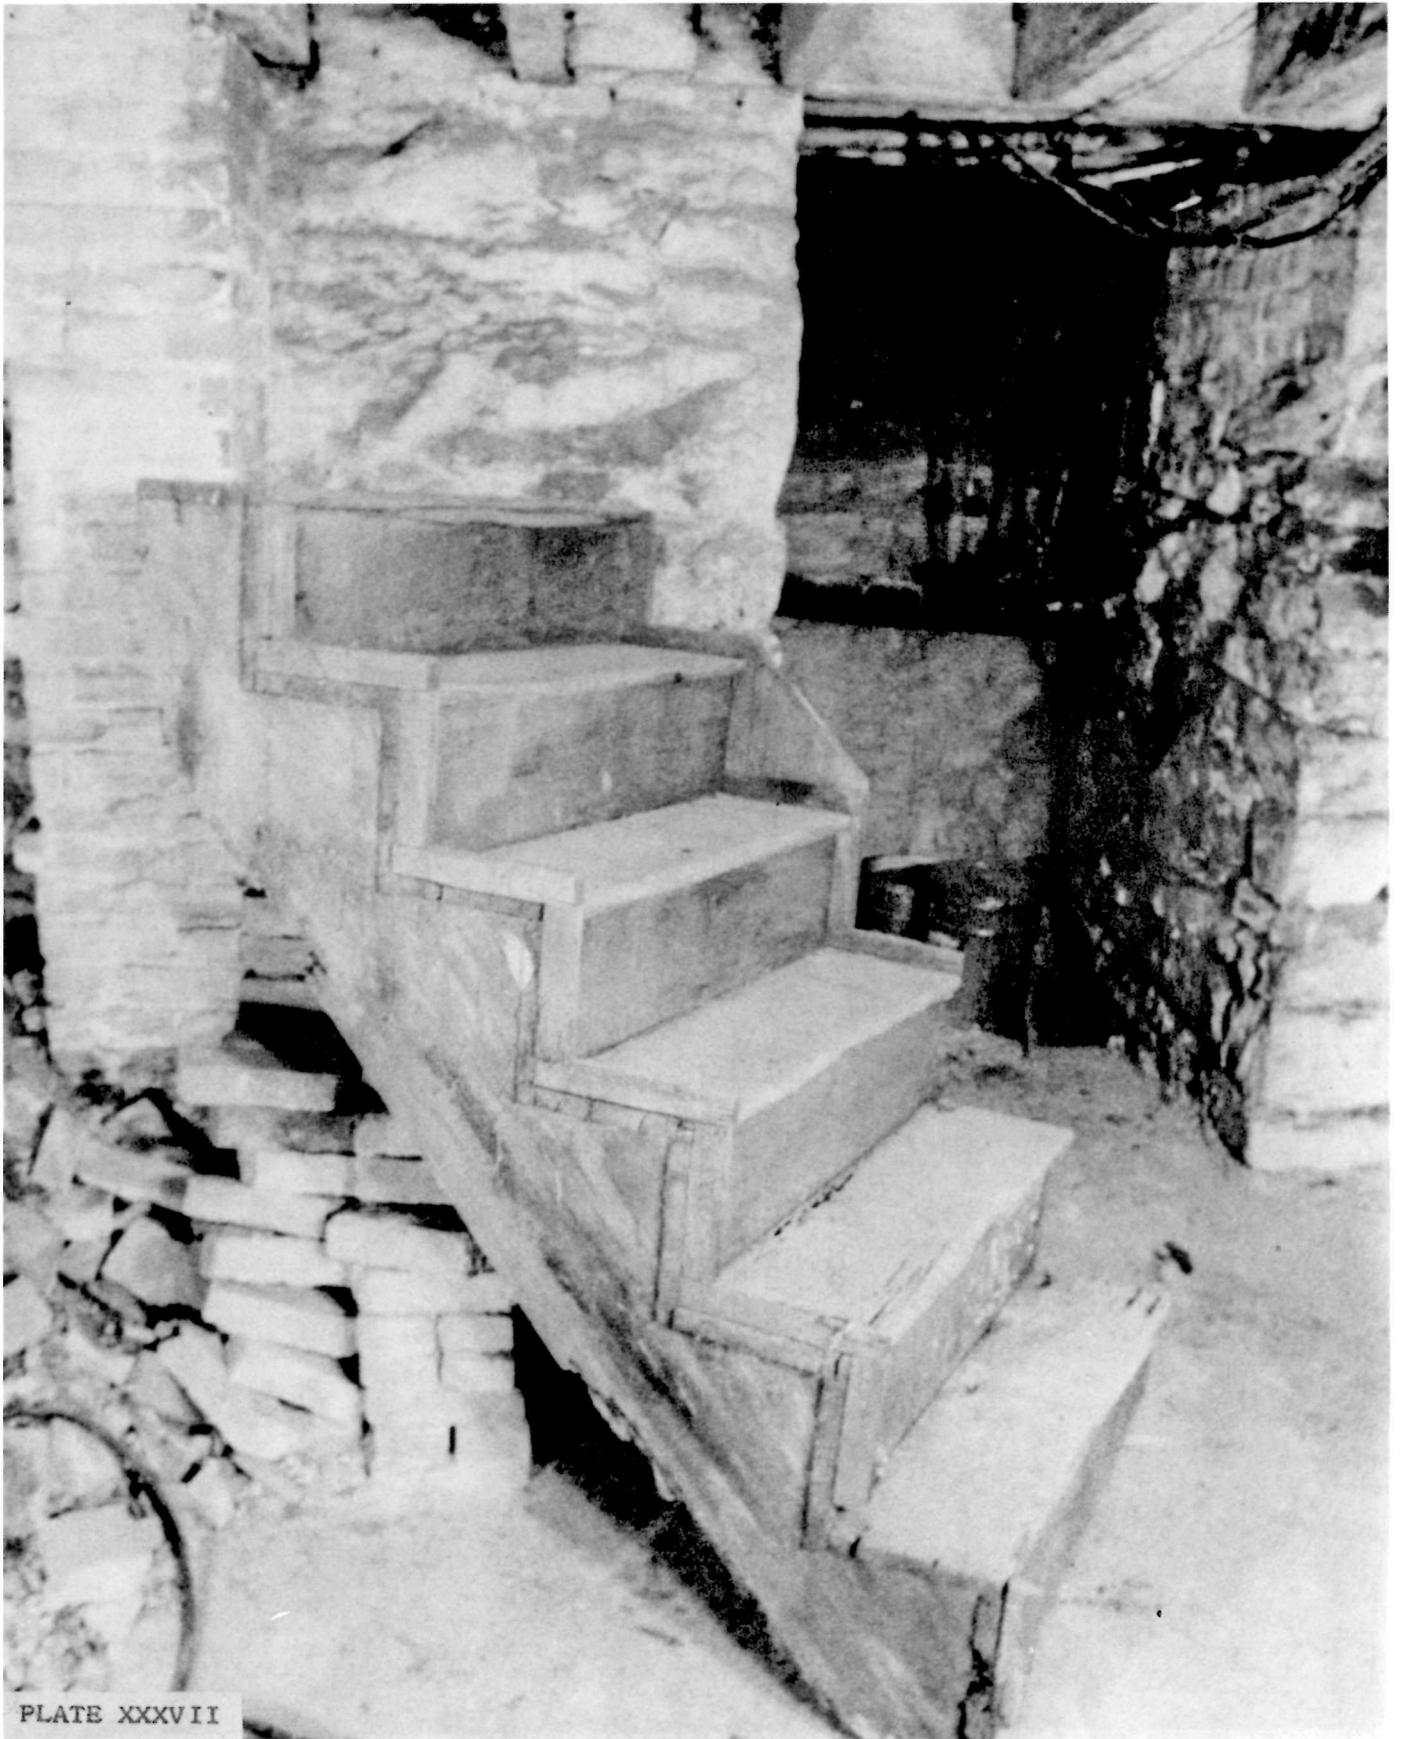
PLATE XXXVII

The interior stair from the kitchen to the basement must be completely reconstructed. The remains will be used as a model for the new stair.

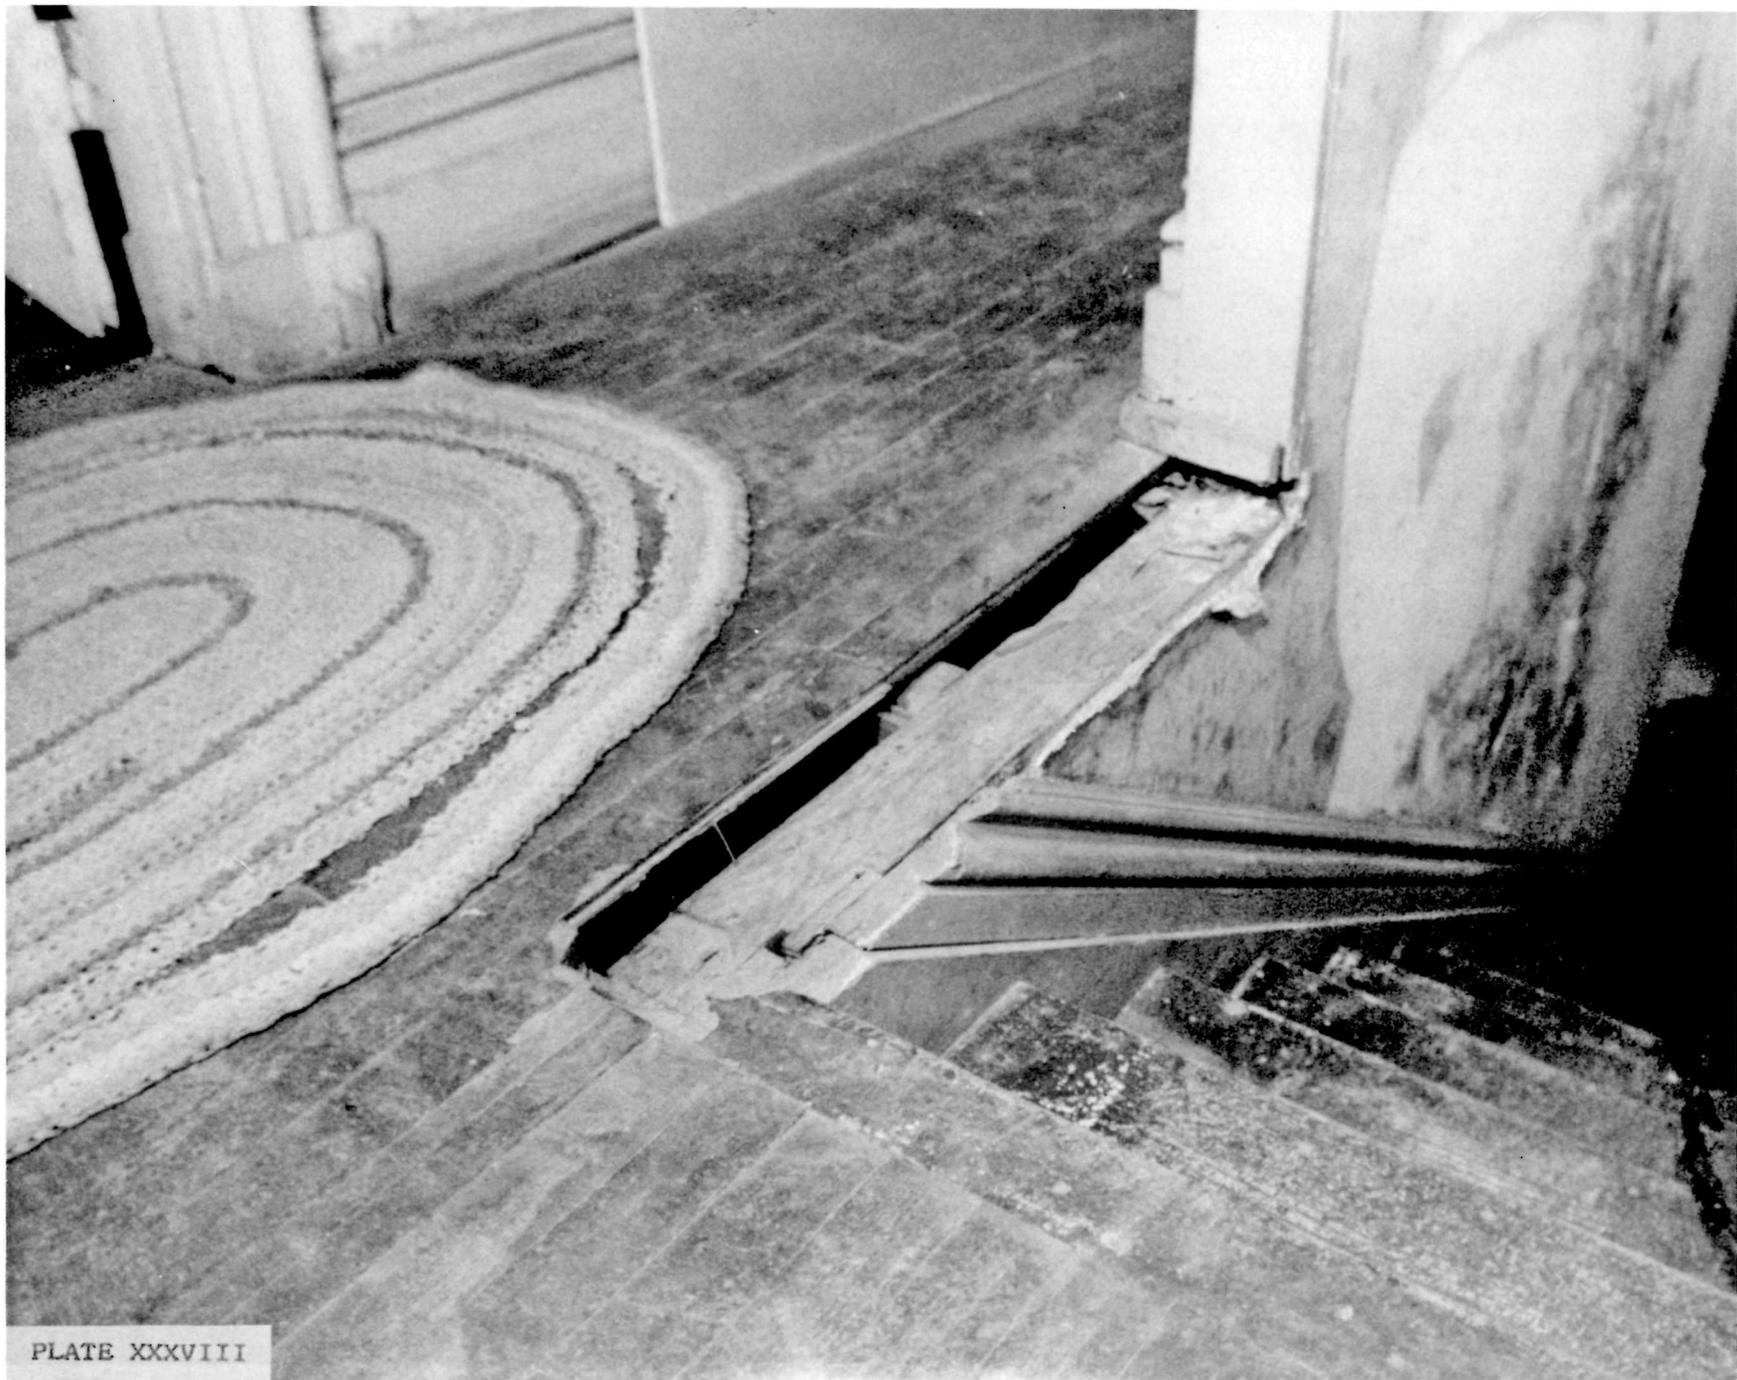
PLATE XXXVIII

The balustrade at the second floor landing of the main stairway has been stored for safe keeping and will be reinstalled.

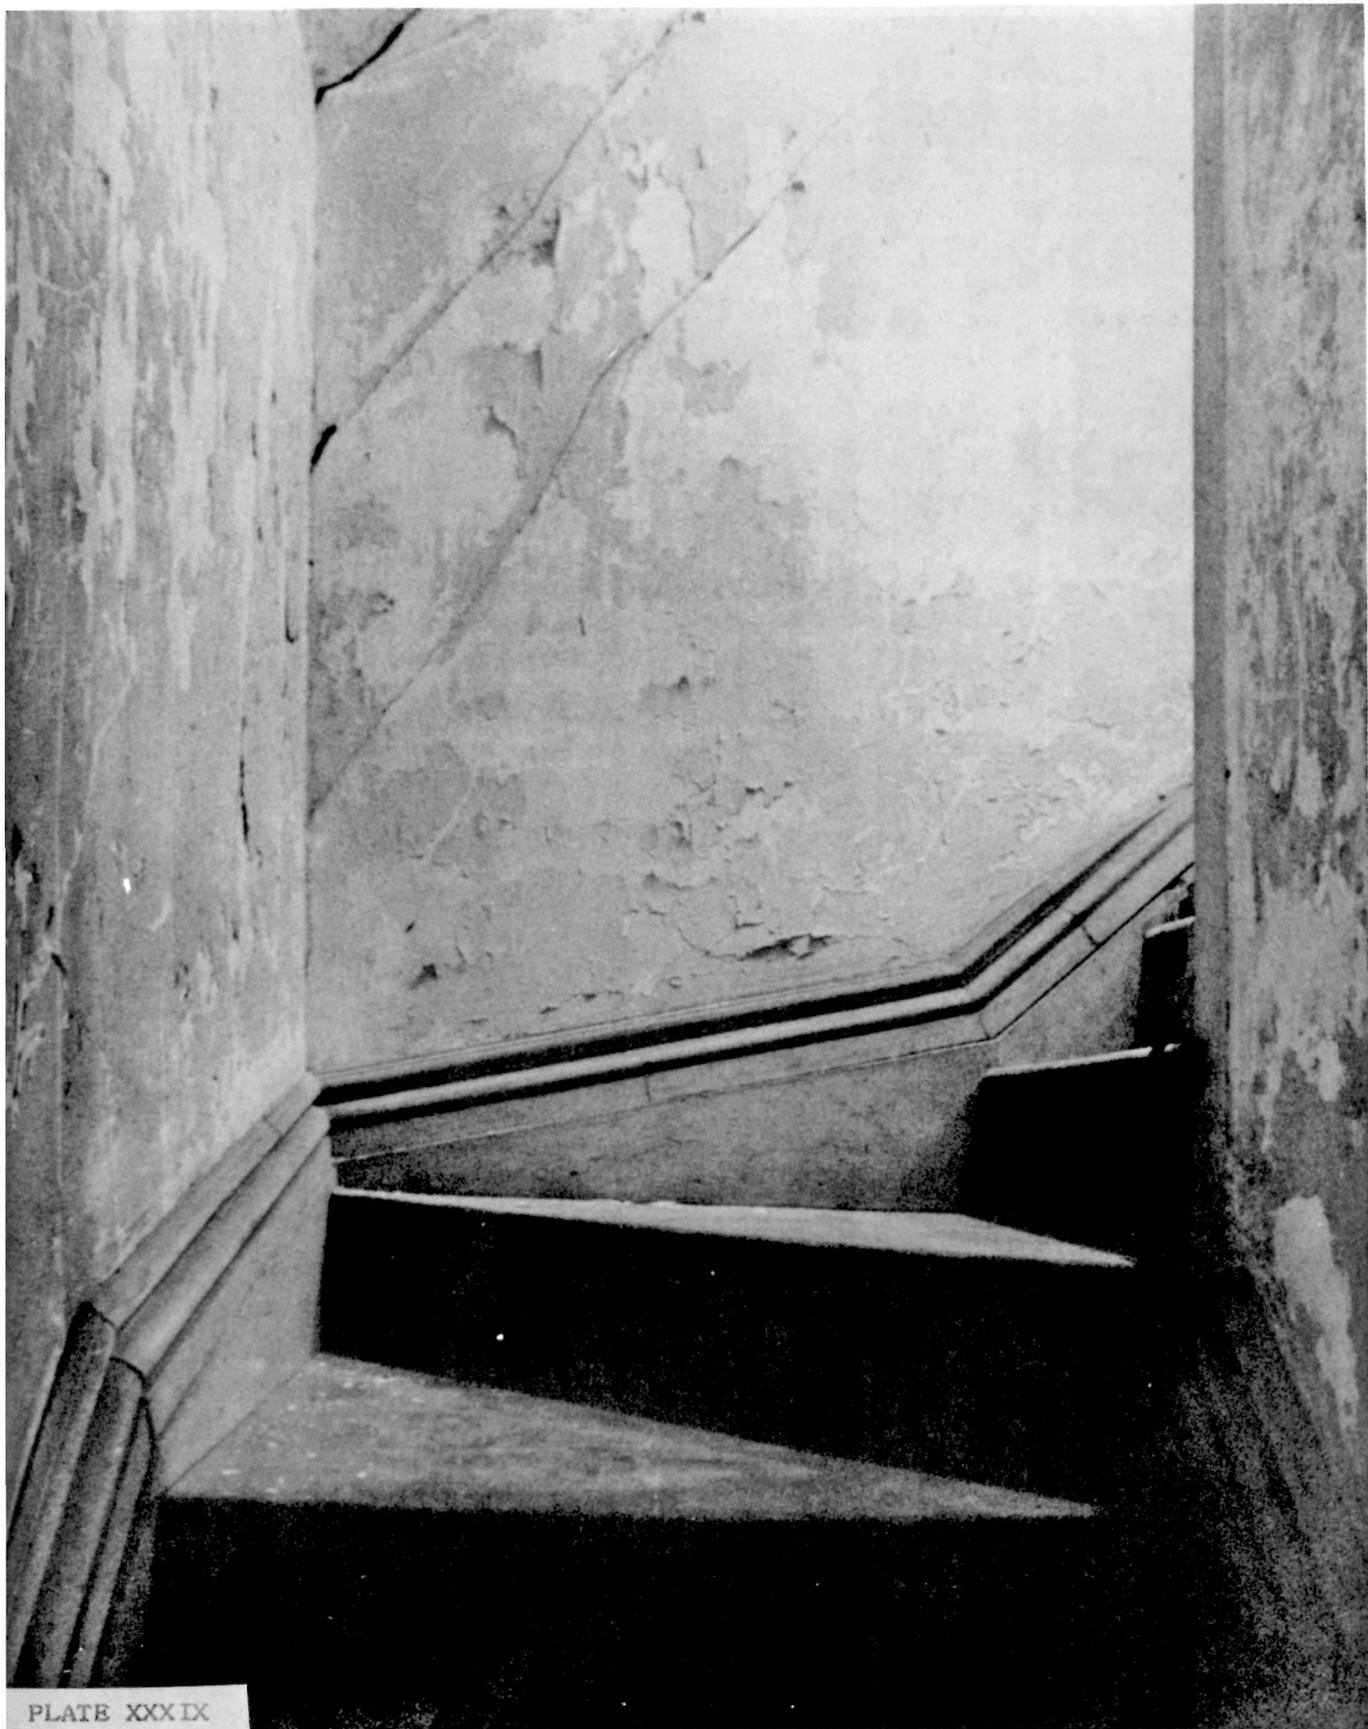
PLATE XXXIX

This photograph shows the general condition of the stairway from the second to the third floor.

Note also the condition of the painted plaster walls.

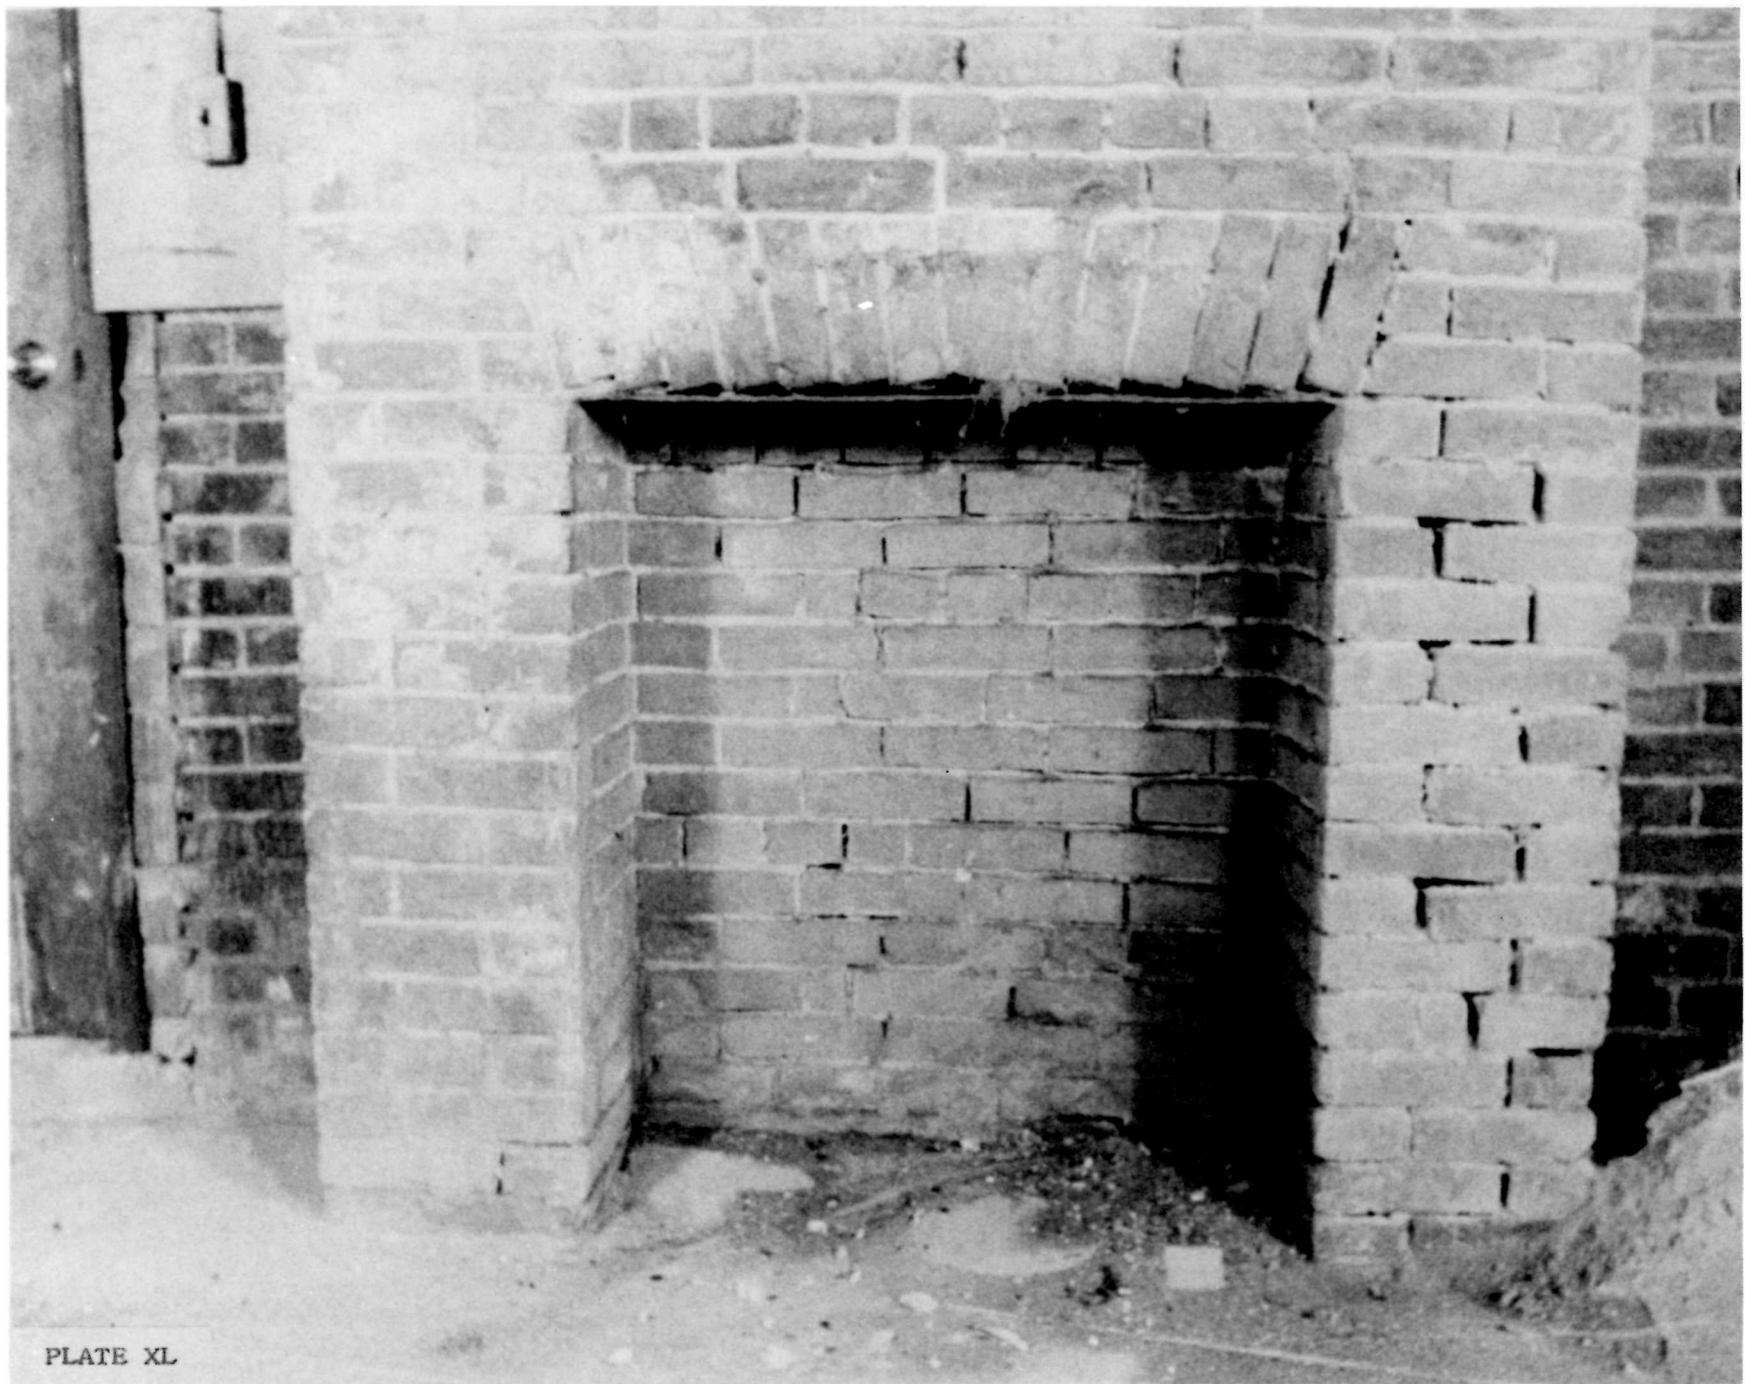
PLATE XL

Fireplace located in basement room #1 will require repointing.

This chimney could be utilized by the heating system.
