**Frederick Douglass
Home**

HISTORIC STRUCTURES REPORT

ARCHITECTURAL DATA

JUNE 1970

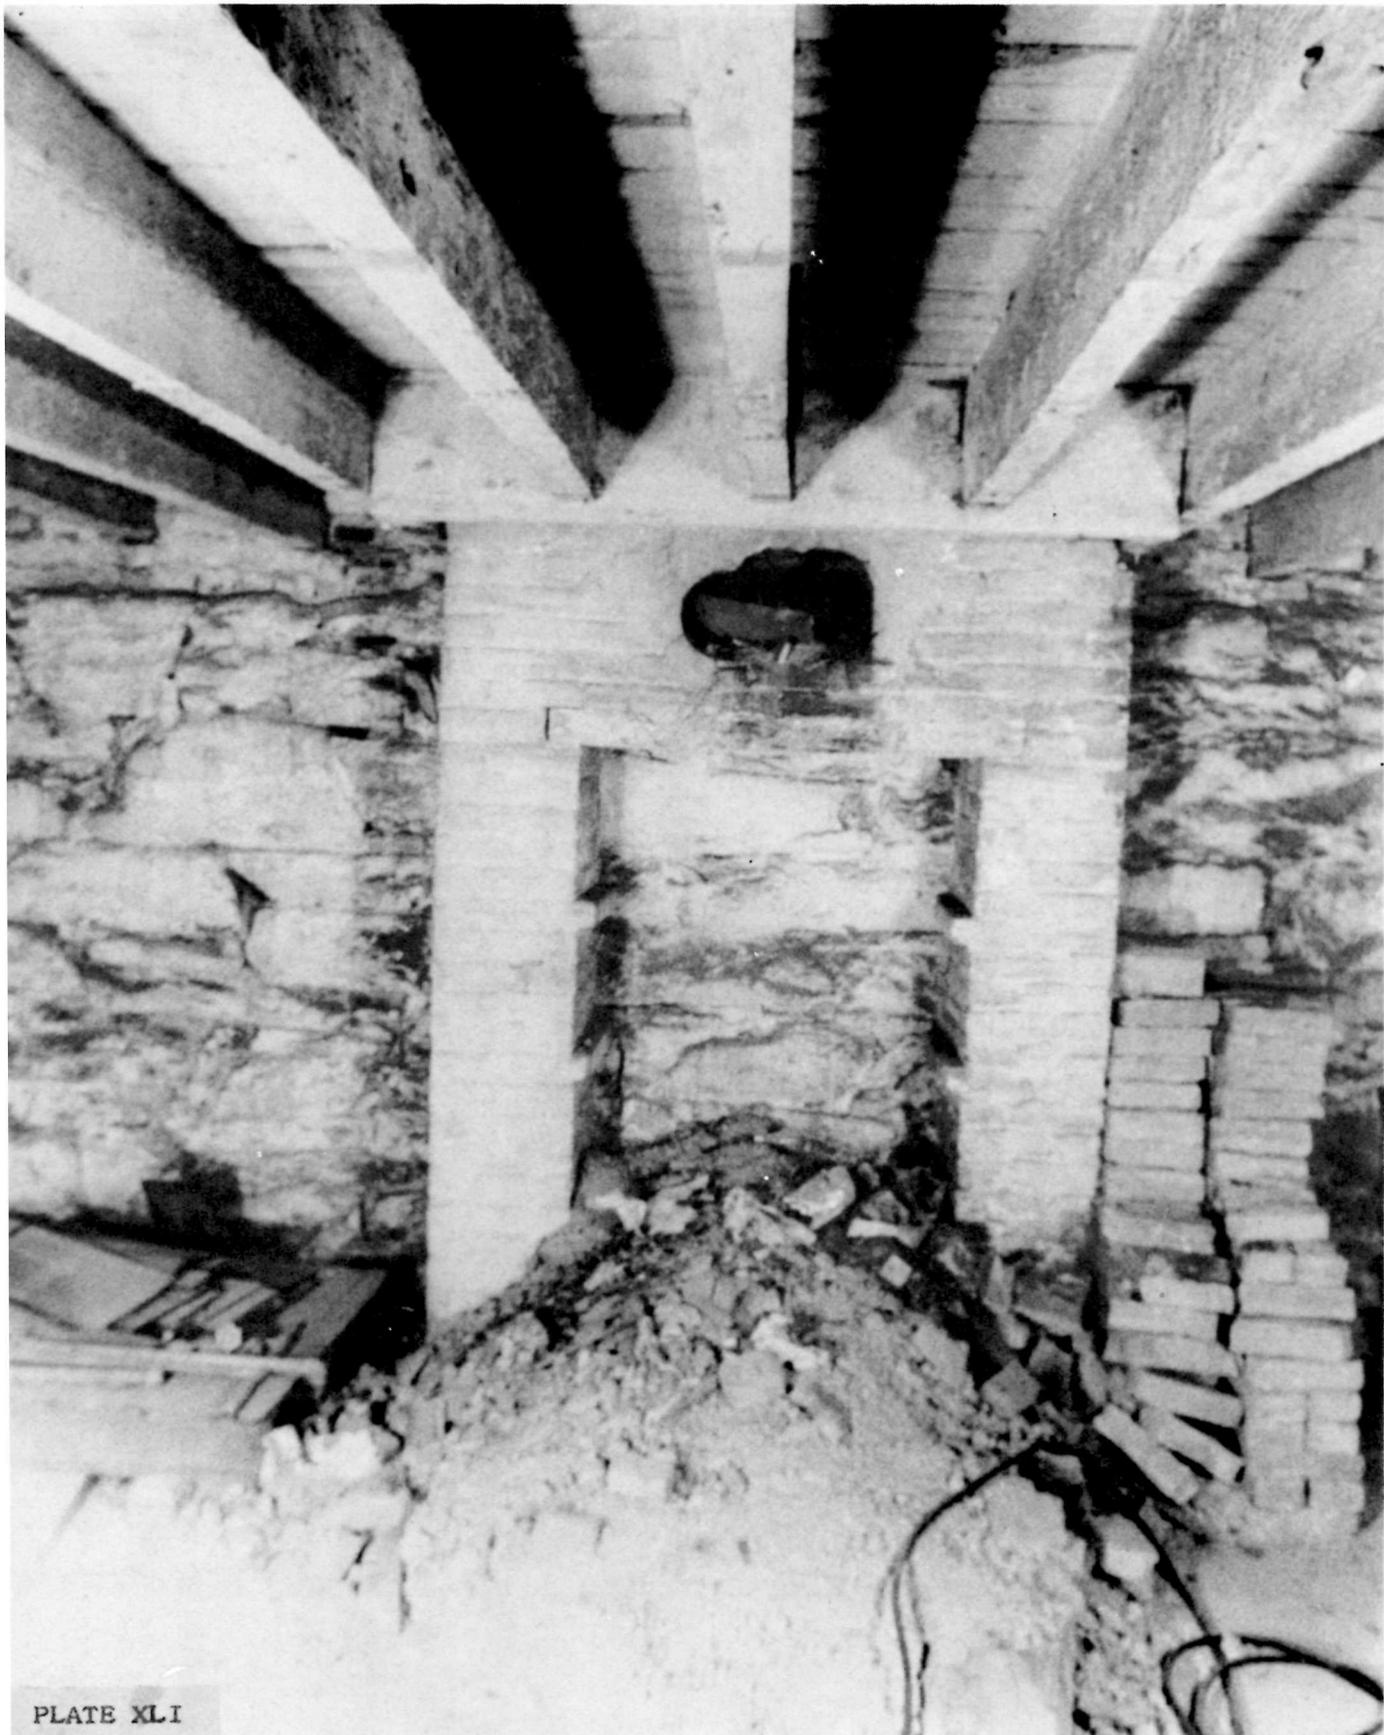
PLATE XLI

Chimney base in basement room #2 will require some repair.

This is another chimney that could be utilized by the heating system.

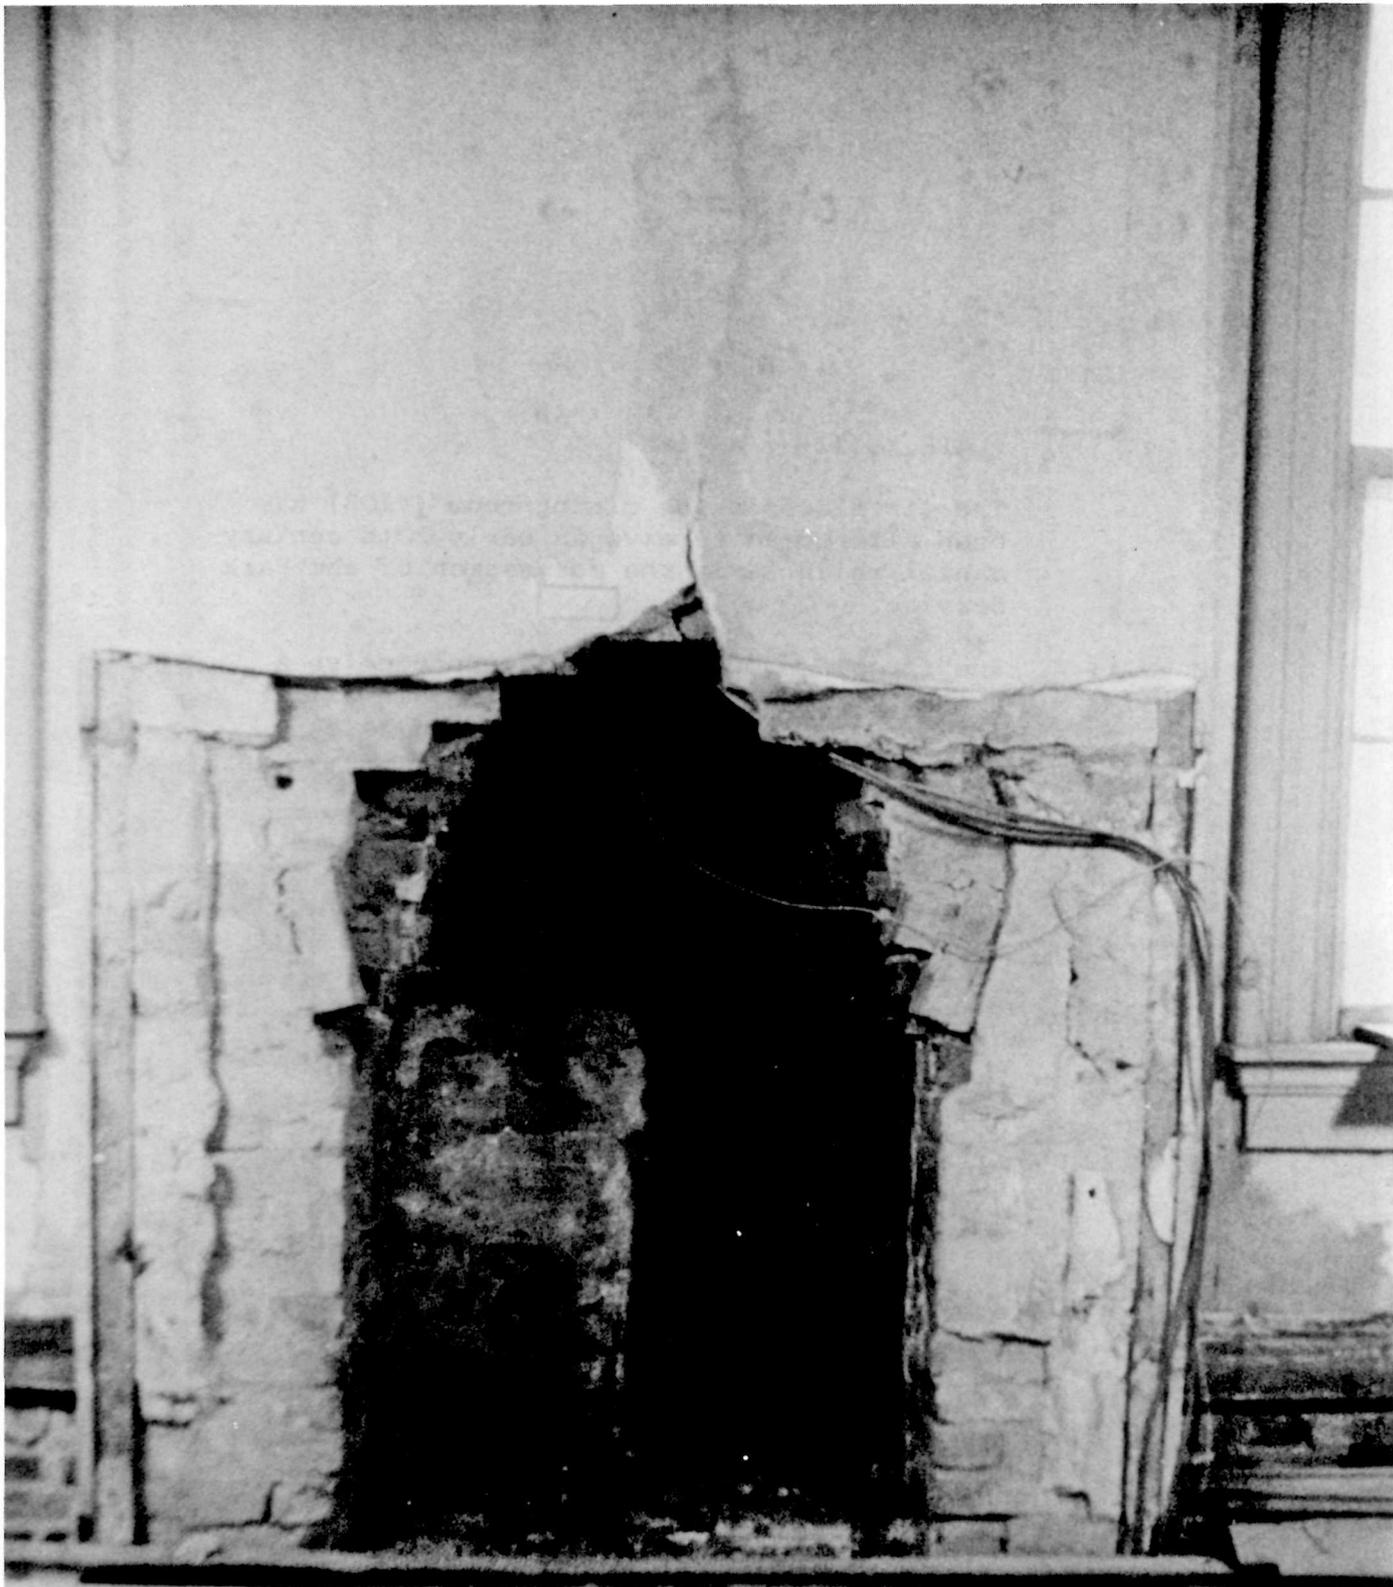
PLATE XLII

Fireplace in west parlor (room #102) will require extensive repair to return it to its original condition.

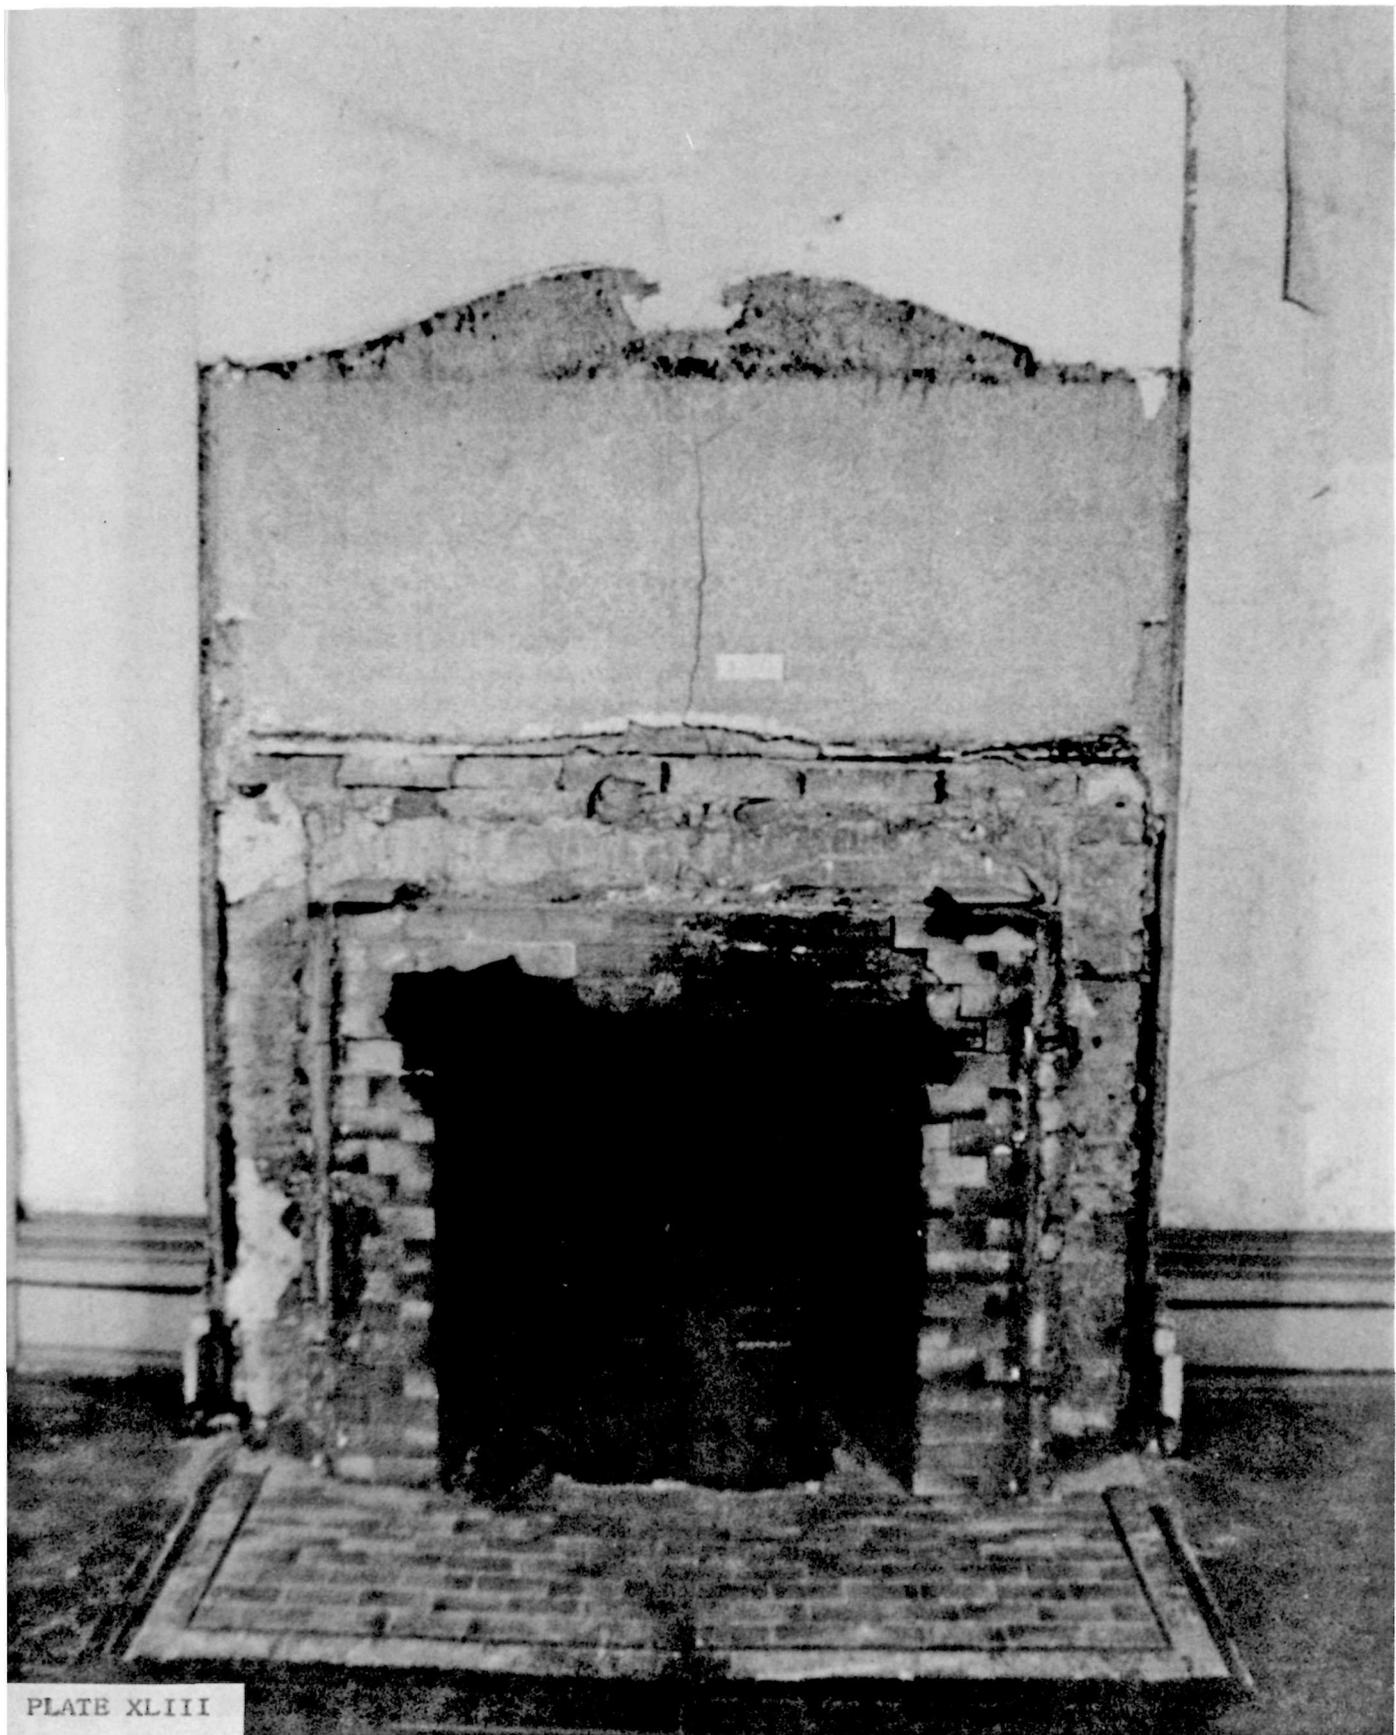
PLATE XLIII

The fireplace in the dining room (#103) has been altered to receive an early 20th century mantel which is in the possession of the Park Service.

The fireplace must be rebuilt to receive a mantel of the Douglass period. This will include the removal of the ceramic tile face and hearth.

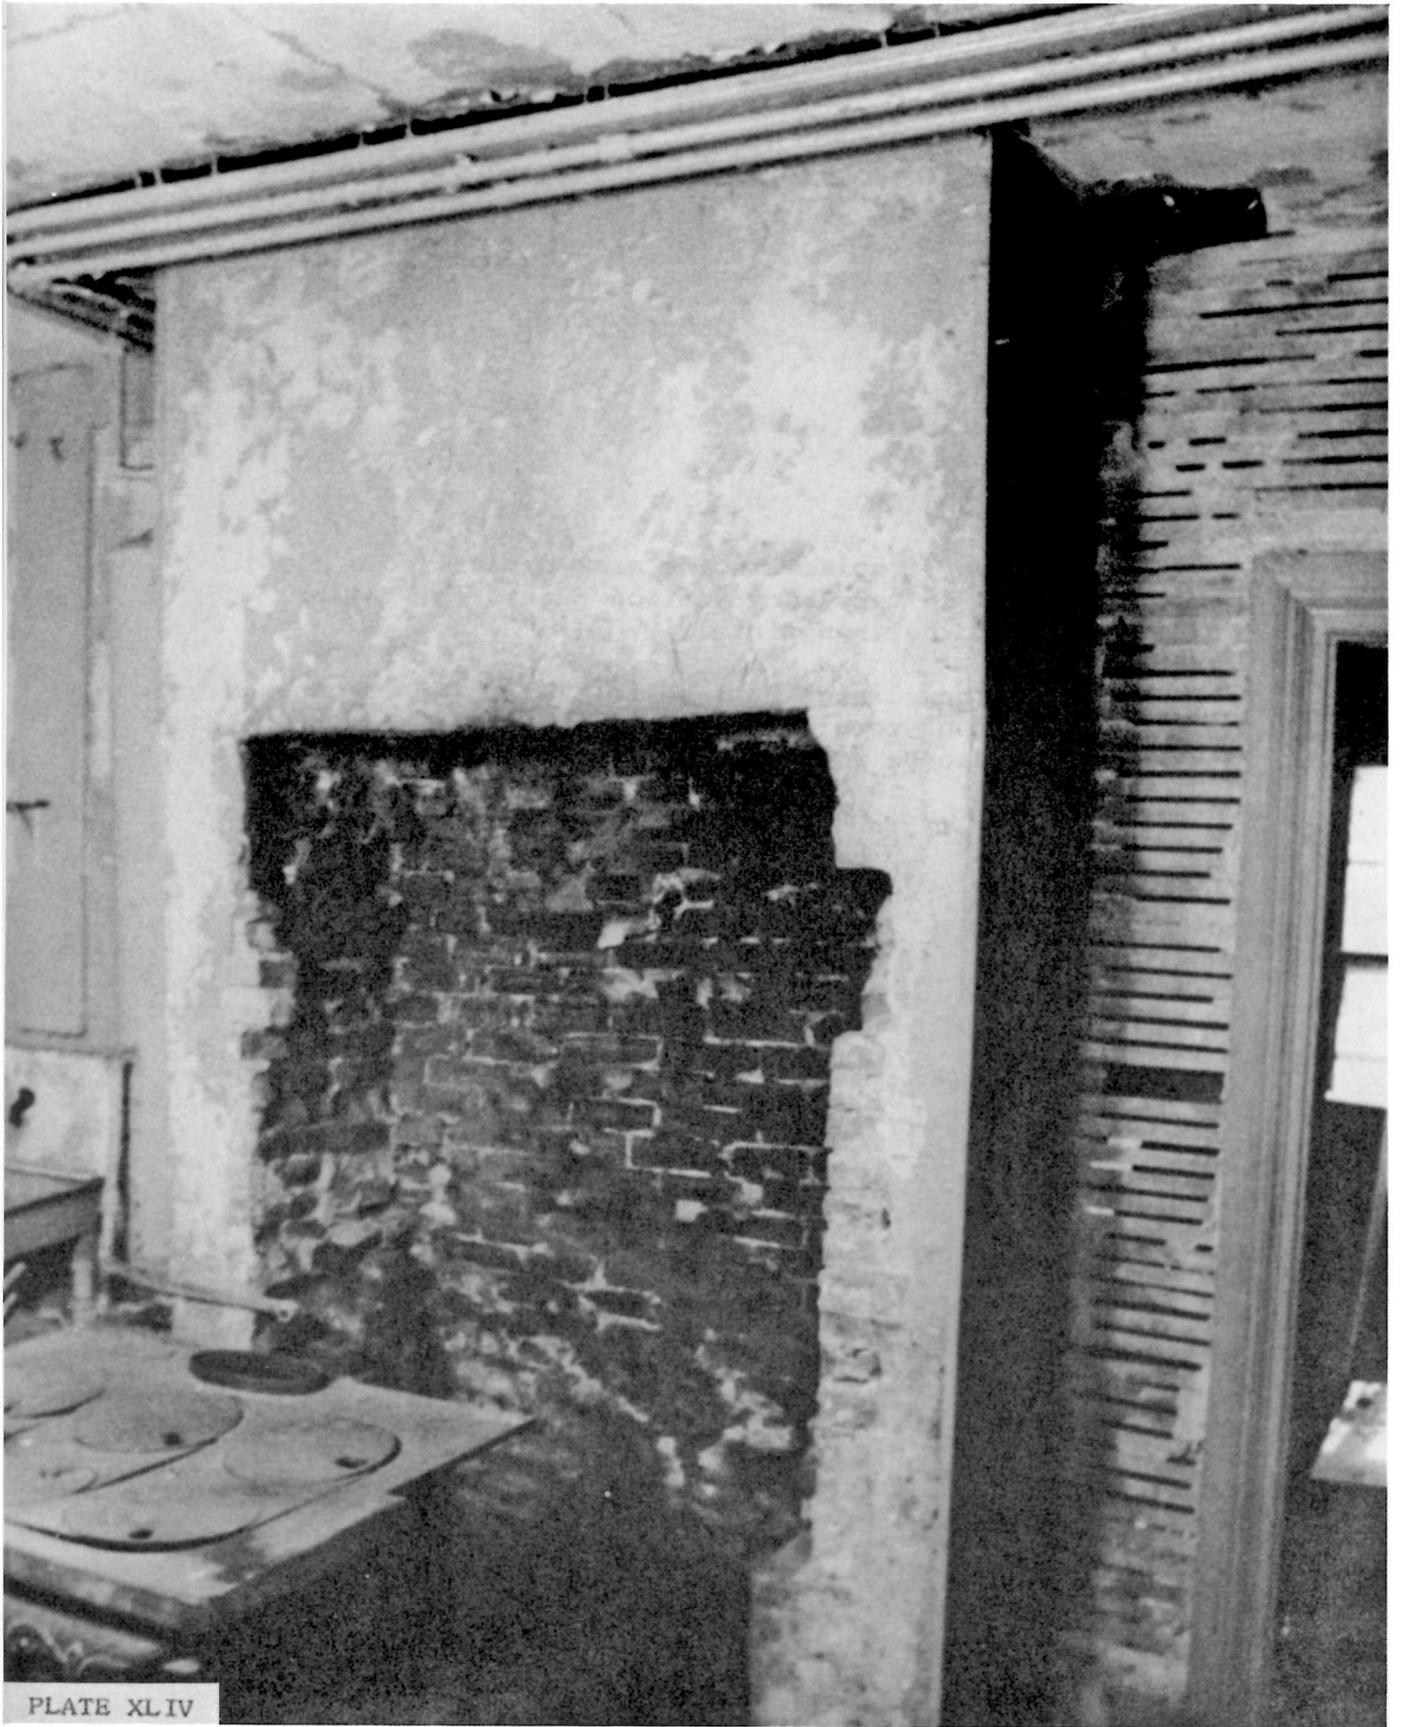
PLATE XLIV

The kitchen fireplace (room #104) will require rebuilding, the installation of a closure and thimble to receive the stove pipe.

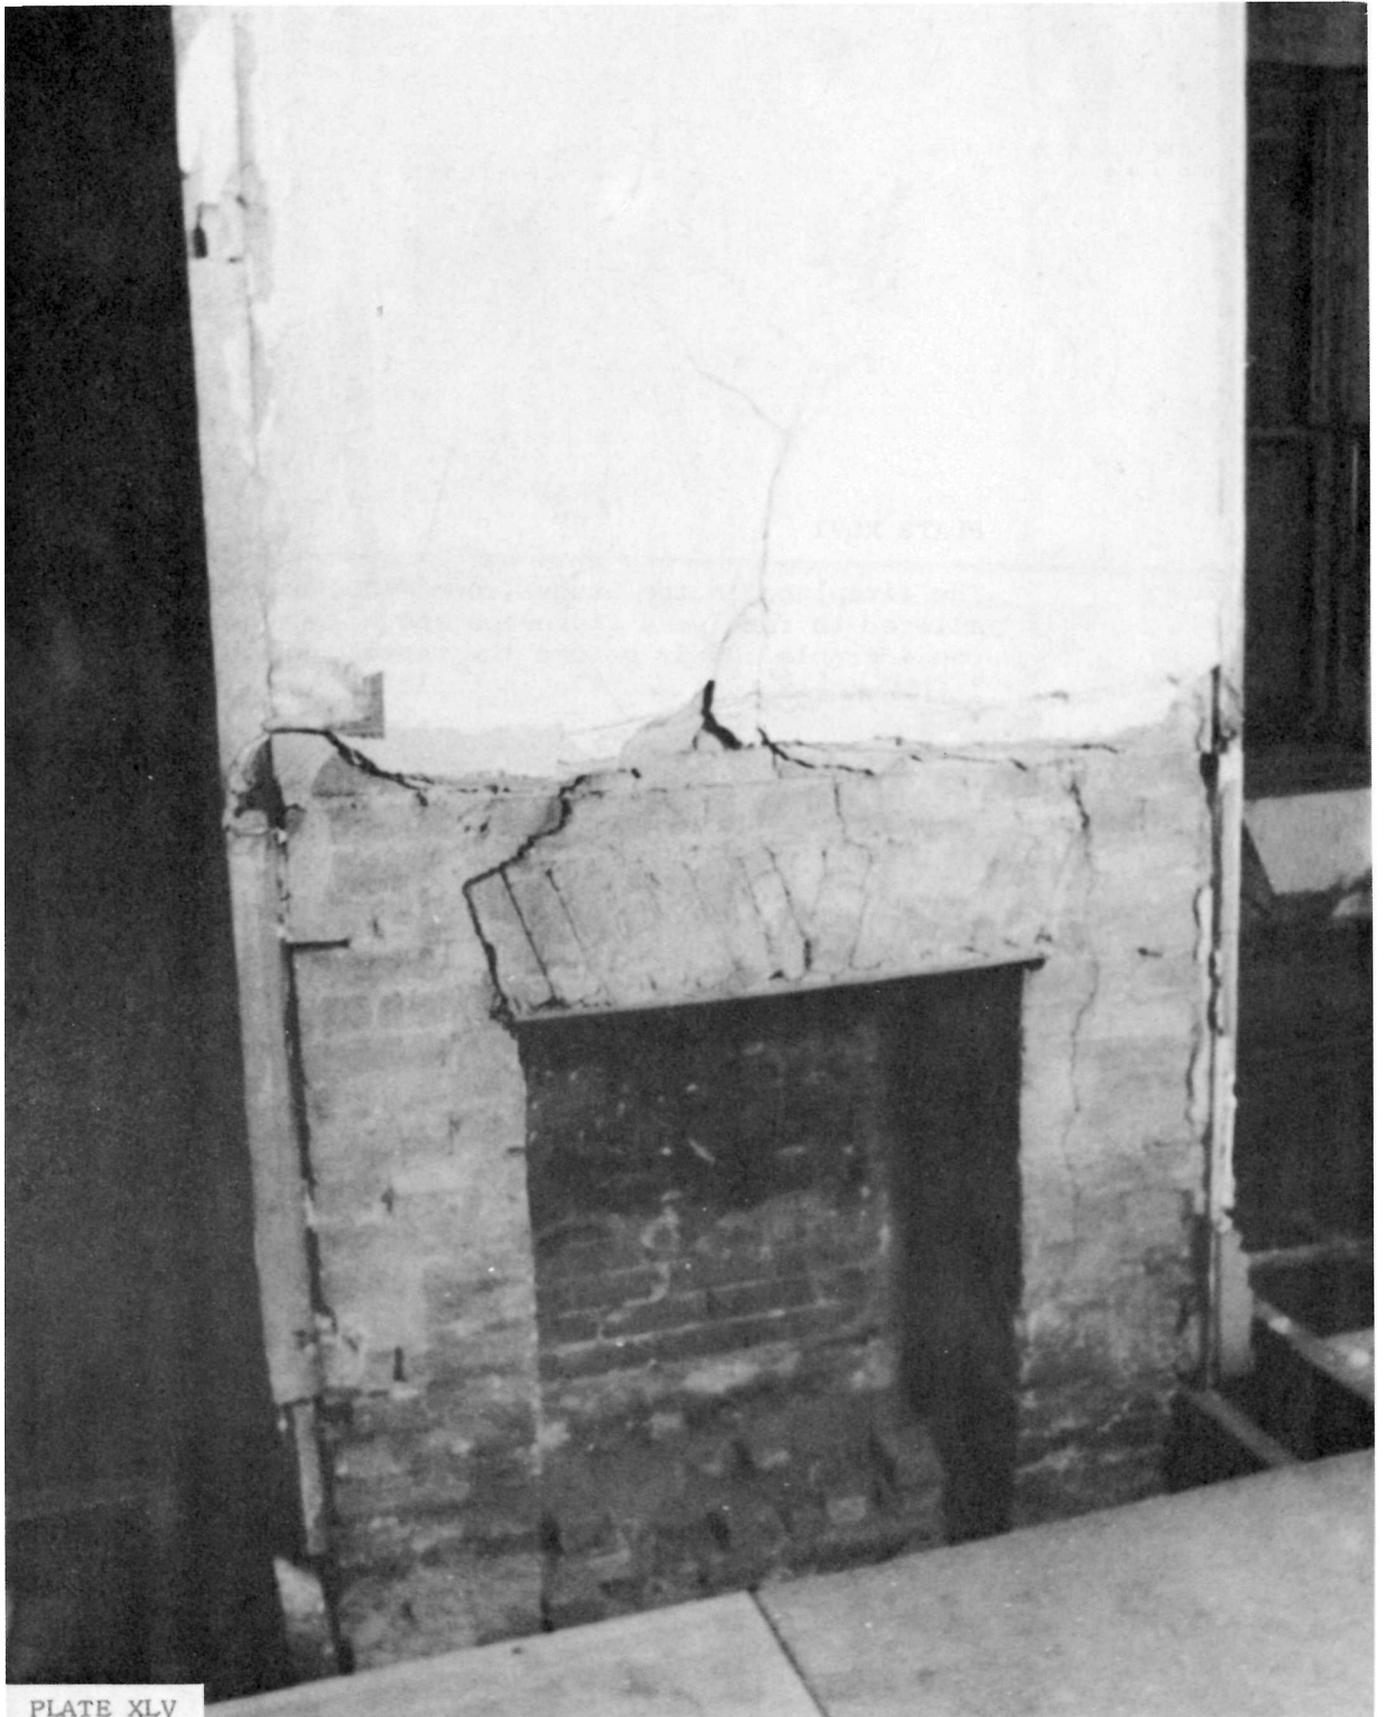
PLATE XLV

The fireplace in the east parlor (room #108) is in very bad condition due to the failure of the iron lintel.

A new lintel must be installed and the chimney front rebuilt. The fireplace and hearth must also be rebuilt.

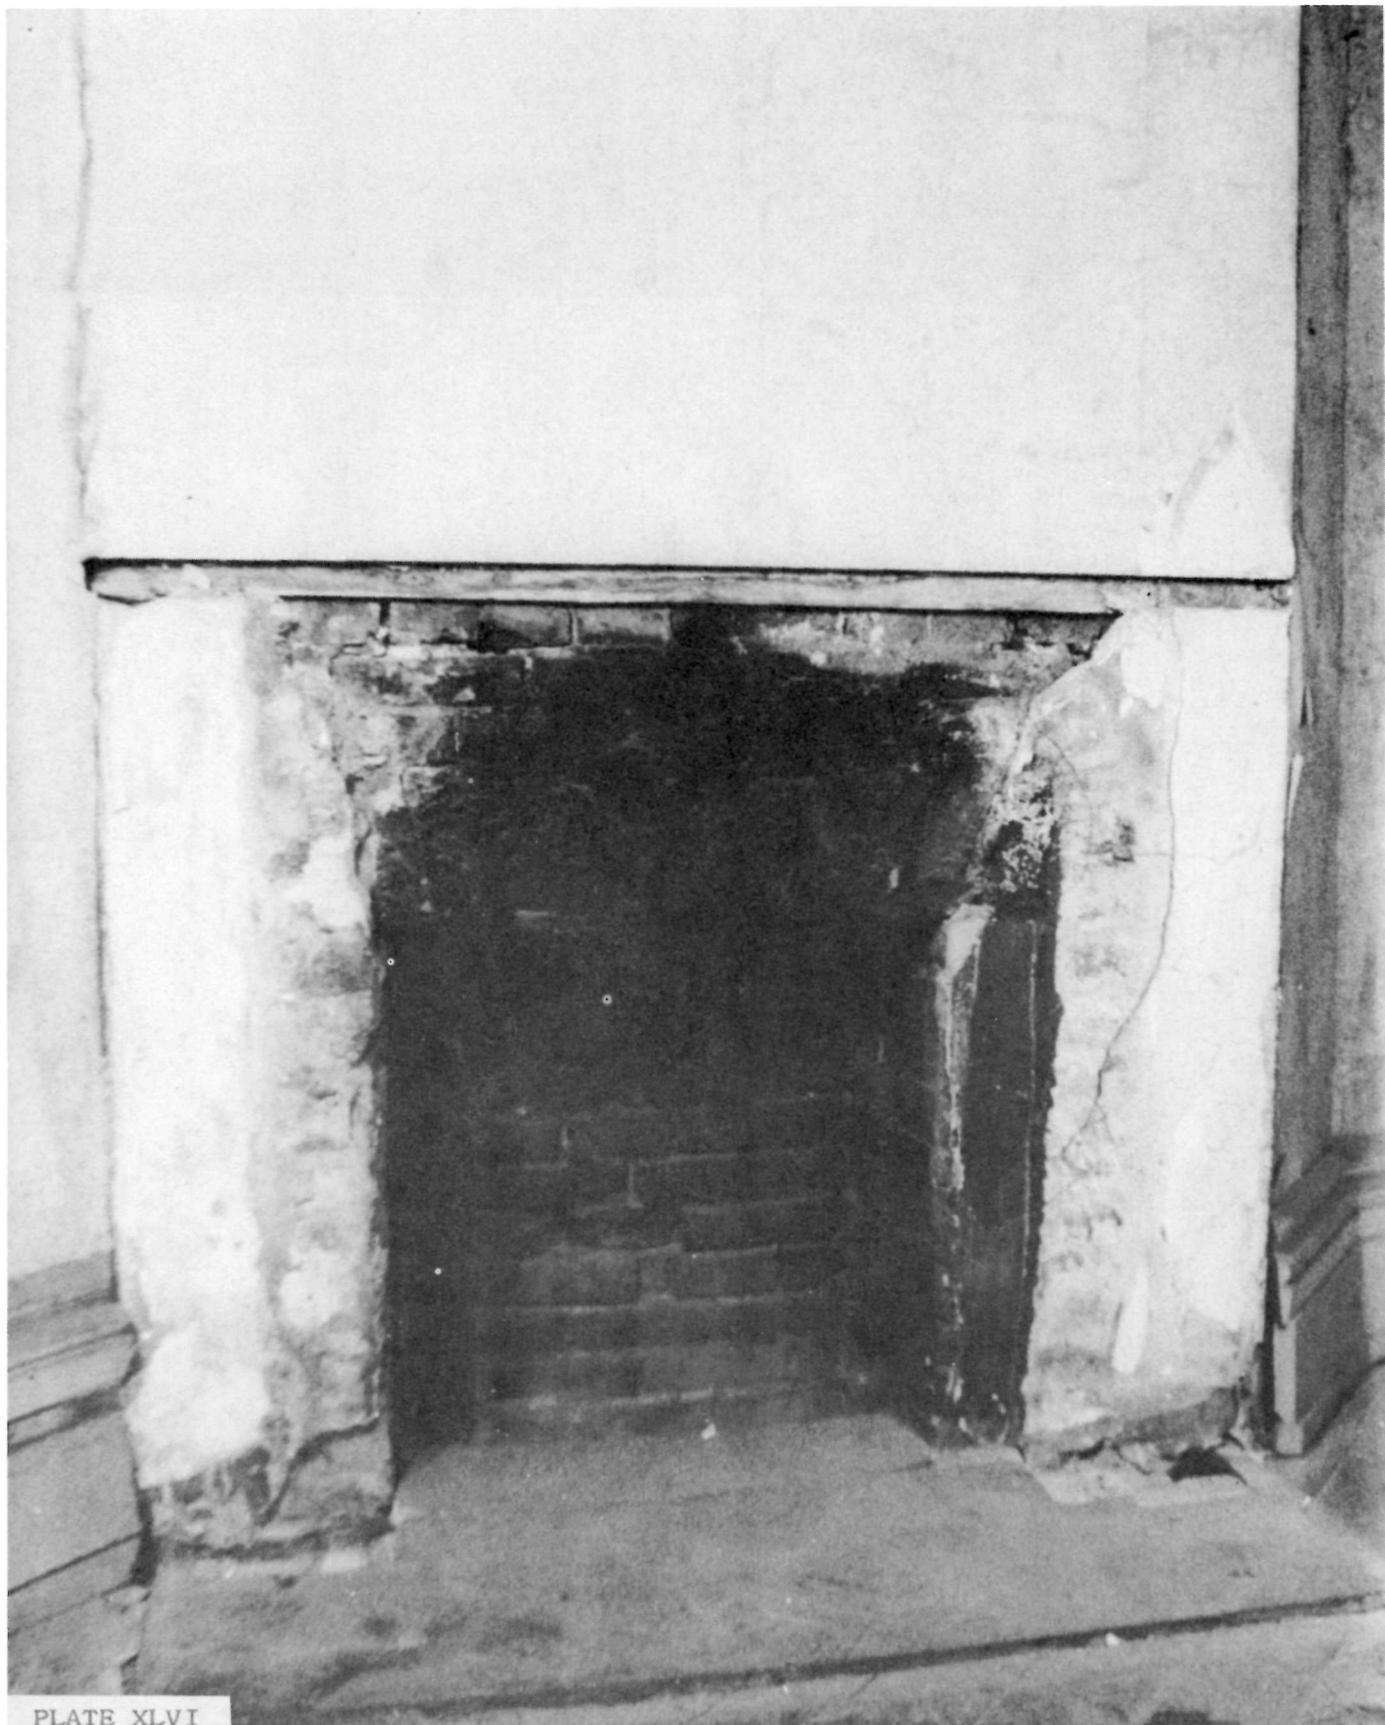
PLATE XLVI

The fireplace in the Study (room #109) has been altered to receive a stovepipe and will require considerable repair before the mantel, which is now in storage, can be installed.

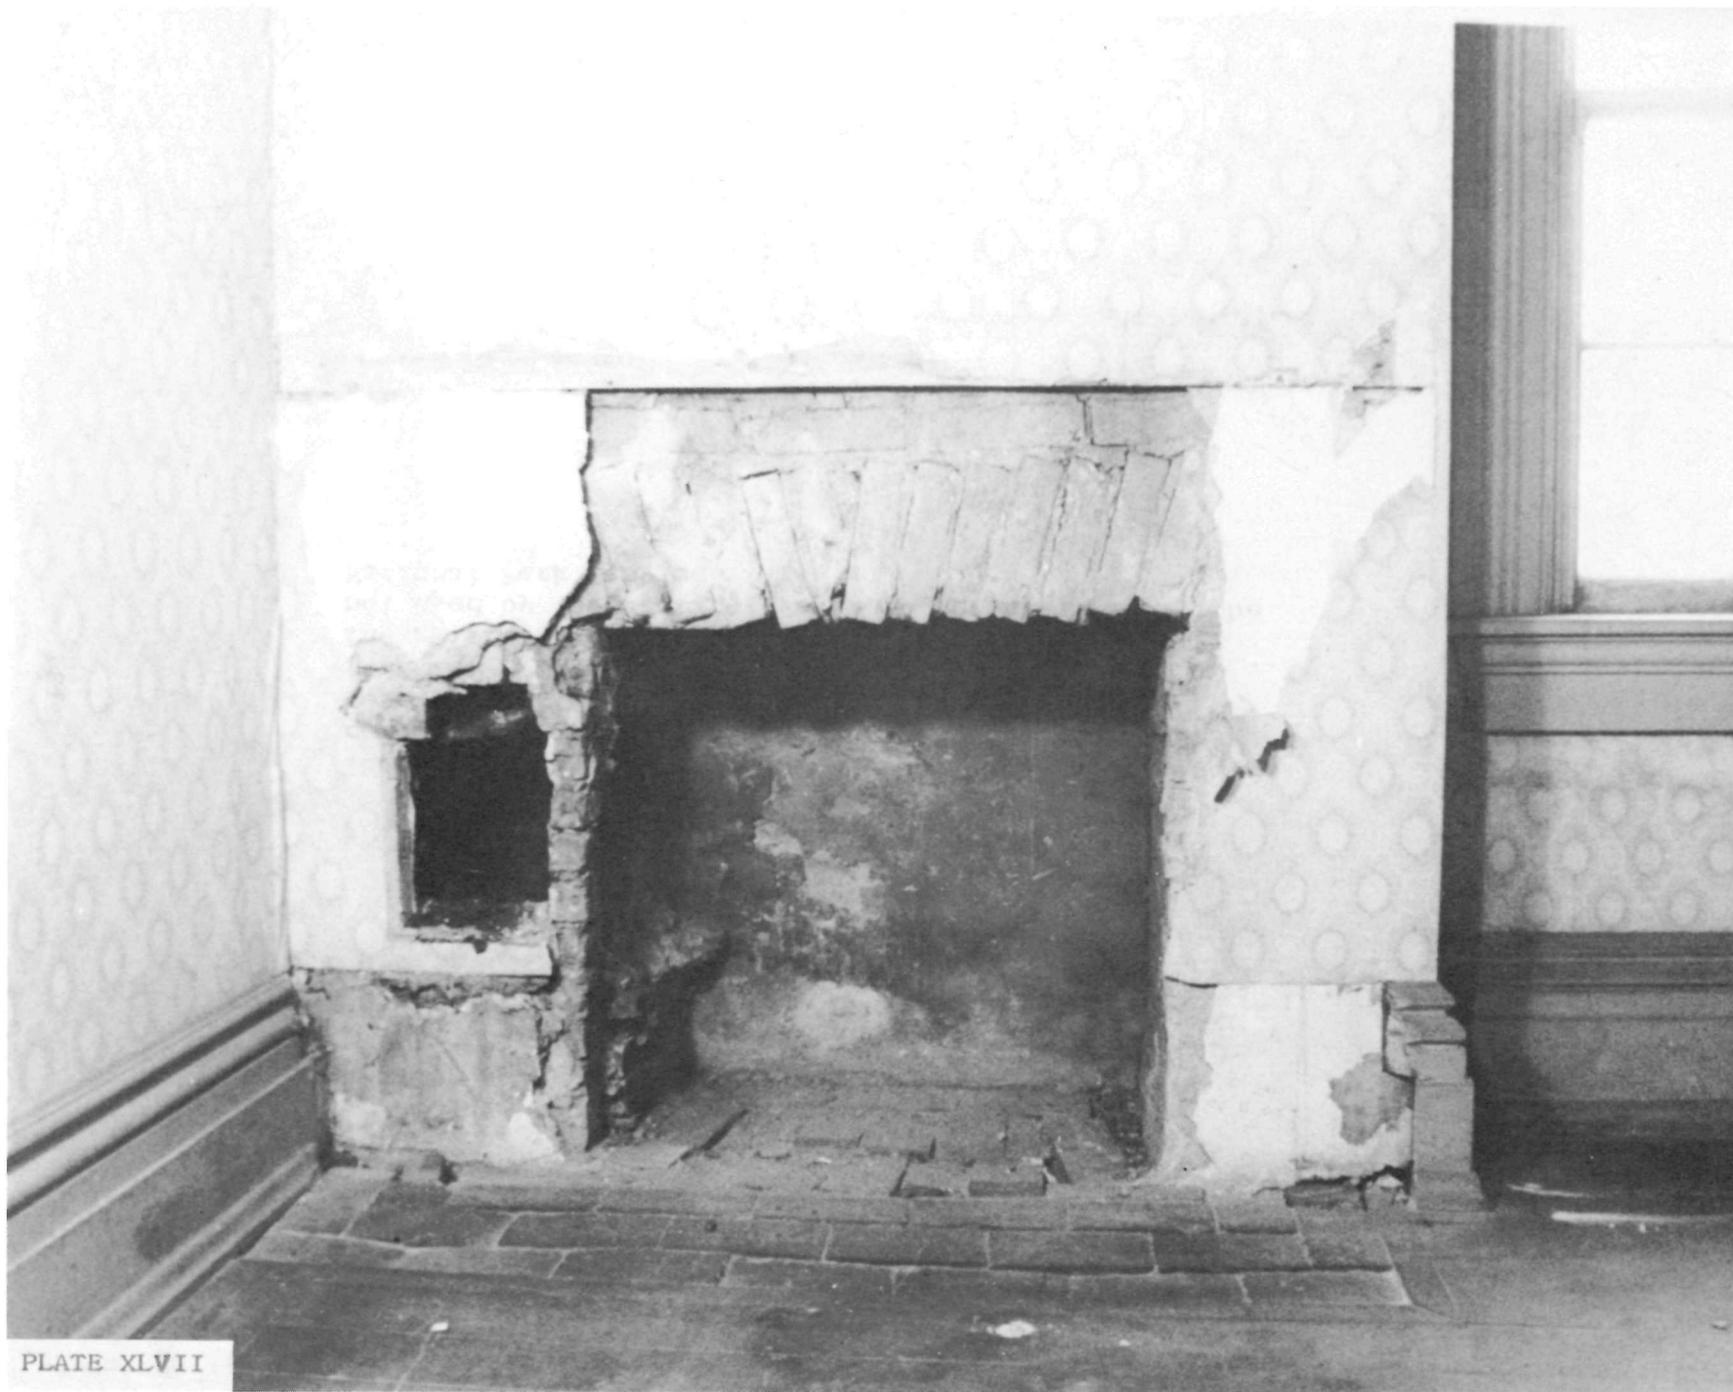
PLATE XLVII

It is assumed that the fireplace in bedroom #207 was closed off and the mantel removed to provide duct space when the central heating system was enlarged.

A replacement mantel will be installed based on the two existing second floor mantels.

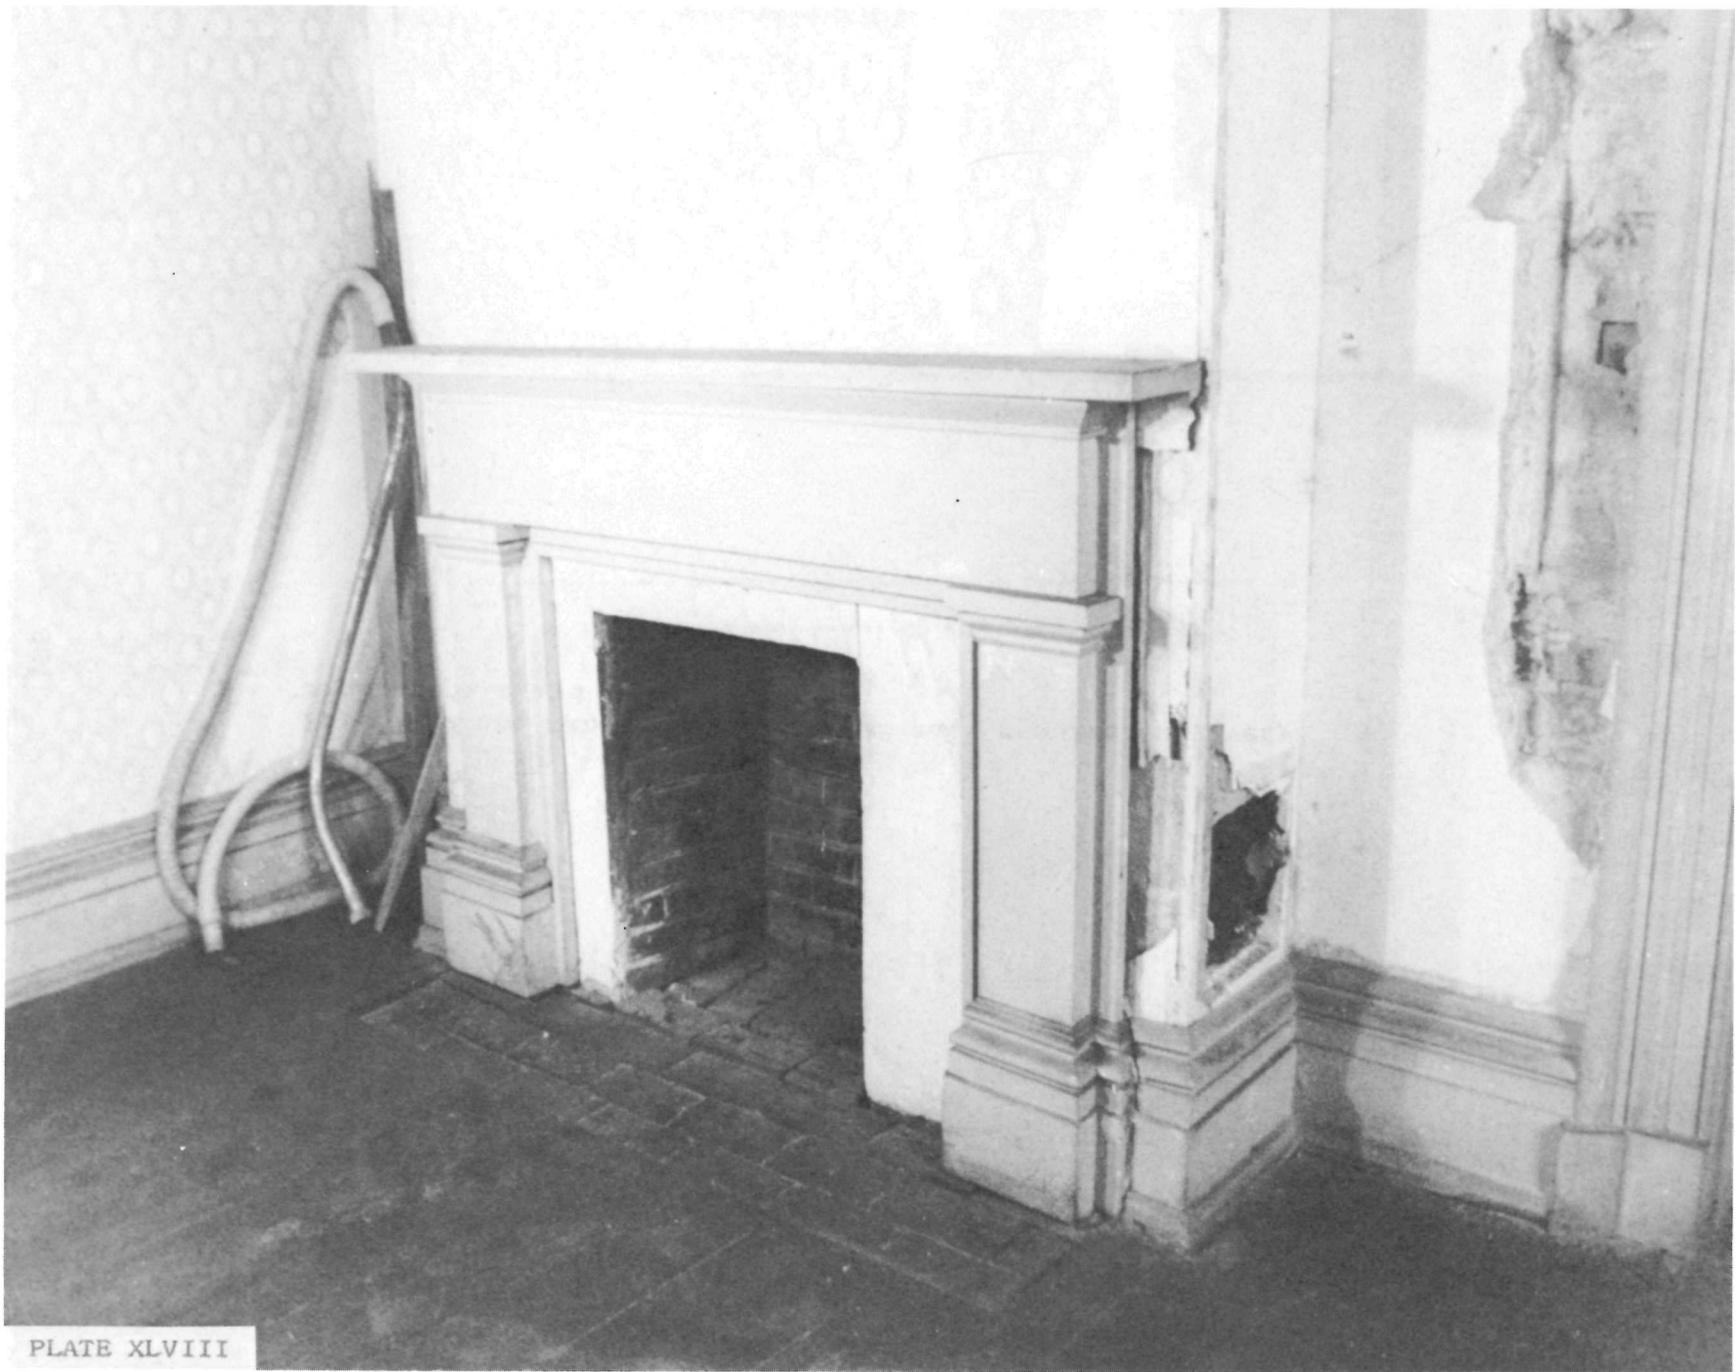
PLATE XLVIII

The fireplace and mantel in bedroom #205 is in good condition. It will only need repointing and minor repair.

The existing hot air grill will be closed if it is not used by the heating system to be installed by the National Park Service.

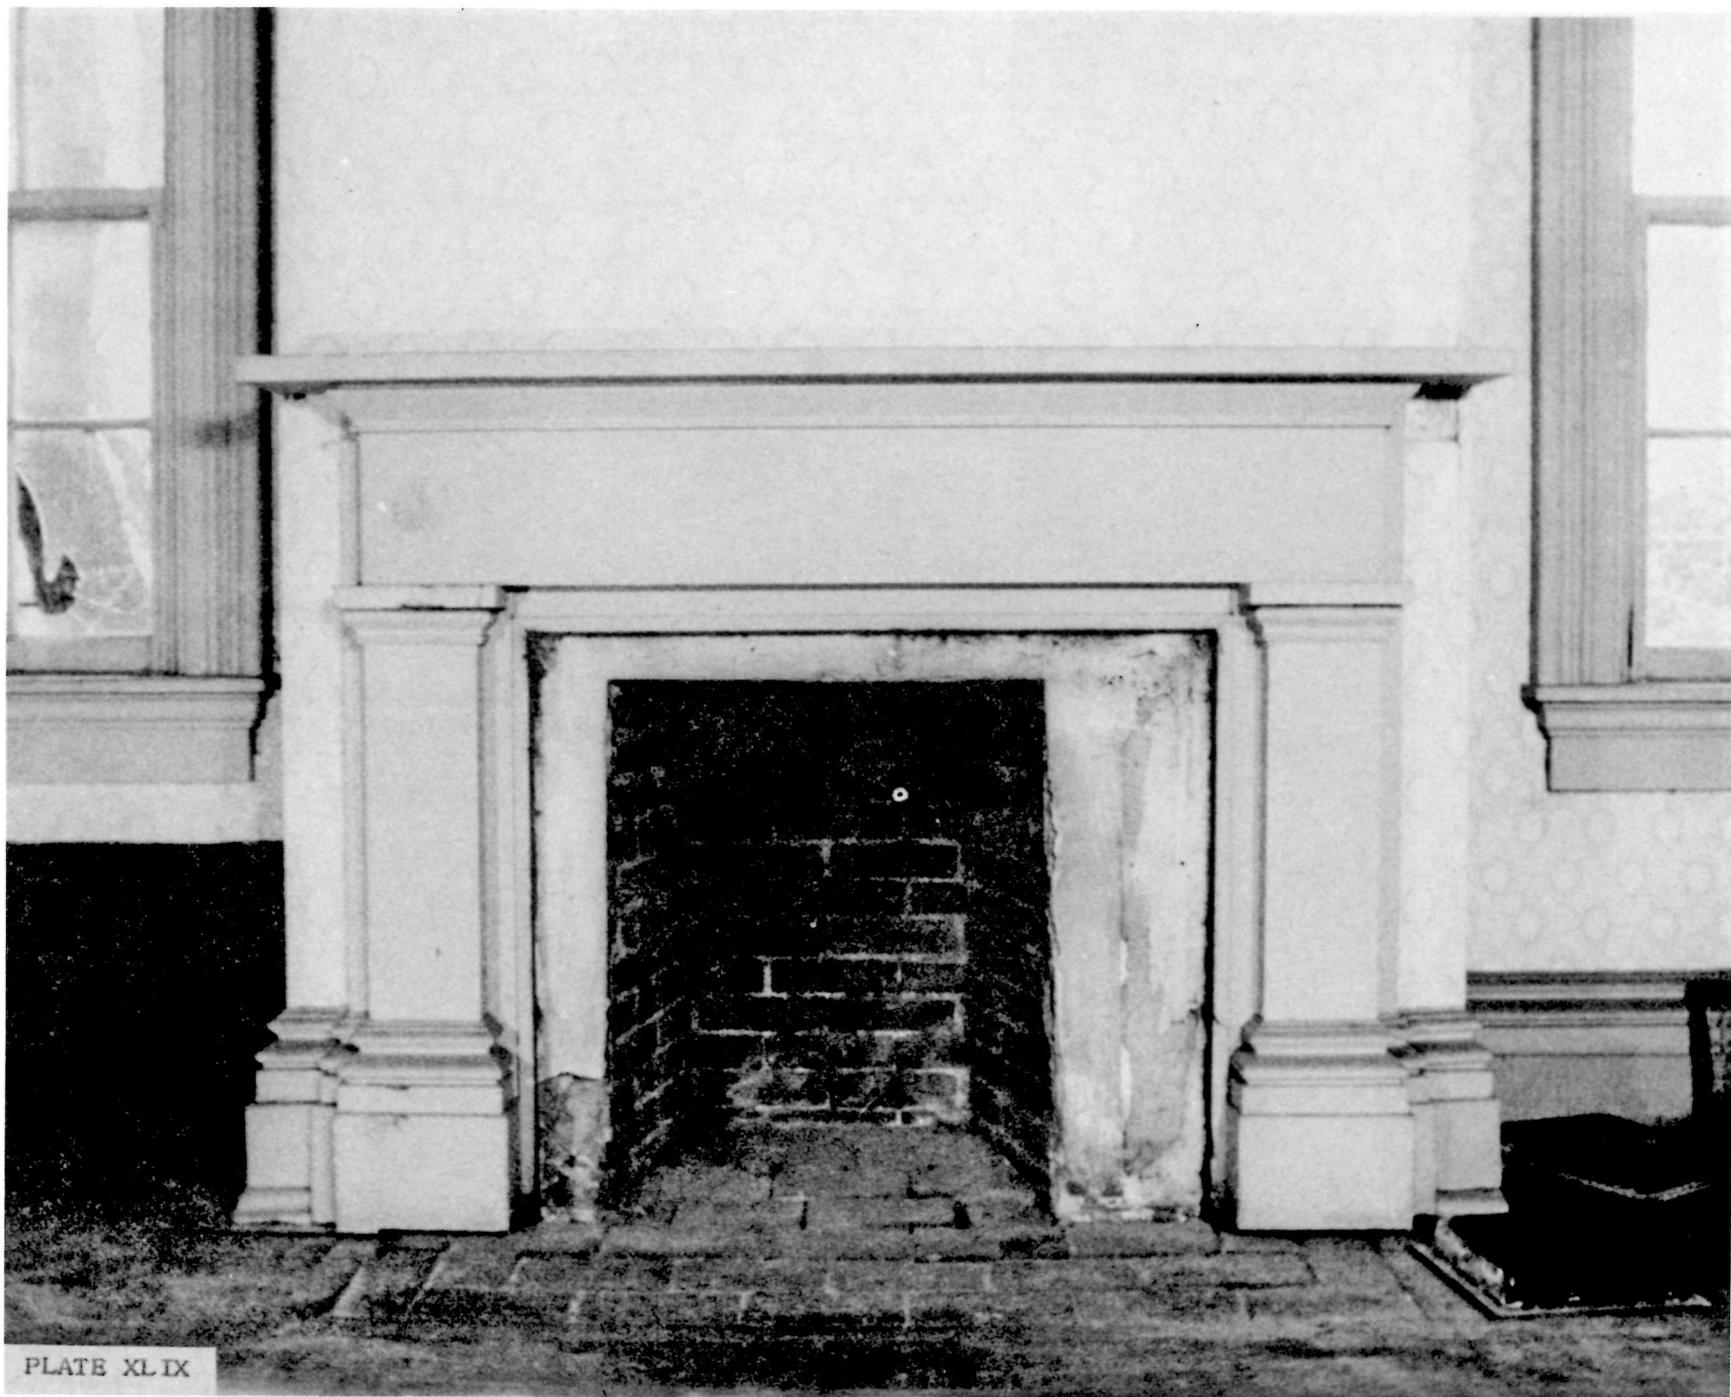
PLATE XLIX

Fireplace and mantel, bedroom #208 will require only very minor repair and repointing.
