**Frederick Douglass
Home**

HISTORIC STRUCTURES REPORT

ARCHITECTURAL DATA

JUNE 1970

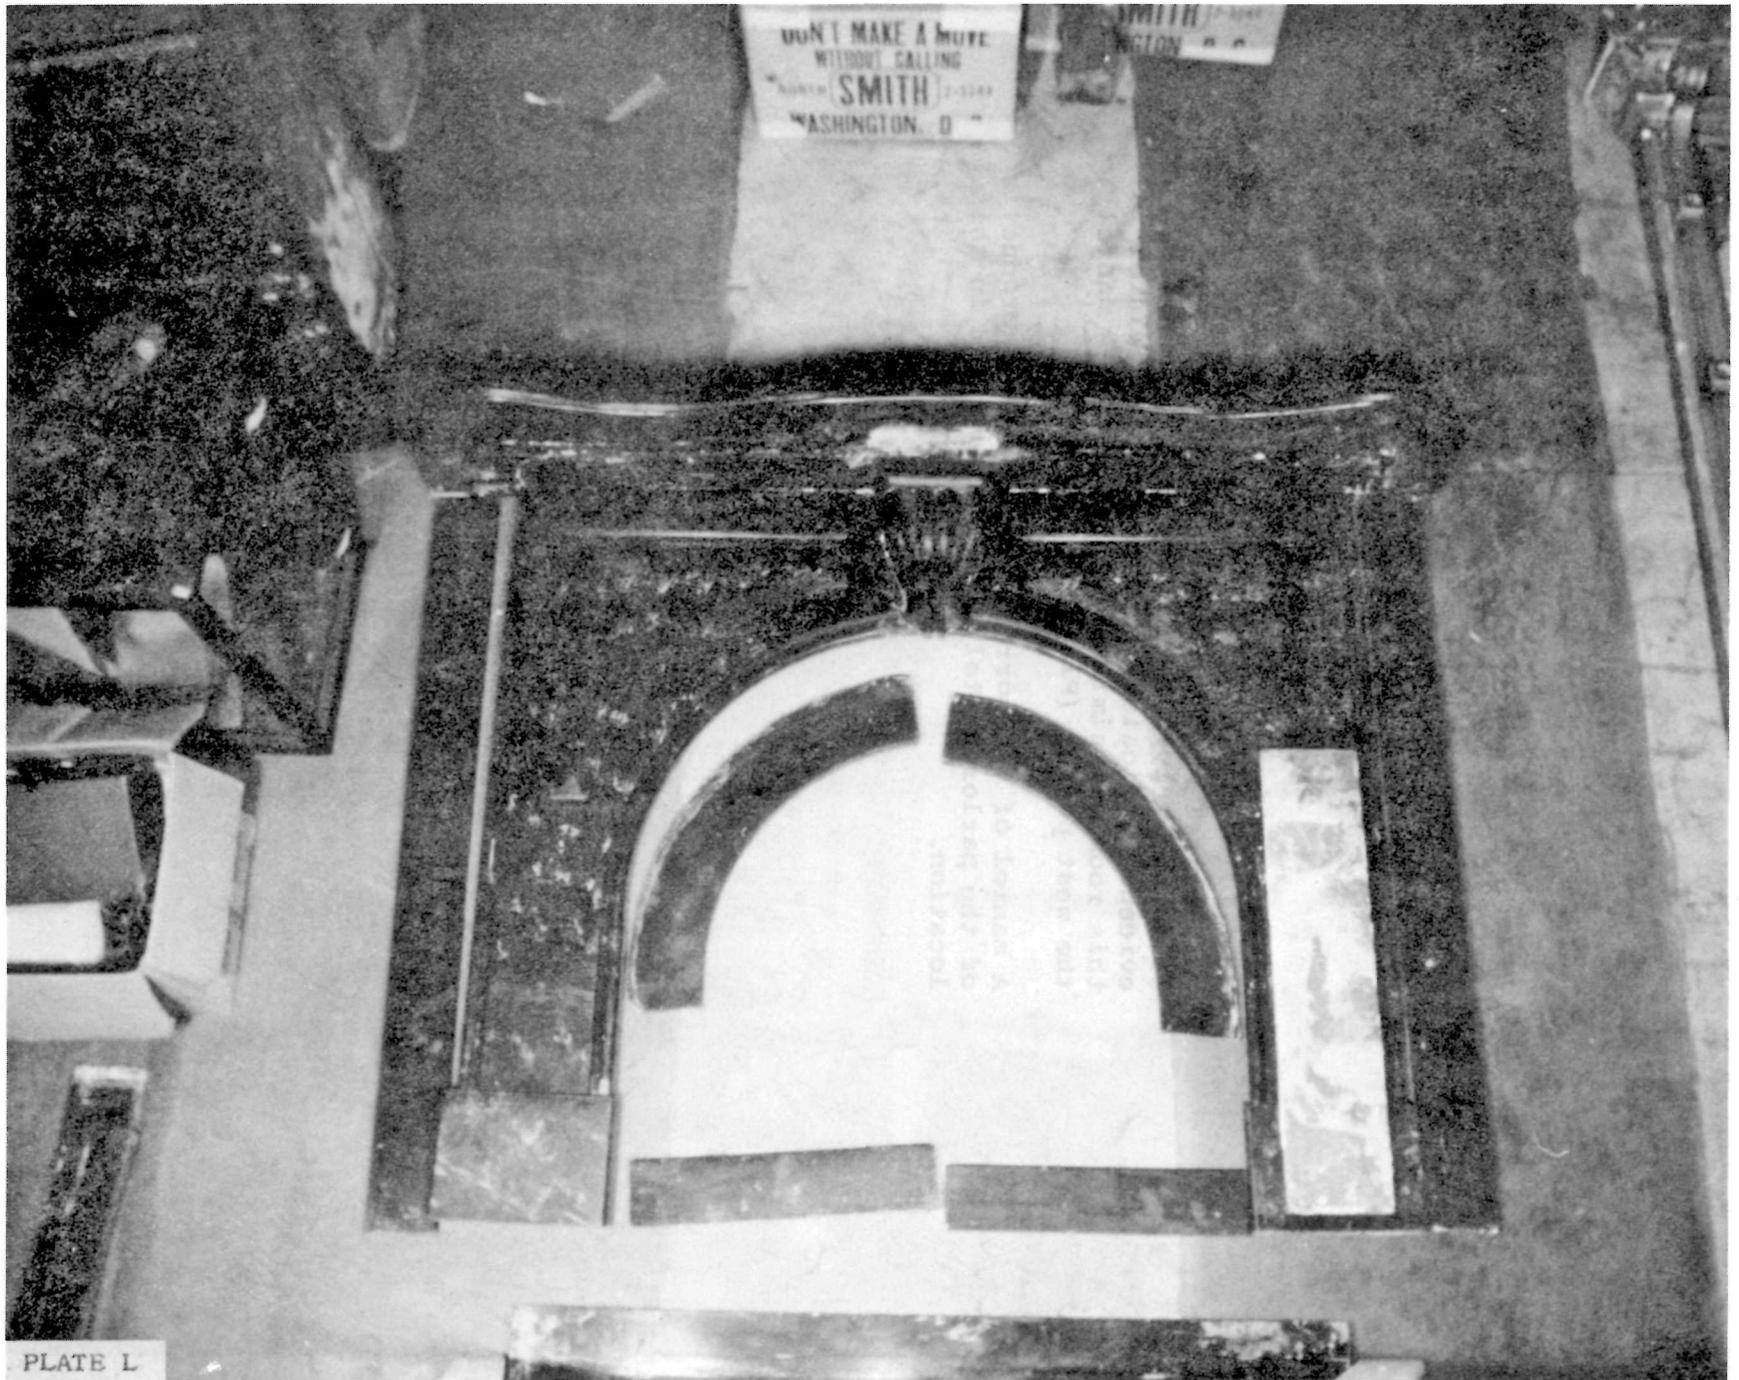
PLATE L

This mantel belongs in the west parlor (room #102). It will be reinstalled.

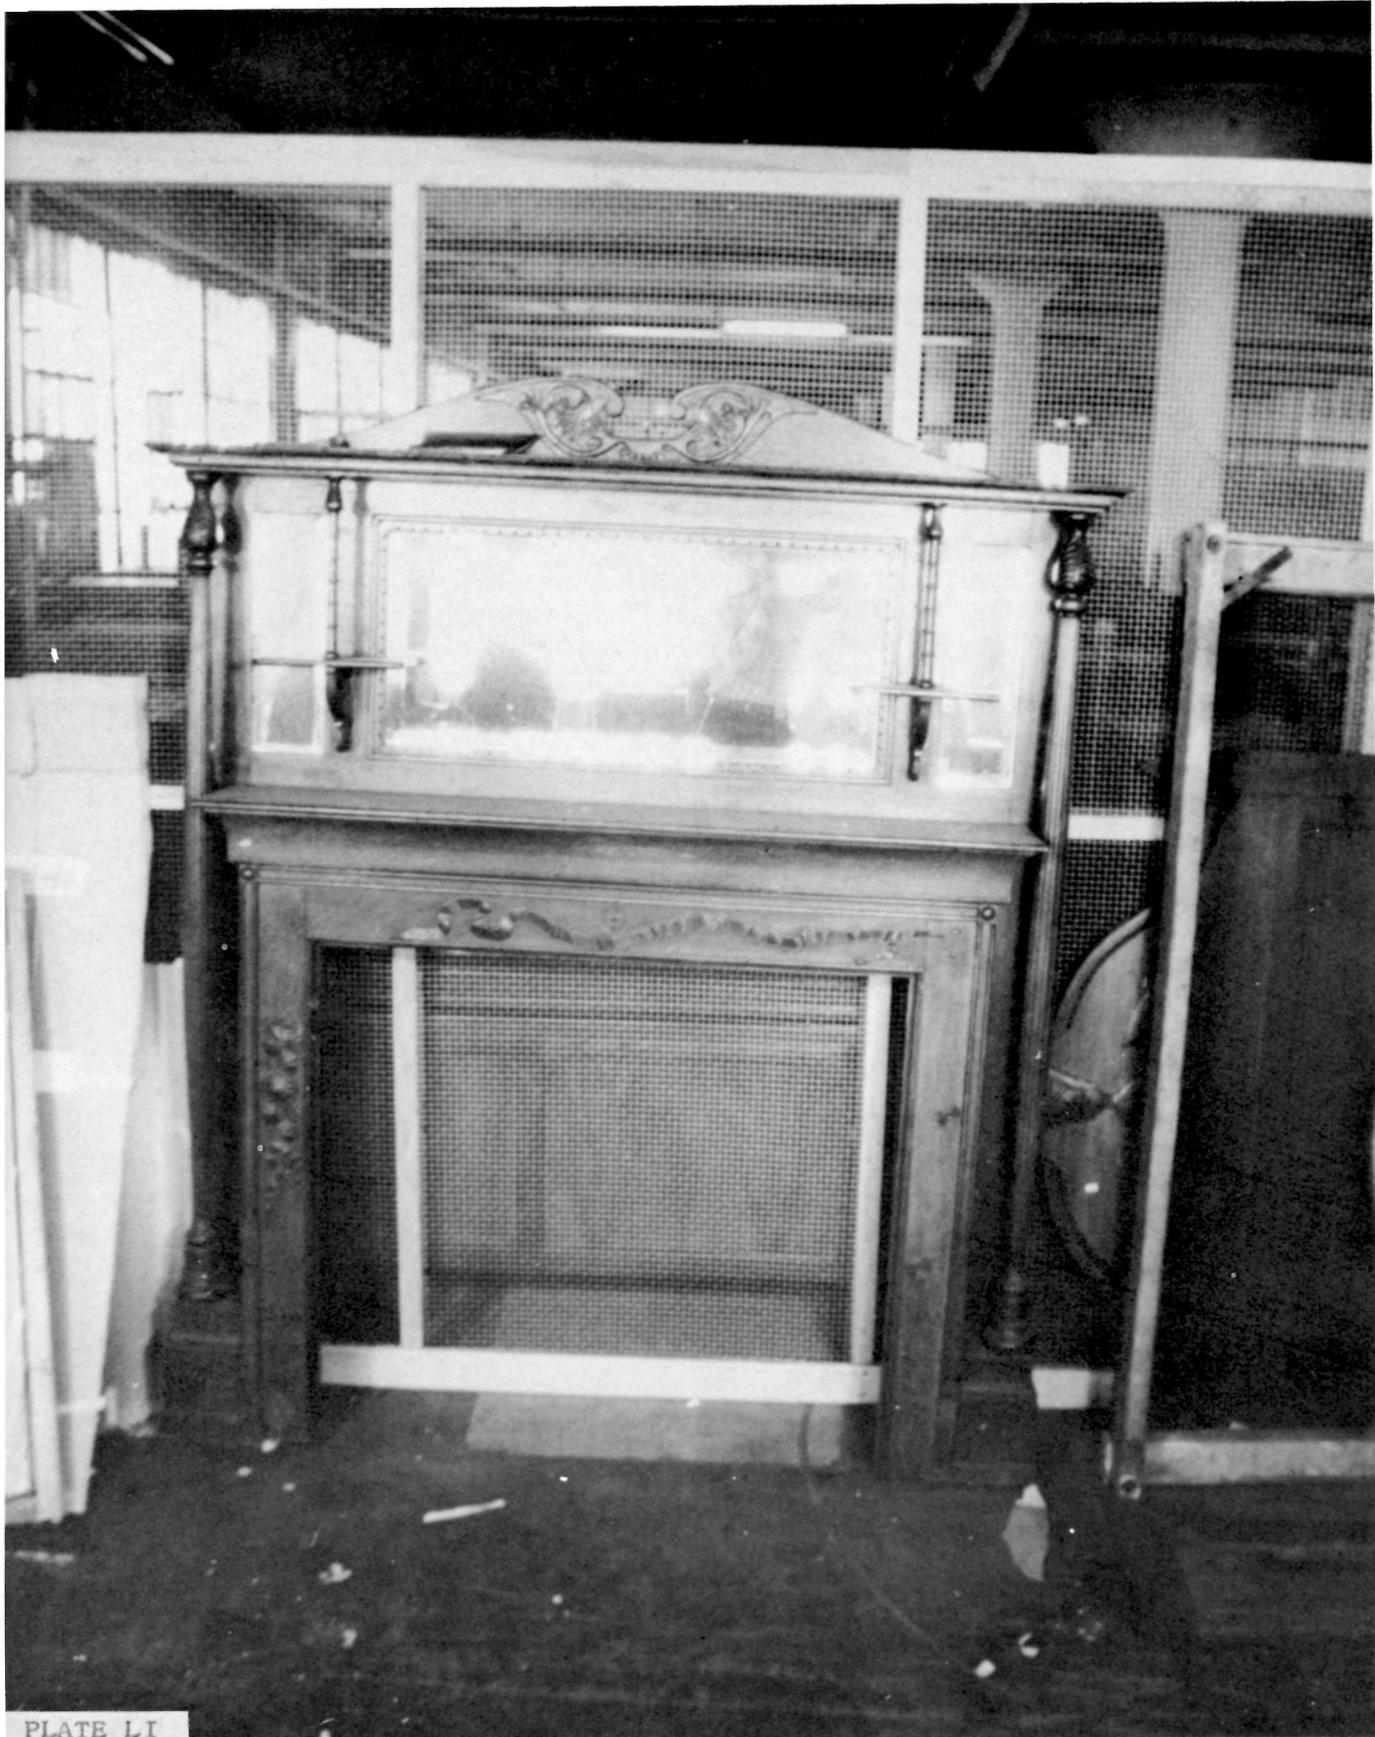
PLATE LI

This mantel was located in the dining room (#103). It is an early 20th century design. Physical evidence indicates that the original mantel in this room was similar in design to the mantel in the west parlor (Plate L).

A mantel of the correct period or a reproduction of the parlor mantel will be installed in this location.

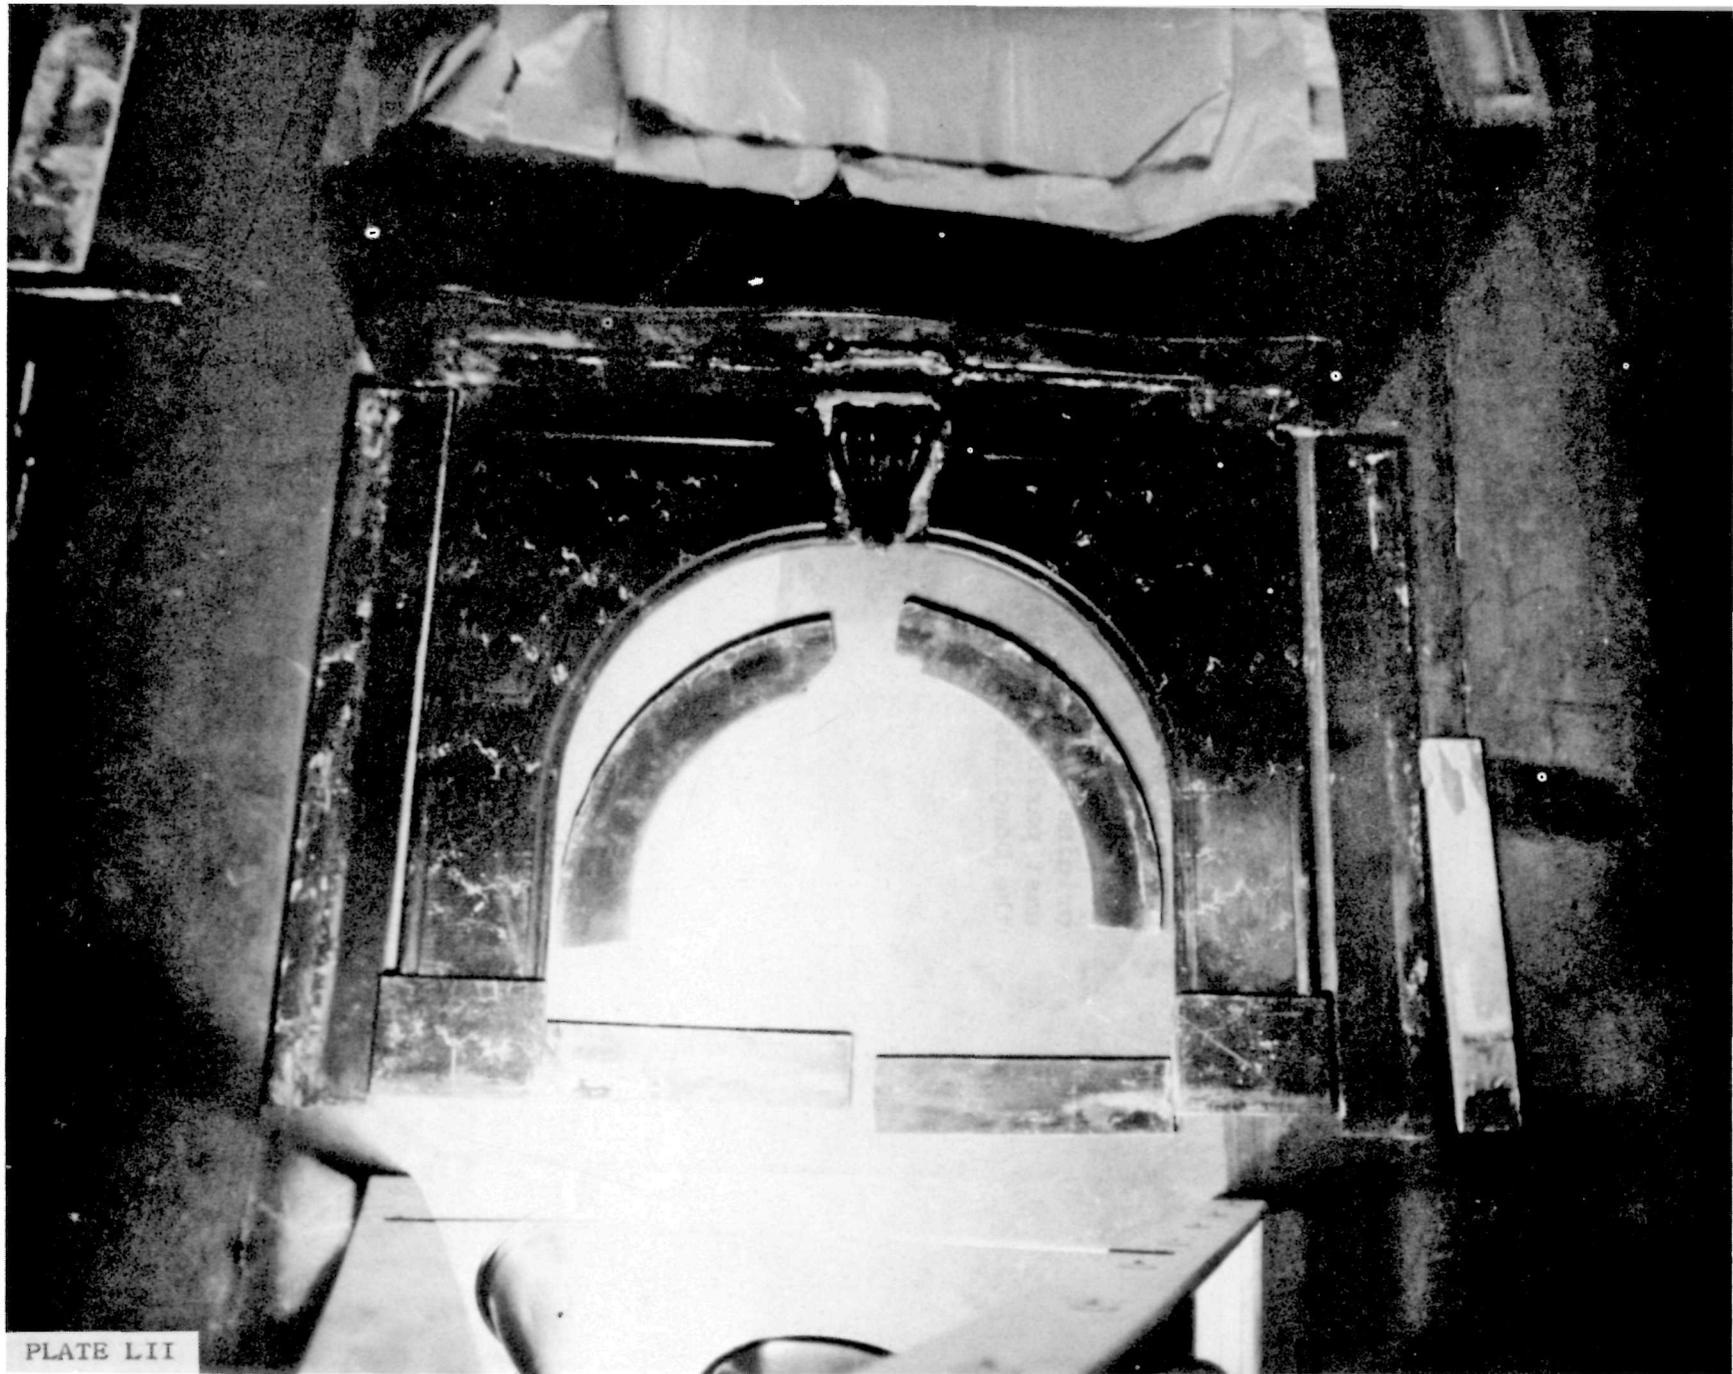
PLATE LII

Mantel from east parlor (room #108) is very similar to the mantel from the west parlor with the addition of a large mirror above. (see plate LIII).

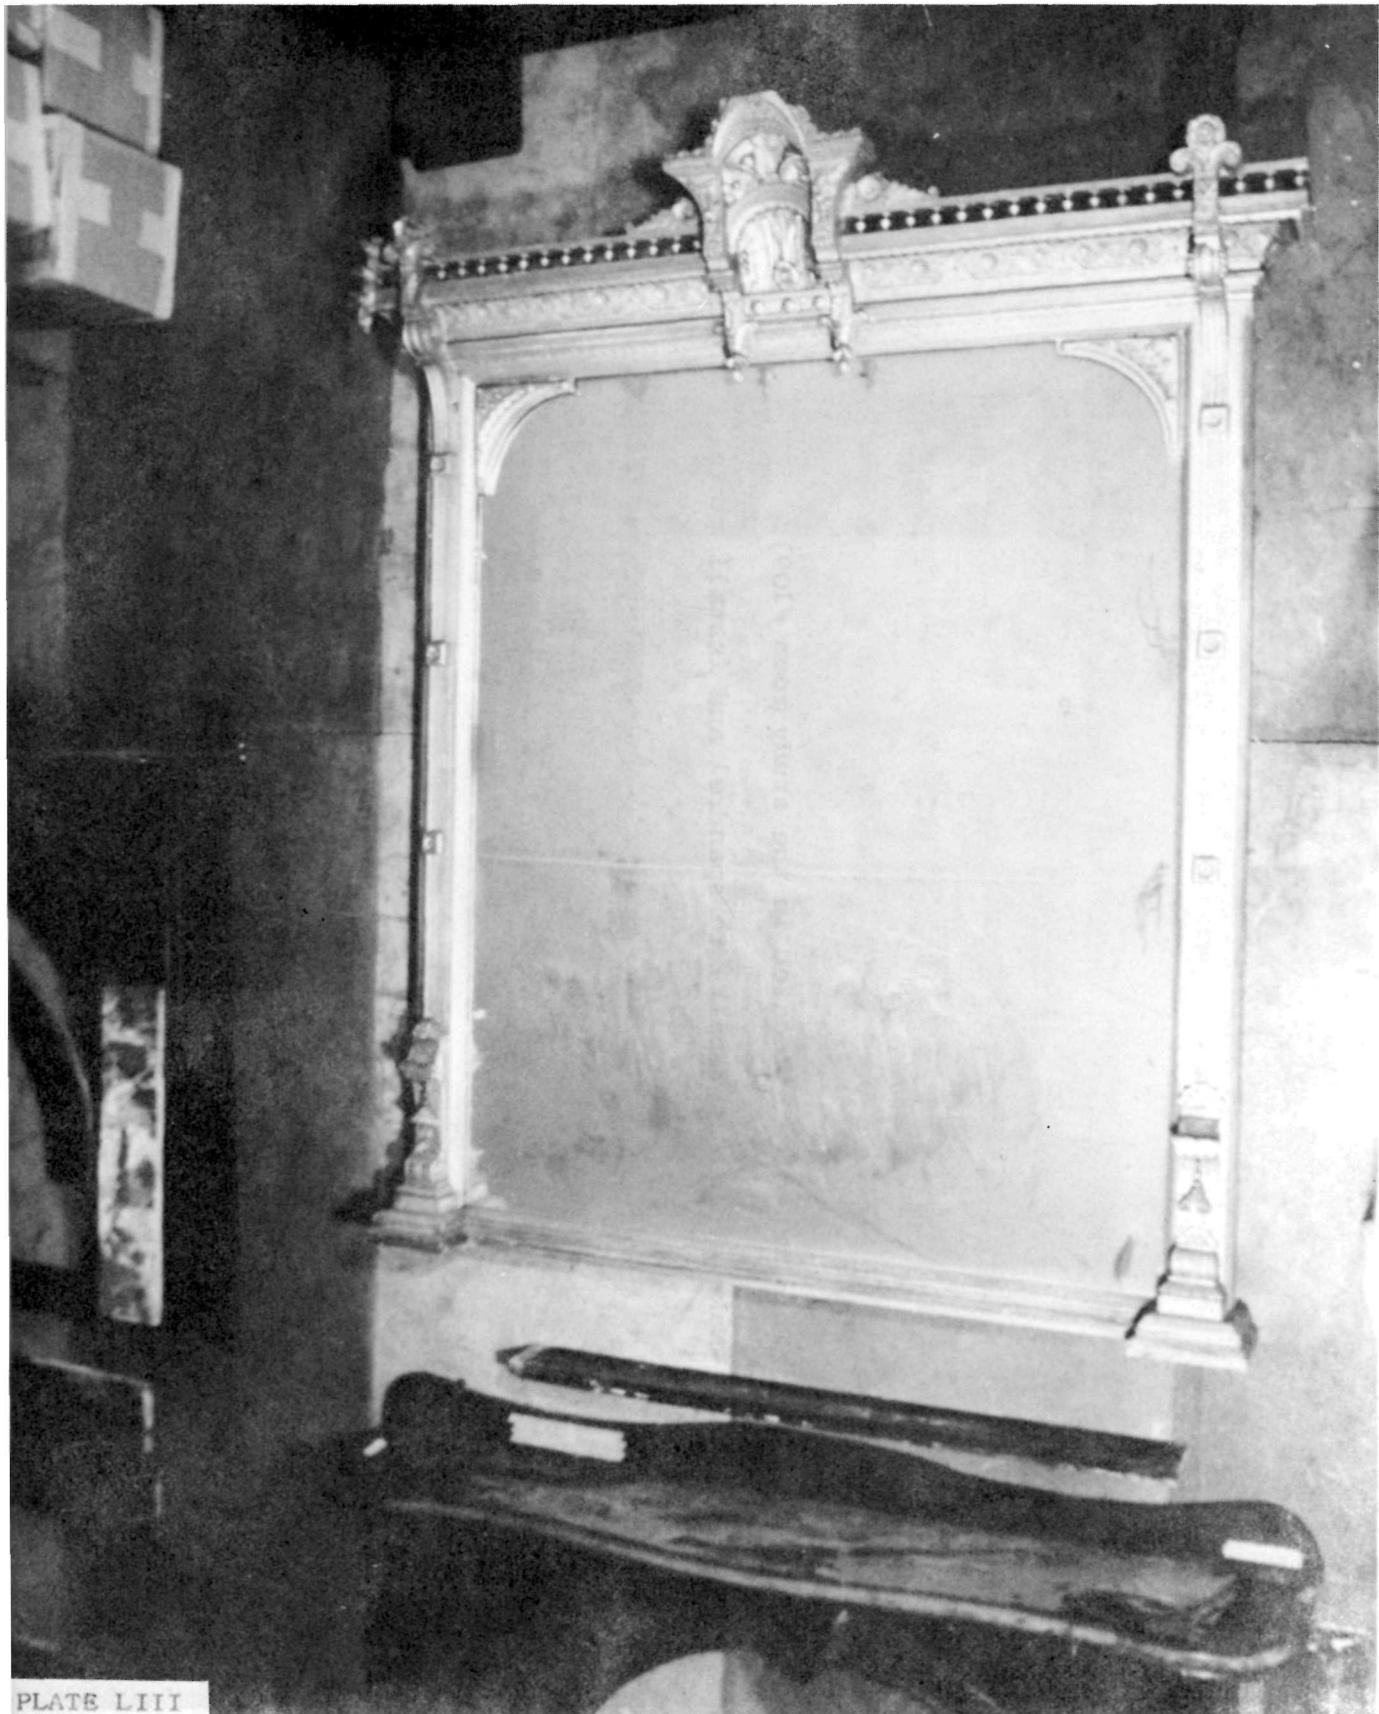
PLATE LIII

It is evident that this mirror was not originally part of the mantel in the east parlor however it was in place during the Douglass period and will be installed.

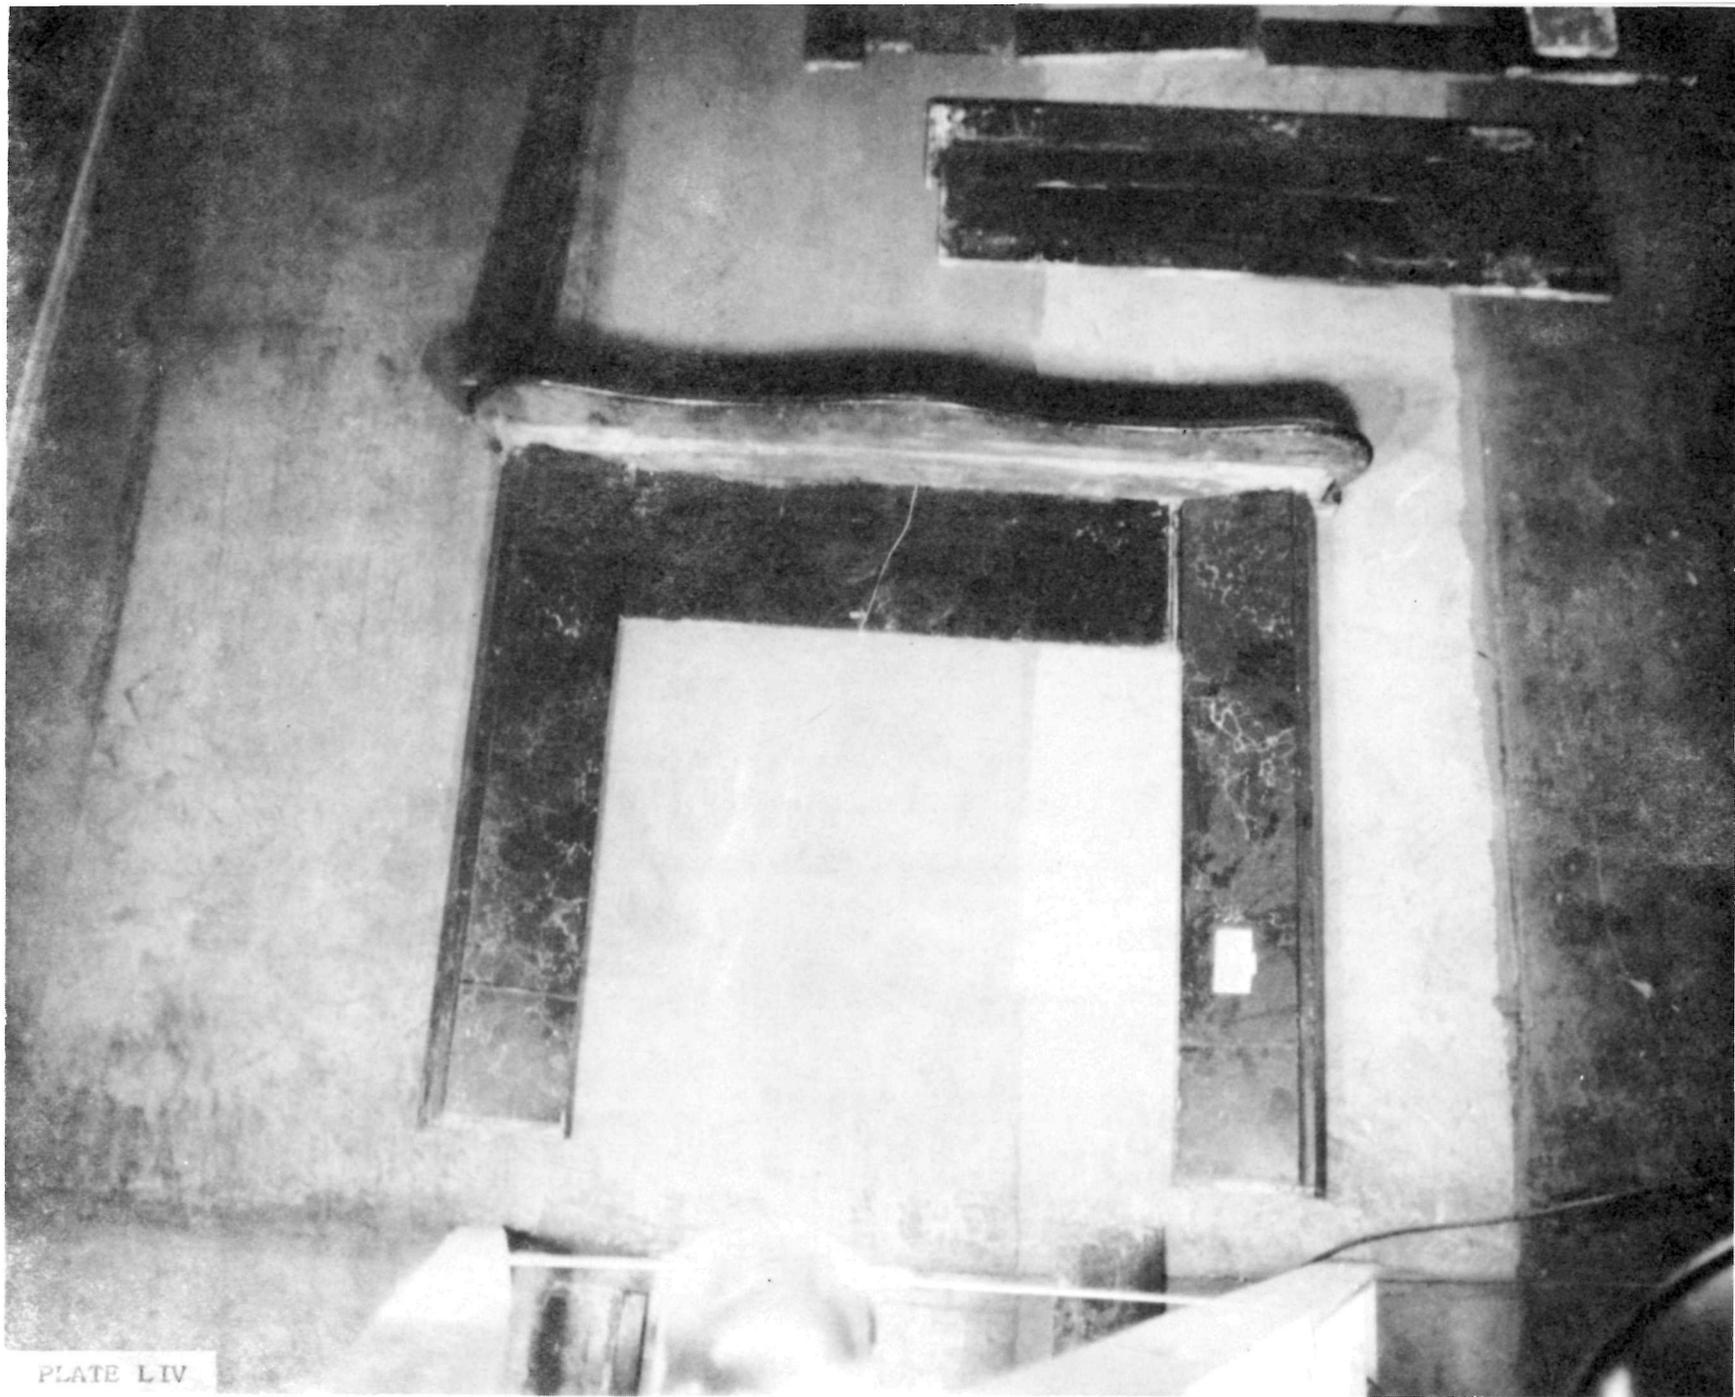
PLATE LIV

This mantel was located in the study (room #109).

Make necessary repairs to spandrel and install mantel.
