# HISTORIC STRUCTURE REPORT

1029 GURNEE AVENUE "THE MURAL BUILDING"

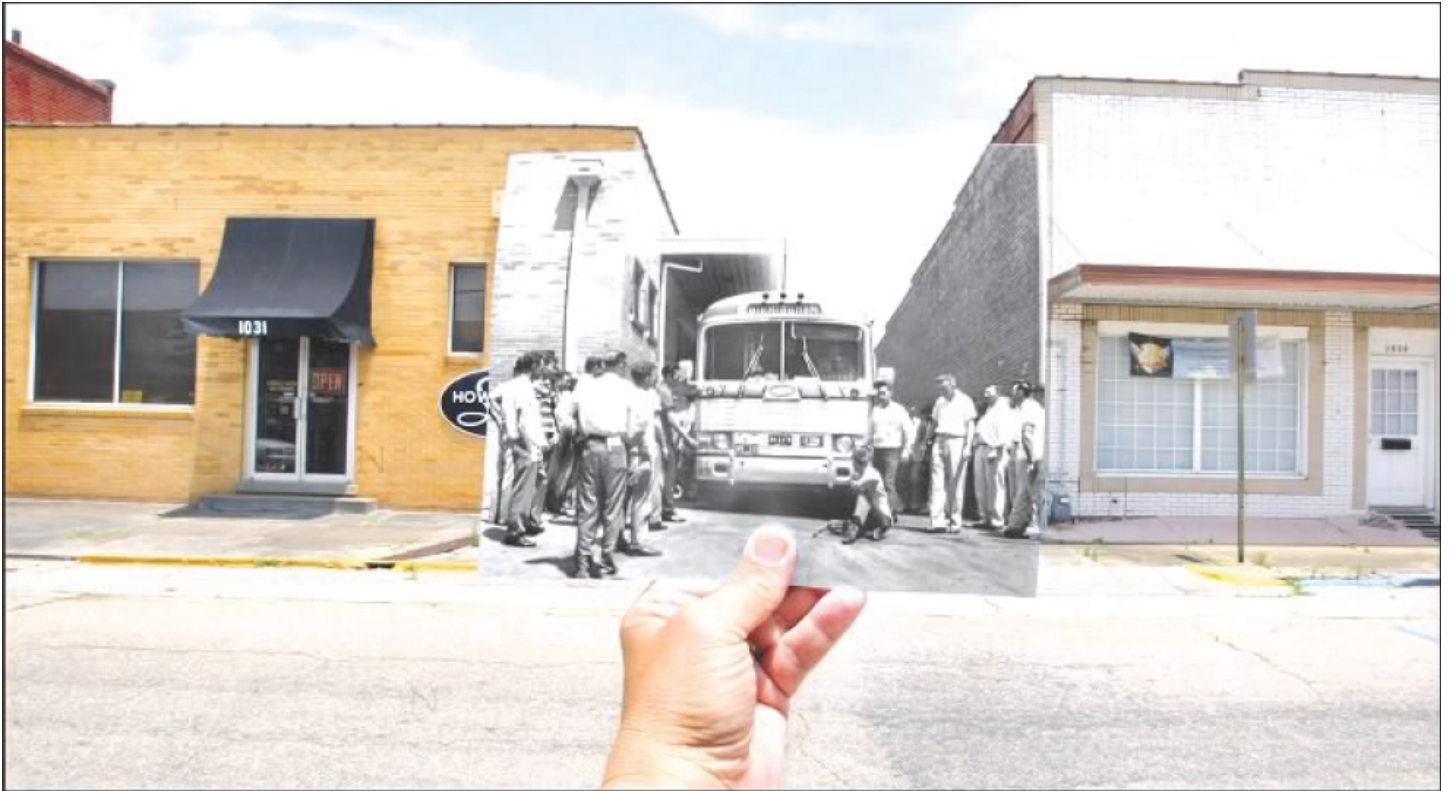
Stephen Gross/The Anniston Star

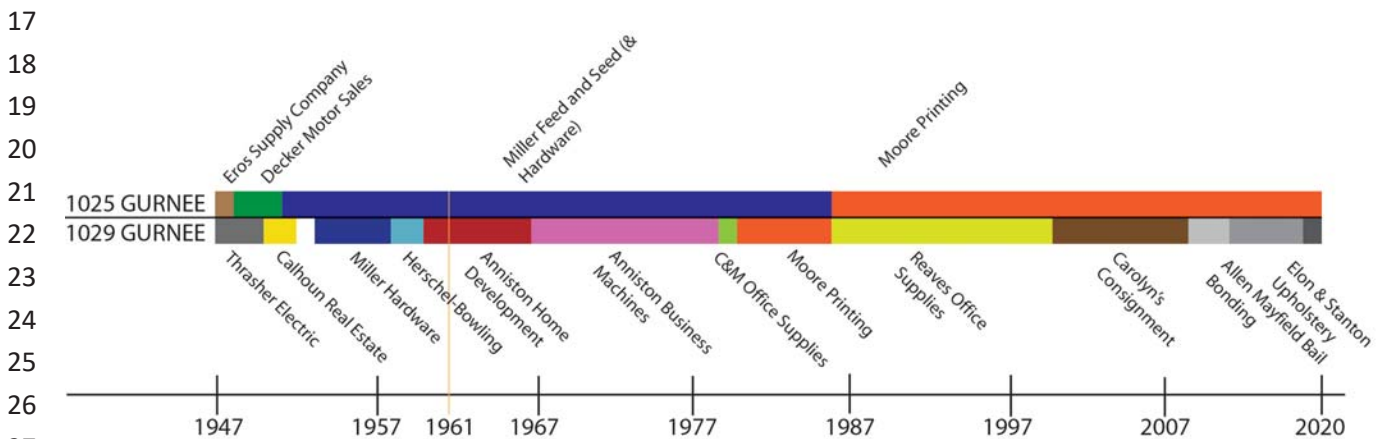
28  
 29 The businesses that occupied the two commercial spaces comprising 1025-29 Gurnee Avenue define the role of  
 30 the subject building in downtown Anniston over time. Typical of a small downtown commercial building, it was  
 31 built to lease and known to the local community by whichever business occupied it at the time. Today, the building  
 32 might be known as “Moore’s” for Moore Printing. In the past, it was known for a time as “Millers”, for Miller’s Feed  
 33 and Seed. The following are historical vignettes of several of the business that occupied the two spaces initially  
 34 and through the period of significance. Information about tenants was gathered from city directories and Anniston  
 35 Star newspaper archives.

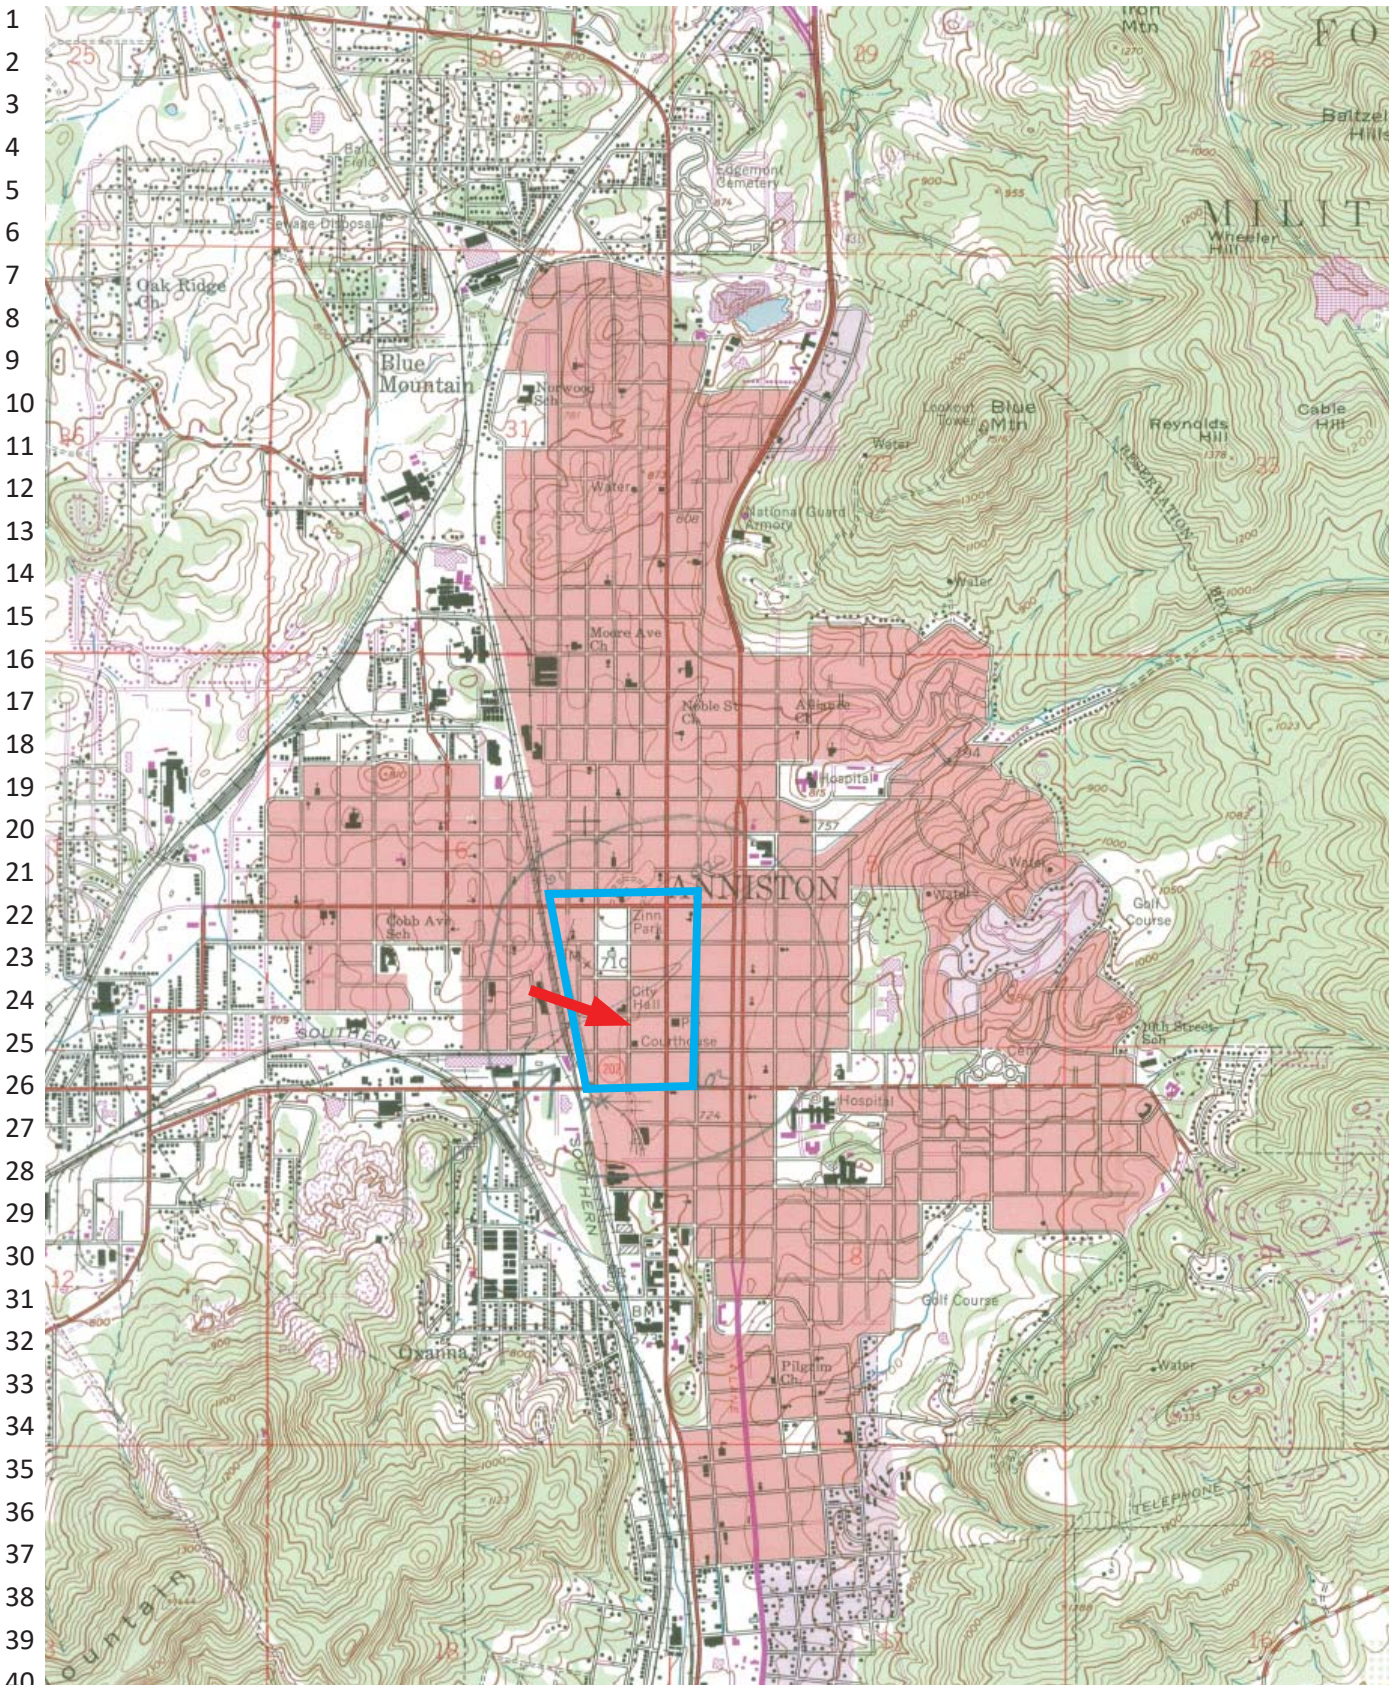
Figure 7: Detail of USGS Topographic map, Anniston Quadrangle, Calhoun County, AL. 7.5 Minute Series, Photorevised, 1972 showing the City of Anniston (developed areas highlighted in red). Map retrieved from the Anniston Downtown Historic District (NRIS 91000663) National Register Nomination with hand-drawn boundary of the district, highlighted in blue here. The Mural building is indicated by red arrow.

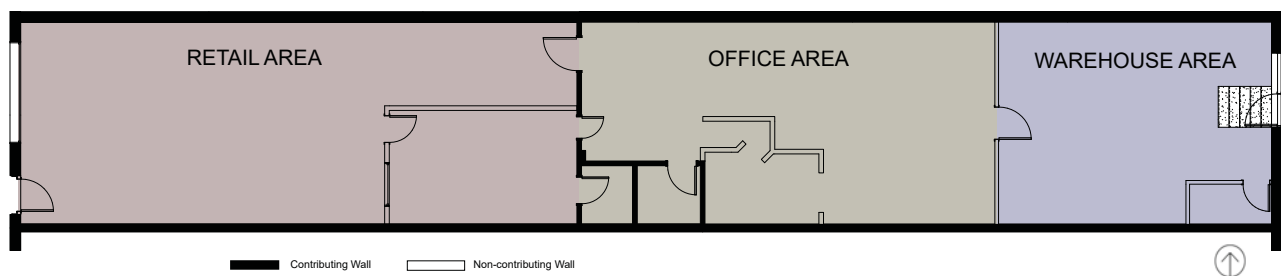
Figure 13: Floor plan showing the arrangement of spaces within the building.

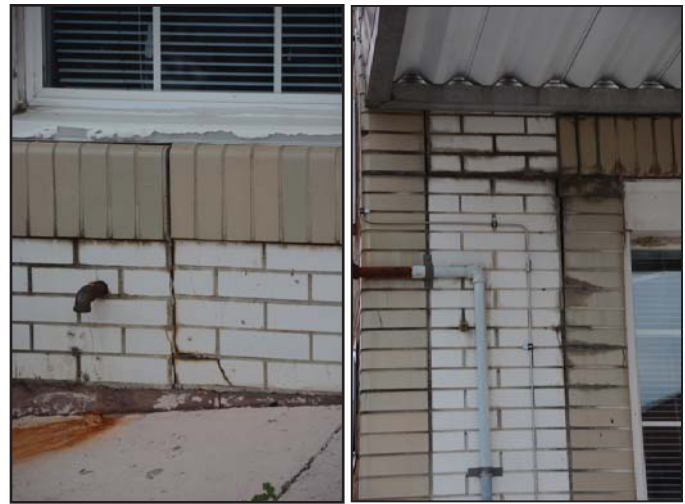
Figure 14: Cracking and water staining in the white and tan brick veneer on the east elevation. Left is below the Gurnee Avenue-facing window and right is left of the same window's header. Photo by author, 2020.

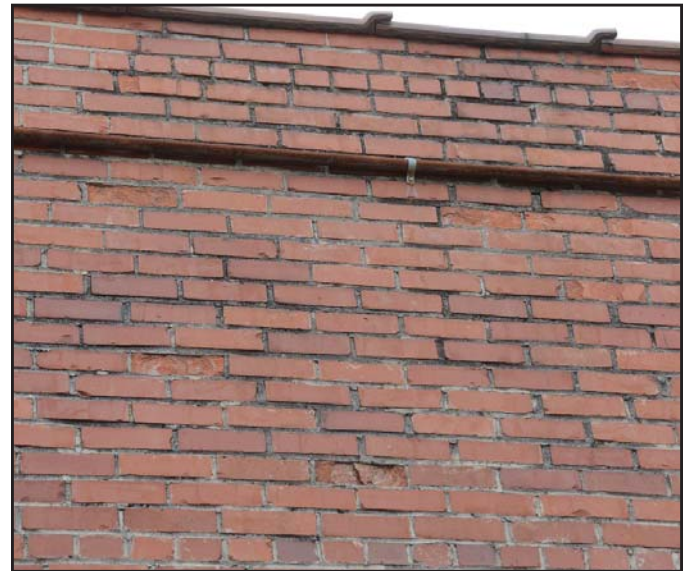
Figure 15: Some brick face spalling and wetness is evident on the upper portion of the north elevation. Photo by author, 2020.

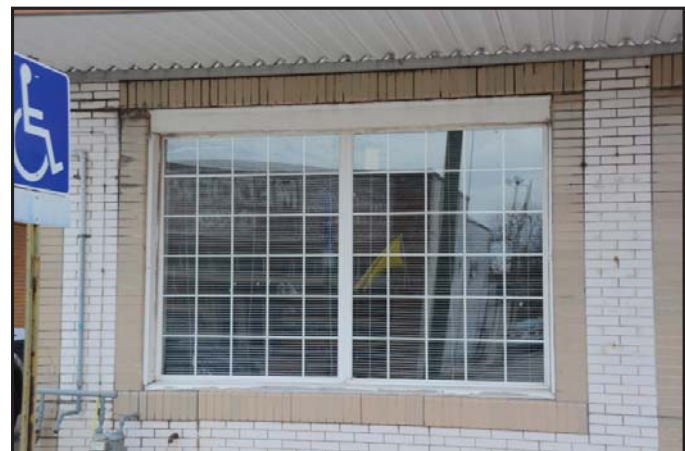
Figure 16: West elevation window of 1029 Gurnee Avenue. Photo by author, 2020.

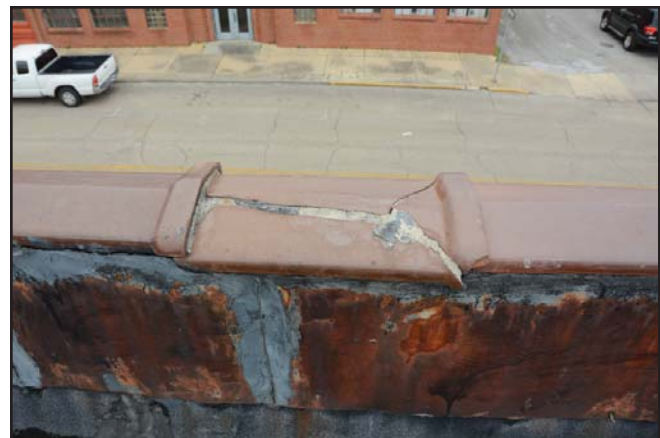
Figure 22: Terra cotta coping tiles. The center tile in this image is cracked and has been repaired with mortar. Photo by author, 2020.

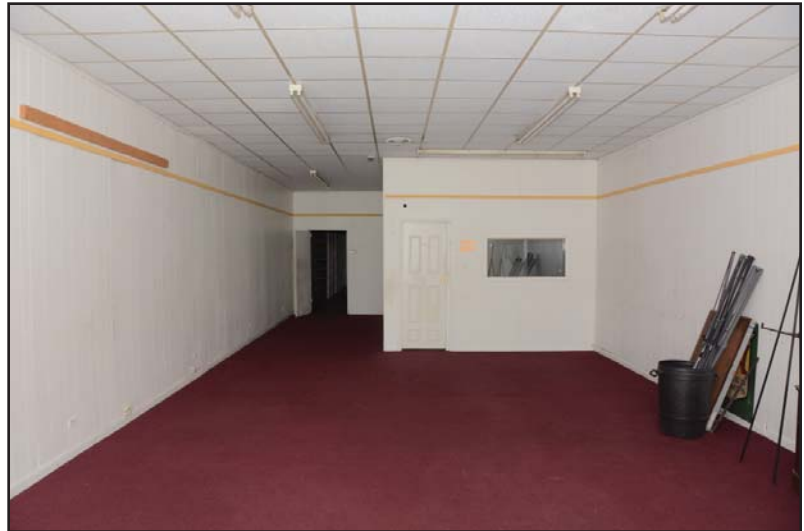
Figure 23: View of the retail space, facing east. Photo by author, 2020.

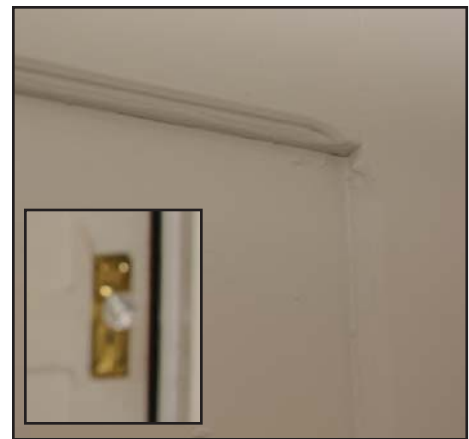
Figure 26: Detail of lambs-tongue chamfer. Inset shows detail of brass-plated escutcheon plate and glass knob. Photos by author, 2020

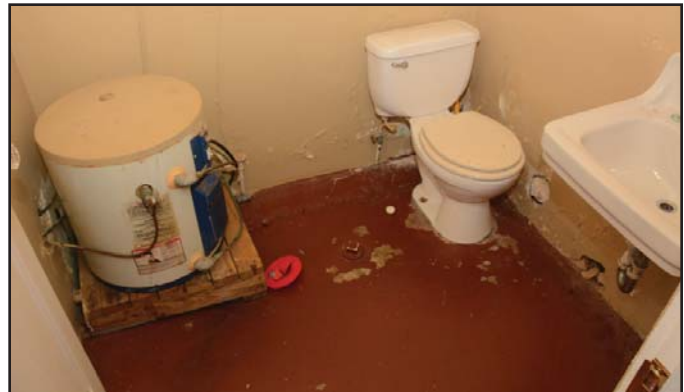
Figure 31: East restroom showing typical condition of fixtures and finishes. Photo by author, 2020.

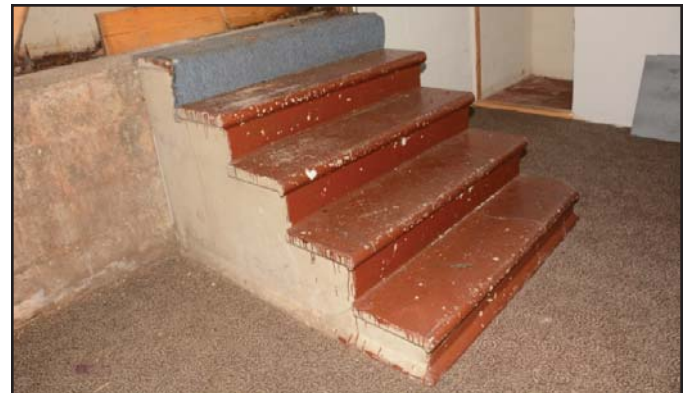
Figure 32: Non-contributing concrete stairs located at the rear of the warehouse space.
