Historic Structure Report

*Building 25
Enlisted Men's Barracks
Fort Hancock, New Jersey
Sandy Hook Unit
Gateway National Recreation Area*

HISTORIC STRUCTURE REPORT

February 2002

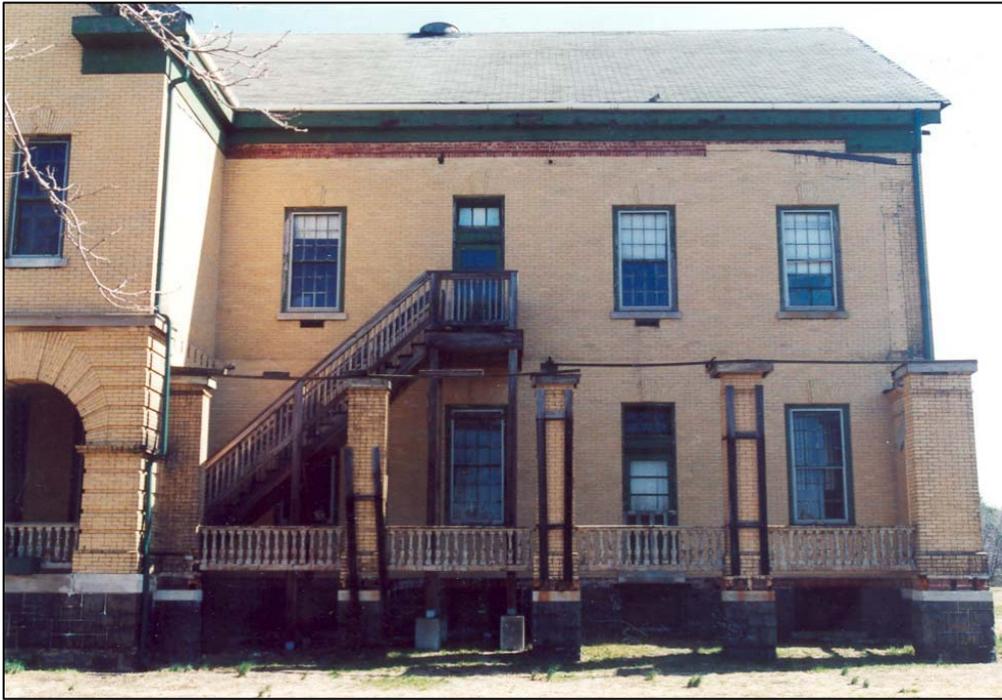
Figure 74. West elevation, showing replacement box cornice and fire escape.

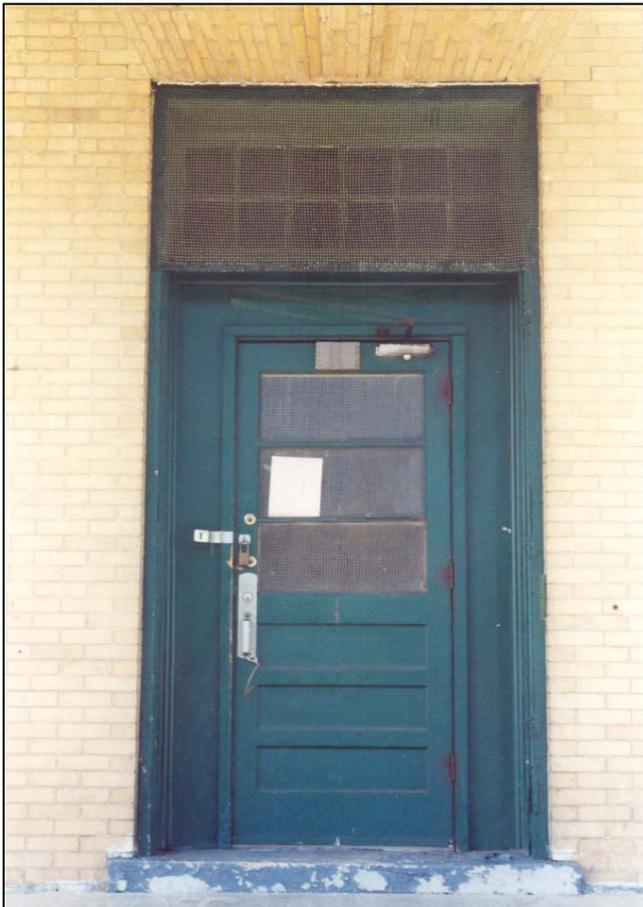
Figure 75. East elevation, first-story doorway, showing perimeter infill with replacement door and original transom.

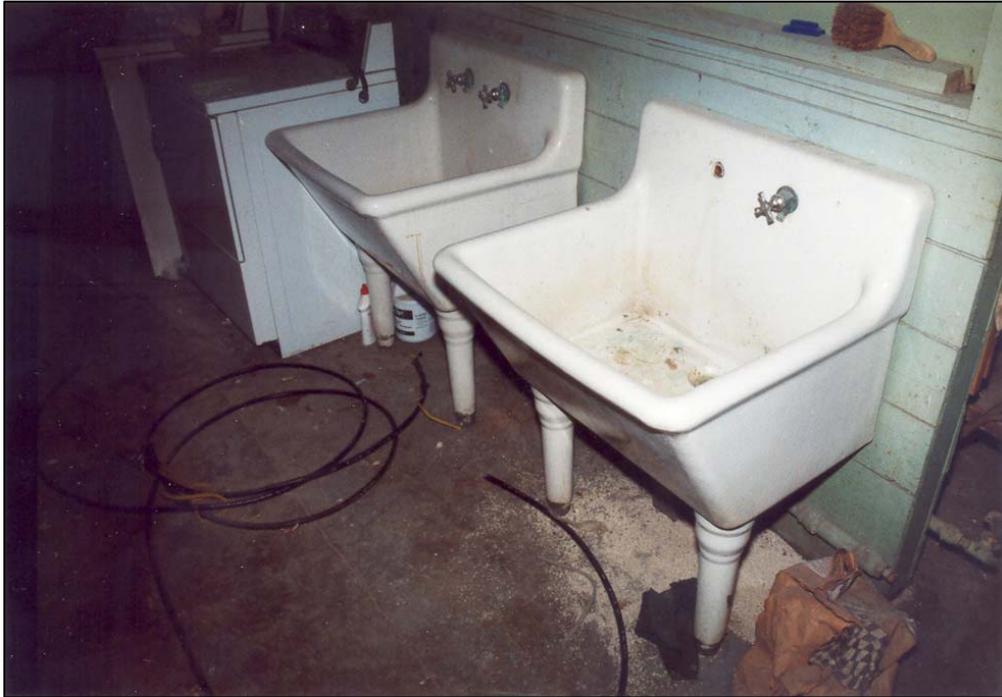
Figure 76. North side of basement, partition and laundry sinks in northeast corner.

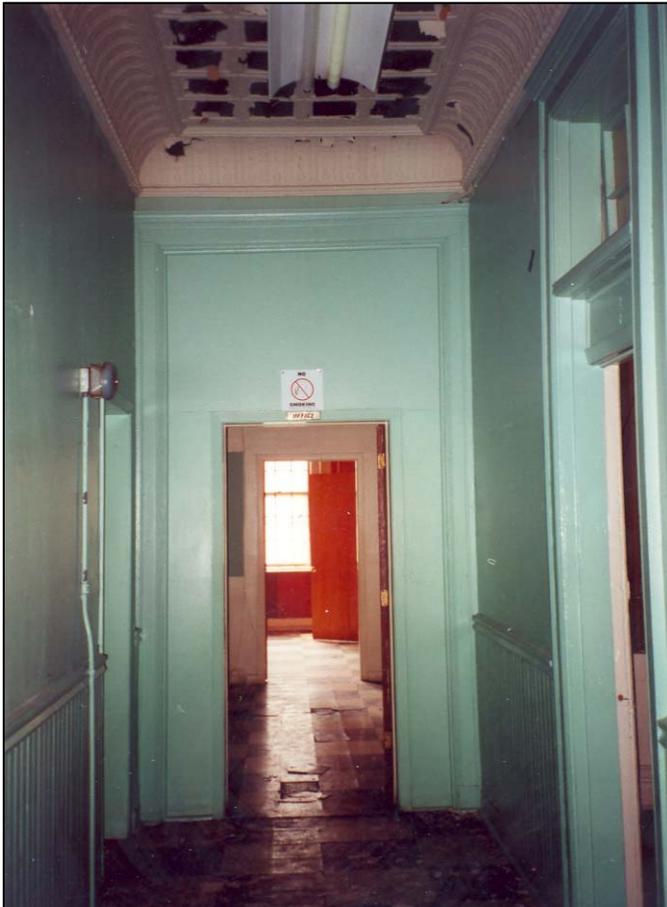
Figure 79. Doorway from side hall to mess room, showing perimeter infill for replacement door and covered transom.

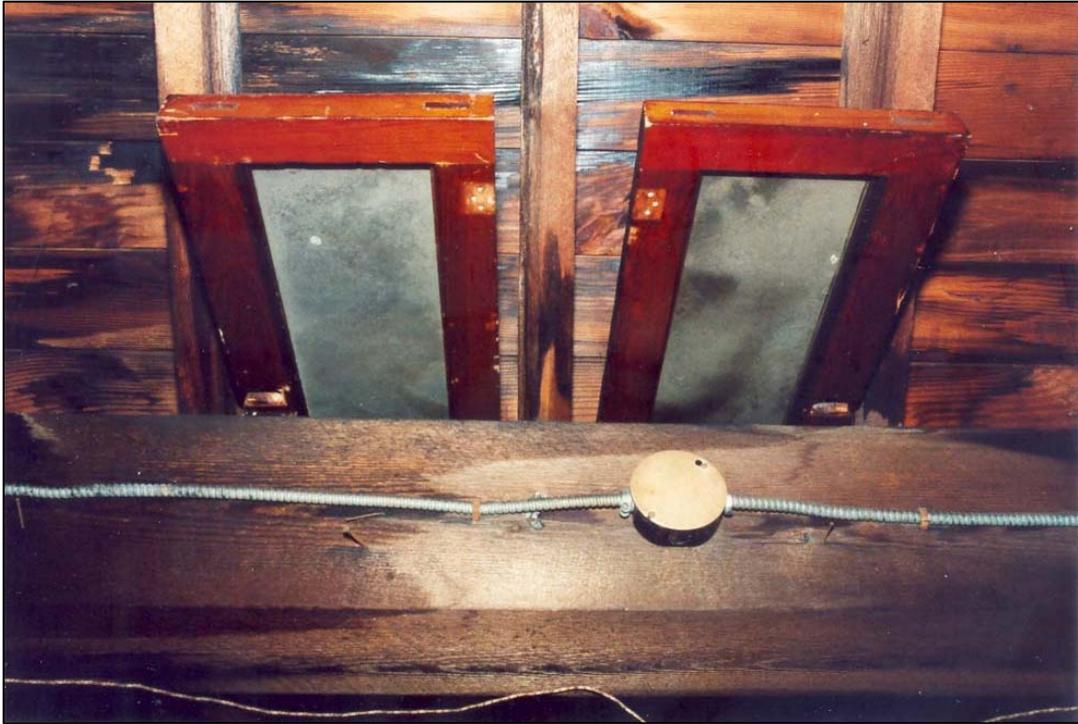
Figure 80. Pantry cupboard doors stored in south side of attic.

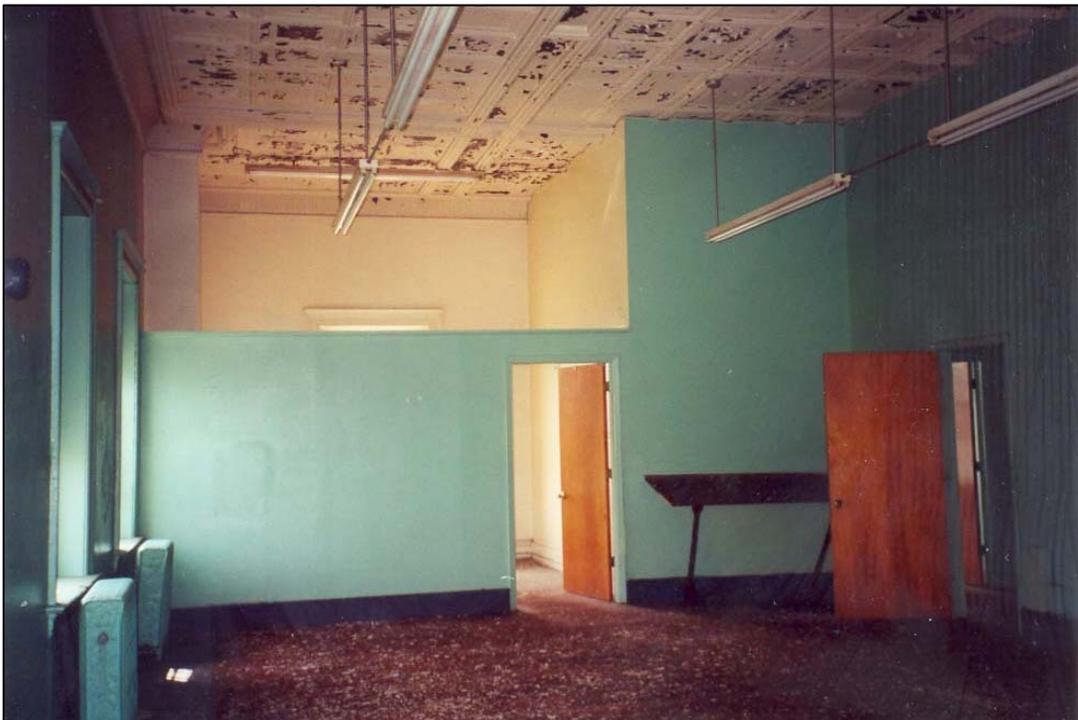
Figure 81. South dormitory, showing 1964 partitions.

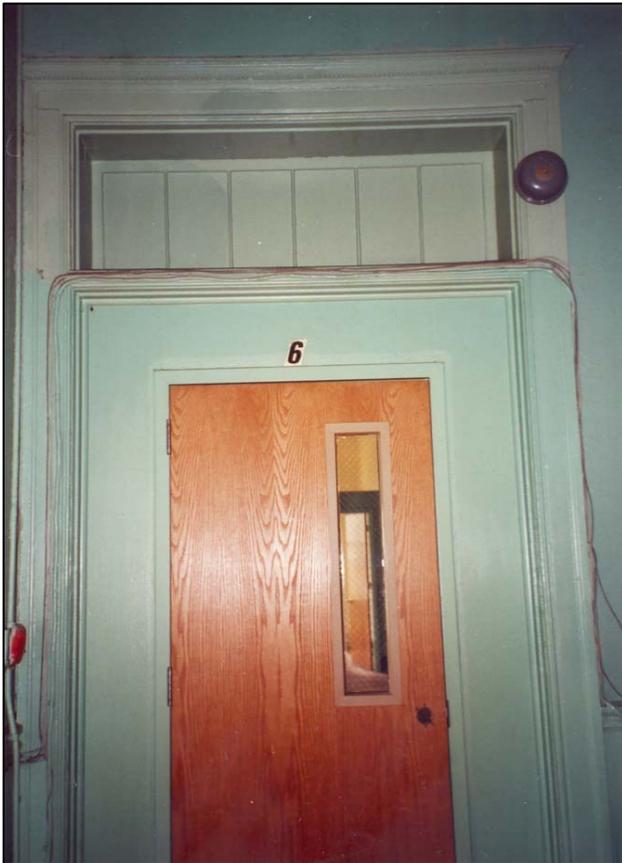
Figure 82. Doorway from center hall to south dormitory, showing perimeter infill with replacement door and painted transom.

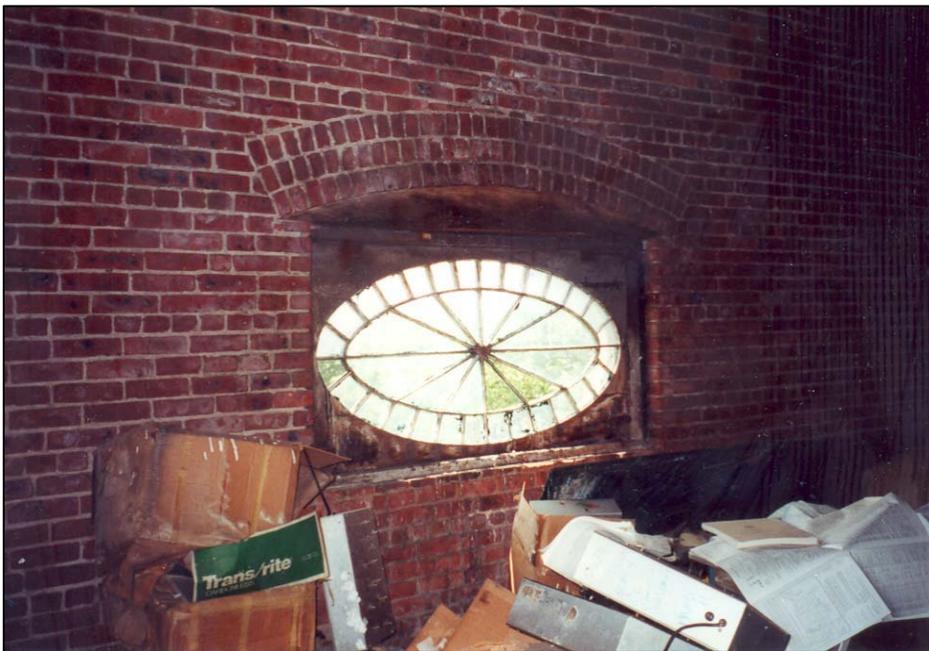
Illumination is provided by bare light bulbs screwed into sockets attached to the exposed electrical lines. These supplement the natural light obtained from the gable oculi (fig. 83).

Figure 83. South side of attic, south wall, showing interior construction of opening for oculus.
