Slope Map and Locations of Irrigation-induced Landslides and Seepage Areas, Hagerman Fossil Beds National Monument, Idaho

by
Alan Chleborad and Philip Powers

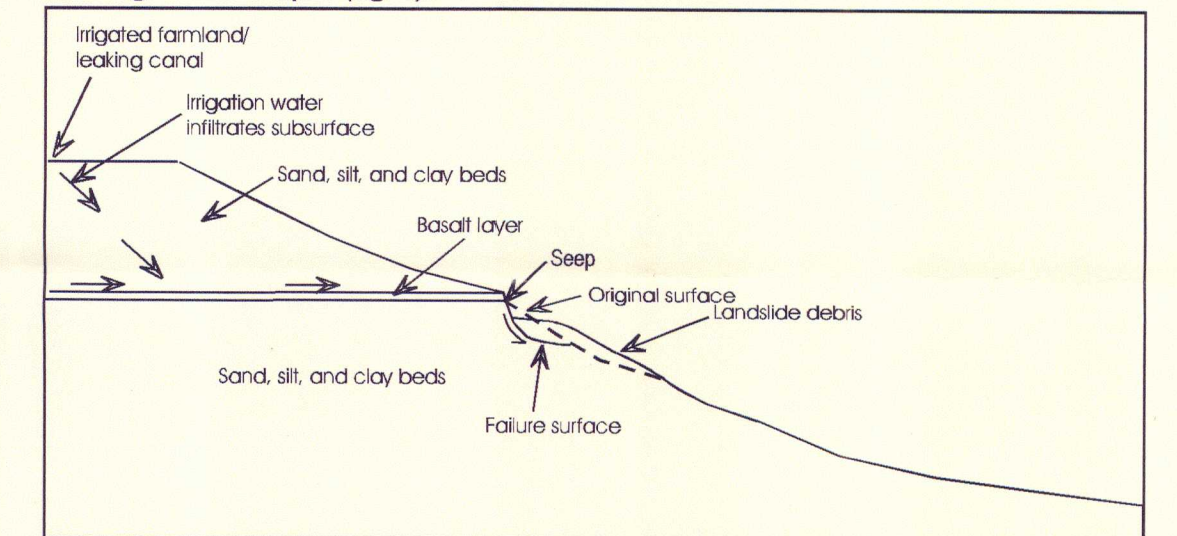
Previous observations indicate that the slope movements are directly related to irrigation water that has seeped from the canals located on agricultural lands above the bluffs (Young, 1984; Riedel, 1992). The canal seepage travels downward in the subsurface to a perched aquifer and then flows laterally to the bluff face where it forms seeps that wet or saturate large volumes of sediments at and below the points of discharge on the slopes (fig. 1).

Figure 1. Generalized bluff profile depicting the 1991 Fossil Gulch area landslide and conditions that led to the failure.

The seepage and resulting addition of water to previously dry or unsaturated sediments promotes slope instability and landsliding in two principal ways: 1) by reducing the shear strength of the sediments that support the slope, and 2) by increasing the overall driving force that tends to cause failure. The driving force may be increased by the added water weight and possibly by seepage forces caused by flow of water through the sediments. Shear strength may be reduced by increased pore-water pressure and by the destruction of bonds or cementing agents that bind the soil particles. Slope steepness is an additional important factor that controls slope stability. Other factors being equal, the steepest slopes are the most susceptible to failure.
