Geologic Analysis of Rock Deterioration
At Selected National Park Service
Archeological Sites :

ROCK MOTION HAZARD

ROCK DETERIORATION REPORT A

June, 1978

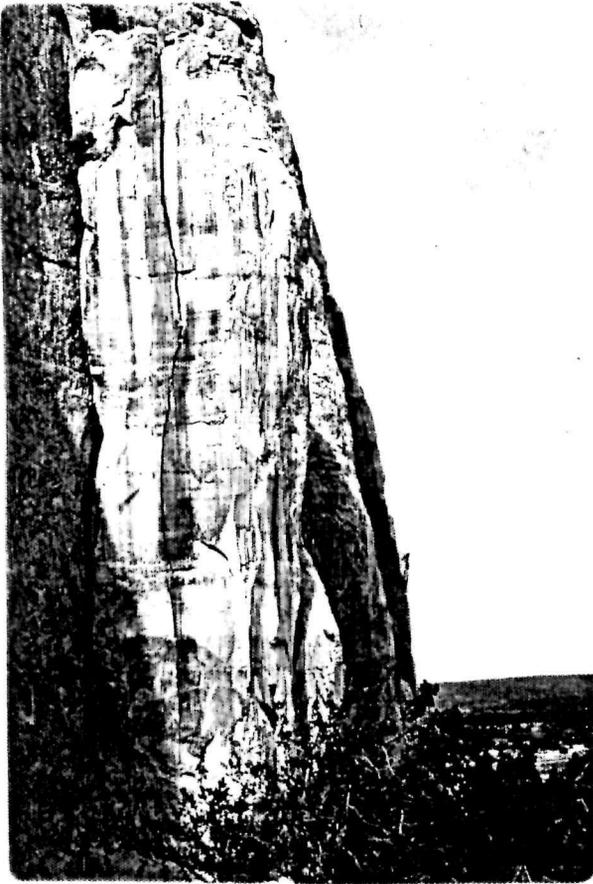
Figure 6 shows a monolith of large size in motion on the southeast face of Inscription Rock. The obvious fracture is not of immediate concern, as its weather-rounded edges and mineral staining on the fracture surface suggest recent stability. The less obvious crack shows current motion by sharp edges, lack of patina, and delicate hair-line crack propagation downward (through a historic inscription) (Figure 7).

The abrupt "horsetailing" or dendritic propagation appears to indicate that this monolith has begun moving on the ultimate pivot point and the present phase of motion could be terminal. The nature of motion is not dependent on failure, plastic flow, or glide on incompetent underlayers. Failure is within the rock itself. Immediate monitoring is suggested.

Figure 6. Monolith in motion, El Morro, southeast face of Inscription Rock. The well weathered joint (rounded edges) that separates the monolith from the cliff does not appear to be active. The vertical crack down the center of the monolith, though rounded by weathering near the top, is sharp-edged and unweathered in its lower portion.

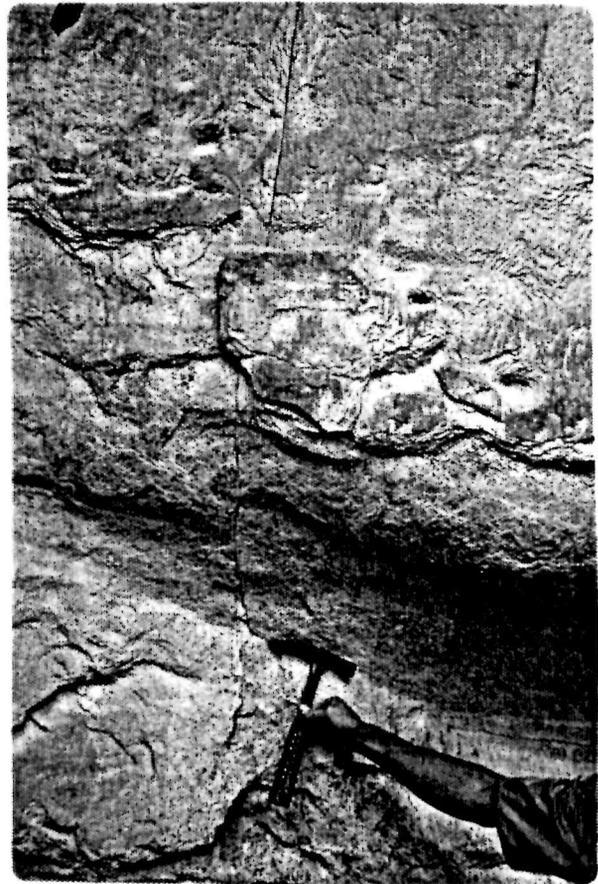
Figure 7. Lower portion of active crack shown in Figure 6. The crack "horsetails" at this point, i.e., becomes dendritic with multiple hairline traces extending 0.3 to 0.6 meters below the rock pick.

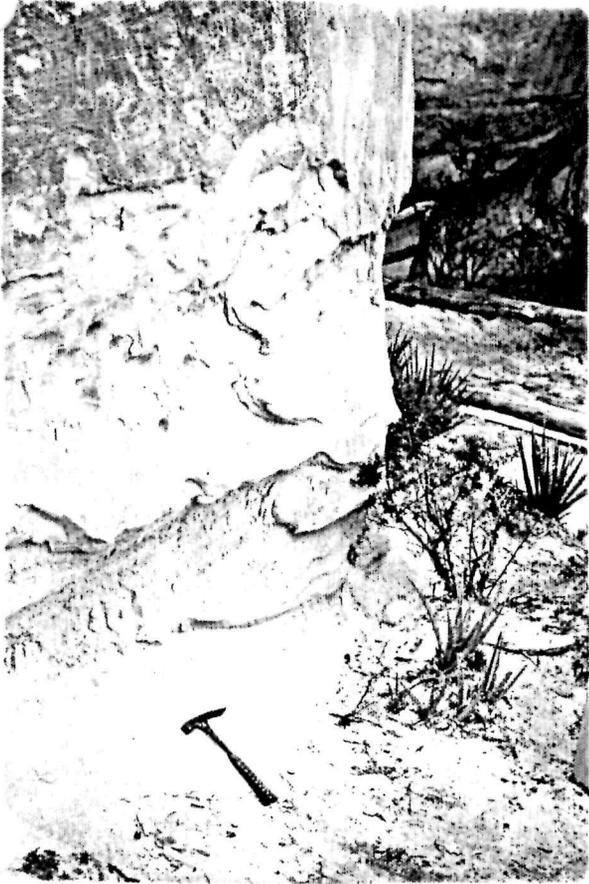
Other instances of rock fall or slabbing are inevitable due to the undercutting of the cliff by the cove-like rock-weathering/erosion near present ground level. Slabbing poses a minor hazard to people and is presently threatening inscriptions and pictoglyphs above the undermined zone (Figure 8). At least one other joint block monolith along the southeast face shows potential for movement. Vertical cliffs such as that above and northeast of the pool should be examined periodically for small slabs that could detach and fall or bounce to the trail immediately below.

Figure 8. Intense deterioration at ground level undermines cliff face making slabbing or collapse inevitable. (Southeast face of Inscription Rock, El Morro, below E. Pen Long inscription) Here no immediate threat exists to people but petroglyphs and historic inscriptions are slabbing away. Note petroglyphs on the original red-stained face.

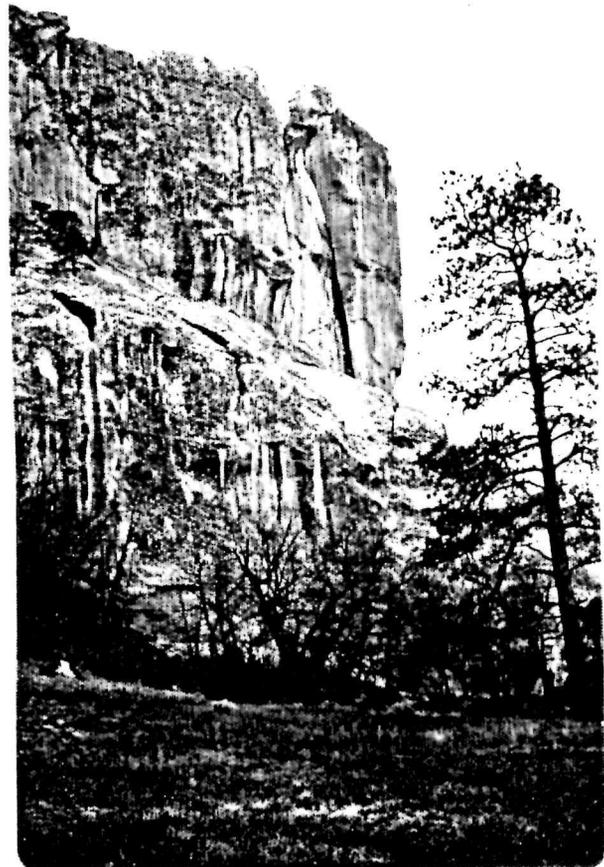
Figure 9 looks southwest from the walkway along the northwest side of Inscription Rock. The precarious looking monolith on the skyline does not show definite signs of current motion, but the large mass (100

Figure 9. Large monolith entirely separated from northwest face of Inscription Rock (El Morro). Apparently not in motion presently, it rests on a small pedestal of deteriorated sandstone. Motion could be instantaneous. Triggering by seismic vibration is possible.

to 1000 ton range) rests on a small pedestal of deteriorated rock. The possibility exists of sudden fall with little previous motion. It is subject to seismic shock.

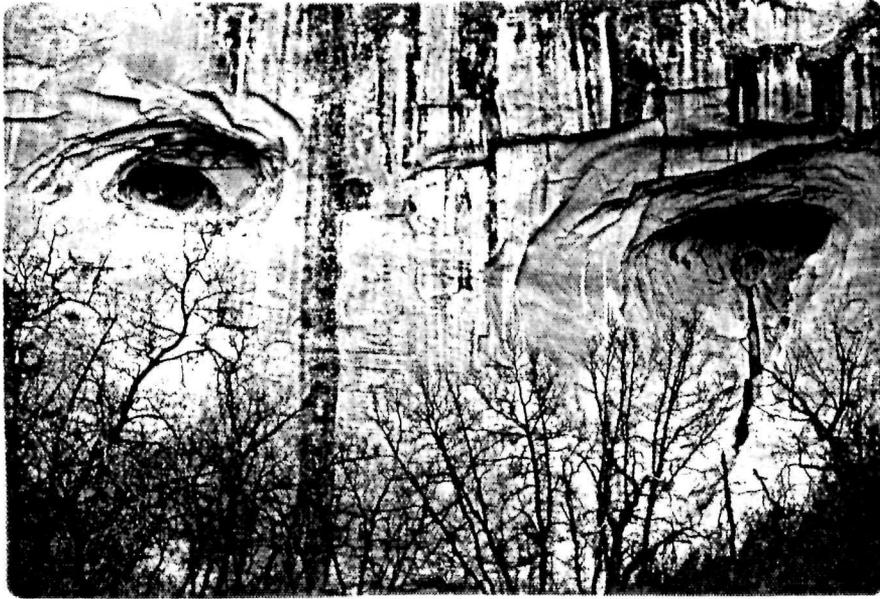
Alcove formation is underway at the two centers shown in Figure 10. Moisture is evident on most of the slab faces one week after a 10" spring snowfall and freeze-thaw no doubt contributes to periodic rock fall from the enlarging alcoves. Danger is slight as trails do not pass near.

Figure 10. Active alcove formation on northwest face of Inscription Rock (El Morro). Note moisture on slab faces (gray coloration). Rock falls must occur frequently.

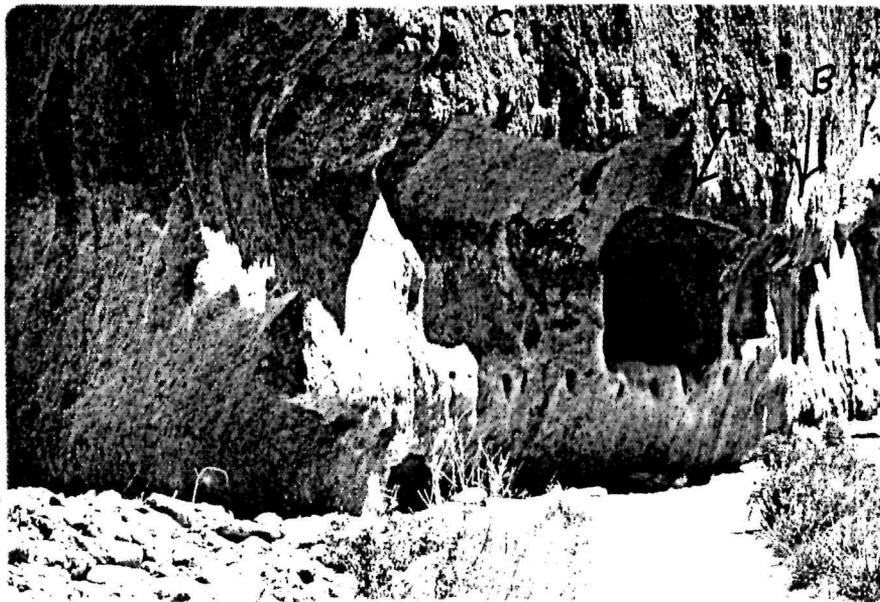
Figure 11 shows base coving at the cliff base and instability over an artificial opening. A small (10 kg) overhead block is loosened by crack propagation and is ready to fall. It should be removed or

Figure 11. Western-most cliff room at Longhouse, Bandelier. Active motion around the artificial opening: A. 10 kg-scale block ready to fall on visitor path. B. 500 kg-scale block defined by freshly propagating cracks. C. 100 kg-scale block. Note fresh diagonal faces above-left of room indicating post-habitation rock fall. Base-coving is evident.

pinned immediately, considering heavy visitor traffic here. A one-half ton slab is in motion and cracks are propagating around it at the upper right of the opening (Figure 11); fall is probably not imminent, but monitoring would be advisable and interesting. A 100 kg-scale block is in motion 3 feet above and to the left of the room opening. This situation typifies small-scale instabilities in the Longhouse cliff.

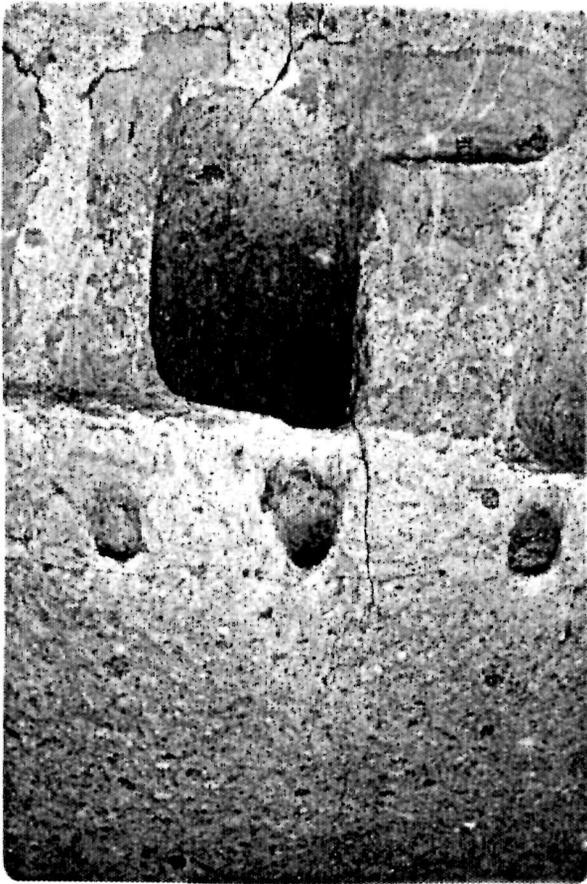
Larger-scale hazards are forming in the central Longhouse area (Figure 12). Hairline cracks in plaster indicate significant motion of 1000 ton magnitude monoliths. Branching pattern of cracks may indicate a maturing of the motion to terminal phase. Figures 13 and 14 show similar motion of other large monoliths in the same area as Figure 12. The leaning slab in the background is the late 1960's fall. It would appear expedient to monitor several of these cracks beginning as soon as possible.

Figure 12. Hairline branching cracks in plaster, central Longhouse area, Bandelier. Cracked plaster indicates post-habitation motion of 1000 ton-scale monolith. Dendritic (branching) pattern suggests that monolith is pivoting on the area of instability, created by rooms, vents, and niches.

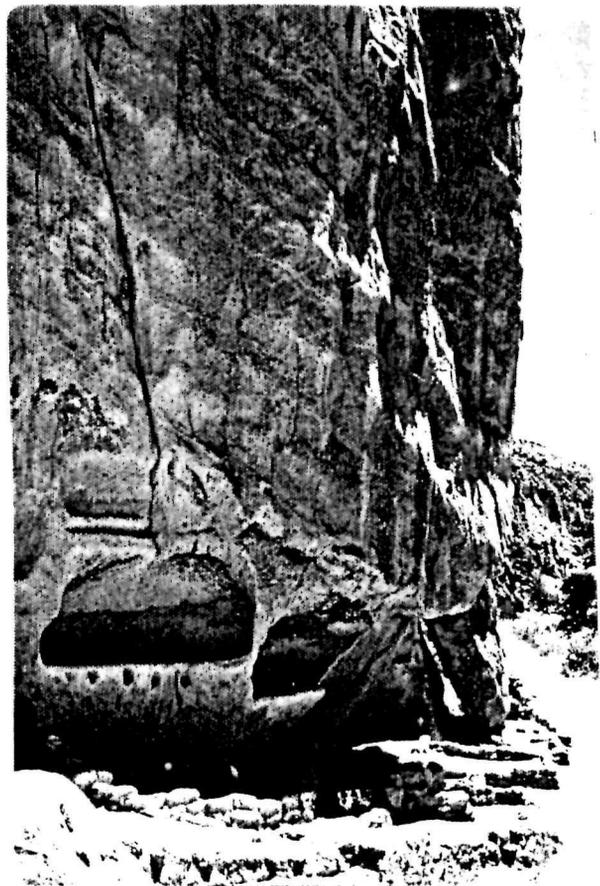
Figure 13. Central Longhouse area, Bandelier. Old crack left of center shows recent motion (cracked plaster). Many other fresh cracks indicate extreme instability and present motion in this area of closely-spaced rooms and deep undermining of cliff.

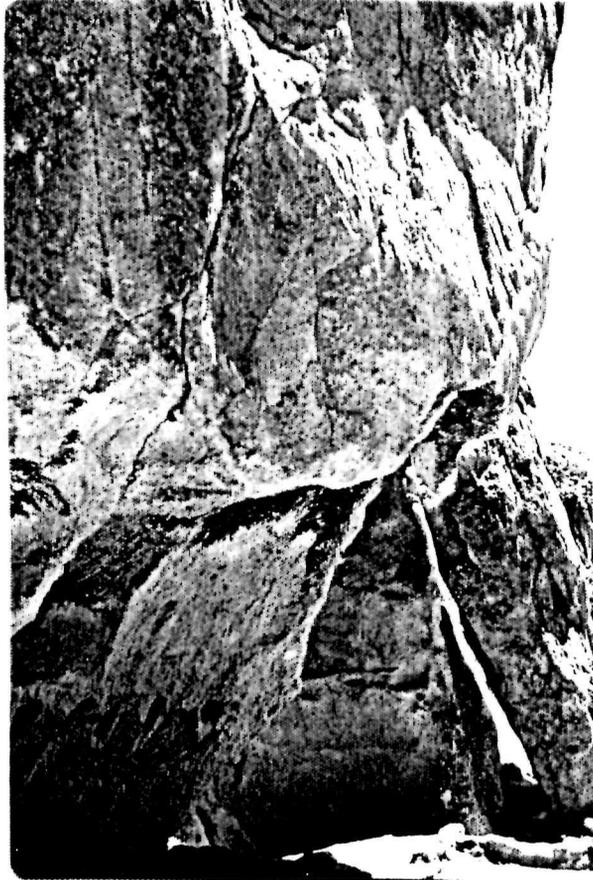
Figure 14. Overhang portion of Figure 13. Branching cracks on large and small scales. Area is travelled by visitors. Large leaning monolith in background in 1960's fall.

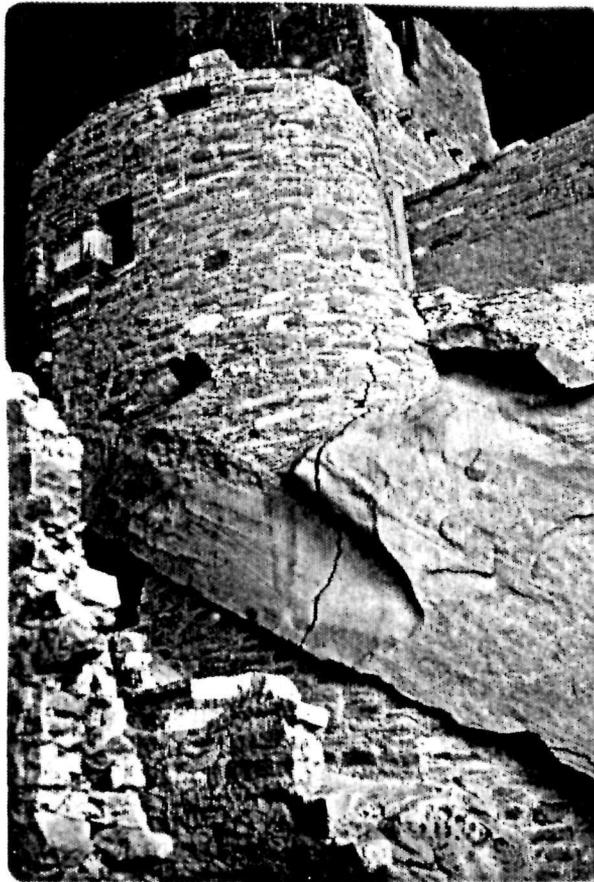
Cliff Palace itself has been in motion due to large-scale creep of the talus slope on which it is built. Figure 15 is of a crack extending through a talus block and masonry. This is but one of dozens of crack systems in talus and masonry that show instability throughout Cliff Palace. Stabilization attempts, including a successful drainage tunnel

Figure 15. Cliff Palace, Mesa Verde. Post-habitation crack in talus block and masonry due to creep of slope material. Motion may have been stopped or slowed by drainage and stabilization, but is likely to reoccur or accelerate.

below, seem to have stopped or slowed motion. Acceleration with time or increase in precipitation is likely. The situation here requires monitoring of changes in location or elevation of points in the ruin and on the slope. Periodic transit levelling as well as monitoring of certain cracks would be possible. Mass motion should be large prior to catastrophic failure (accelerated creep should precede slump or slide).

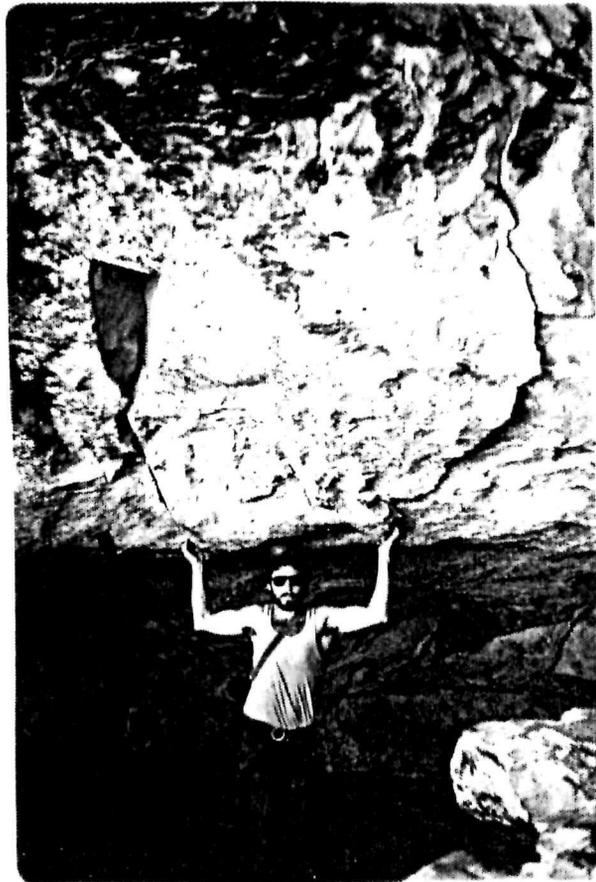
At Balcony House there is a serious problem overhead. A large slab (100 ton magnitude) one to three meters wide and approximately 35 meters long is detaching from the roof of the alcove (Figure 16). The bounding cracks are sharp and fresh, showing centimeters of movement of the sagging slab; much of the movement has occurred since habitation. Where the slab arches near the floor, a small block has been recently dislodged by the movement (Figure 16). The ruin is open to visitors and pathways pass beneath the slab. A large part of the ruin is threatened by this developing fall. Sudden fall with little additional motion is a possibility--this is a case for immediate engineering attention, not just monitoring.

Figure 16. Lower portion of a long arched slab detaching from alcove roof above Balcony House, Mesa Verde. Recent movement is evidenced by offset, broken smoke crust and recent dislodgement of the small block (cavity above Jay's right hand).

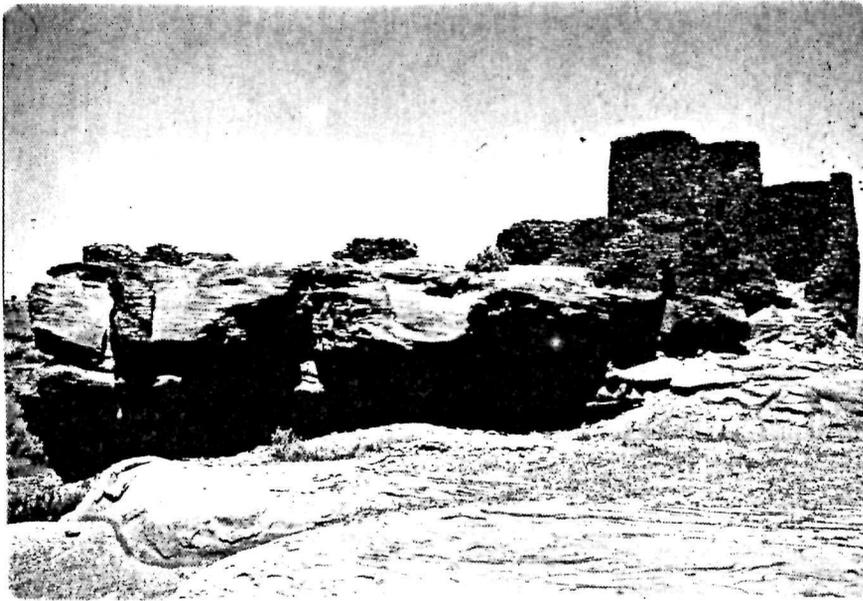
Many of the ruins are built on outcrop pedestal or small bluffs such as Wukoki Ruin (Figure 17). There alternating soft massive sandstone and harder layered sandstone alternate with some softer shale beds included. The soft sandstones or shales cove moderately to severely at the base leaving slabs of the hard layered rock suspended and unstable. Some movement is evident in a 1000 kg scale slab and smaller crack-bounded layer segments. The fall area is accessible to visitors.

Figure 17. Wukoki Ruin, Wupatki, built on outcrop pedestal of Moenkopi Sandstone. Rock motion is evident on the opposite side of the pedestal (180° from photo view) in overhanging slabs.

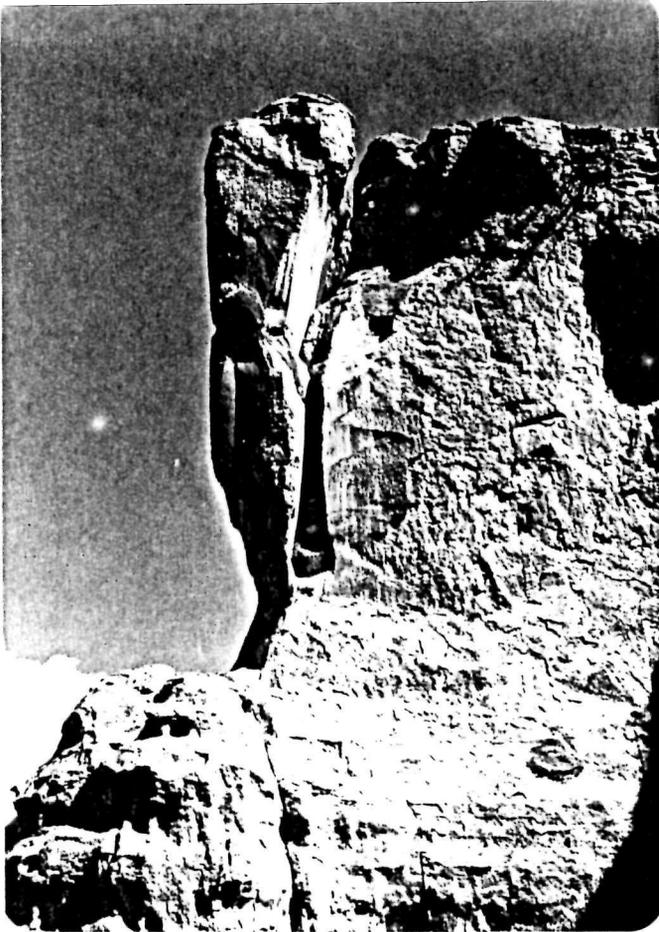
A climb to the base of Woodpecker Rock proved conditions to be as precarious as suggested by earlier distant view. The small base pedestal is weather-deteriorating and old diagonal fractures provide further weakness (Figure 3A). Surprisingly, no actual motion (new cracks or strain slabbing) can be seen.

Figure 3A. Base of Woodpecker rock is softened by weathering. Fall is "geologically imminent" but no actual motion is apparent with which to predict timing. El Morro.

Woodpecker Rock must be considered an immediate threat to the present trail alignment below. The situation does not lend itself to instrumental monitoring--failure could be total and without warning.

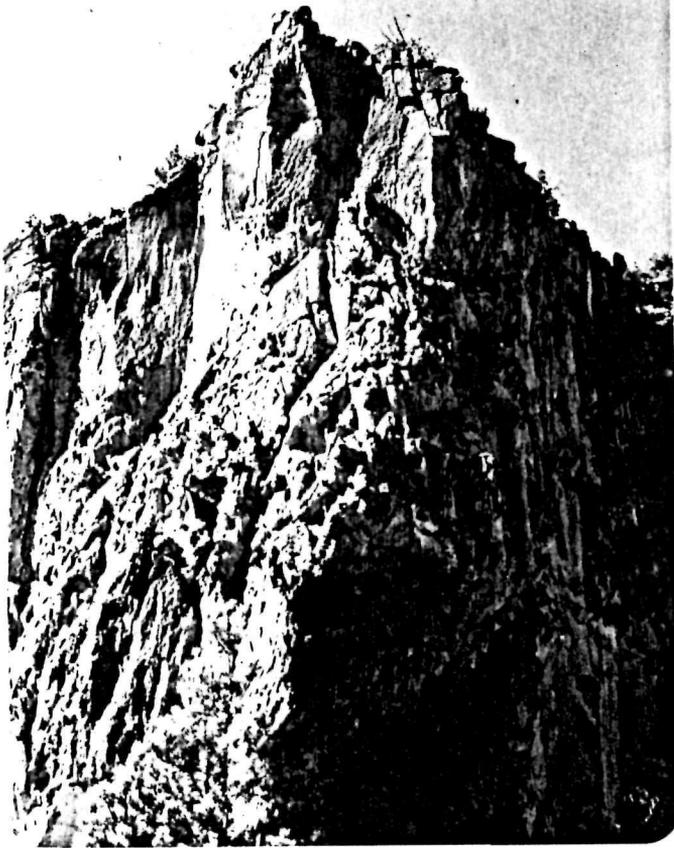
Figure 5A. Detached, perched blocks exist right and left of the peak. Cliff-point above east end of Long-house, Bandelier.

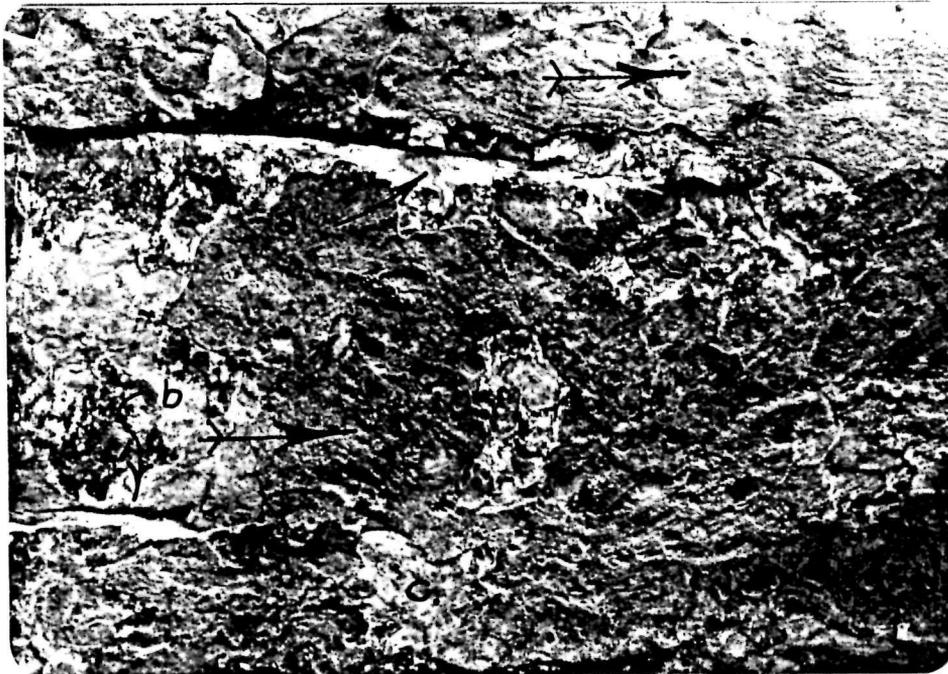
Figure 6A. Balcony House, Mesa Verde. Ceiling of alcove, taken from floor of central kiva. Crack systems of the arched ceiling slab are propagating in the direction of the arrows. Fragments have fallen from "a" and "b". In area "c" strain is shown by surface flaking. Photo documents present status of cracks.

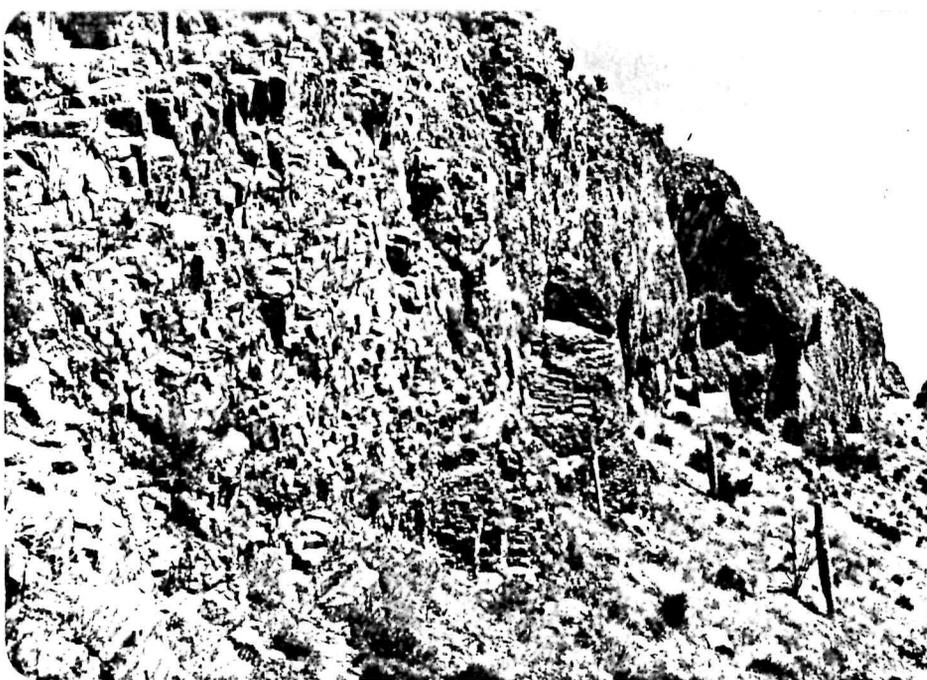
Figure 1. Tonto. Fractured quartzite above trail (seen in right foreground) grades to massive, carbonate-cemented phase (right midground). Trail to Upper Ruin.

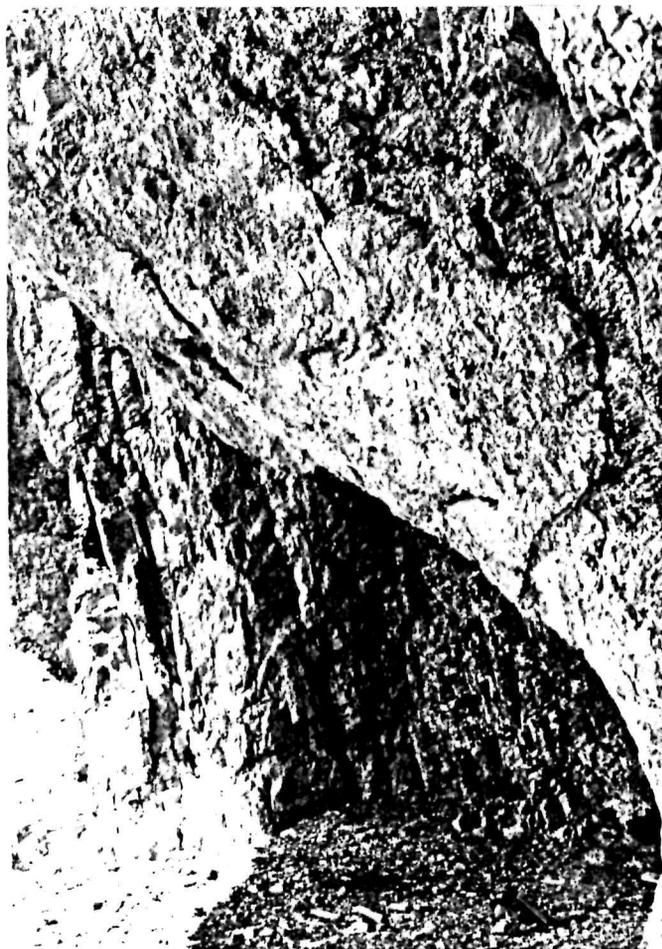
Figure 2. Tonto. Distinct slabbing processes in alcove 50 m south of Upper Ruin. Despite the threatening appearance, fall is not common from the cemented quartzite breccia.

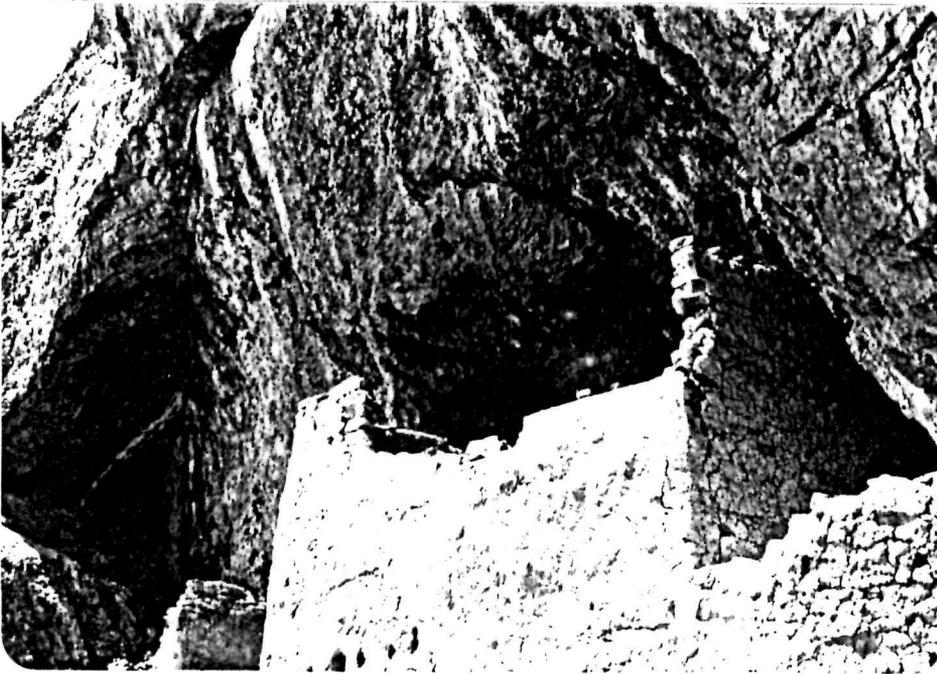
Figure 3. Tonto. Distinct slab above the Upper Ruin. Does not appear to be in motion presently.

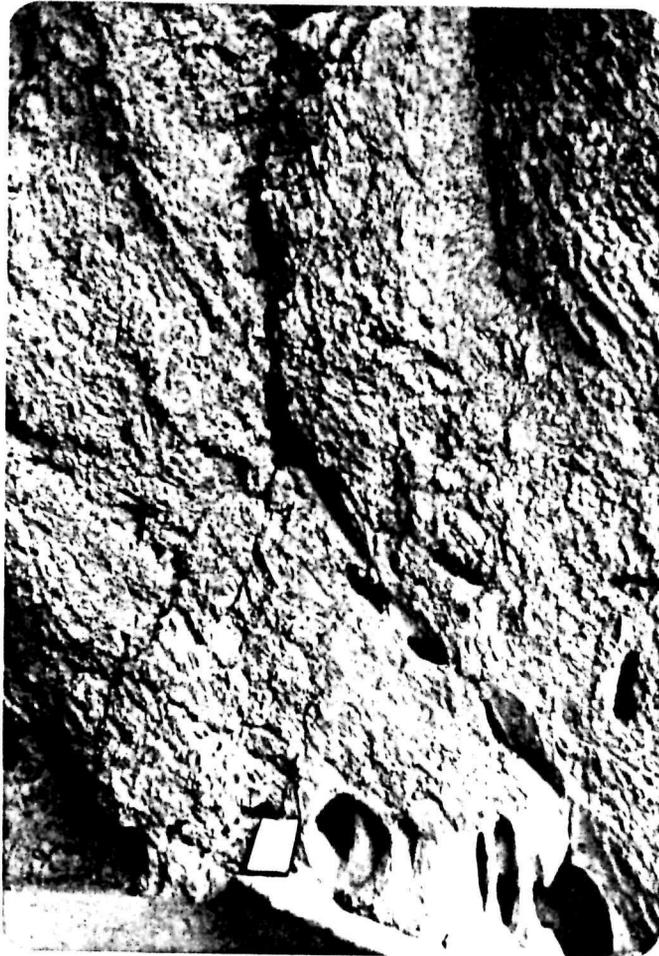
Figure 7. Lower Ruin, Tonto. Reactivating crack systems at north end buttress of Lower Ruin. Large old crack (center, vertical) branches into new hairline cracks above, right, and left of notebook. Other fresh hairline cracks have opened several feet below and to the right out of view. (Looking north from room 7.)

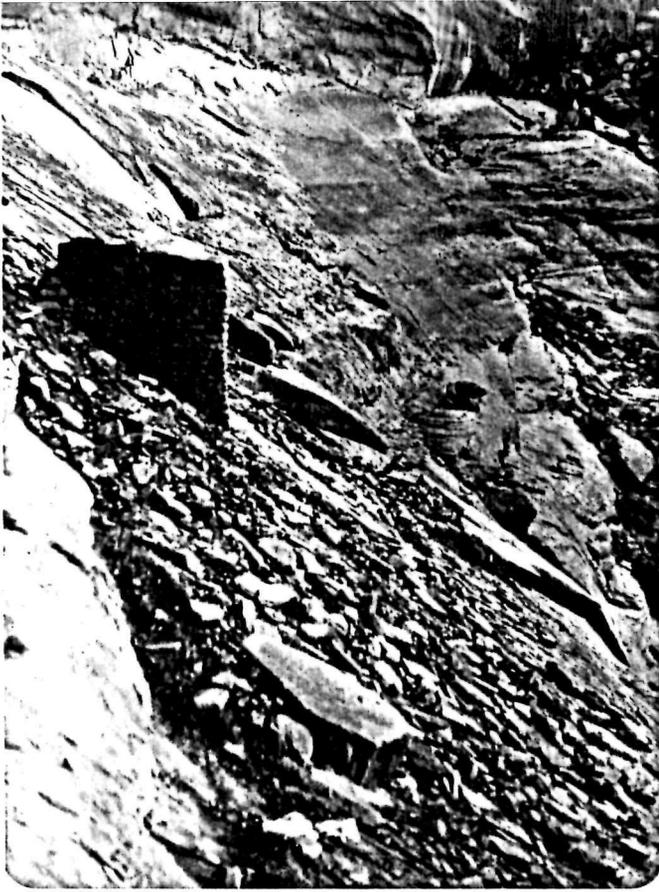
Figure 8. Precarious-looking talus blocks, northeast end of Sliding Rock Ruin, Canyon de Chelly, support small segments of masonry.

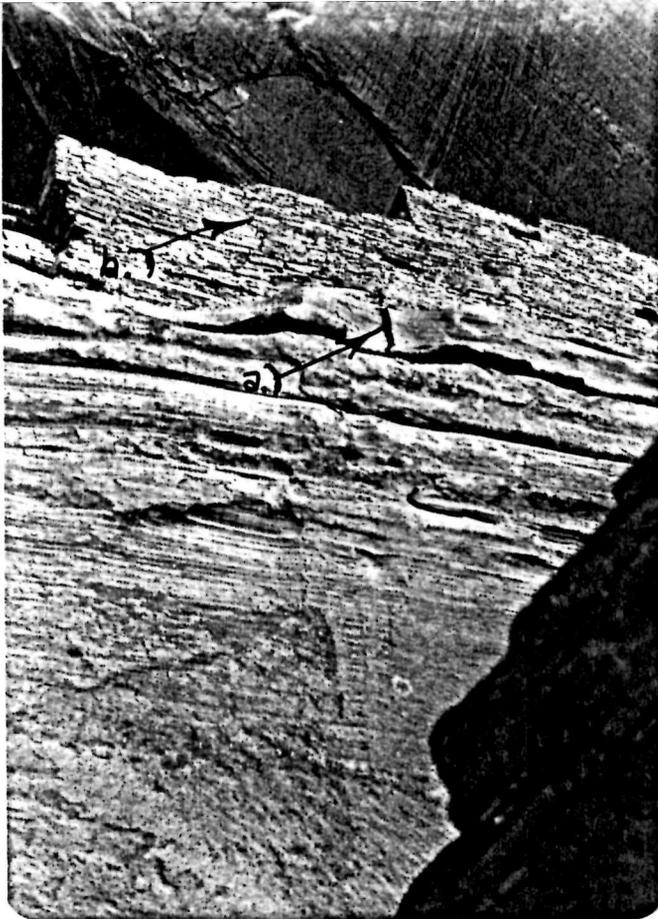
Figure 10. White House Ruin, Canyon de Chelly. Offset at crack (a) shows past motion that may be continuing since habitation. Masonry is cracking above (b).

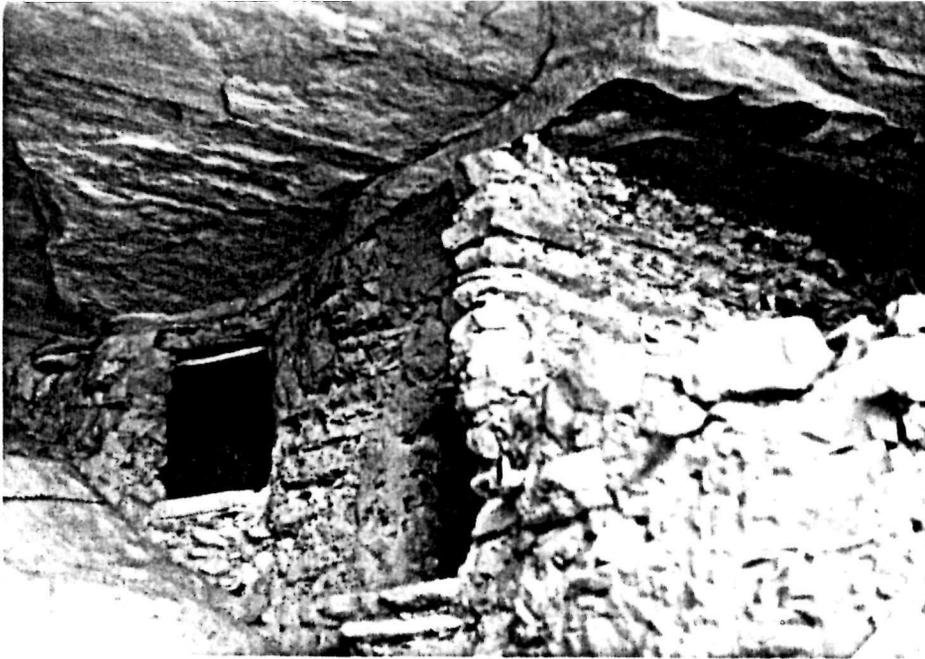
Figure 12. Keet Seel. Recently active ceiling slabbing has temporarily ceased at point of support over the masonry wall. (A large slab-fall has been reported in this area a few weeks after this photo, causing considerable damage to a wall.)

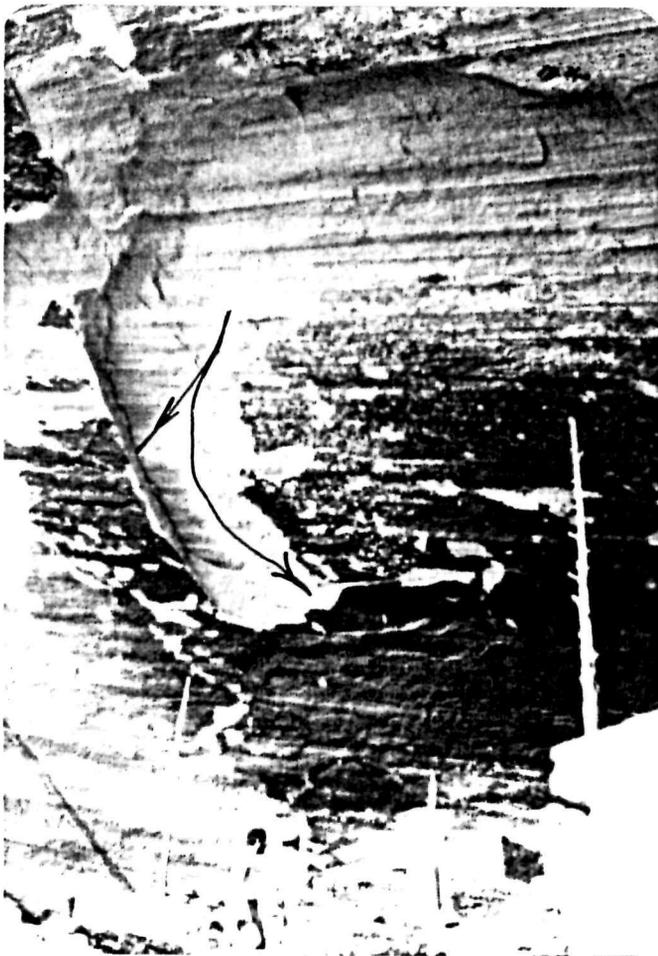
Figure 13. Arch-like zone of progressive slabbing shows clearly the amount of fall since habitation. Keet Seel. (A second rock fall reported by Monument staff may be from this zone.)

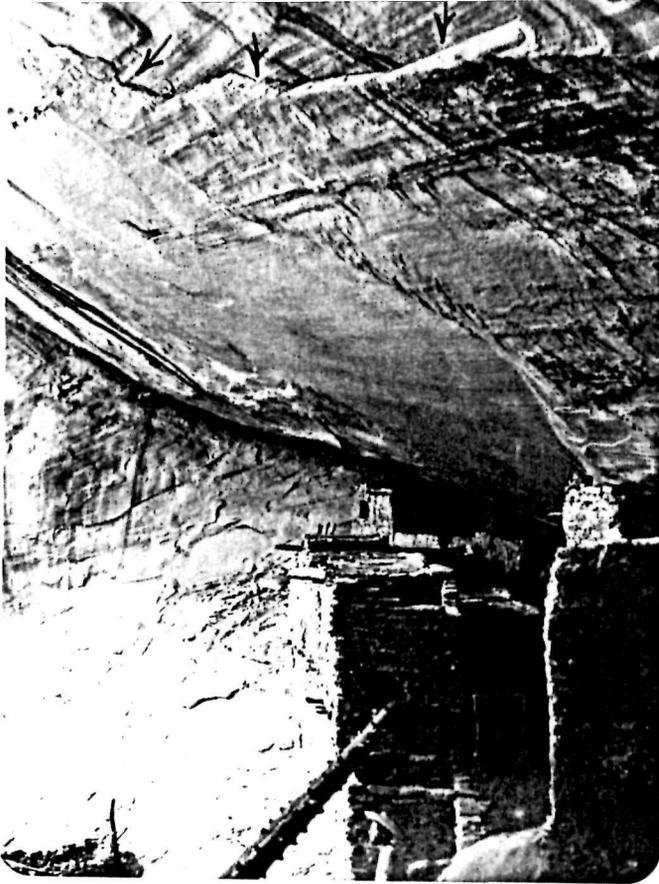
Figure 14. Sheet of rock in motion. Location is inopportune, directly above the visitor access ladder. Note water coursing behind the sheet as indicated by stains. Keet Seel.

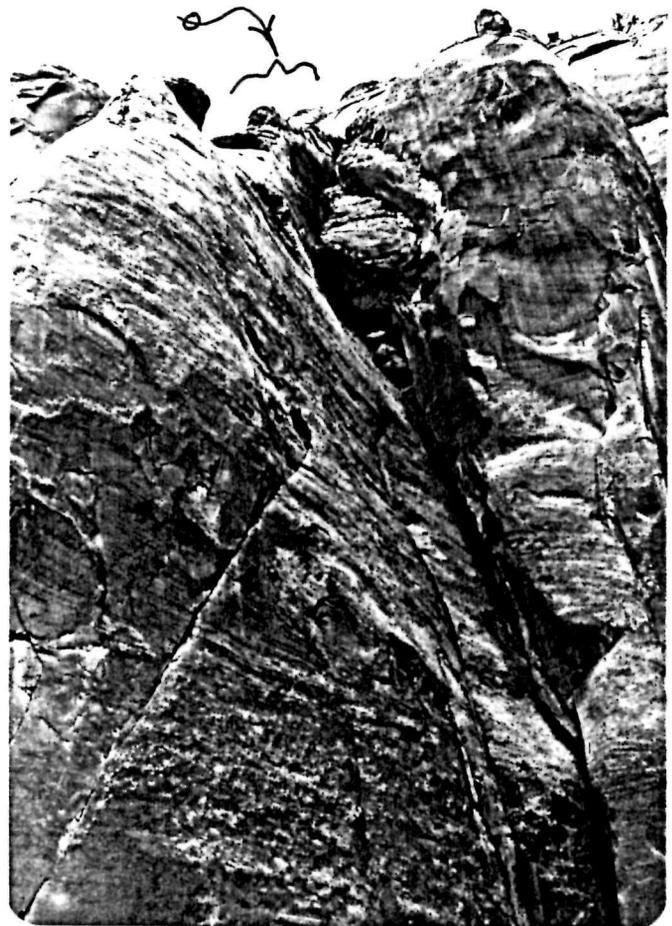
Figure 15. Area of fatal rock fall of 1978. Near Keet Seel campground.

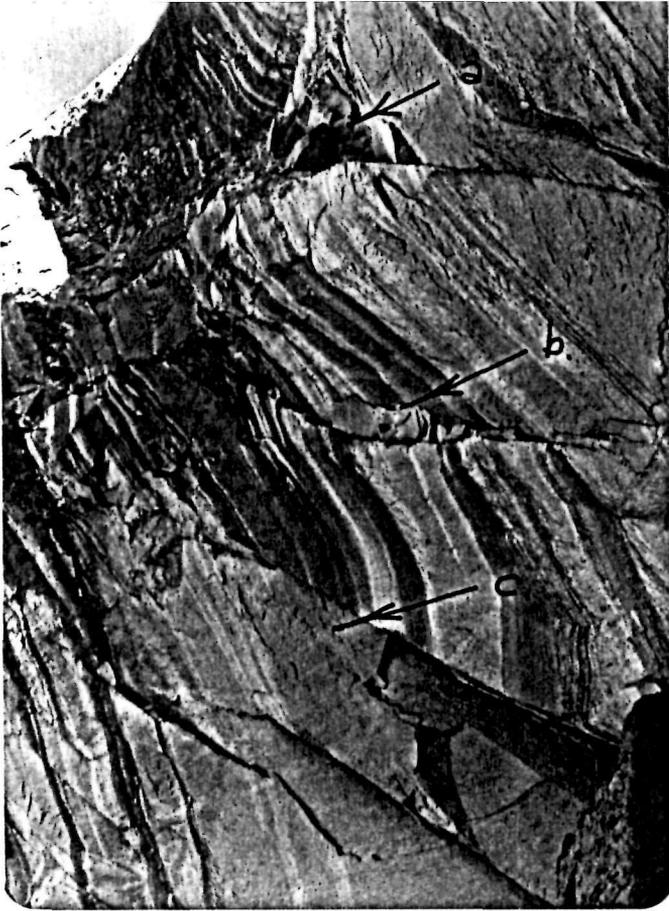
Figure 16. Apparent and real instabilities, Inscription House alcove.

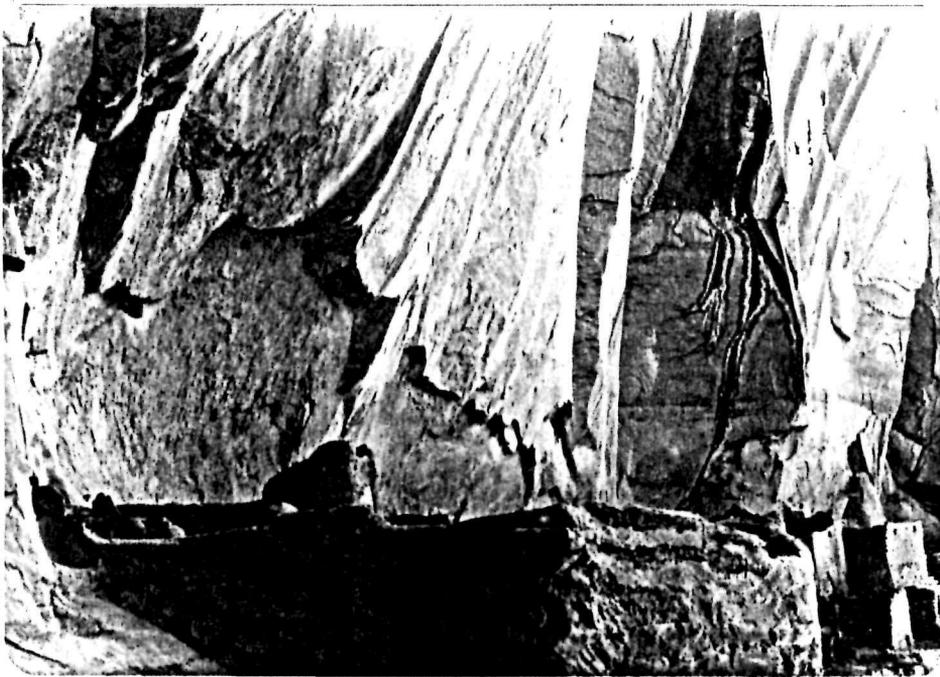
Figure 17. Base sapping across central portion of alcove has contributed to progressive post-habitation instability and rock fall including that of zone (c) in Figure 16.

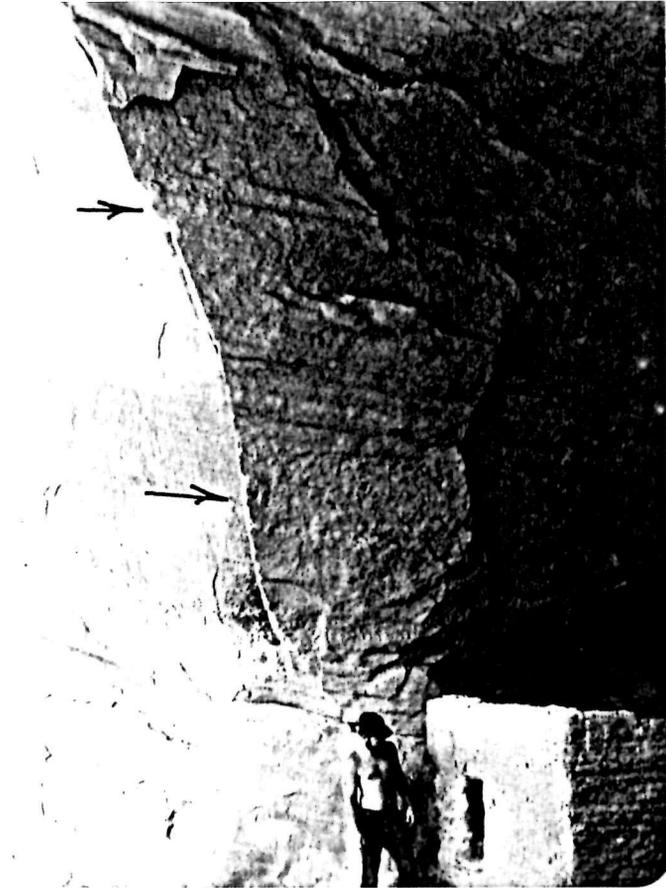
Figure 18. Opening into grotto at end of Inscripted House ruin. Arched side-wall has a detached slab that is in motion.

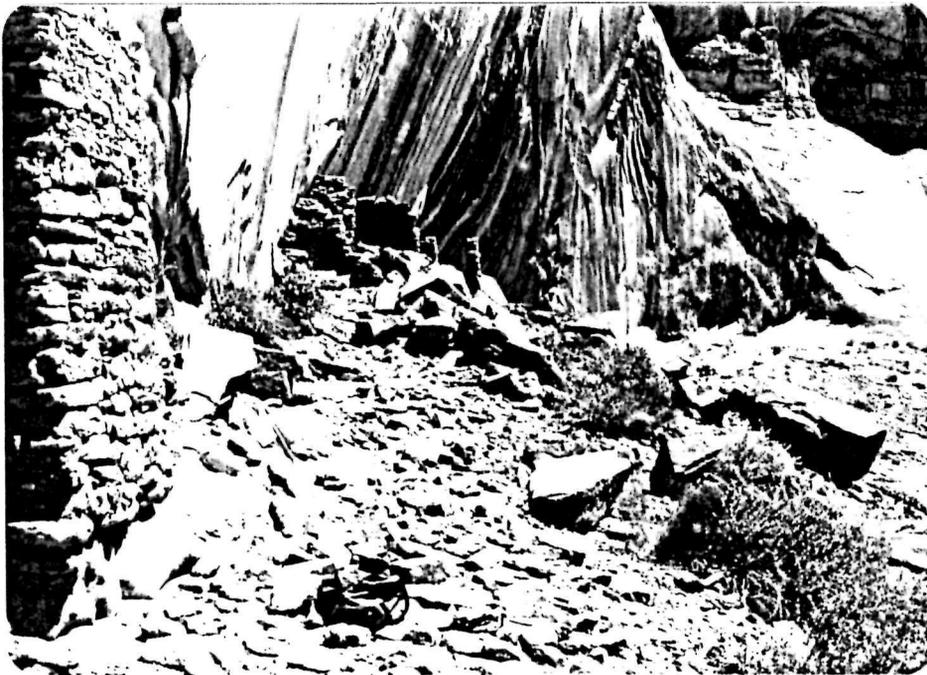
Figure 21. One of several recent falls at Snake House (below (a) of Figure 20).

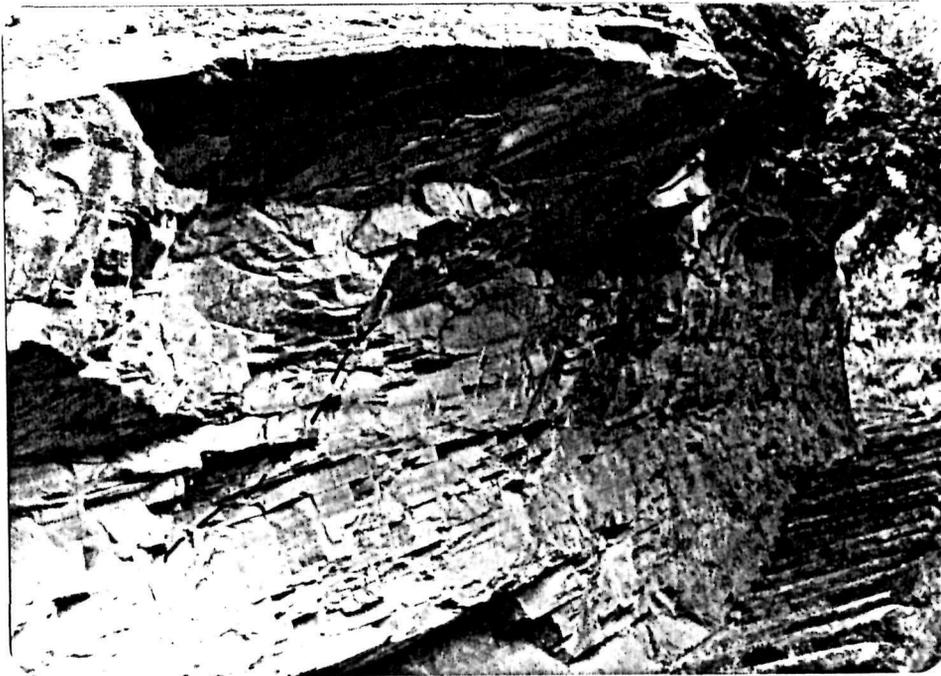
Figure 25. Betatakin Trail, Navajo. Overhang appears to be stable in spite of diagonal fracture (no motion is apparent). Minor block separation has occurred on the lip.

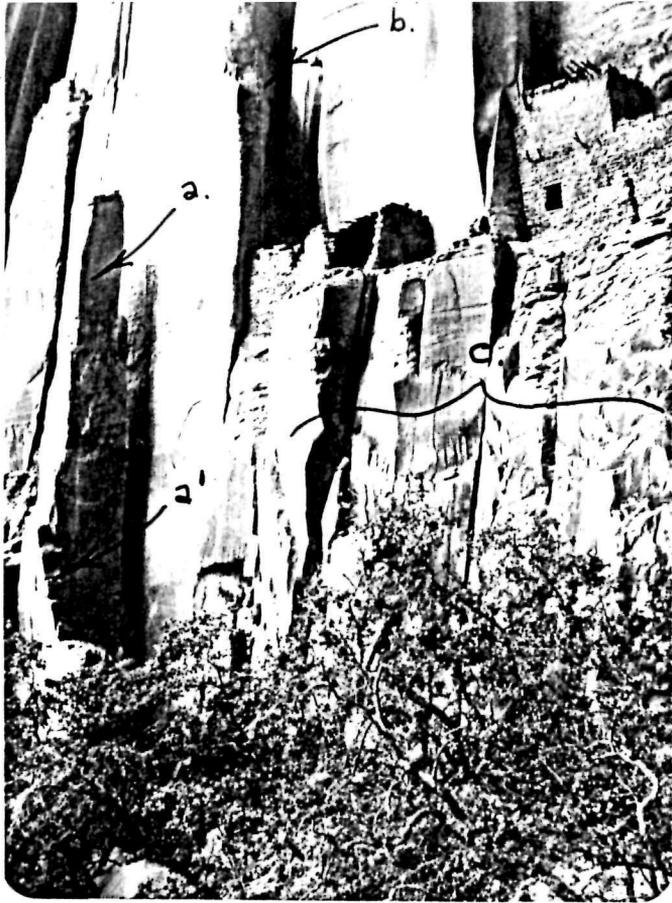
Figure 26. Visitor exit trail passes beneath unstable section at west end of Betatakin (Navajo). See text for explanation.

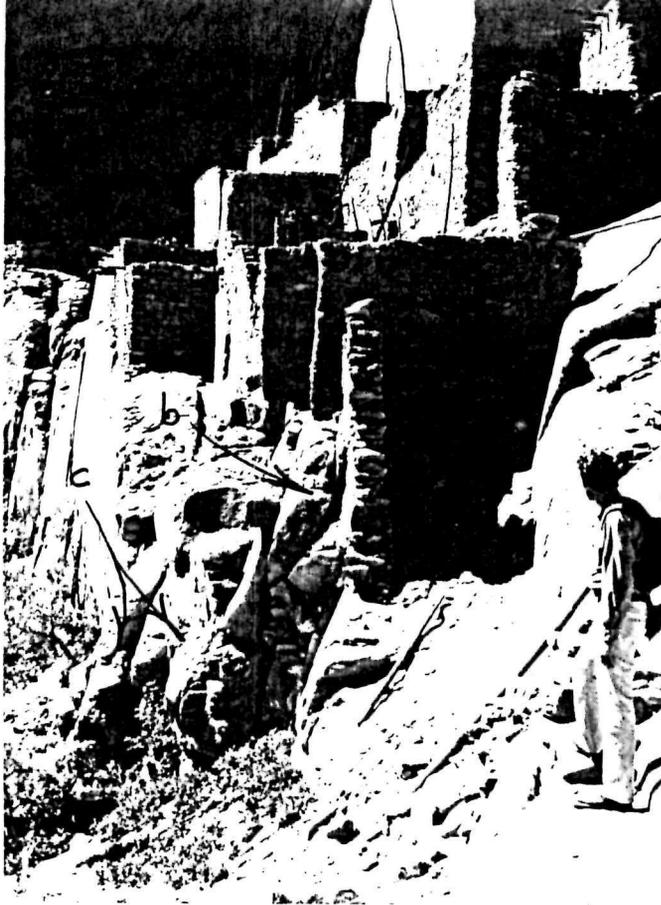
Figure 28. Cracks at "a" due to motion of block "b". Section "c" is settling in the shale. Recent fall debris lies beyond and below. Betatakin.

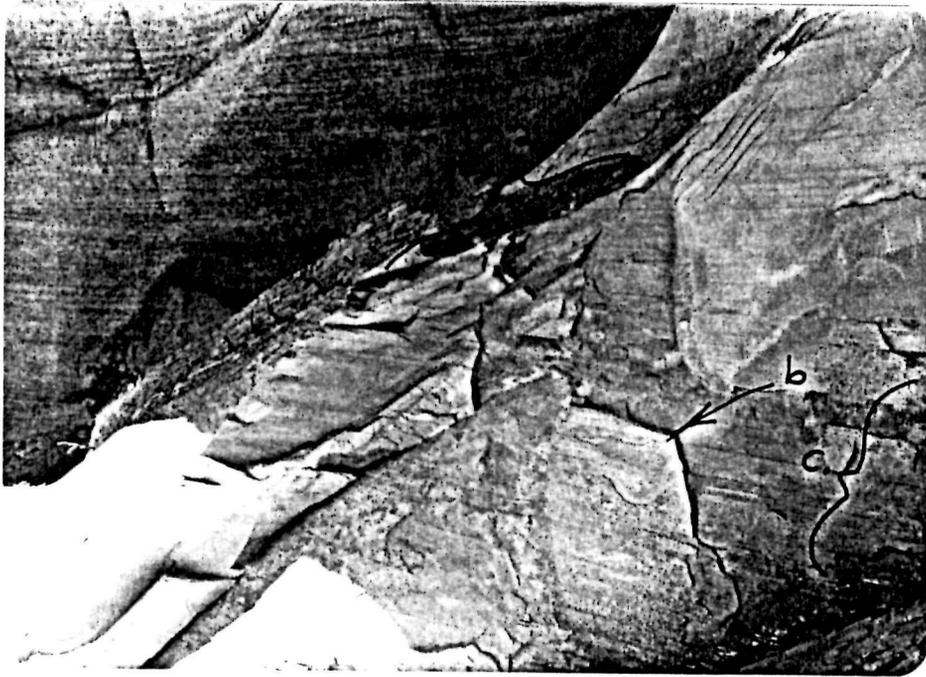
Figure 30. Upper end of "the flake" is working and has caused post-habitation fall (section "a"). Slab "b" is detaching due to moisture deterioration which extends beyond view through section "c".
