Geologic Analysis of Rock Deterioration
At Selected National Park Service
Archeological Sites :

ROCK MOTION HAZARD

ROCK DETERIORATION REPORT A

June, 1978

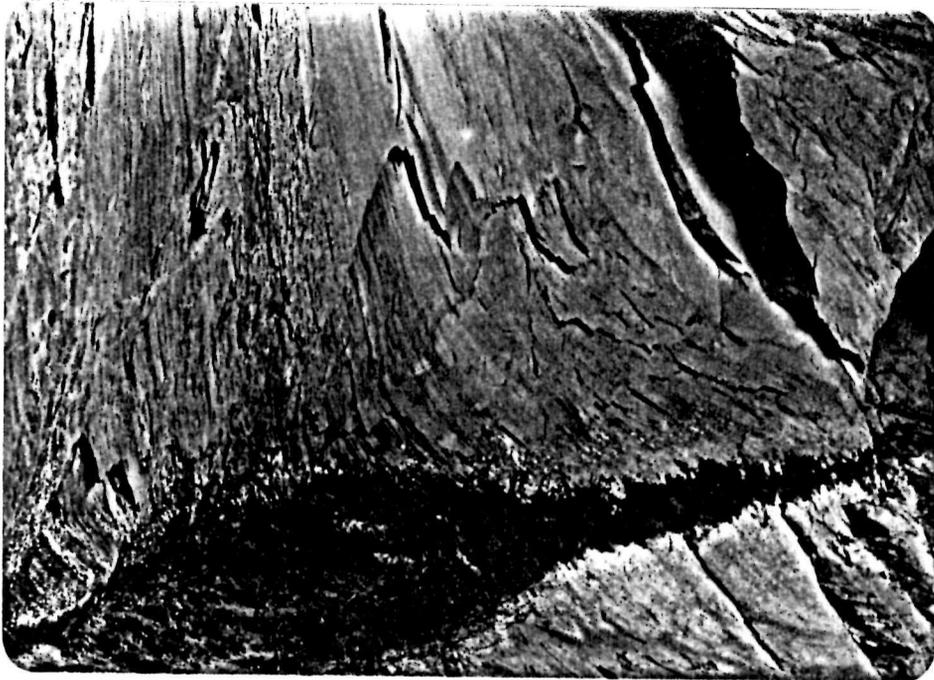
Figure 31. Classic slabbing upward from moist zone, rear of alcove, Betatakin.

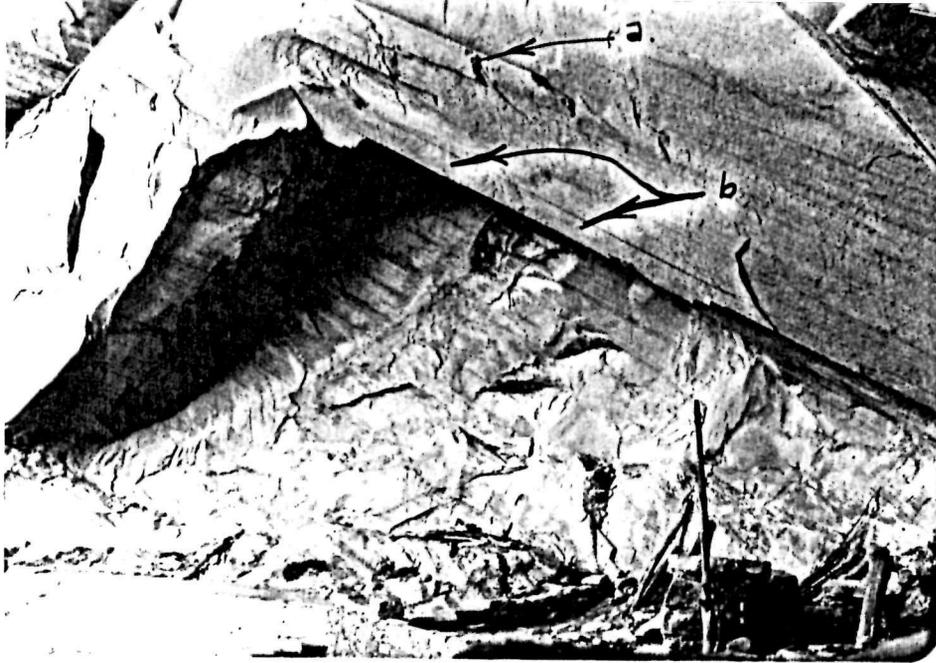
Figure 32. Upper east extremity of Betatakin. Prism-like slab "a" is ready to fall. Sheet "b" is detaching but is unpredictable.

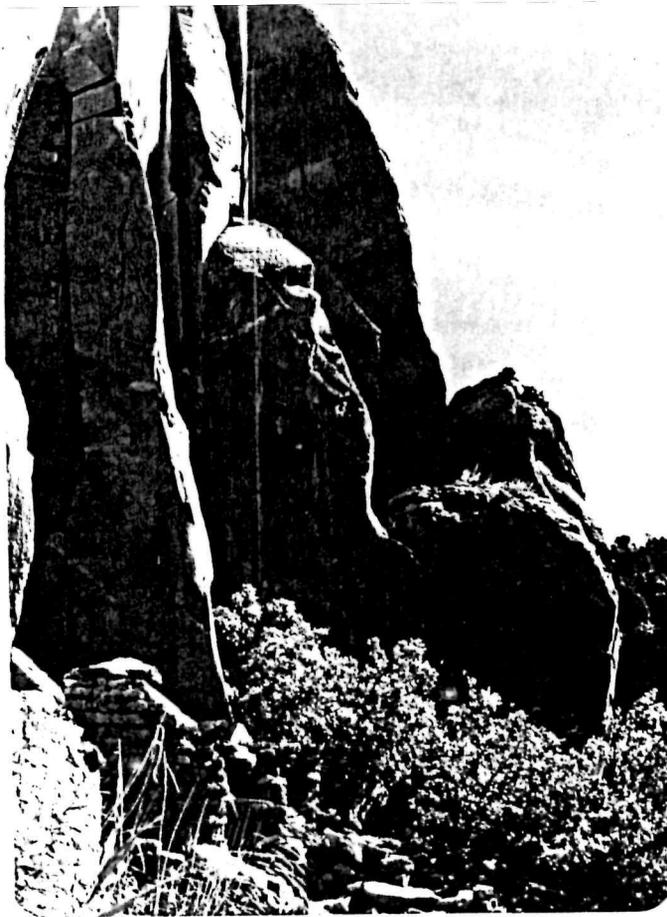
Figure 34. Looking east from Rock Art area, Betatakin. Monolith is in motion with balanced blocks on tip. Instability in recess has caused recent fall onto small ruins.

The inner cliff sections may move downward relative to outer detached monoliths such as in Figure 34. This suggests that the underlying shale may be behaving plastically under load of the massive buttress sections. Detachments settle less rapidly or actually rise if shale wells up under flow.

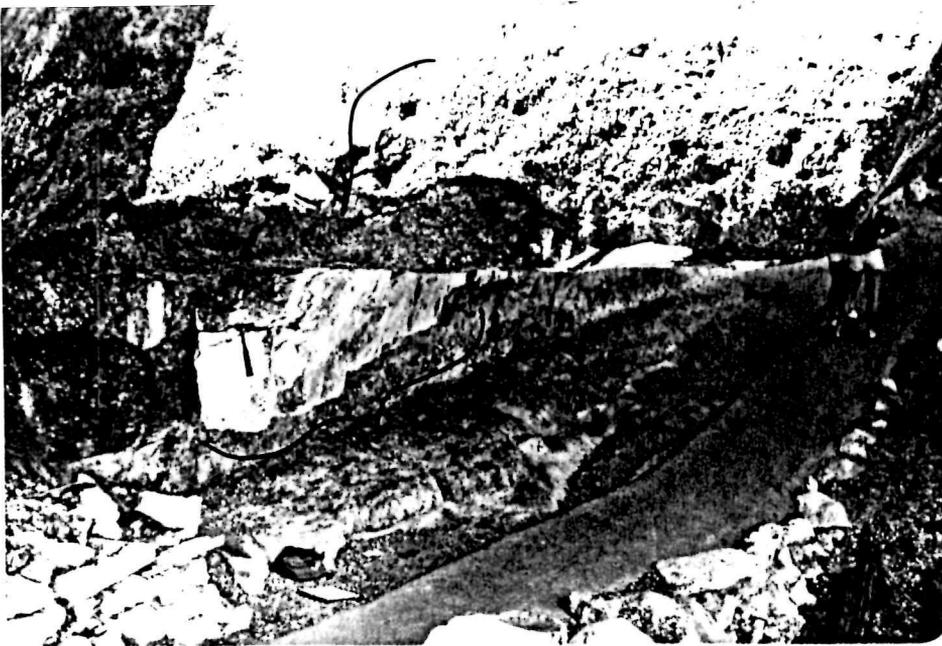
Figure 38. At trail guide point number 6. Overhanging ledge shows strain along hinge point by flaking, slabbing, and discontinuous cracks. Walnut Canyon.

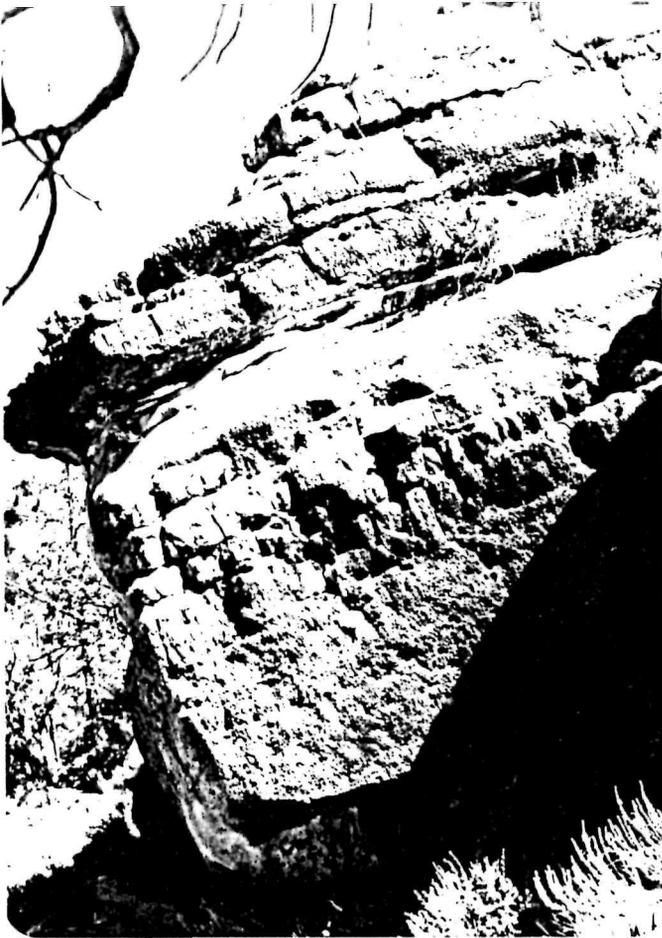
Figure 40. 500-ton scale float block seems to overbalance its support point adjacent to the Island Trail (far S.E. end). Other large blocks of landslide origin rest against the rear of this block. Walnut Canyon.

½-1 meter gap adjacent to the trail (Figure 40). No motion has been observed by Monument staff, but preventative reinforcement is desirable. Whatever geometry holds this block in place also keys other rubble behind that rest on the large block.

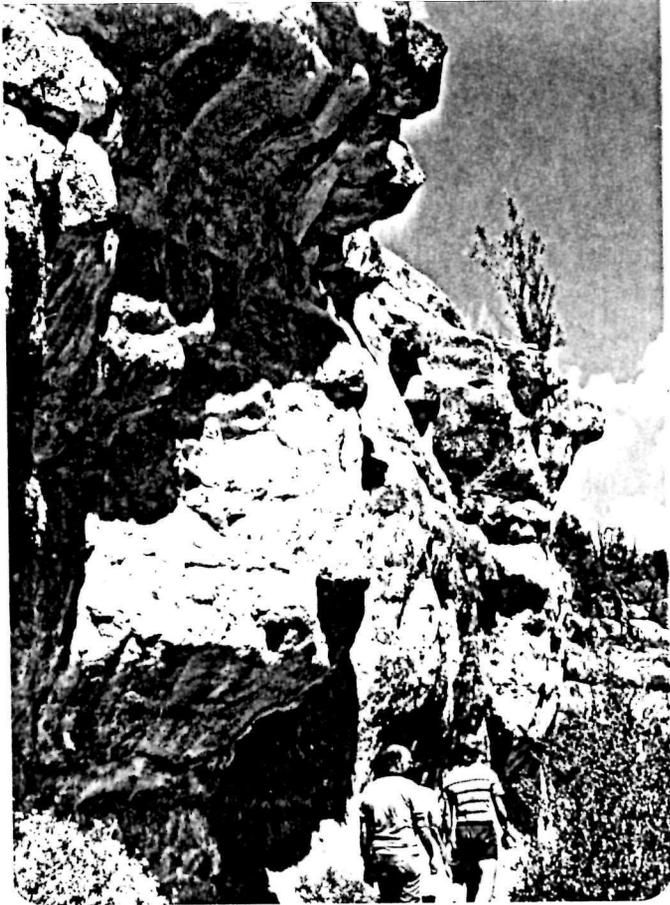
Figure 42. Unstable cliff segment is "working". Shattered soft faces have retreated due to fall exposing the harder rock above, which has also begun to crack. Near trail marker number 17. Island Trail, Walnut Canyon.

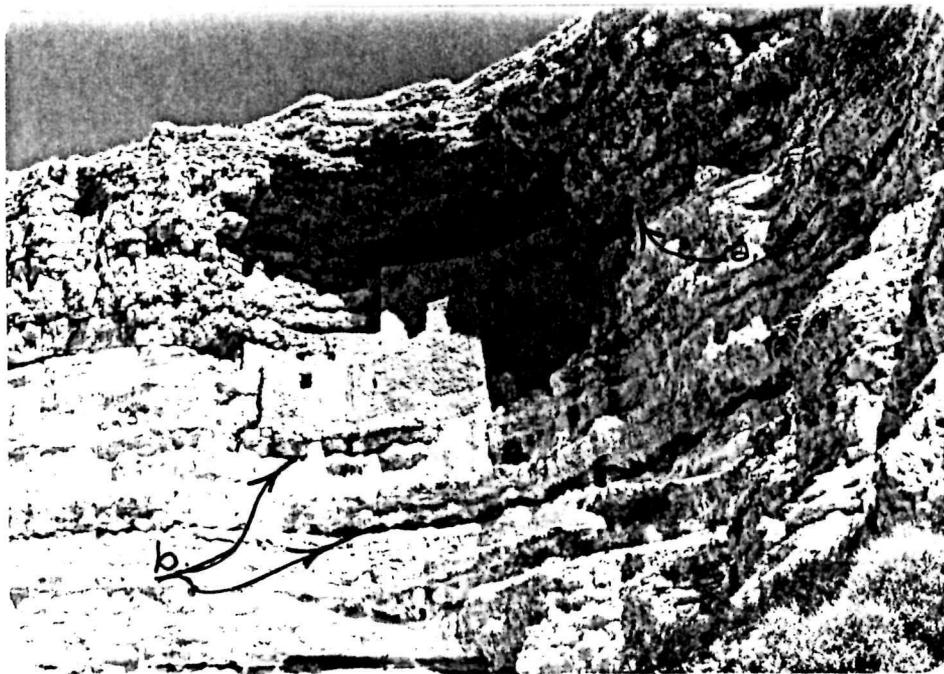
Figure 44. No obvious rock motion exists above or below the ruin. One block ("a") may be in motion. Walls showing old cracks and undermined ledges "b" below will be monitored.

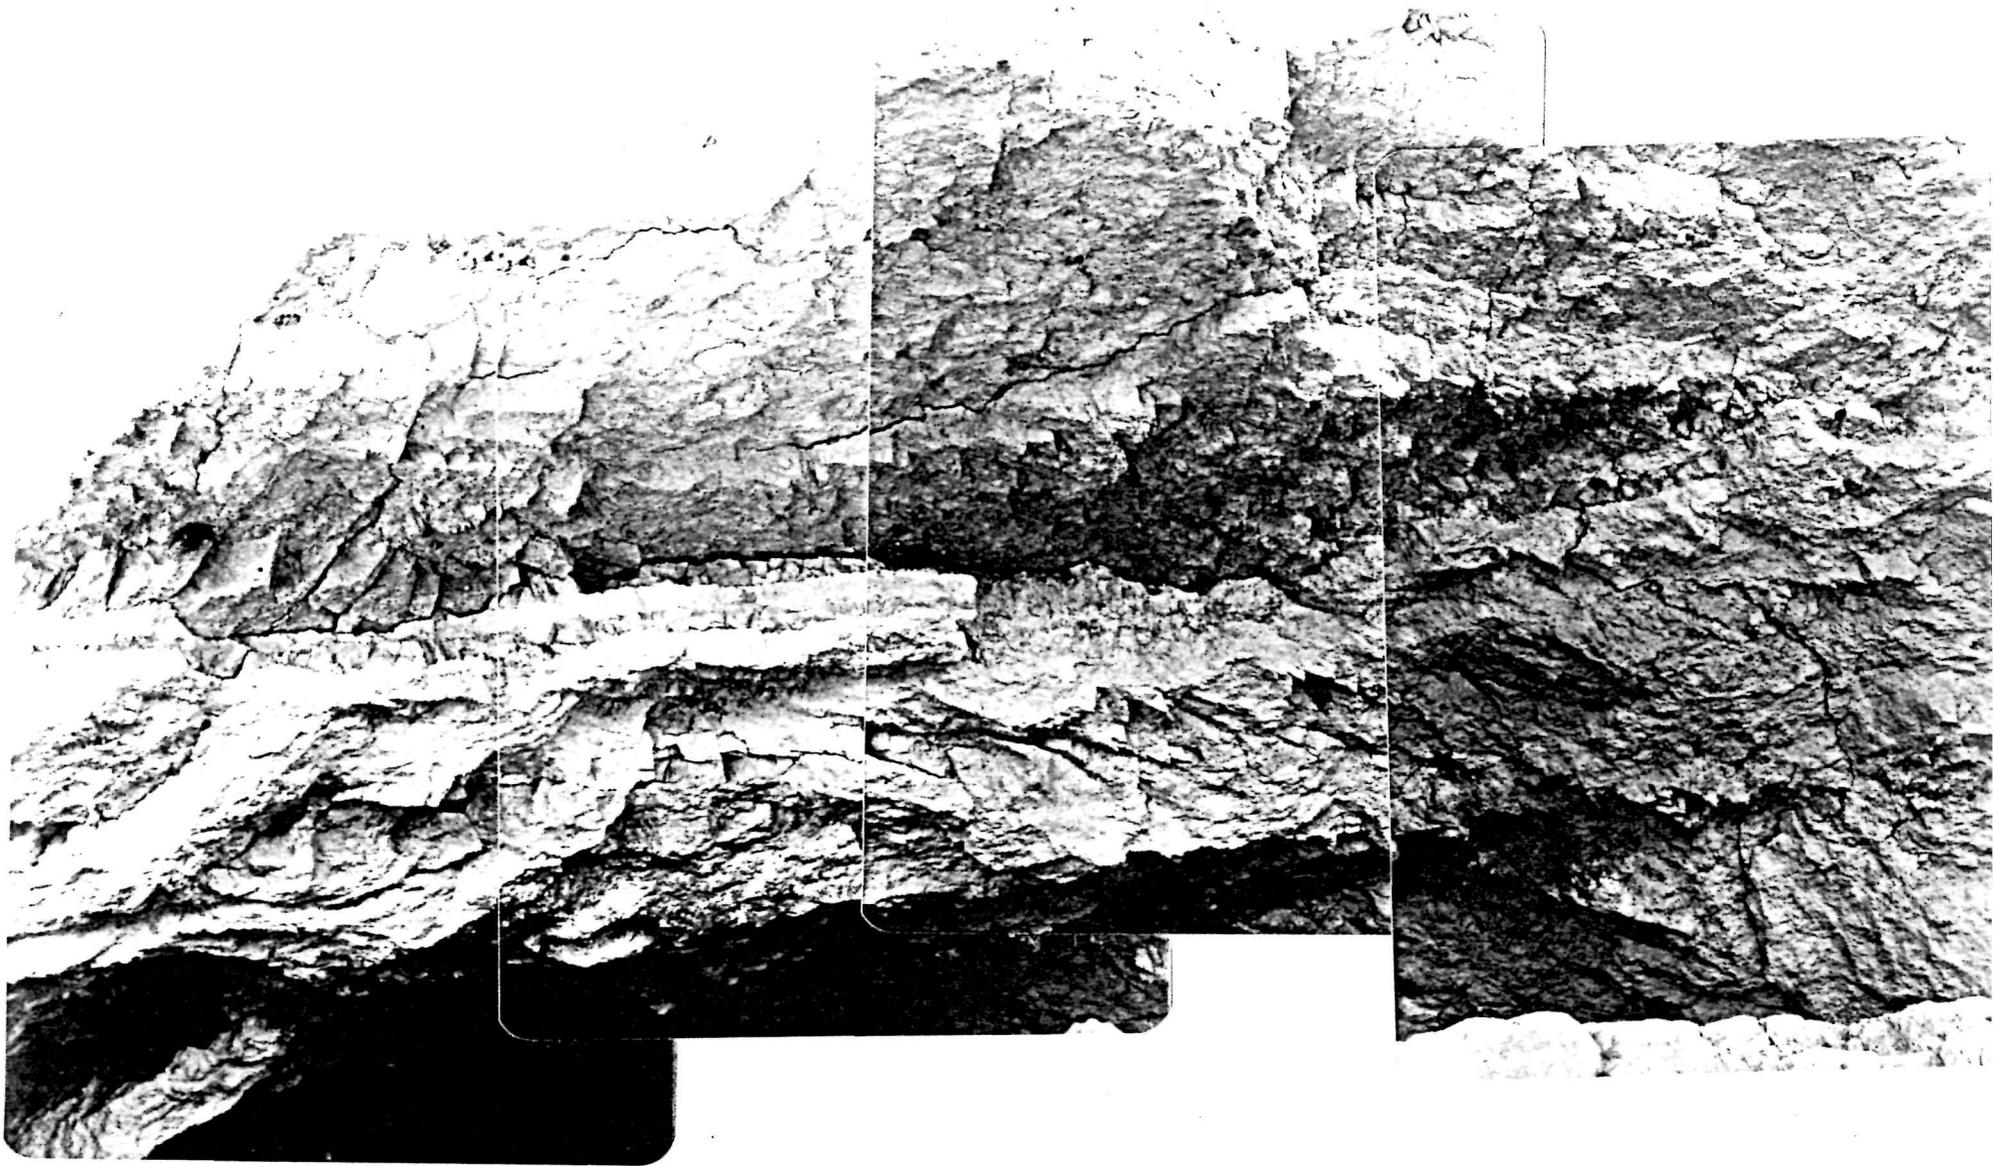
Figure 47. Crack system in grotto below Montezuma Castle. Photo time approximately 10 a.m., October 1, 1978. Kodacolor 400.

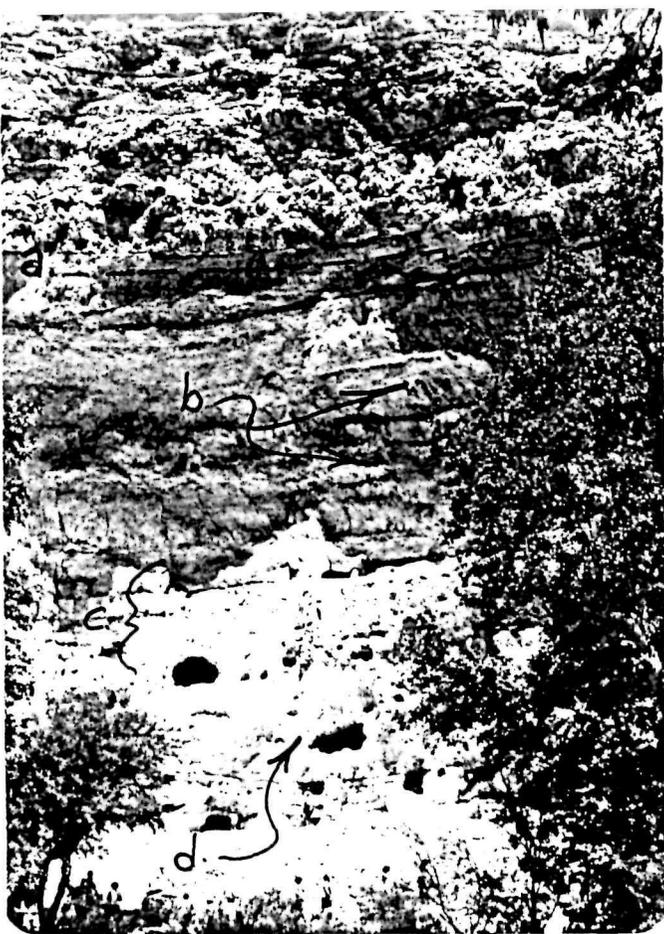
Figure 48. Unstable cliff in and above Castle "A", Montezuma Castle (see text for explanation).

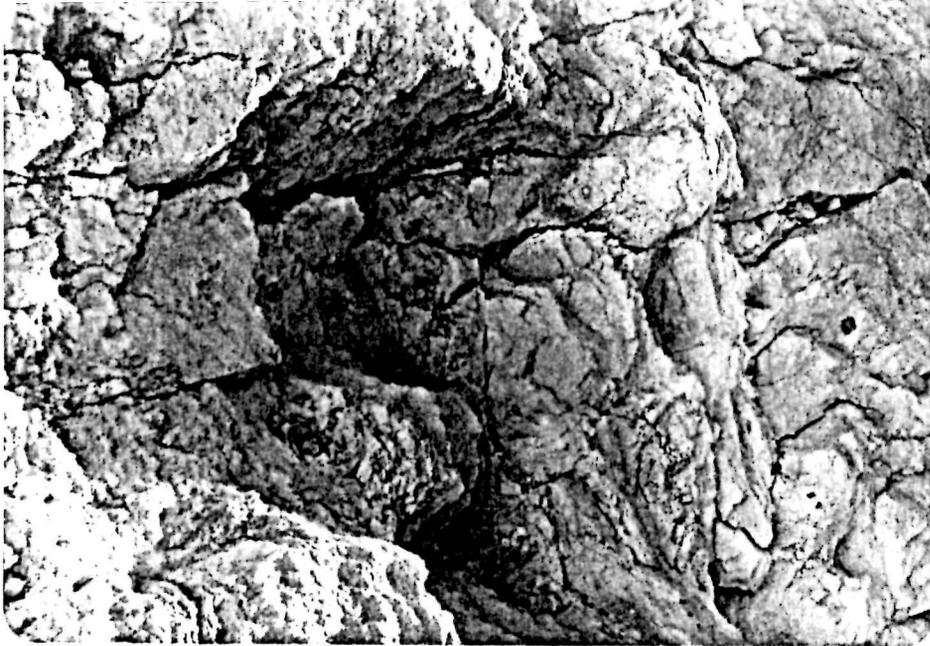
Figure 50. Shattering, zone "c" (Figure 48), Montezuma Castle.

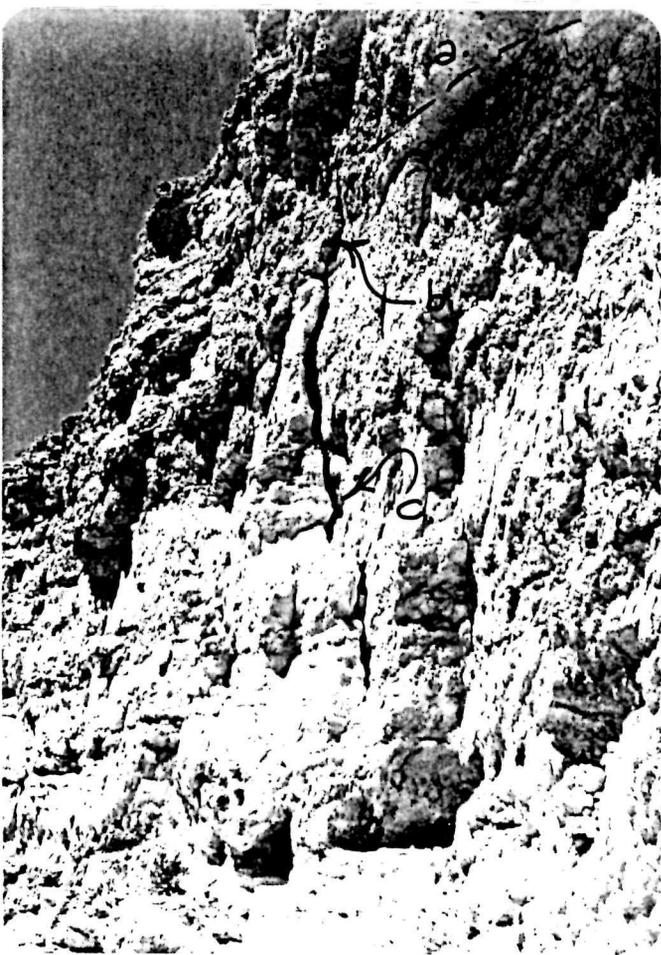
Figure 52. Slab to left of Figure 38 is not highly unstable, except possibly block "b" ("a" is continuation of line "a" of Figure 48--note fresh fall scars). Fracture C may be expanding slowly and could be monitored. Castle "A" Area.

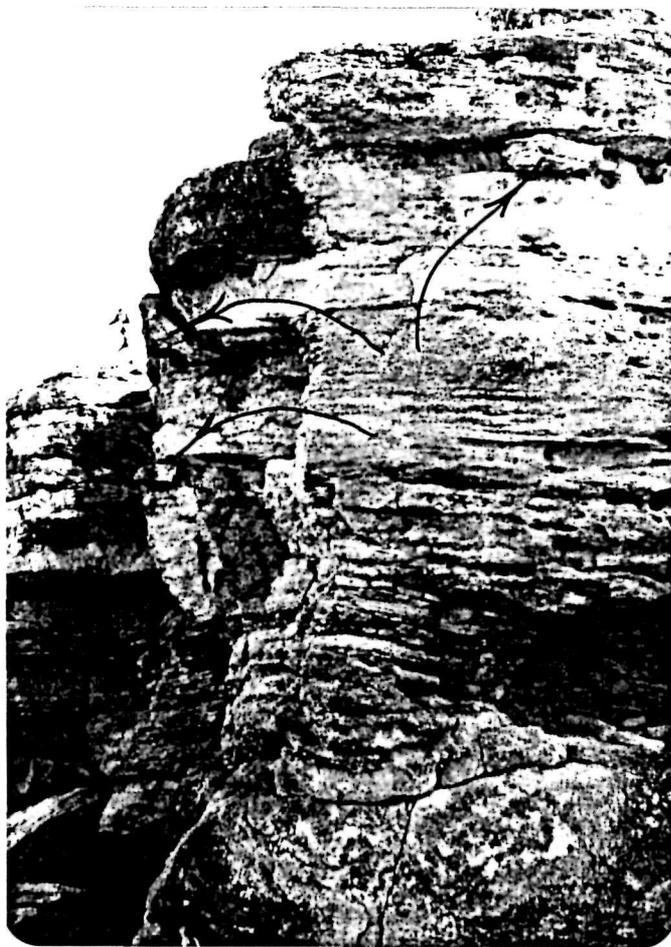
Figure 54. Very loose hanging rocks above first portion of trail into Montezuma Well.
